### **Darley Cliffe Hall Barnsley South Yorkshire**

### **Structural Watching Brief**

Report No. 033

December 2019

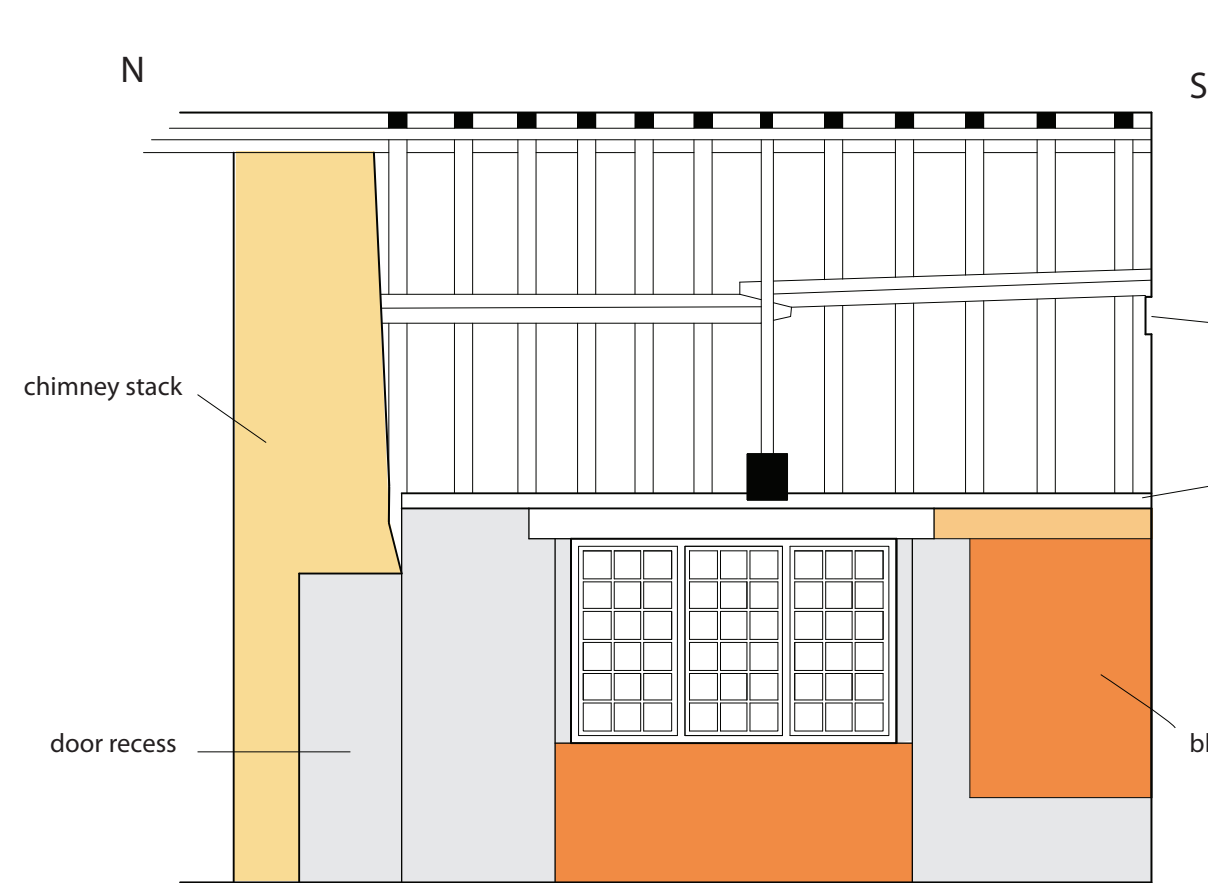
Internal east elevations

The east wall of the kitchen (Figure 3) has a splayed brick window opening with a wooden casement window frame matching the one in the west wall (Image 6). Above the window, there is a wooden lintel and below the window there is phase 2 brick work blocking what once would have been a larger opening. Below the wooden lintel

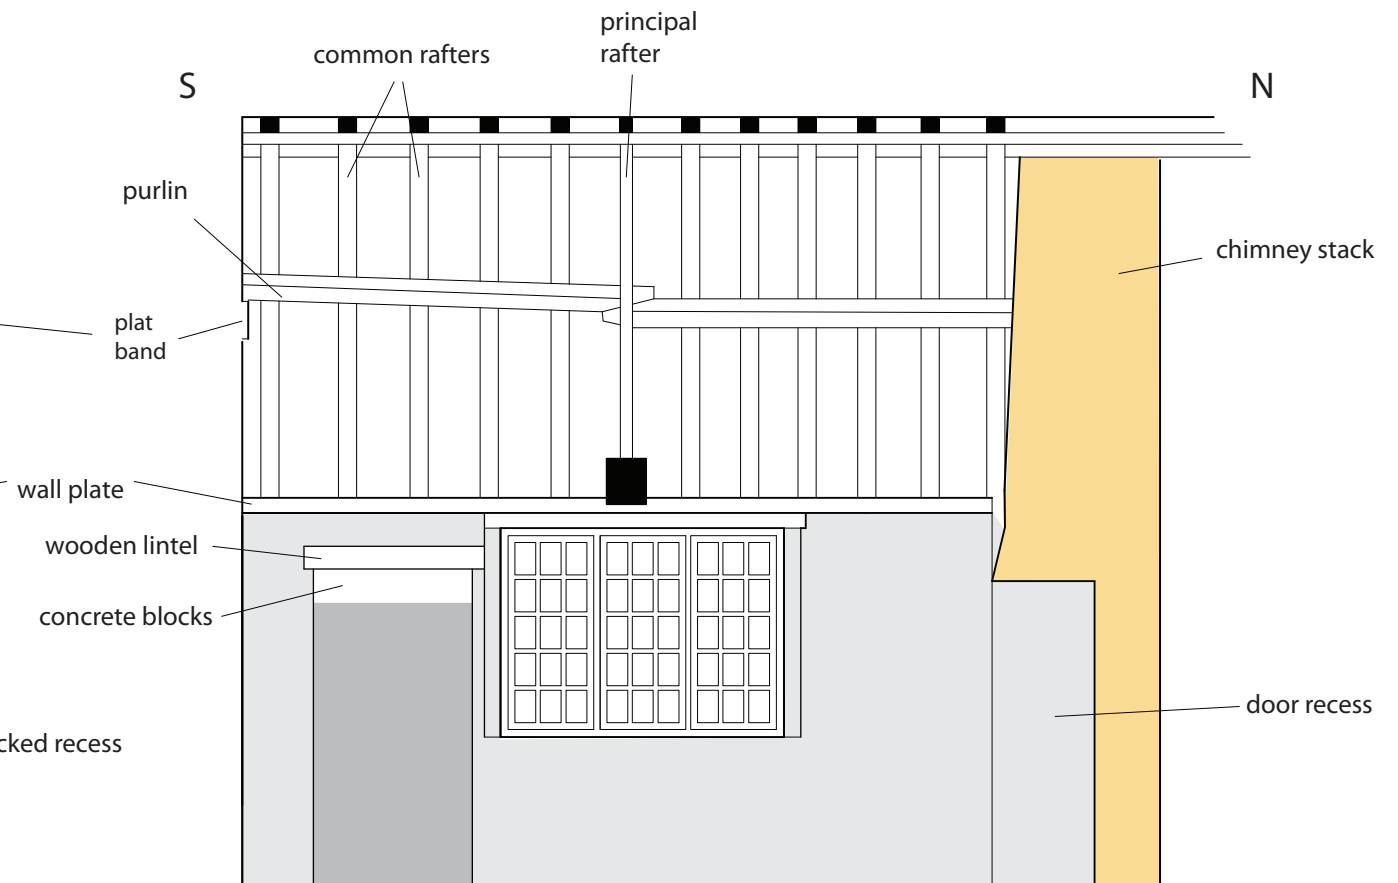
Internal west elevations

The internal west wall of the kitchen (Figure 3) has a centrally-placed splayed window opening fitted with a wooden 3-light casement frame (Image 1) above which there is an exposed wooden lintel. To the south of the window there is a stone blocked doorway with a wooden lintel (Image 2). Just below the lintel of the blocked door there are two courses of concrete blocks which have been added for additional support.

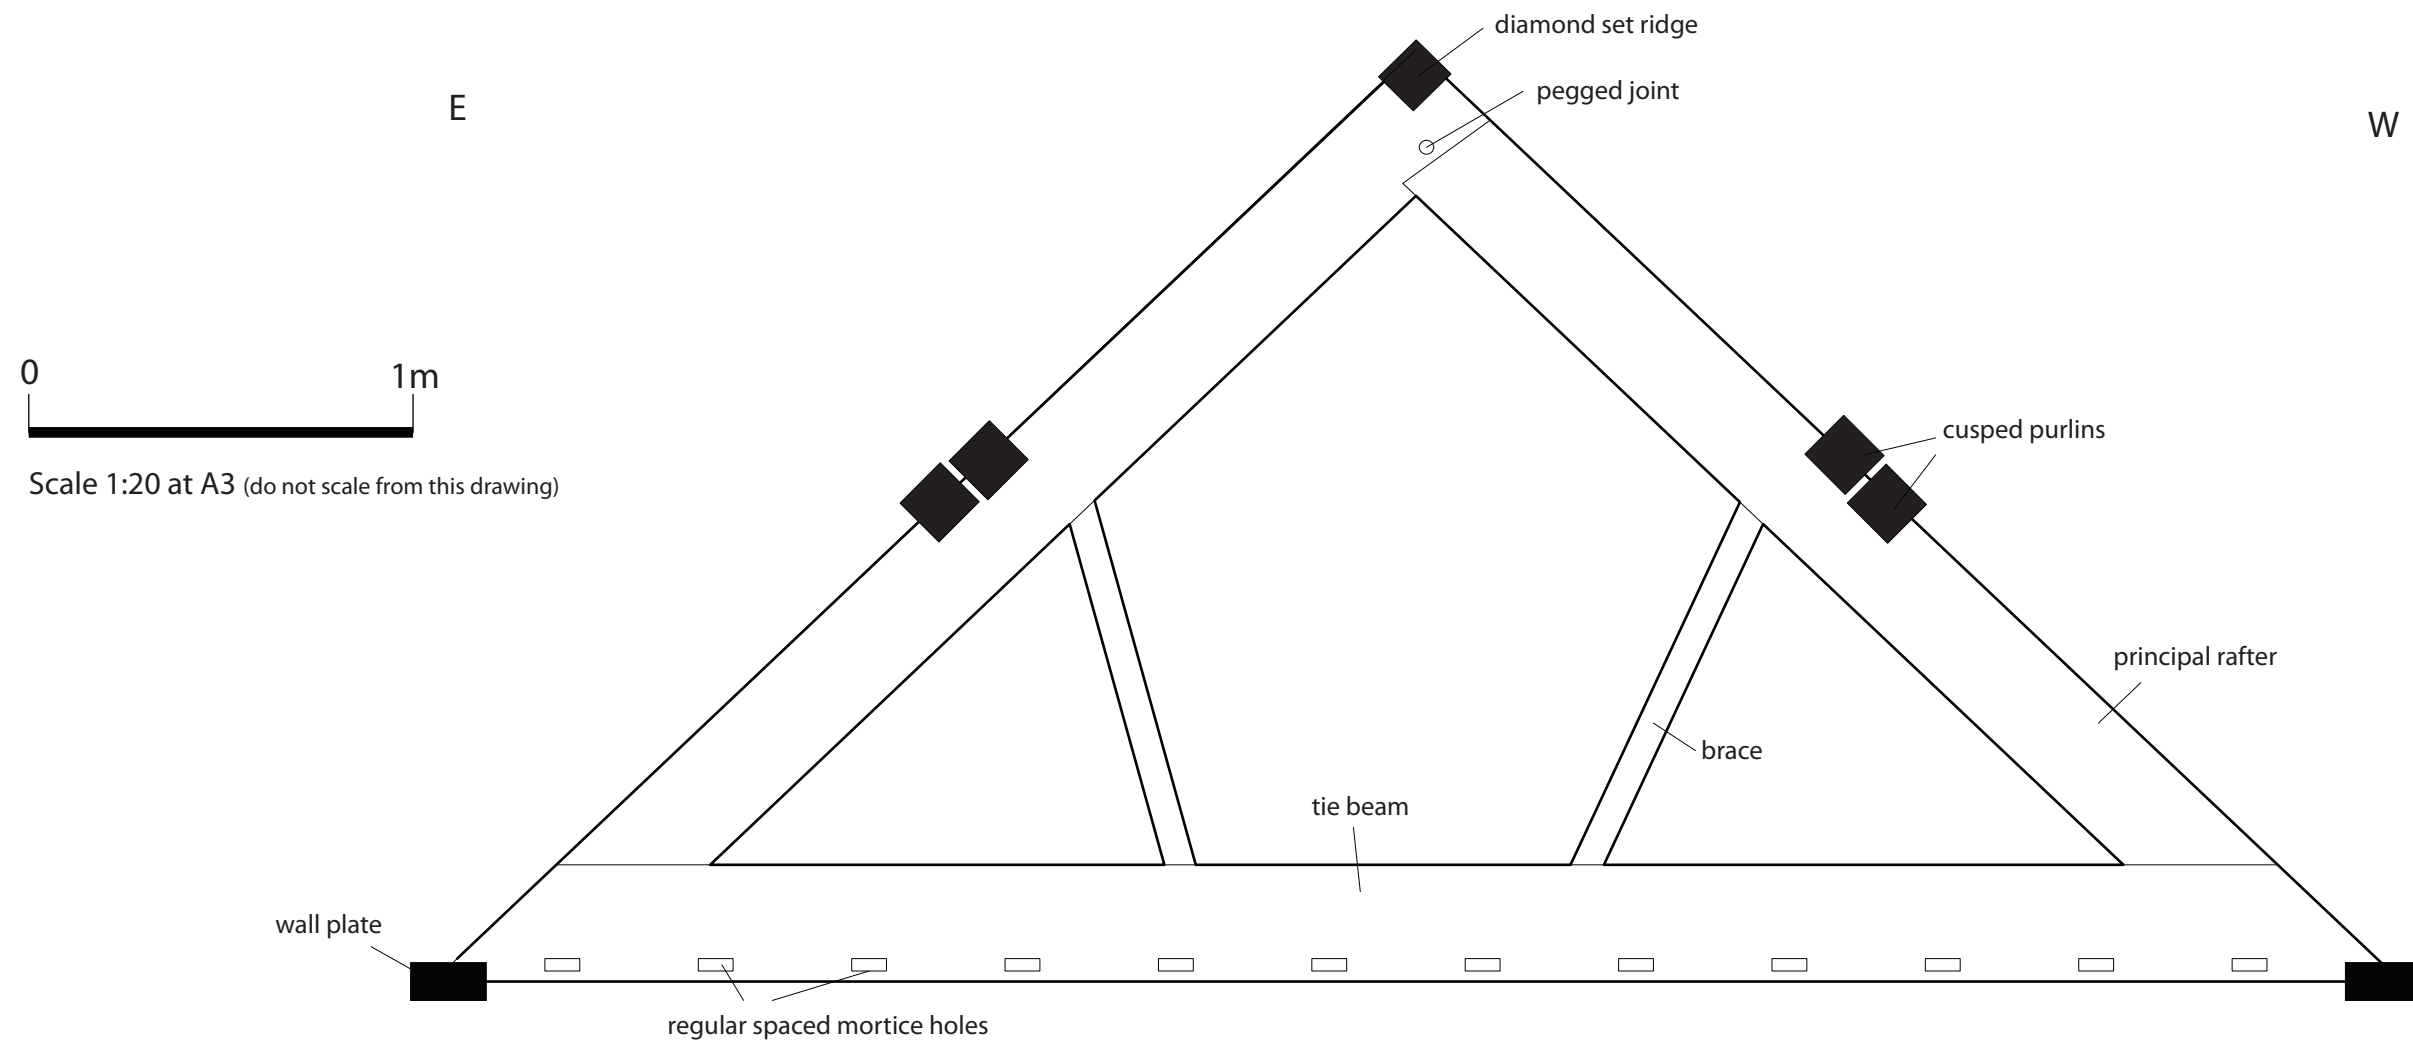
Truss over the kitchen area

The truss over the kitchen (Figure 5) has large principal rafters which are pegged at the ridge (Image 14) and the tie beam has regularly spaced mortise holes to both faces (Image 13). A peg hole was also noted between the principal rafter and the tie-beam, but no peg was present (Image 19). The principal rafters are supported by two roughly cut braces (or queen struts) and have plaster lines indicating the height of a former raised ceiling. The purlins are trenched on to the principal rafters and support irregular-shaped common rafters which have additional softwood bracing (Image 15 to 18). There is a modern breathable membrane between the common rafters and the stone roof slates.

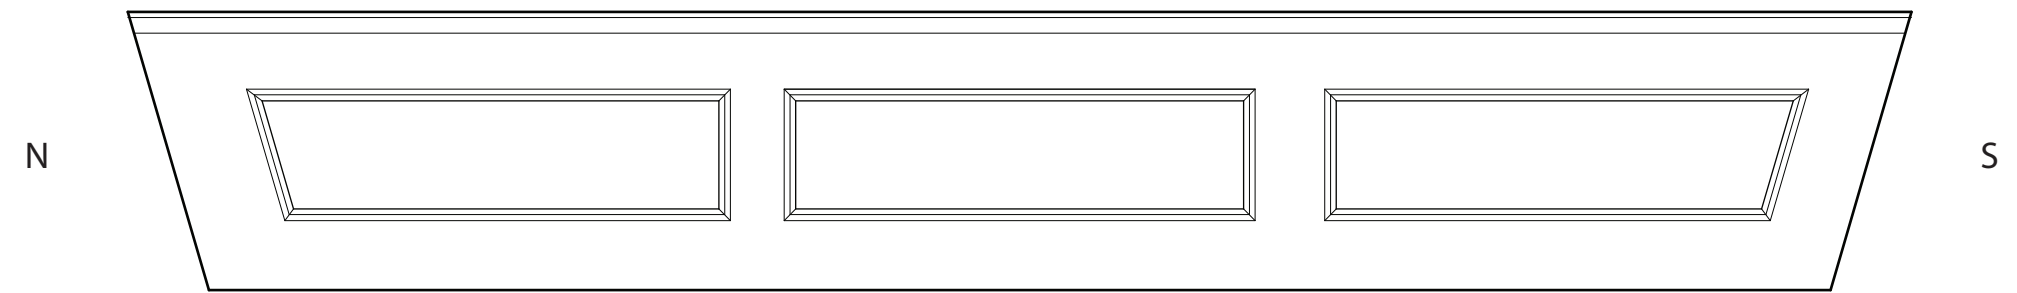
Panelling over east window in the kitchen

and over the window there is a section of wooden panelling which tapers towards the window (Figure 5) (Image 20). To the south of the window there is phase 2 brick blocking a recess, which retains traces of plaster on the stone that continues on behind the brick blocking.

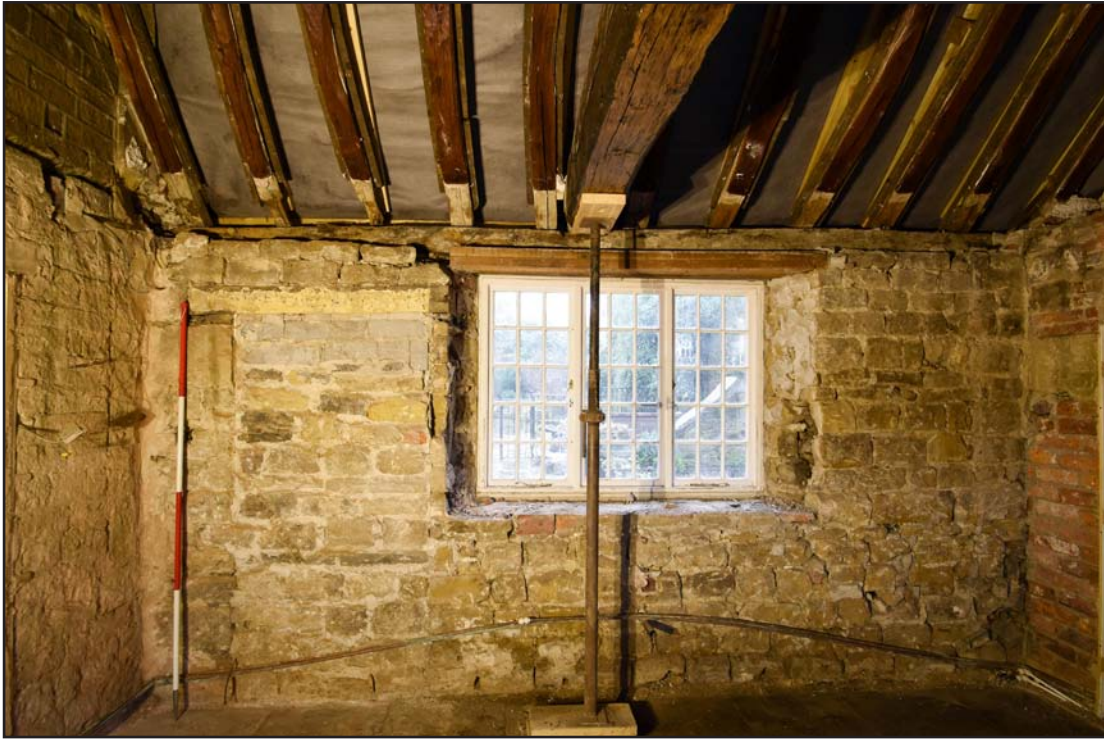
**Image No. 1**

**Description:** Exposed west wall of the kitchen extension

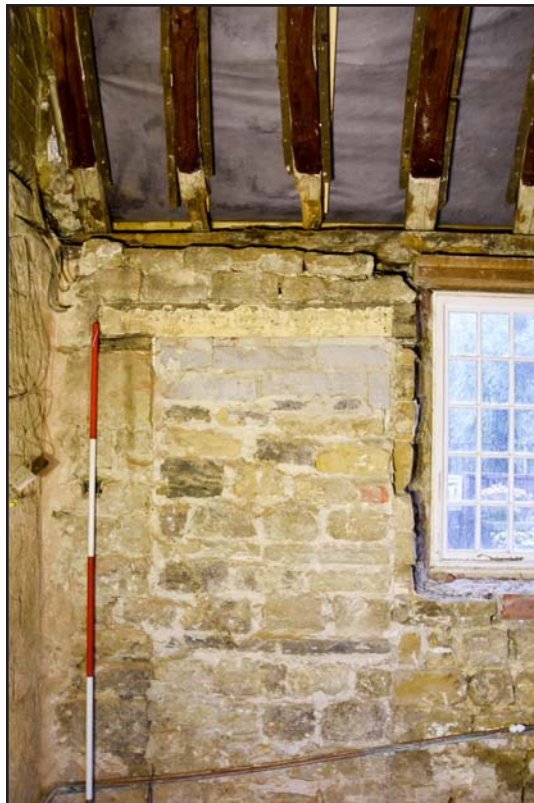
**Image No. 2**

**Description:** Detail of the west wall in the kitchen extension showing a blocked doorway to the south of the window

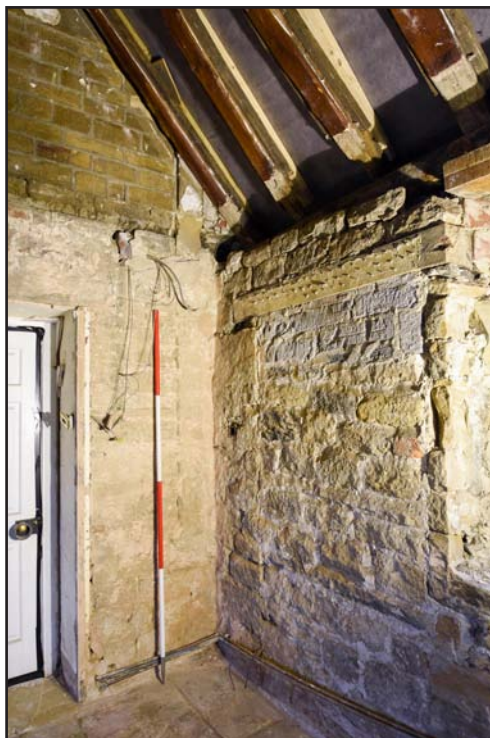
**Image No. 3**

The south wall of the kitchen (Figure 2) contains the doorway into the Hall (Image 4) and to the west of this, there is a straight joint in the stonework (Image 3) which runs up to part of an extant stone window reveal belonging to the hall; the face of the stonework has been hacked for a better key for plasterwork. Above the doorway in the south wall the stonework has been cut back to house the joists for the ceiling which has now been removed. Above the level of cut back, the stonework in the south wall is finely finished and contains a continuous stone plat band visible on the external elevations of the hall, which is used within the kitchen space to support the southern end of the purlins in the roof (image 5).

**Description:** Detail of the west and south walls in the kitchen extension showing a blocked doorway to the south of the window and blocked window opening in the south wall

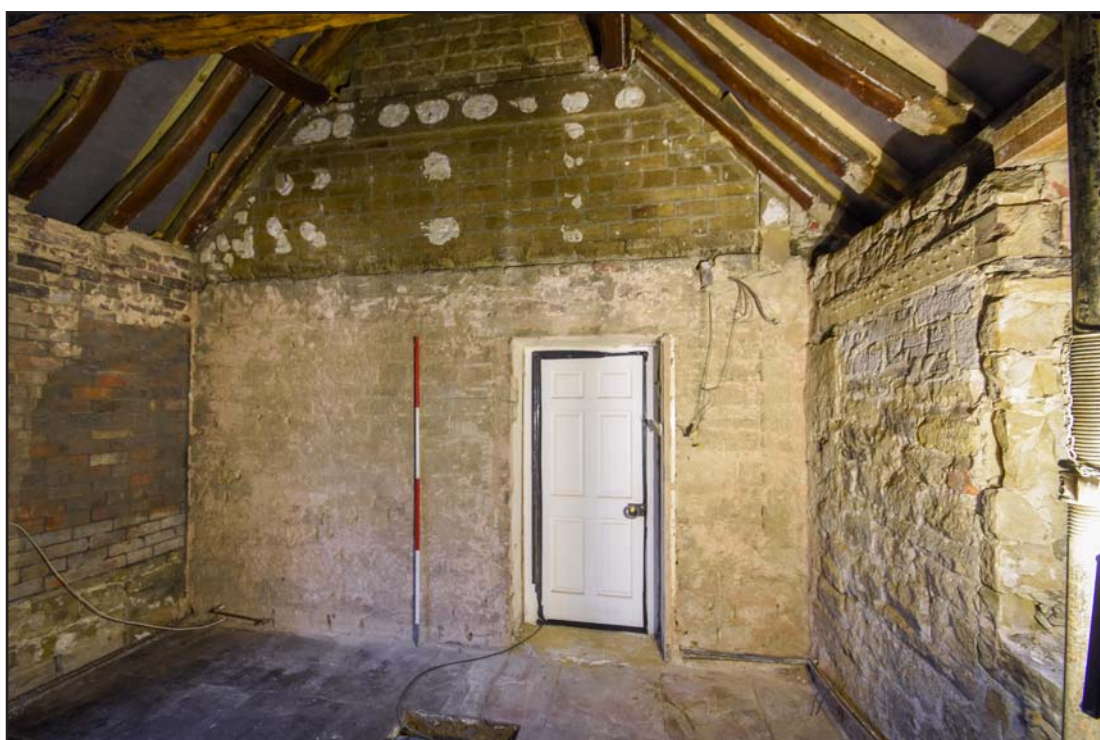
**Image No. 4**

The kitchen is built against the north side of the hall and is rectilinear in plan, orientated on a north-south axis with the principal entry point in the east elevation from the courtyard to the front of the Hall. There is a small entrance vestibule in a late-20<sup>th</sup> century lean-to addition built against the north gable of the kitchen, currently used for storage to the north of the kitchen but this has not been recorded as part of this project. From the entrance vestibule there are two doorways that lead into the former kitchen in the north wall (Image 7). At the southern end of the kitchen there is a six panelled door leading into the Hall (Image 4).

The exposed plat-band and part of a window reveal in the south wall of the kitchen shows that this part of the building is clearly a later extension to the earlier Hall (Image 4). The blocked doorway to the south of the window in the west wall (Image 3) can be seen from the outside (see cover image), however, the large opening in the east wall, that extends below the level of the window, (image 6) cannot be seen from the outside and is somewhat of a mystery as to its function. The traces of plaster running behind the blocked opening to the south of the window in the east wall shows that this was once a plastered recess, perhaps for a cupboard.

**Description:** Exposed south wall of the kitchen extension

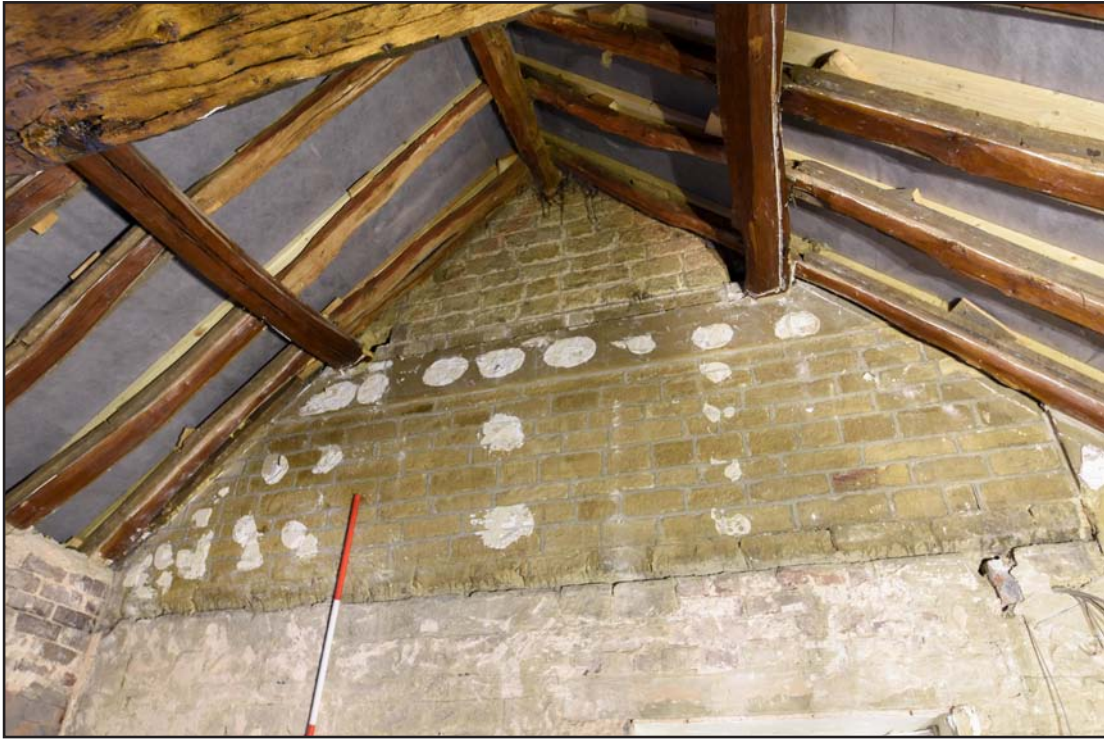
**Image No. 5**

**Description:** Detail showing the purlins of the kitchen extension roof resting on the external plat band of the hall

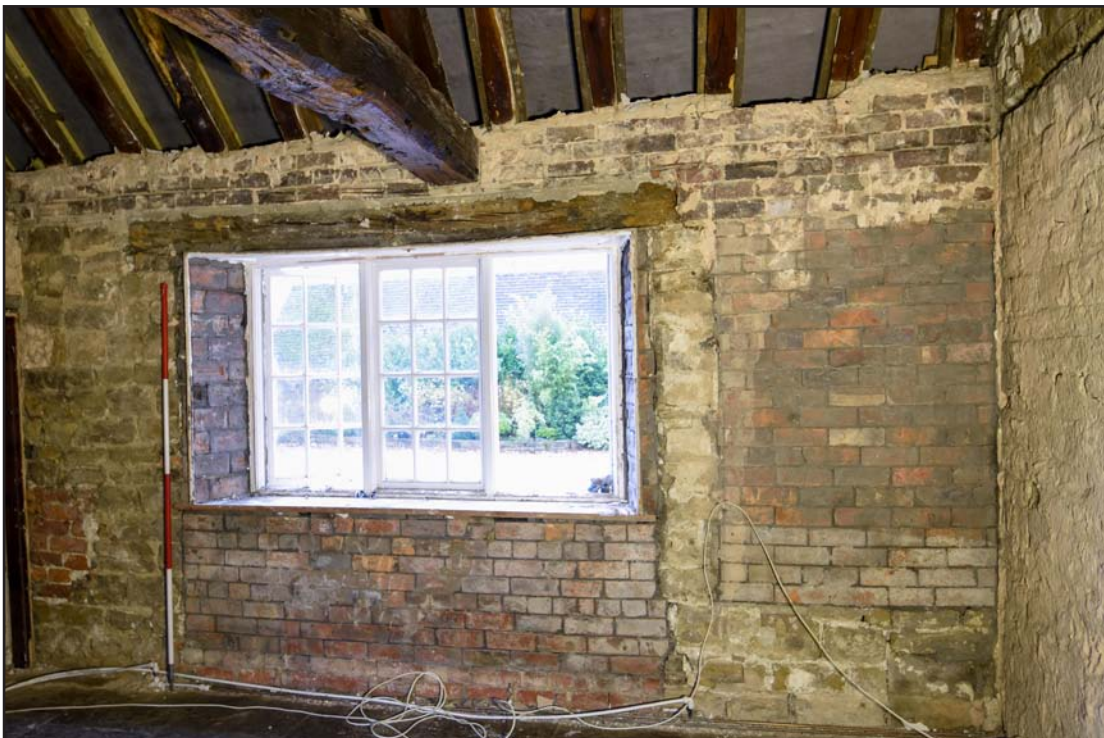
**Image No. 6**

**Description:** Exposed east wall of the kitchen extension showing brickwork below the window and a brick blocked recess to the south of the window

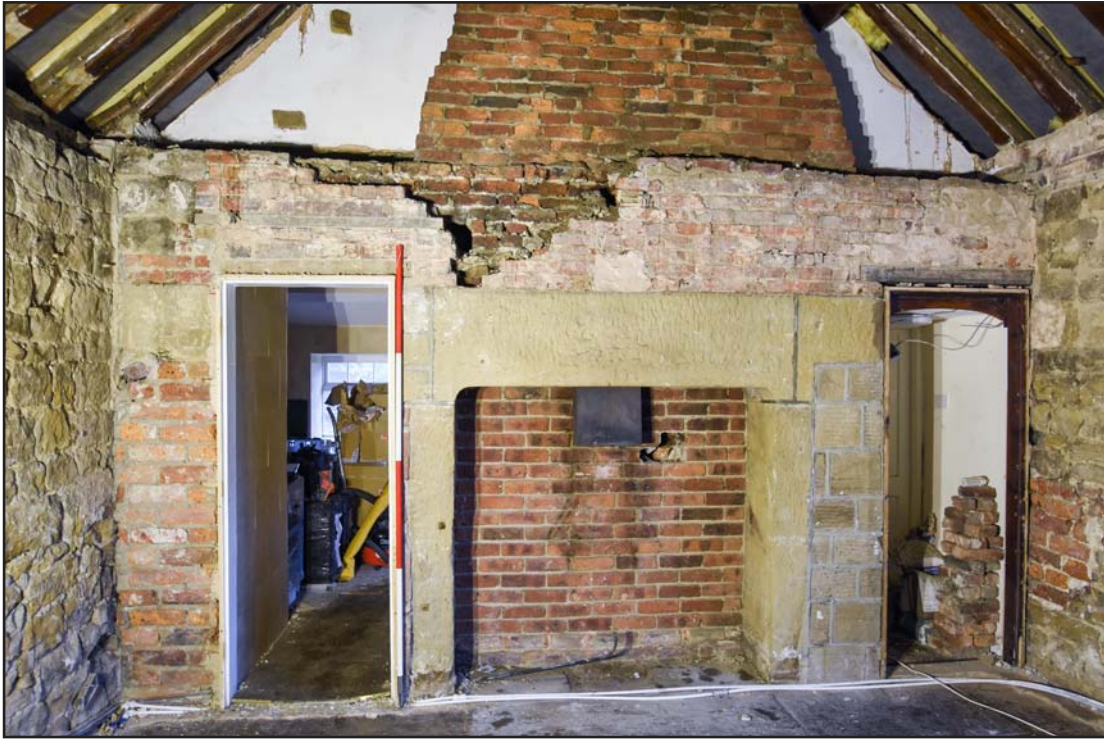
**Image No. 7**

The north wall of the kitchen (Figure 2) contains 2 doorways into the entrance vestibule, one on each side of a fireplace which has a large stone lintel (Image 7). Above the stone lintel of the fireplace there are 9 courses of phase 2 brick and behind this, there are exposed courses of phase 1 brick which make up the chimney stack (Image 8). To the east of the fireplace, there is part of a large stone lintel which appears to have been cut by the doorway and the space below this is blocked by finally-tooled phase 2 stonework. The open fireplace has a modern metal flue projecting below the line of the lintel and the back of fire back is lined with modern engineering phase 3 brick laid in a stretcher bond.

**Description:** Exposed north wall of the kitchen extension showing doorway and a stone fireplace

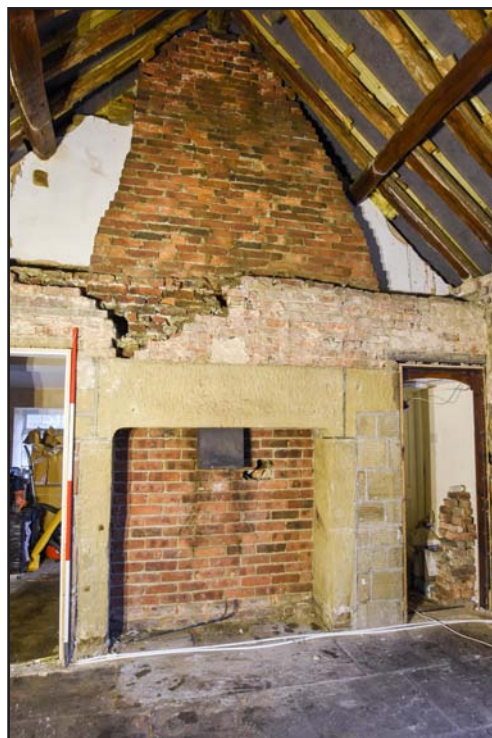
**Image No. 8**

**Description:** Exposed north wall of the kitchen extension showing the stone fireplace with a brick stack above

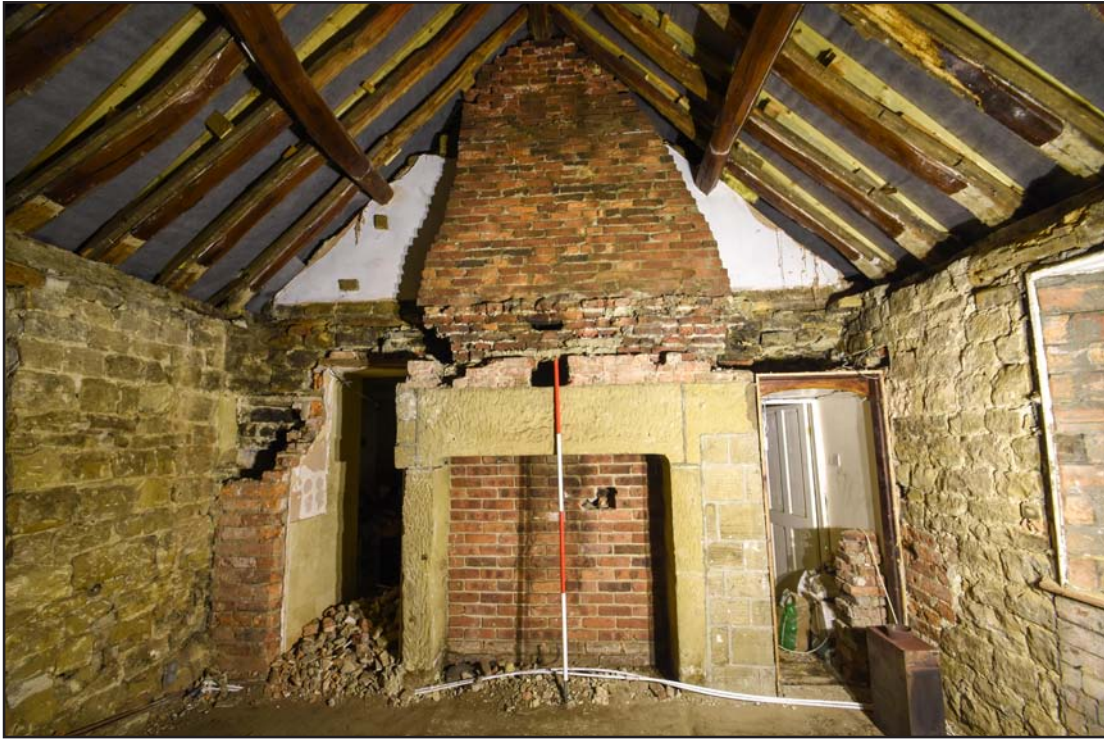
**Image No. 9**

**Description:** North wall after the removal of some of the later brick exposing more of the chimney stack

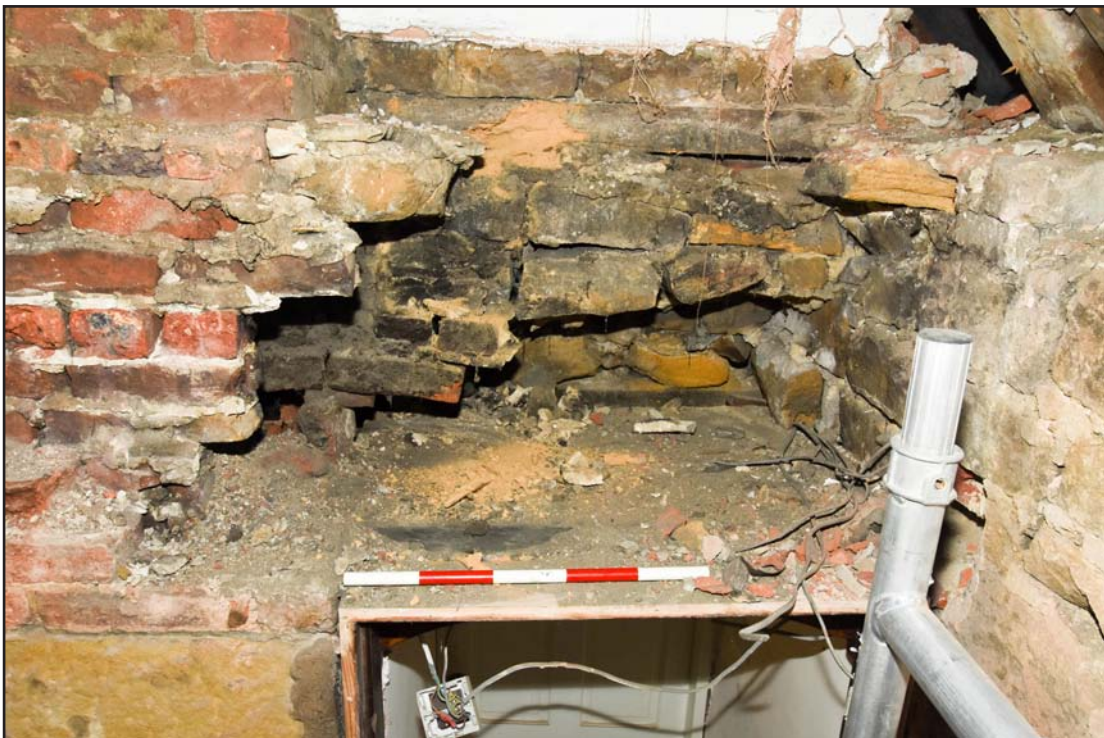
**Image No. 10**

**Description:** Exposed flue above the doorway in the north wall

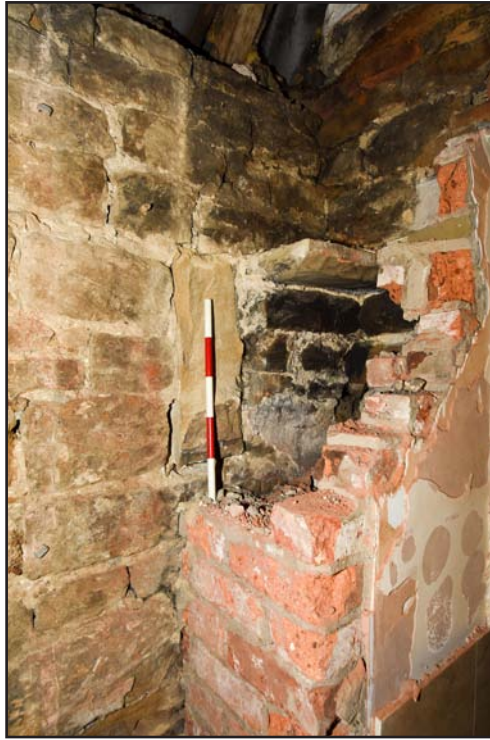
**Image No. 11**

**Description:** Exposed flue to the side of the doorway in the north wall

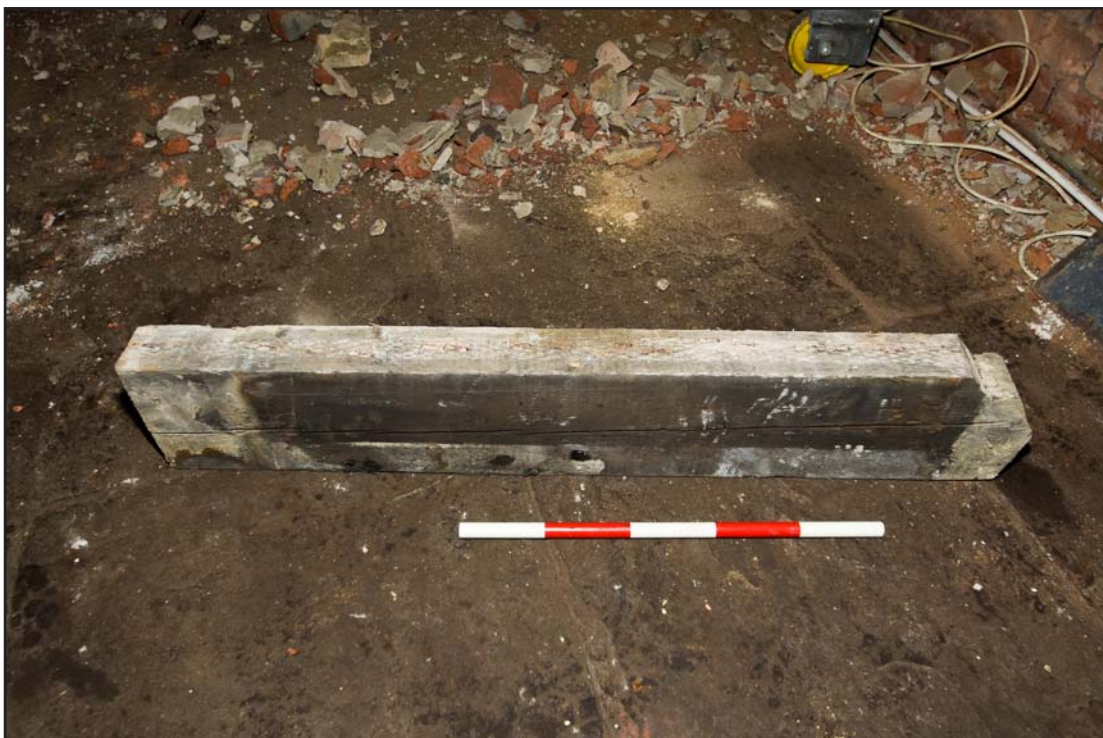
**Image No. 12**

To the west of the fireplace in the north wall, there is brick work (phase 2) above and below a large block of stone that is tied into the west wall. When the brick above this stone and above the doorway to the east of the fireplace was removed the tops of flues were exposed running into the brick stack (Image 9, 10 and 11). The lintel above the doorway to the east of the fireplace was also removed but shows no signs of reuse (Image 12).

**Description:** Door lintel removed from above the doorway into the entrance passage of the kitchen extension

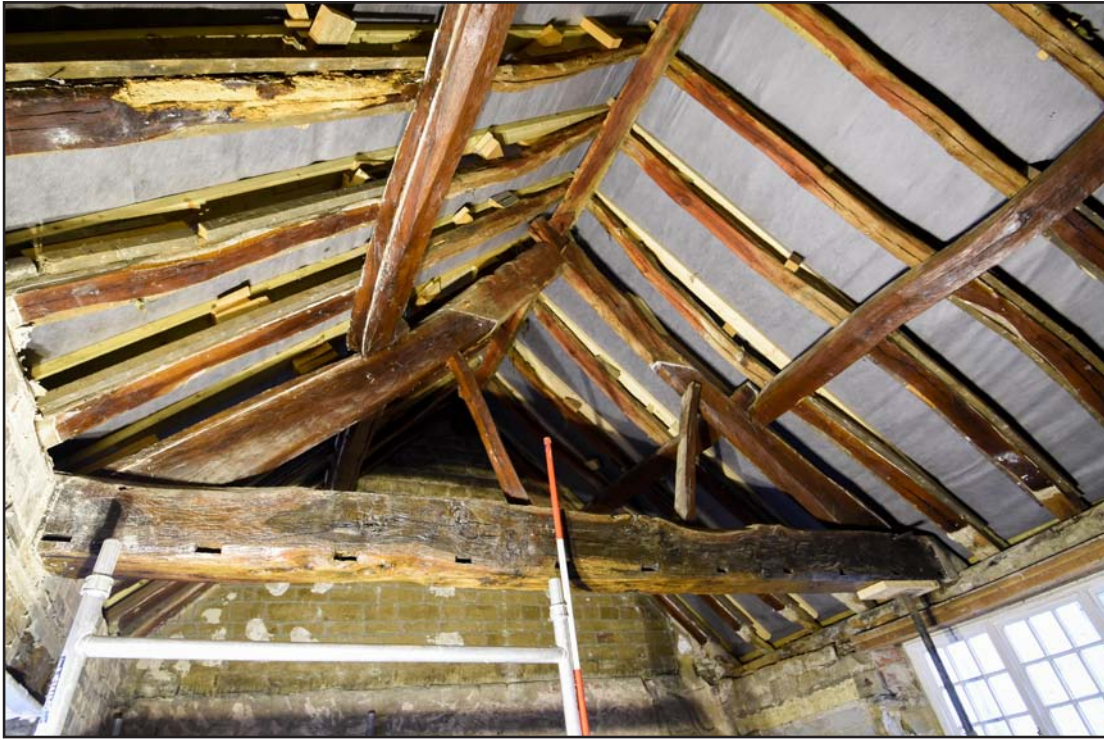
**Image No. 13**  
**Film No.** Darley Cliffe Hall\_016  
**Direction:** SW  
**Description:** North face of the truss

The kitchen structure has been recently reroofed evidenced by the presence of softwood bracing to the common rafters and the breathable membrane below the stone slates. The height of the cut back in the stone of the south wall matches the height of the regularly spaced mortise holes in the tie beam showing the level of the former roof structure, however, the presence of plaster lines on the principal rafters, and purlins (Image 13) shows that there was an earlier ceiling present.

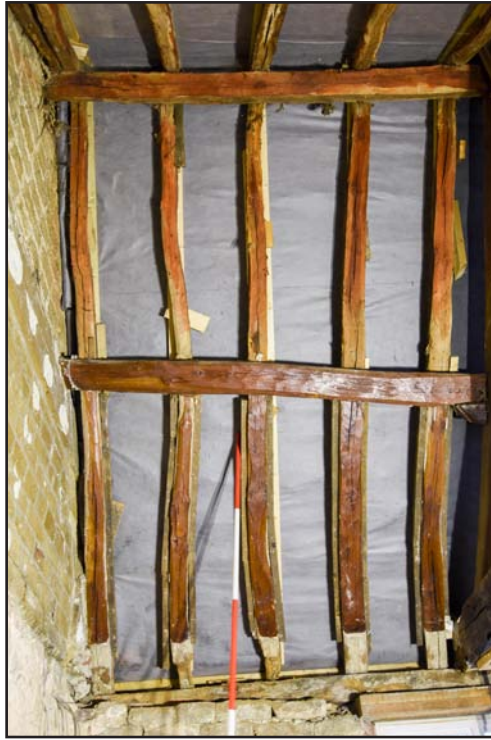
**Image No. 15**

**Description:** West slope of the roof showing the common rafters in the south bay

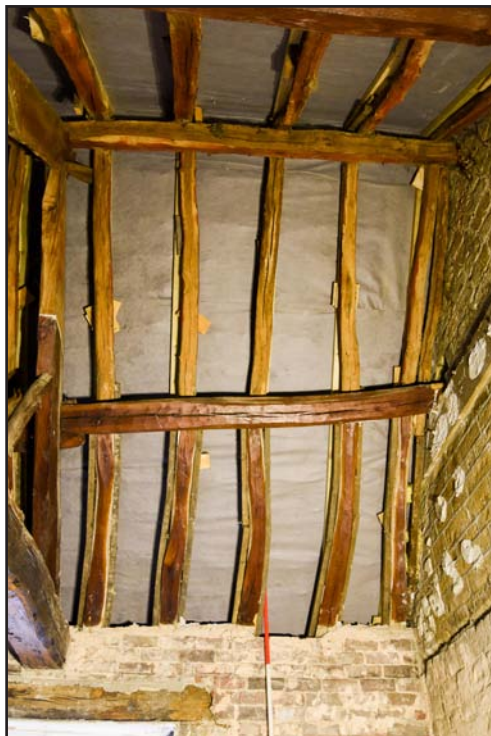
**Image No. 16**

**Description:** East slope of the roof showing the common rafters in the south bay

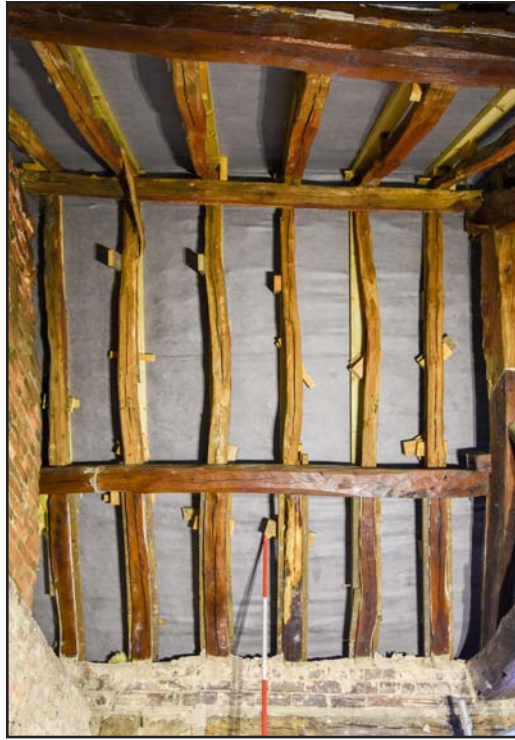
**Image No. 17**

**Description:** East slope of the roof showing the common rafters in the north bay

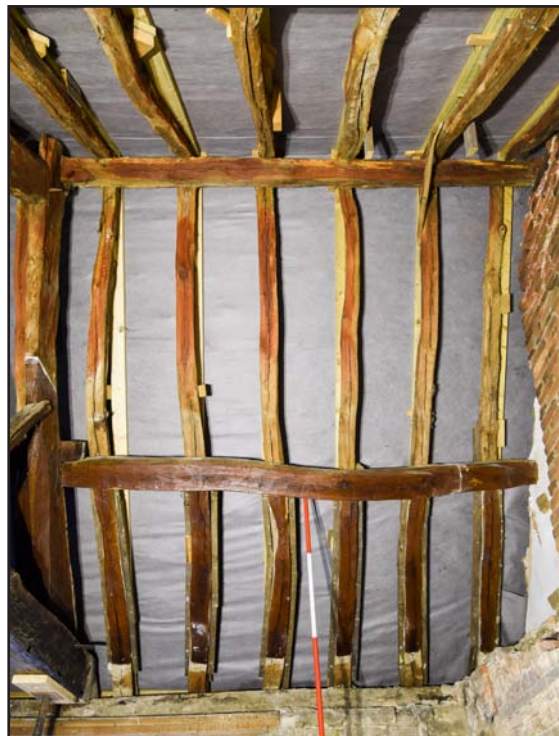
**Image No. 18**

**Description:** West slope of the roof showing the common rafters in the north bay

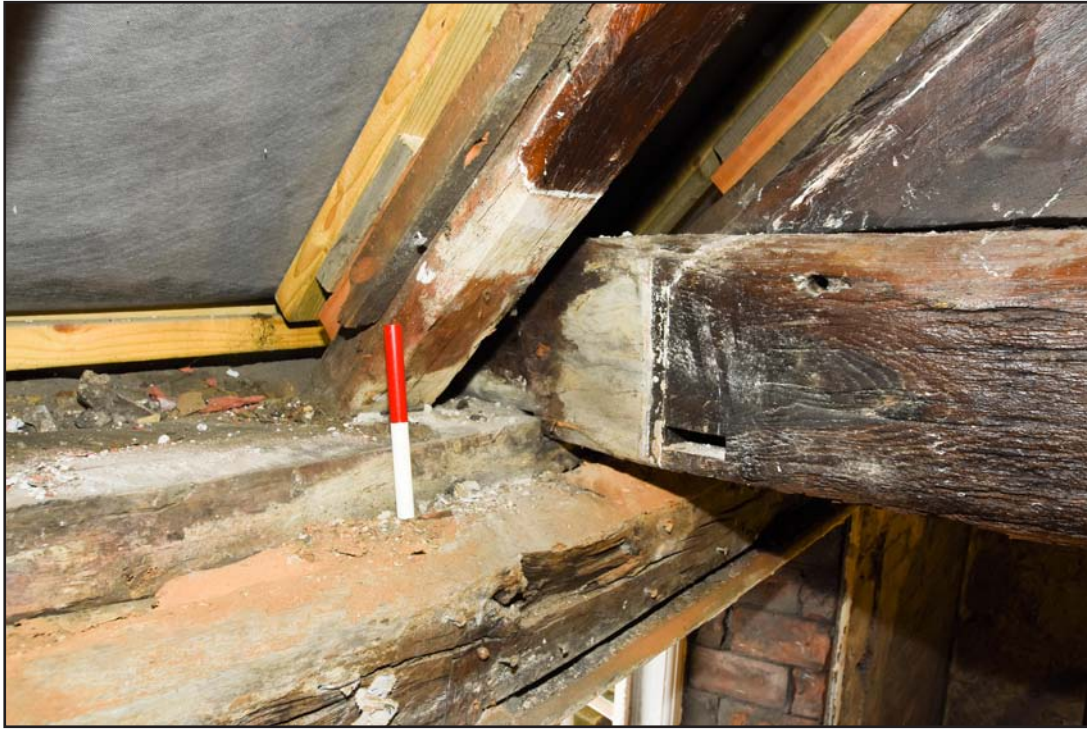
**Image No. 19**

When the courses of phase 2 brickwork, which capped both the east and west walls, were removed it revealed the wall plates on either side of the room showing that the tie beam was notched to fit over the wooden wall plate (Image 19).

**Description:** Detail showing the wall plate and the tie beam over the window in the east wall

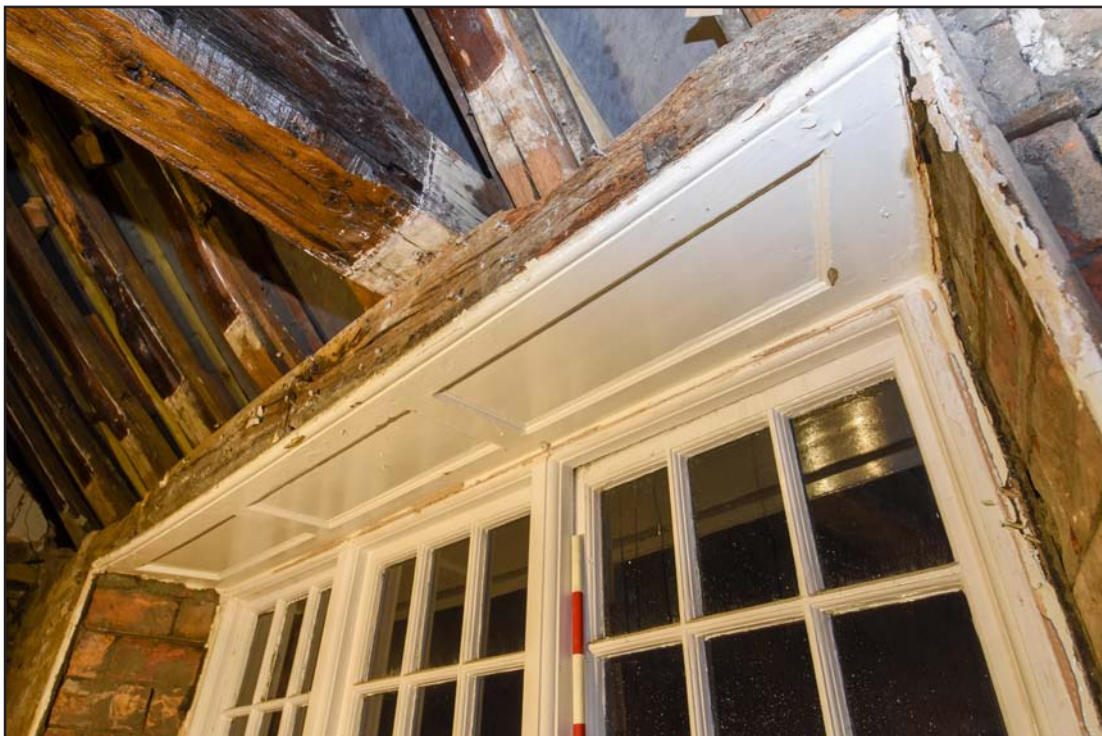
**Image No. 20**

**Description:** Detail of the panelling over the east window

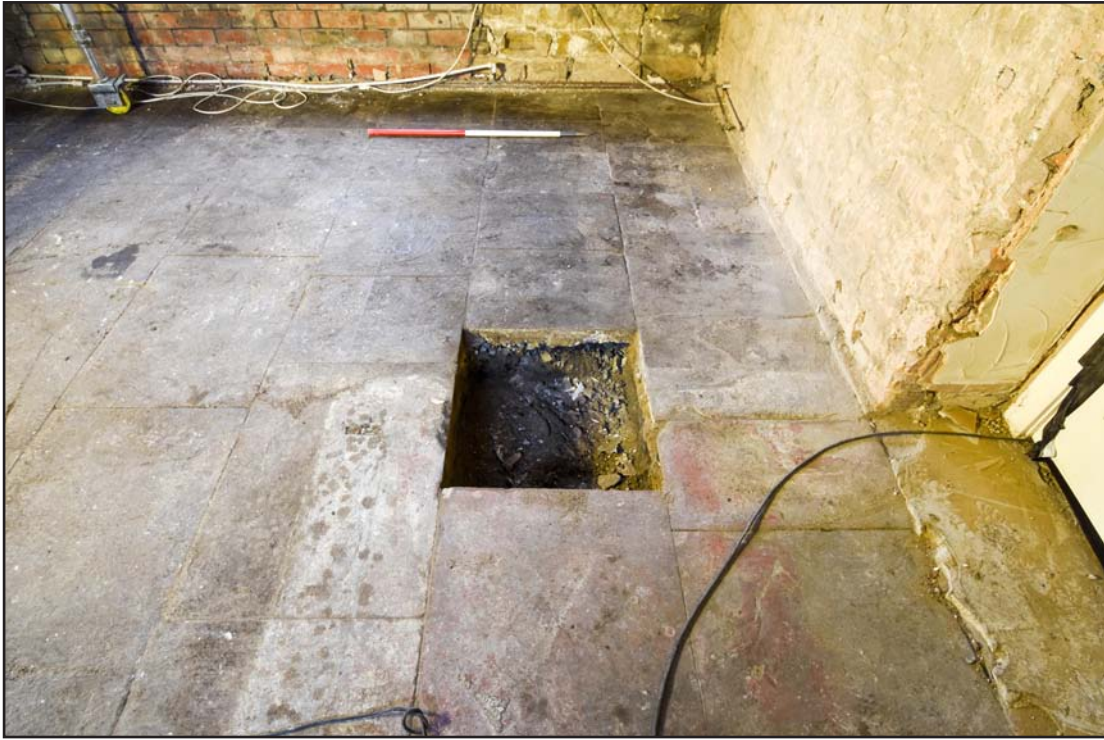
**Image No. 21**  
**Film No.** Darley Cliffe Hall\_018  
**Direction:** NE  
**Description:** Stone flagged floor in the south east quadrant of the room

The kitchen has a stone flagged floor covering an area 4.95m by 4.50m (Figure 4) (Images 21 to 24). The jointing between the stone flags are narrow and the length of each of the flags is relatively uniform varying between 0.61m and 0.70m at their extremes. One of the flags had been removed to reveal the bedding material for the floor to be a combination of sand, dark soil, ash over a bed of coal (Image 21).
