WHALEY ROAD, BARUGH GREEN, BARNSELEY

PHASE 2 SITE INVESTIGATION REPORT

MELIA SMITH & JONES LIMITED

Report No. K0030-BLP-ENV-R-003

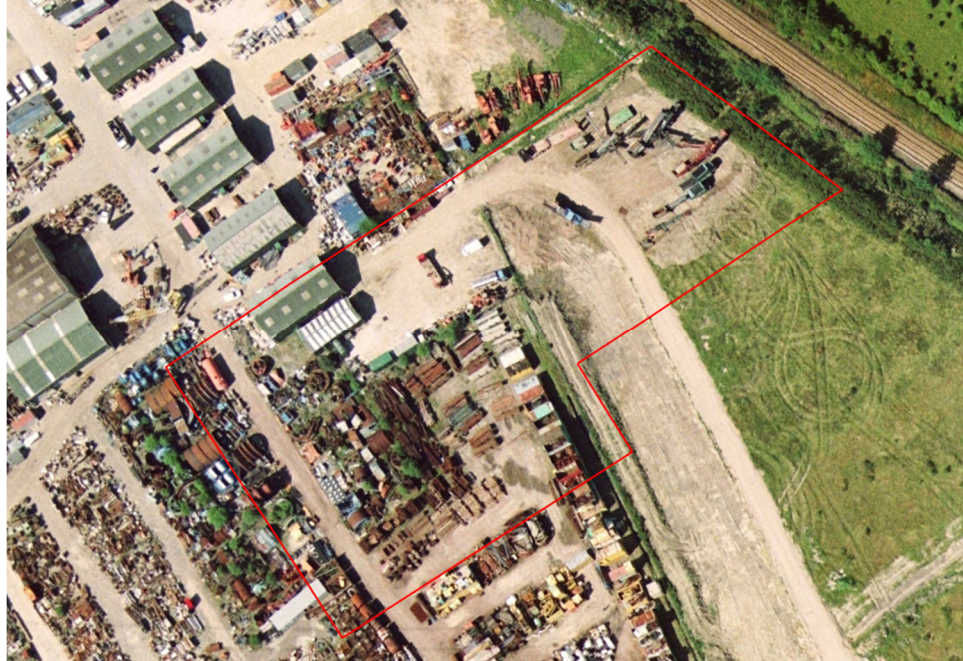
According to the Google Earth imaging, from **1999**, the south-western half of the site was utilised for storage of building products and included bowzers and 2 No. portal frame structures. The north-eastern half of the site was a parking area for plant (crusher and flat bed wagons).

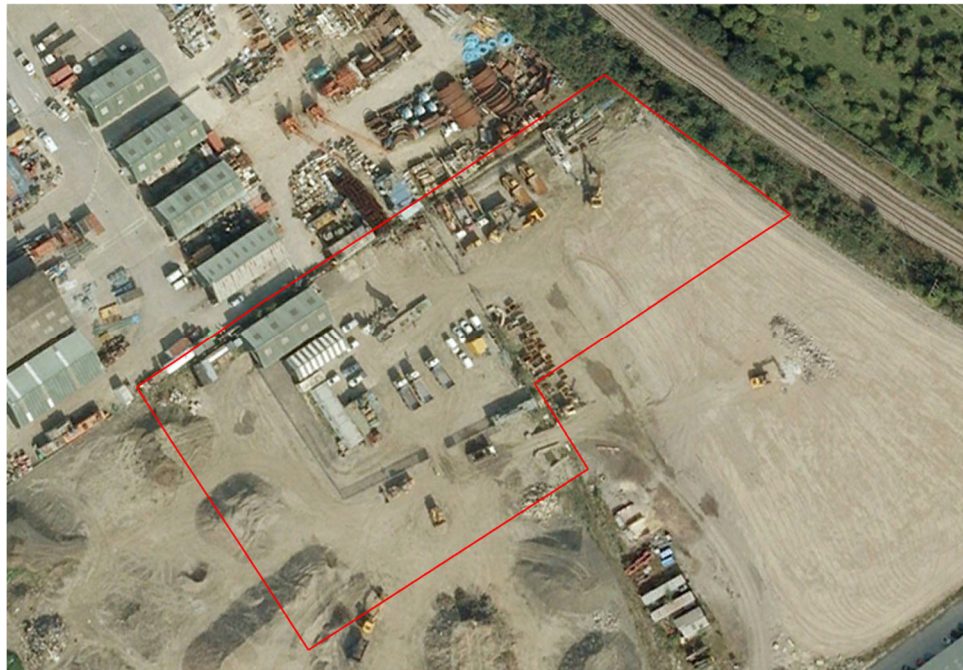
By **2009**, the site had been cleared and covered by hardcore, with several stockpiles and plant.

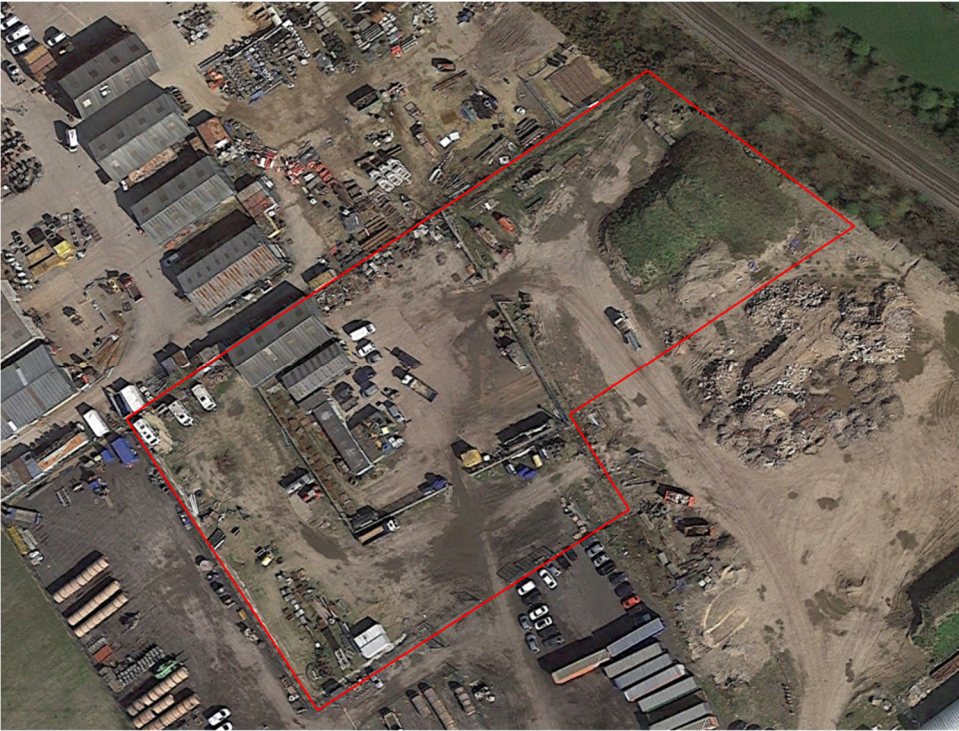
<p>By 2018, the north-eastern half of the site was utilised for soil storage/processing</p>

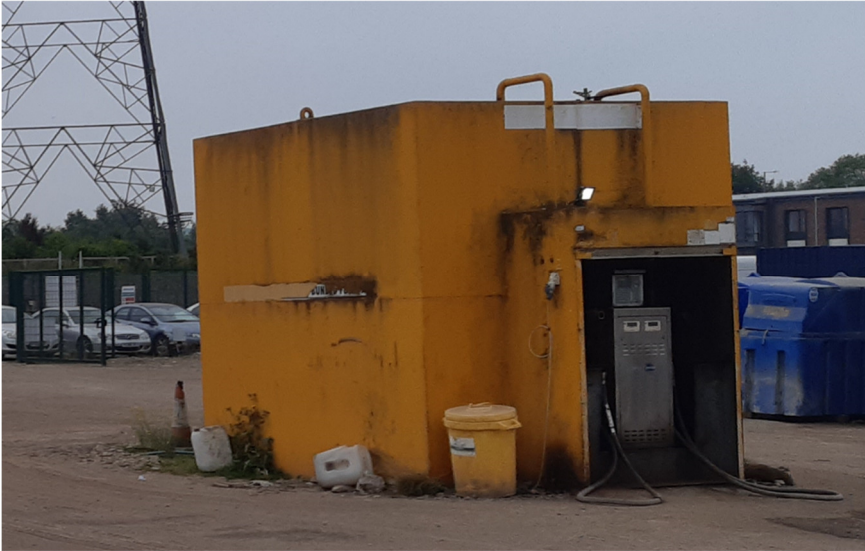
Above Ground Tanks:
1 No. yellow square apparently double bunded (2 No. parallel) above ground diesel tanks with 2 No. fuel pumps (Fuel Safe 5000 bunded fuel tank noted on rear of the unit).

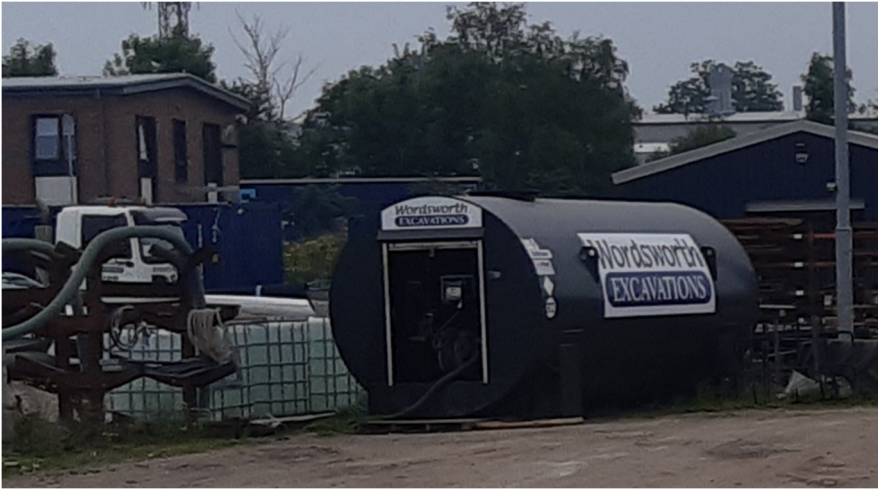
1 No. large capacity (15,000 litre) diesel tank (assumed double bunded with single filling pump). IBC's with AdBlue situated adjacent.

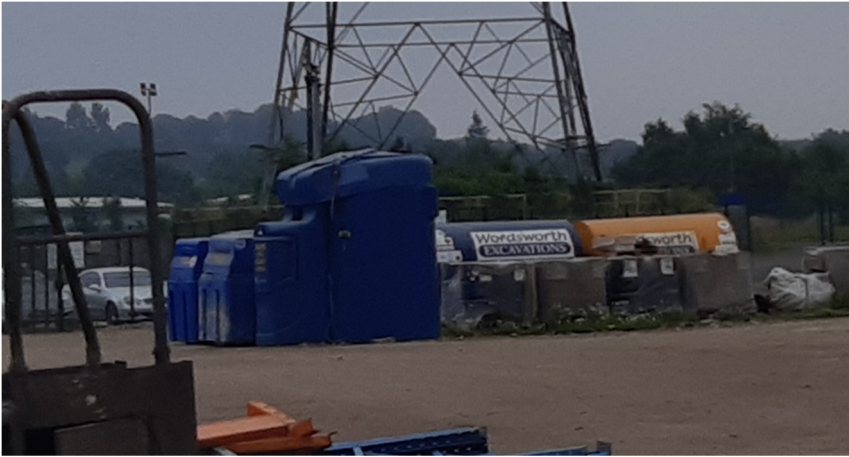
<p>Storage of transient site (metal and blue plastic Tuffa tanks) double banded diesel tanks were present. Drums of bituminous emulsion were present situated on crates and covered with hessian.</p>

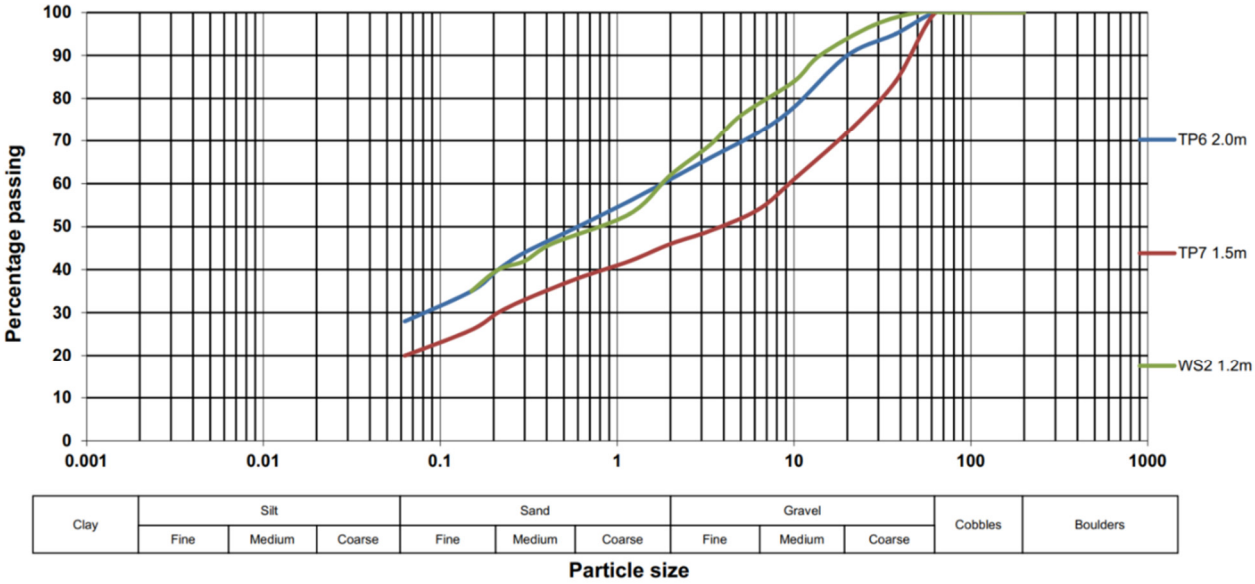
Figure 4 Summary of Laboratory Particle Size Distribution Data

Three particle size distribution tests were completed. Trial pits TP6 and TP7 were both described as being demolition rubble and have a high granular content, with only between 20% and 30% cohesive content. WS02 encountered what has been described as colliery spoil with coal brick and ash, with a high cohesive content (30%). These results have been compiled with the figure below.
