**HILLTOP FARM, REDBROOK ROAD,  
BARNSELY.**

**BAT SURVEY.**

**Ref No:- 120414.**

**Date: 21<sup>st</sup> June 2012.**

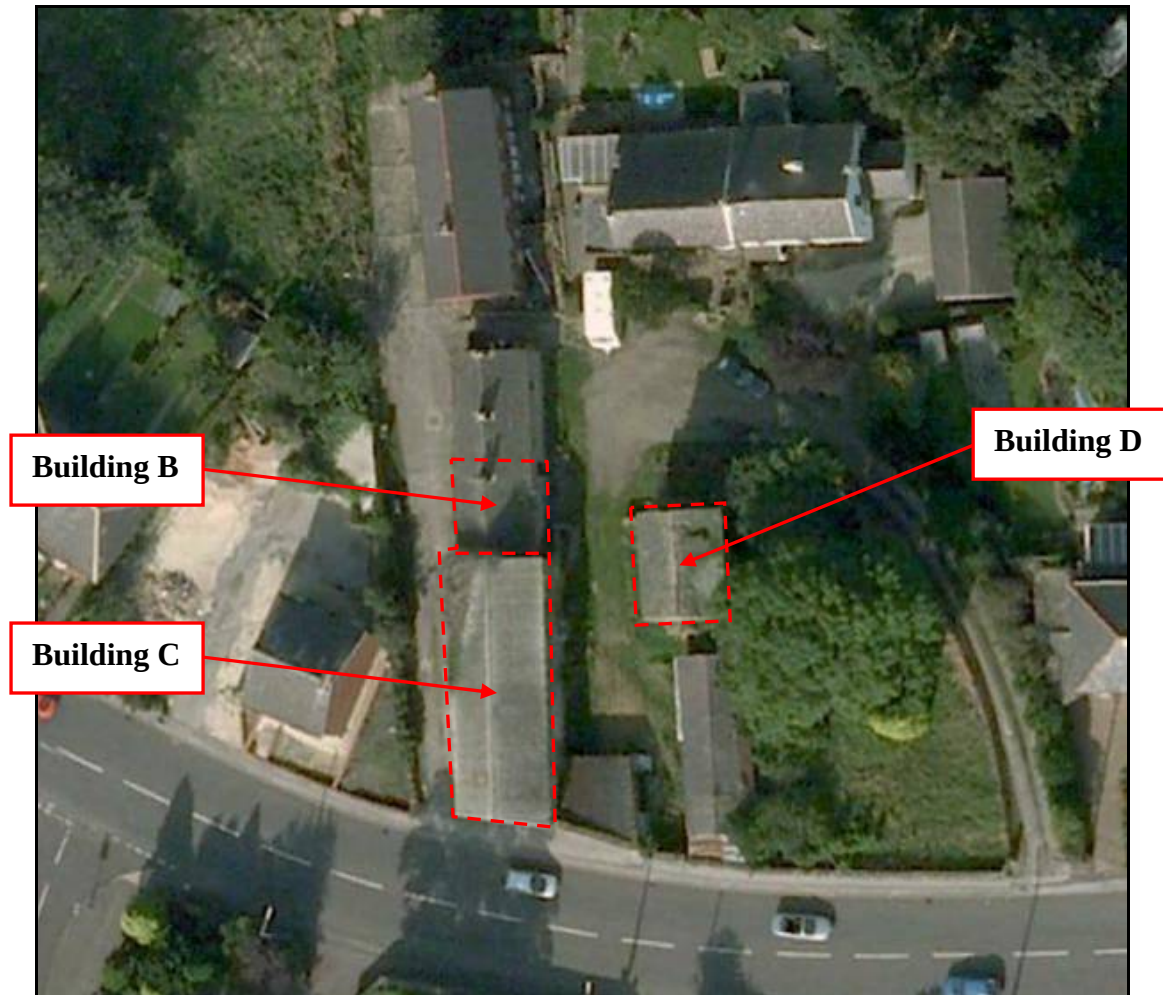
3.2.2. The buildings included in the new application and that were covered during this survey are shown in the aerial plan below and are labeled buildings B, C and D for continuity from the previous survey report reference 071104.

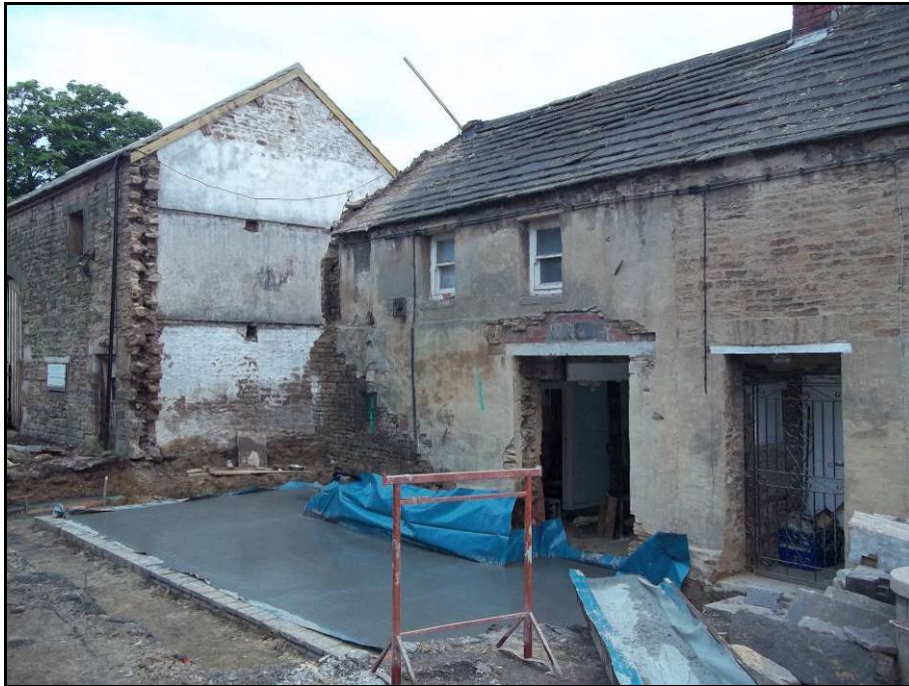
### 3.2.3. Building B.

3.2.3.1. Building B surveyed comprises part of two semi detached cottages, one of which is lived in. Some internal works have already been carried out on this building.

3.2.1.2. The walls are solid stone and are mostly rendered. The window and door frames are well sealed and there are no fascias or soffits.

3.2.1.3. The roof is a pitched, stone tiled roof with a number of gaps under and between the tiles. There is no lining under the tiles.

3.2.1.4. The loft is a small loft space with a purlin roof structure and loft floor insulation.

3.3.2. Building B offers very few opportunities for roosting bats and no bat field signs were identified in the loft space or around the exterior of the building.

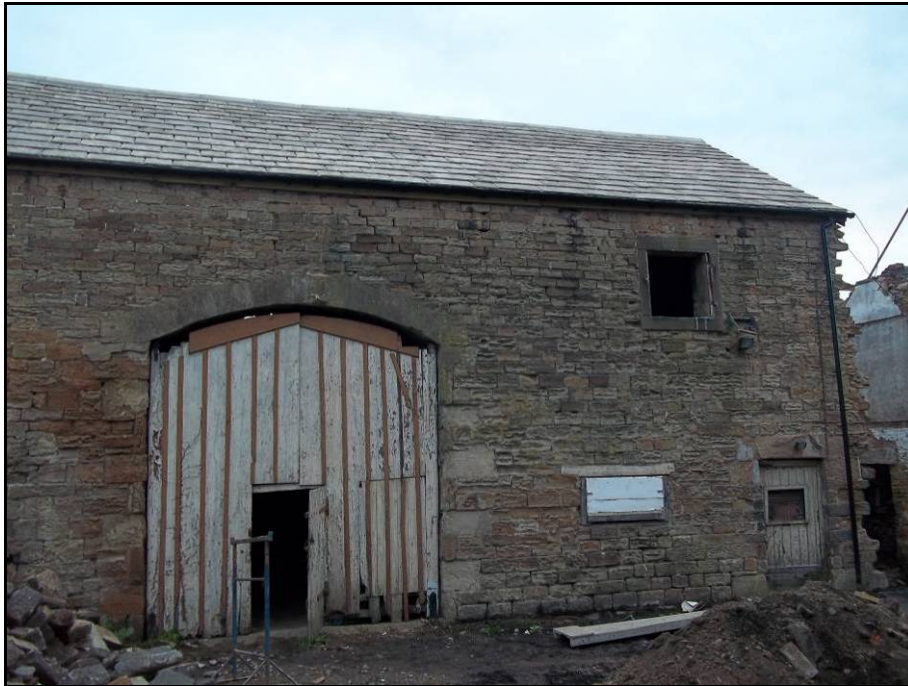
### 3.2.4. Building C.

3.2.4.1. Building C is an old, two storey high, ex slaughter house. It has not been used for a number of years.

3.2.4.2. The building comprises coursed stone walls with deeply weathered faces and with a number of open joints between, leading into the middle of the walls.

3.2.4.3. There is an open window on the west side of the building on the first floor and there are gaps above the doors.

3.2.4.4. The roof was previously a pitched, corrugated roof but has recently been replaced with a pitched tiled roof that is well sealed with no gaps under the roof tiles. The roof beams are of a king post structure. There are some gaps behind the fascias.

3.2.4.5. The interior of the barn is partitioned into three sections. The south section is completely open to the roof. It is obvious that pigeons regularly use this part of the building as there is bird excrement on the floor and pigeons were seen roosting on the roof beams.

3.2.4.6. The middle section of the barn is open to the roof structure with a single storey room built into one end. A large amount of bird excrement was identified across the floor.

3.3.3. Buildings C and D offer potential for roosting bats in the walls. No bat field signs were identified inside or around the exterior of building C.

3.3.5. Evidence of nesting birds were identified inside Buildings C and D, with a disused swallows nest identified on the first floor of Building C.

5.3. It is recommended that the loss of nesting sites are compensated for by providing replacement nest boxes to suit a range of birds including swallows.

5.4. It is recommended that where possible bat roosting opportunities are incorporated into the converted buildings in the form of gaps in the eaves, bat slates or bat bricks.

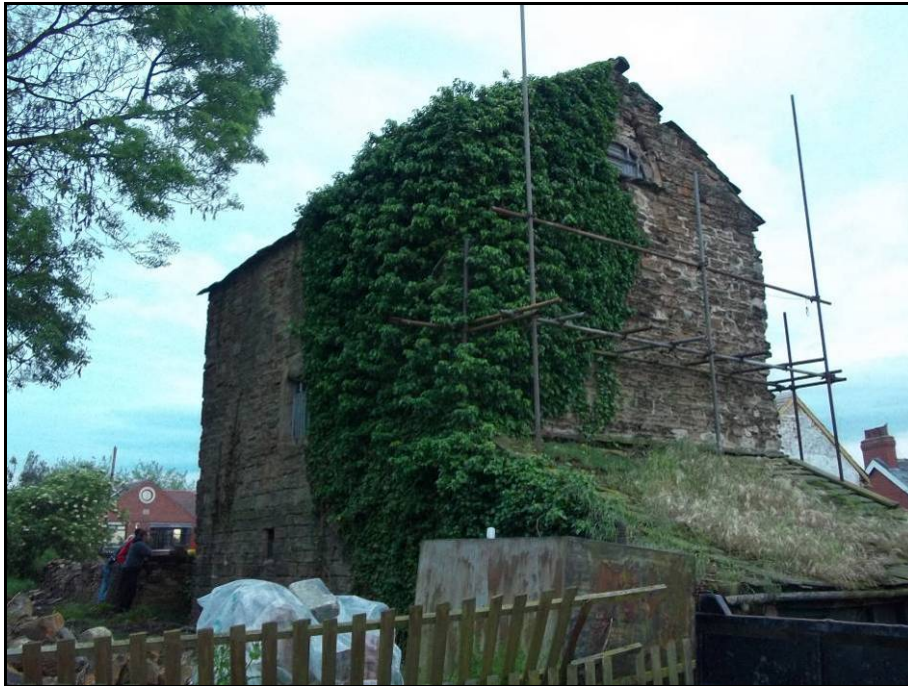
### 3.2.5. *Building D.*

3.2.5.1. Building D is a three storey barn that was previously used for keeping livestock. The walls comprise coursed stone with weathered faces and have a number of gaps between leading into the middle of the walls. There is some dense ivy cover on the walls. There are two open windows on the second floor.

3.6.2. The roof is a pitched, tiled roof that is in poor condition and seems to have no lining. There is an open dormer window in the east facing roof pitch.

3.6.3. There is a small single storey extension on the north elevation of this building that comprises coursed stone walls and a sloping tiled roof that has become established with a cover of grassy vegetation.

3.3.4. The first and second floors of Building D were unsafe to access and could not be thoroughly inspected for bat field signs. No bat field signs were identified on the ground floor or around the exterior of the building.

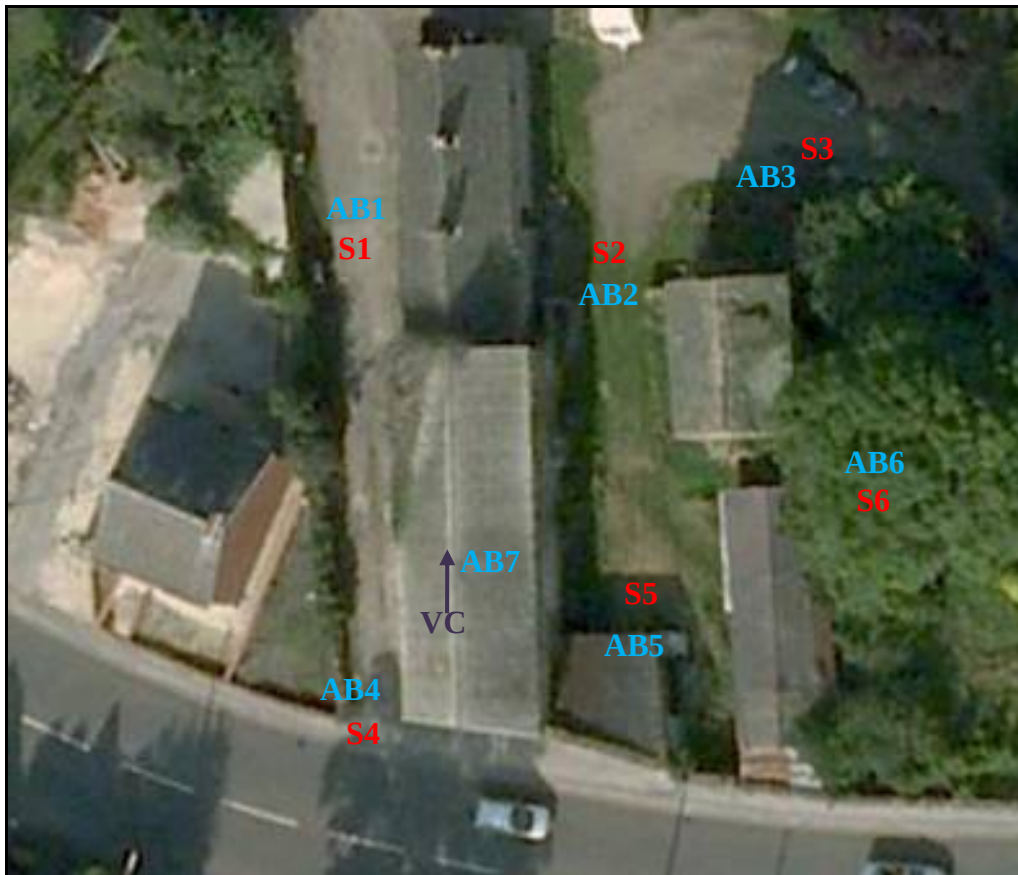
3.4.3. Each surveyor held a Batbox duet bat detector. Seven static Anabats and one video camera were also used to supplement the survey effort. The locations of each surveyor (S), Anabat (AB) and video camera (VC) during the survey are shown in the

plan below. AB7 and the video camera were placed inside Building C with the arrow indicating the direction the video camera.
