**Indicative Foundation Zoning Plan**

**REPORT C6485D REV A  
OCTOBER 2017**

**SETTLEMENT REPORT**

**of land at  
OUGHTIBRIDGE MILL**

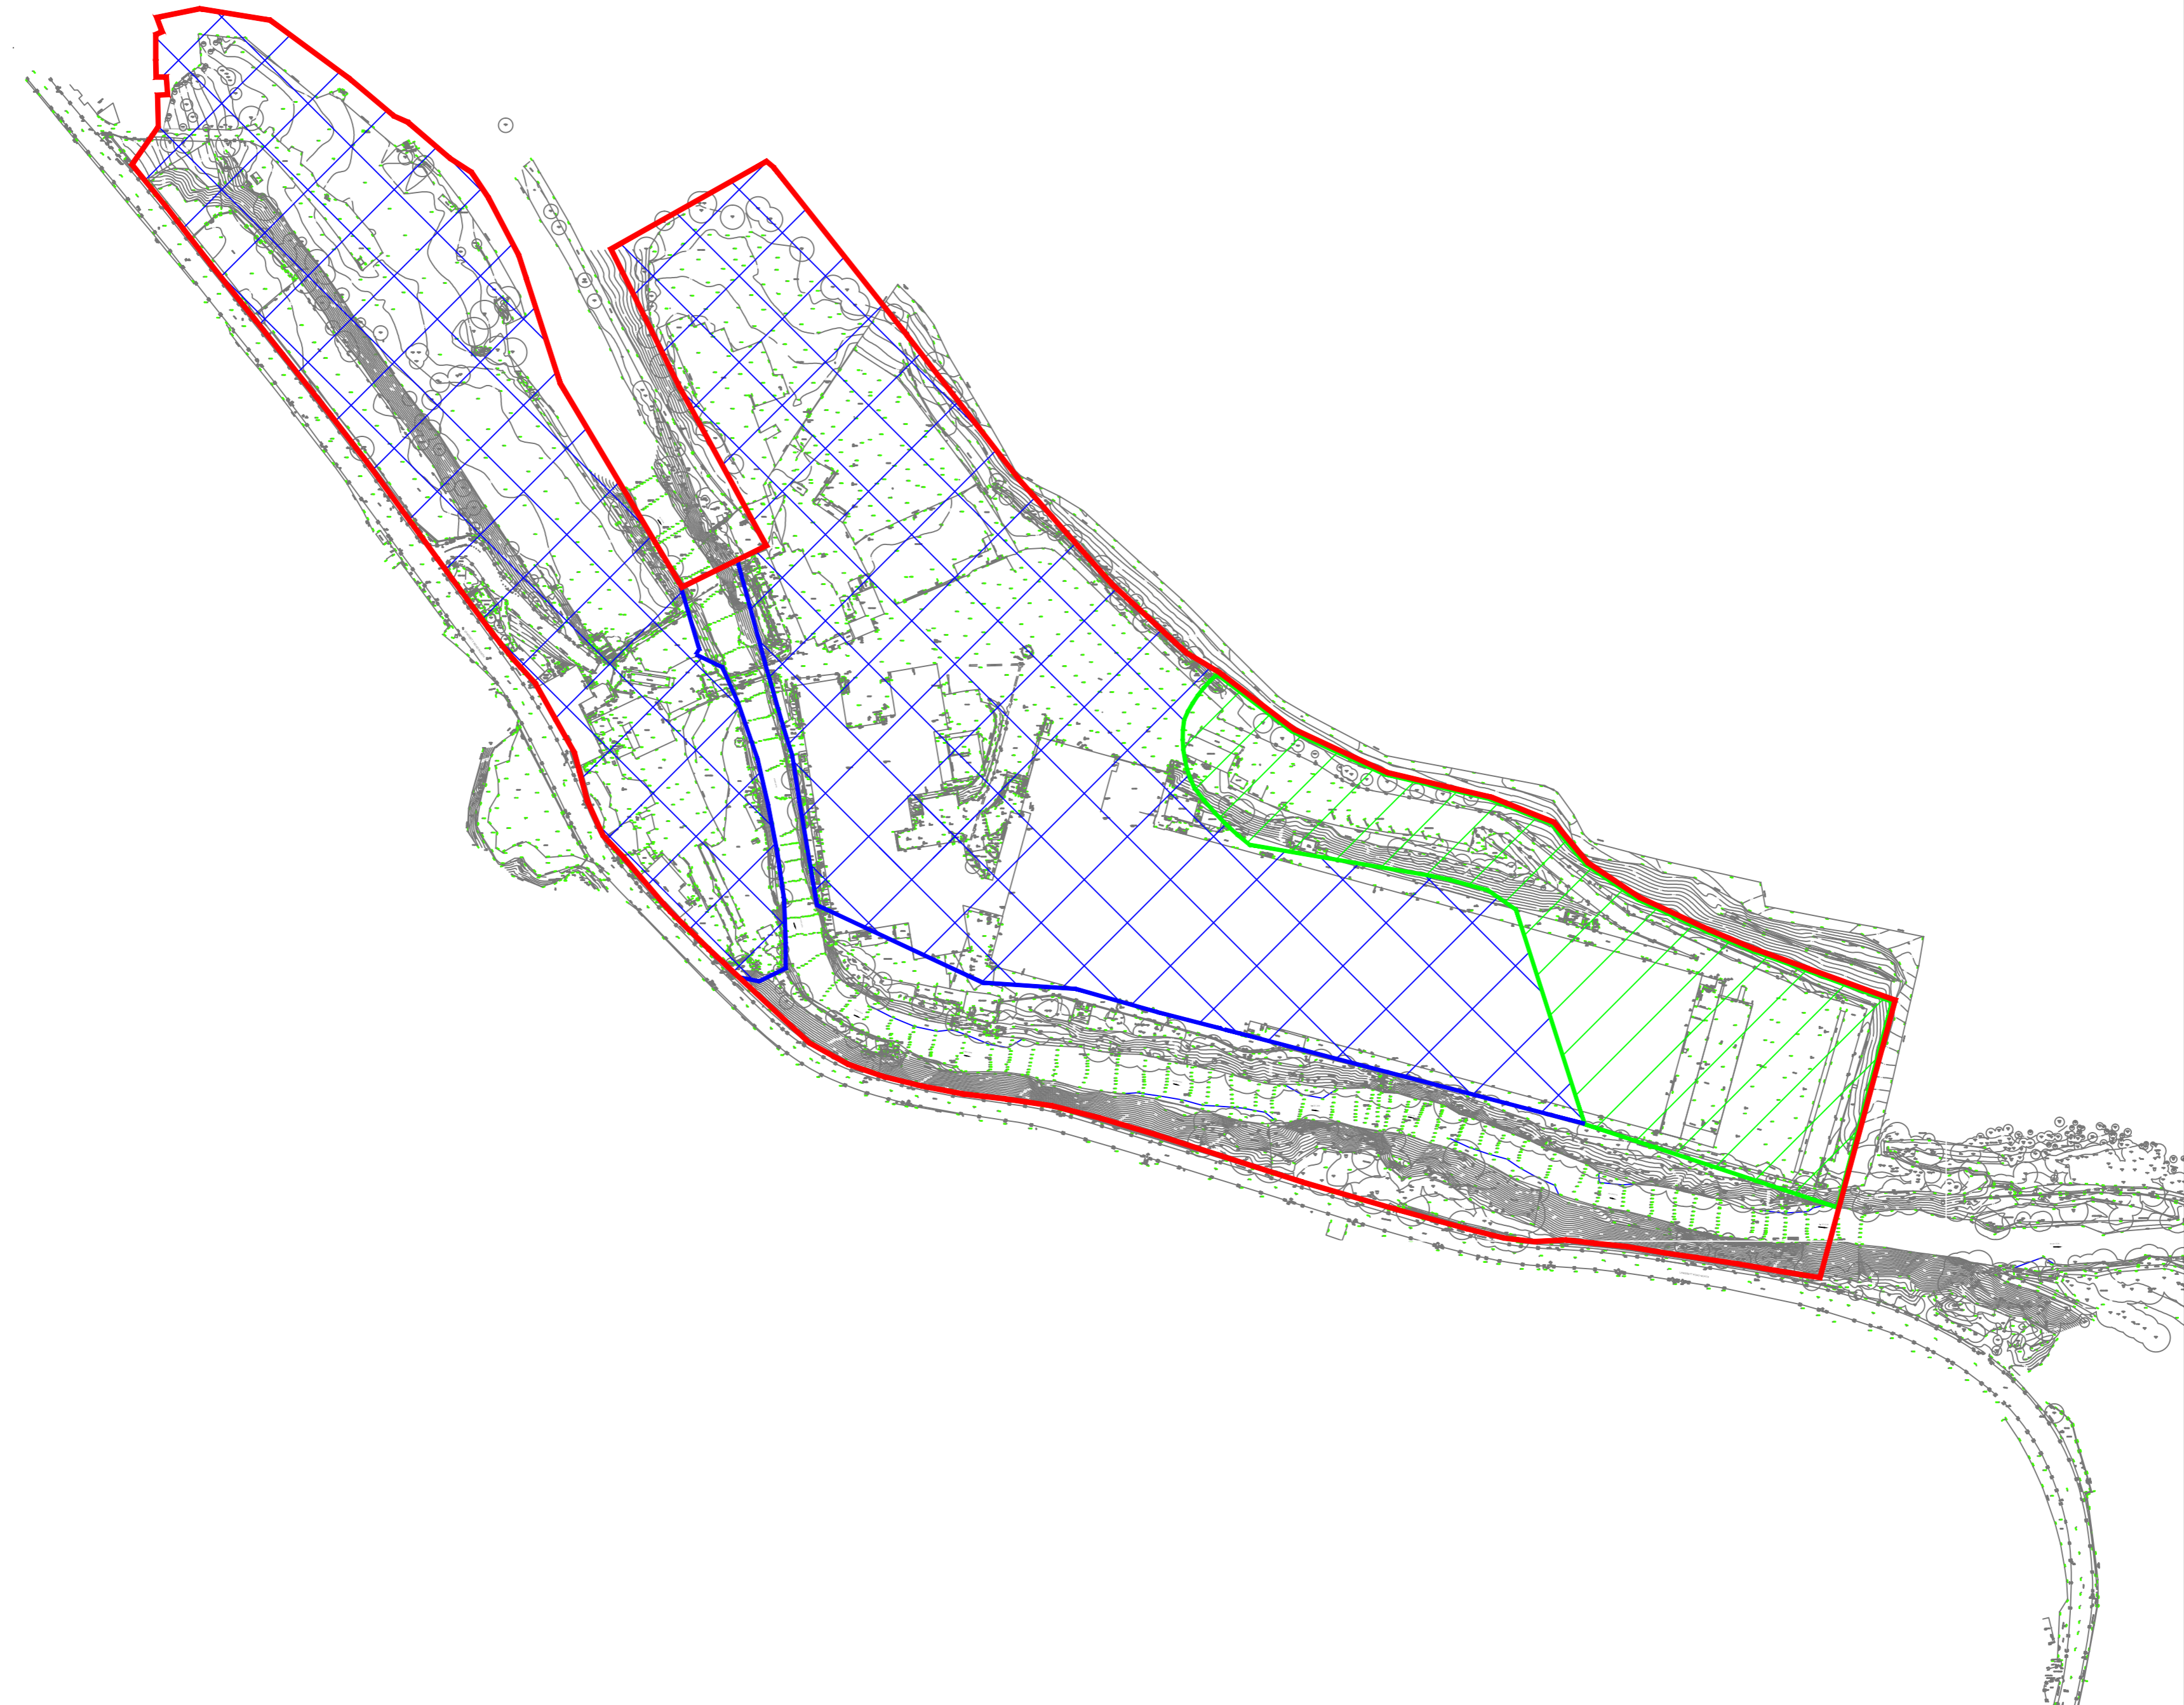
DRAWING NO. C6485A RevA/RS/05	REVISION NO. 0	
DRAWN BY SM	APPROVED BY NJ	
DATE October 2017	SCALE 1:2000	PAPER SIZE A2

Shallow Spread Foundations/  
Trench Fill
  -

Piled Foundations  
pre-bored where necessary

Generalised foundation recommendations for residential dwellings are given within Sirius Geoenvironmental Appraisal Report C6485A Rev A, dated March 2016. Drawing No. C6485D/7 in Appendix A provides a foundation zoning plan based on soil conditions, post enabling. This settlement report discusses settlement within highways, external areas and public open space.
