**HILL END FARM, MAPPLEWELL.**

**BAT SURVEY.**

**Ref No: 220527/REV1.**

**Date: 4<sup>th</sup> August 2022.**

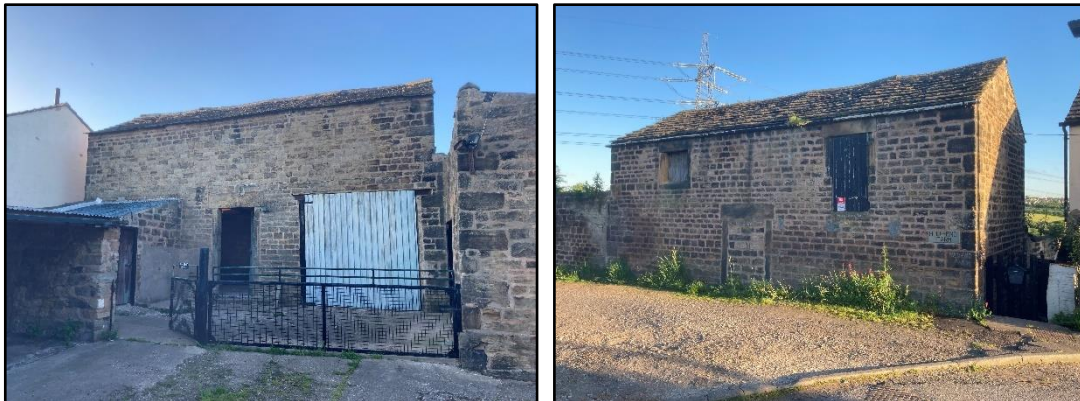
3.3.1.1. Building 1 is the main building on the site. This is a two storey high barn constructed with stone walls and a pitched stone tiled roof. Along the northern elevation there is a gutter fixed on brackets.

3.3.1.2. There is a small, single-storey, mono pitched, roof extension on the southern elevation. This is also constructed with stone walls and a stone, tiled roof. The photographs below show the front and back elevations of the building.

3.3.1.6. Overall, Building 1 was found to be in good condition. There is one window and two doorways in the walls of the building. These were found to have gaps around them where daylight could be seen shining through. In addition, daylight could be seen shining through many gaps between the roof tiles including along the ridge.

3.3.1.7. The external walls are generally well pointed with just the occasional small gap between the stonework. Internally, there are numerous gaps between the stonework. No bat field signs were identified in the stonework of the building around the external gaps or any internal walls.

3.3.1.10. As potential for roosting bats was mostly limited to the internal of the building and no bat field signs were found inside, and there are only a low number of gaps in the external walls, Building 1 was initially assessed to provide **low potential** for roosting bats. This assessment was upgraded to **high potential** for roosting bats following comment from the local authority.

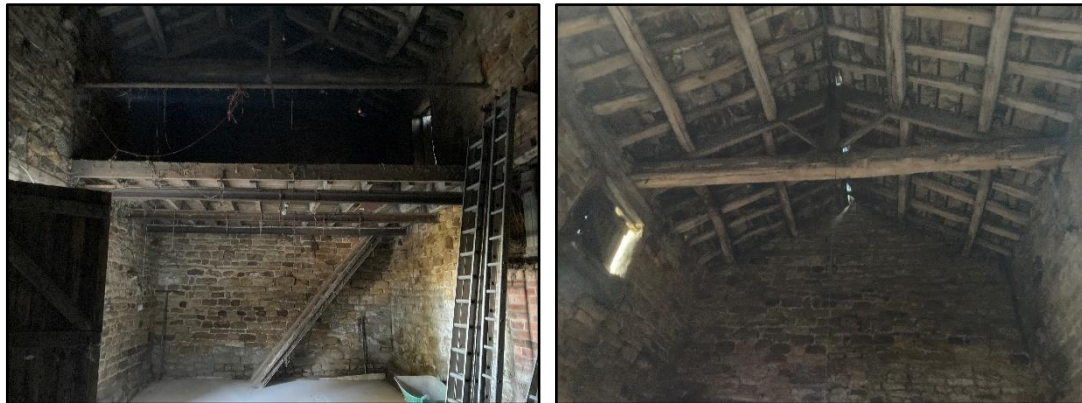
3.3.1.3. Internally, the barn is completely open throughout and up to the underside of the roof structure with a mezzanine floor at the western end of the building.

3.3.1.4. There is no lining under the roof tiles and the roof structure is of a king post design. The ground floor was found to be fairly clean at the time of this survey, whereas the mezzanine floor was found to be very dirty and undisturbed.

3.3.1.5. The photographs below show the internal of the building.

3.3.1.8. There are some occasional gaps in the large beams inside the building that provide potential for roosting bats, although there was no evidence of bats using these. The roof provides very limited potential for bats as there is no lining and there is an abundance of gaps between the tiles.

3.3.1.9. No bat field signs were identified anywhere around the interior or the exterior of the building.

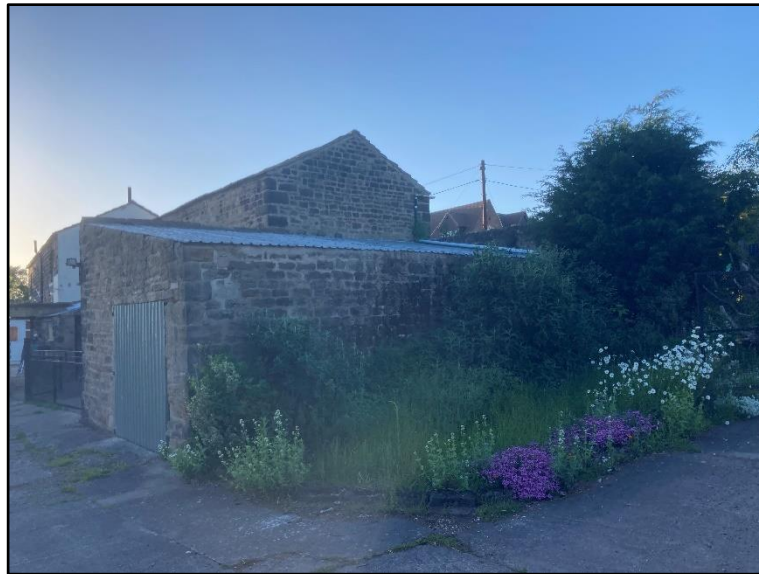
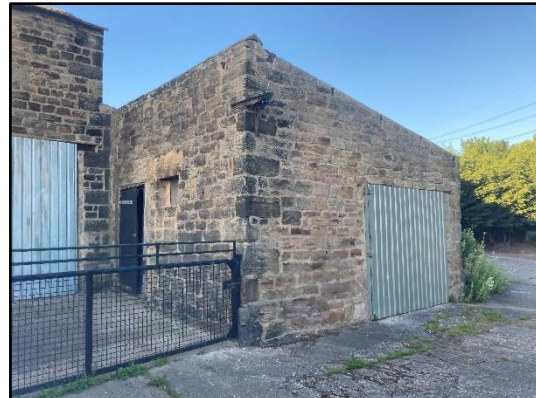
3.3.2.1. Building 2 is a single-storey, mono pitched, barn that is adjoined to the eastern end of Building 1. The walls are stone walls, the roof is a mono-pitched, corrugated sheet covered roof. There is vegetation growing up against the eastern side of this building.

3.3.2.2. The photographs below show the external of Building 2.

3.3.2.7. Overall the building is in good condition. There are occasional gaps between the stonework around the external and internal of the building. There are also gaps in the large beams inside the building although no bat field signs were identified inside the building to suggest any bat roosts roost inside. There is very limited potential around the exterior limited to a small number of gaps in the stonework. Building 2 is therefore assessed to provide **low potential** for roosting bats.

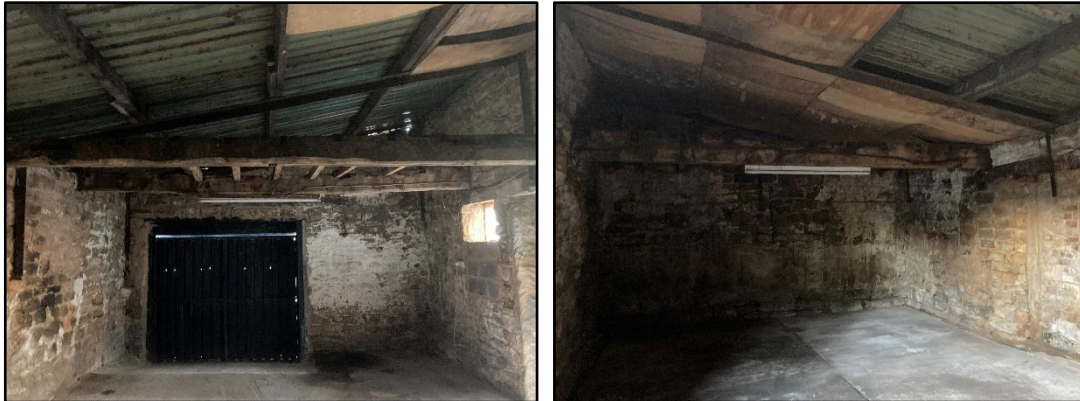
3.3.2.3. Internally, this building is one open room. There are some boards under part of the corrugated roof sheets, but these are not fitted close to the corrugated sheets and therefore there is a wide gap between.

3.3.2.4. There are some large old beams spanning the building, but these appear to be for practical purposes associated with the historic use of the building as opposed to structural purposes.

3.3.2.5. The photographs below show the internal of the building.

3.3.2.6. There are two doorways into the building and one small window. All these have gaps around allowing daylight through.

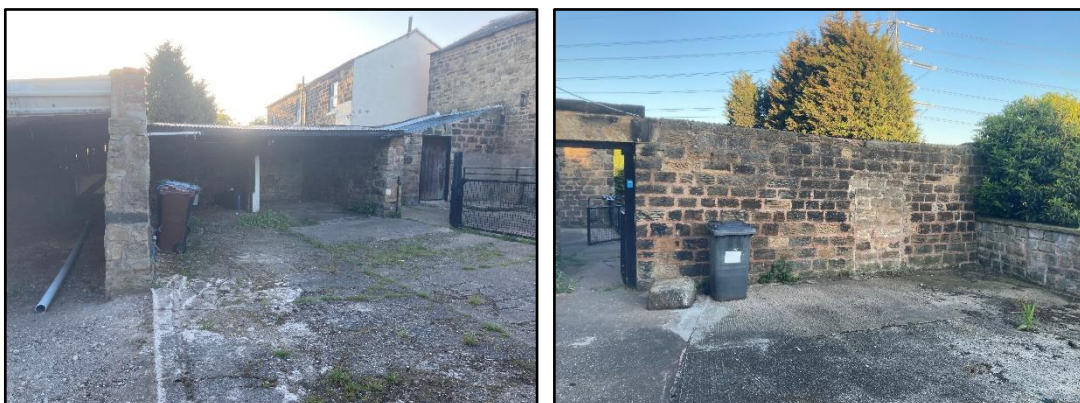
3.3.3.1. Building 3 is a small, single-storey barn constructed with stone walls and a corrugated sheet covered sloping roof. The eastern elevation of the barn is completely open. The photographs below show the external of the building.

3.3.3.2. The external walls are generally in good condition with no gaps. There are some gaps between the stonework internally, although no bat field signs were identified around these features.

3.3.3.3. Overall, Building 3 is assessed to provide **low potential** for roosting bats.

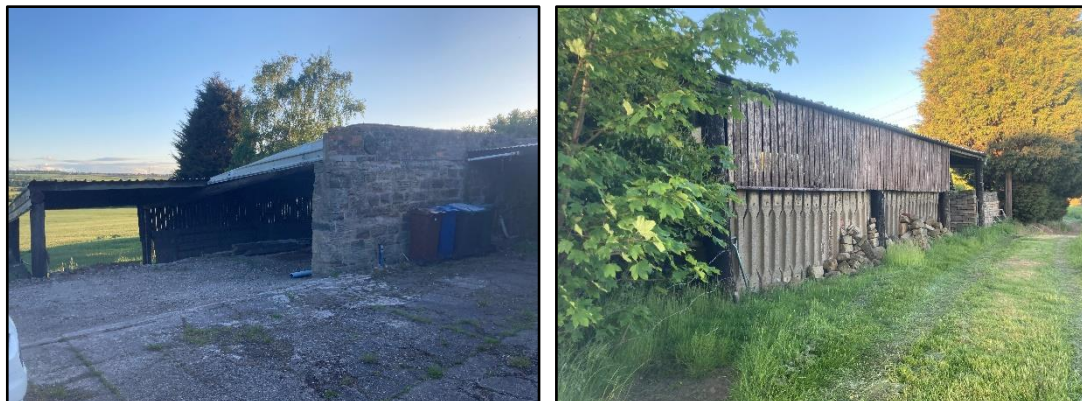
3.3.4.1. Building 4 is another open barn, comprising one stone wall that it shares with Building 3 and the remaining walls are piled, concrete, sleepers and corrugated sheets with some timber slats. The eastern and part of the southern elevations are completely open.

3.3.4.2. The building provides very limited potential for roosting bats and is therefore assessed to provide **negligible potential**.
