PROJECT: Maple Court, Tankersley

TITLE: Trees Constraints Plan

CLIENT: Company Shop and Rula Developments Ltd
 DATE: 06.04.17 SCALE: 1:500@A1
 DRAWN: GT DRAWING NO.: 50104-DR-ARB-102
 CHECKED: MT REVISION: -

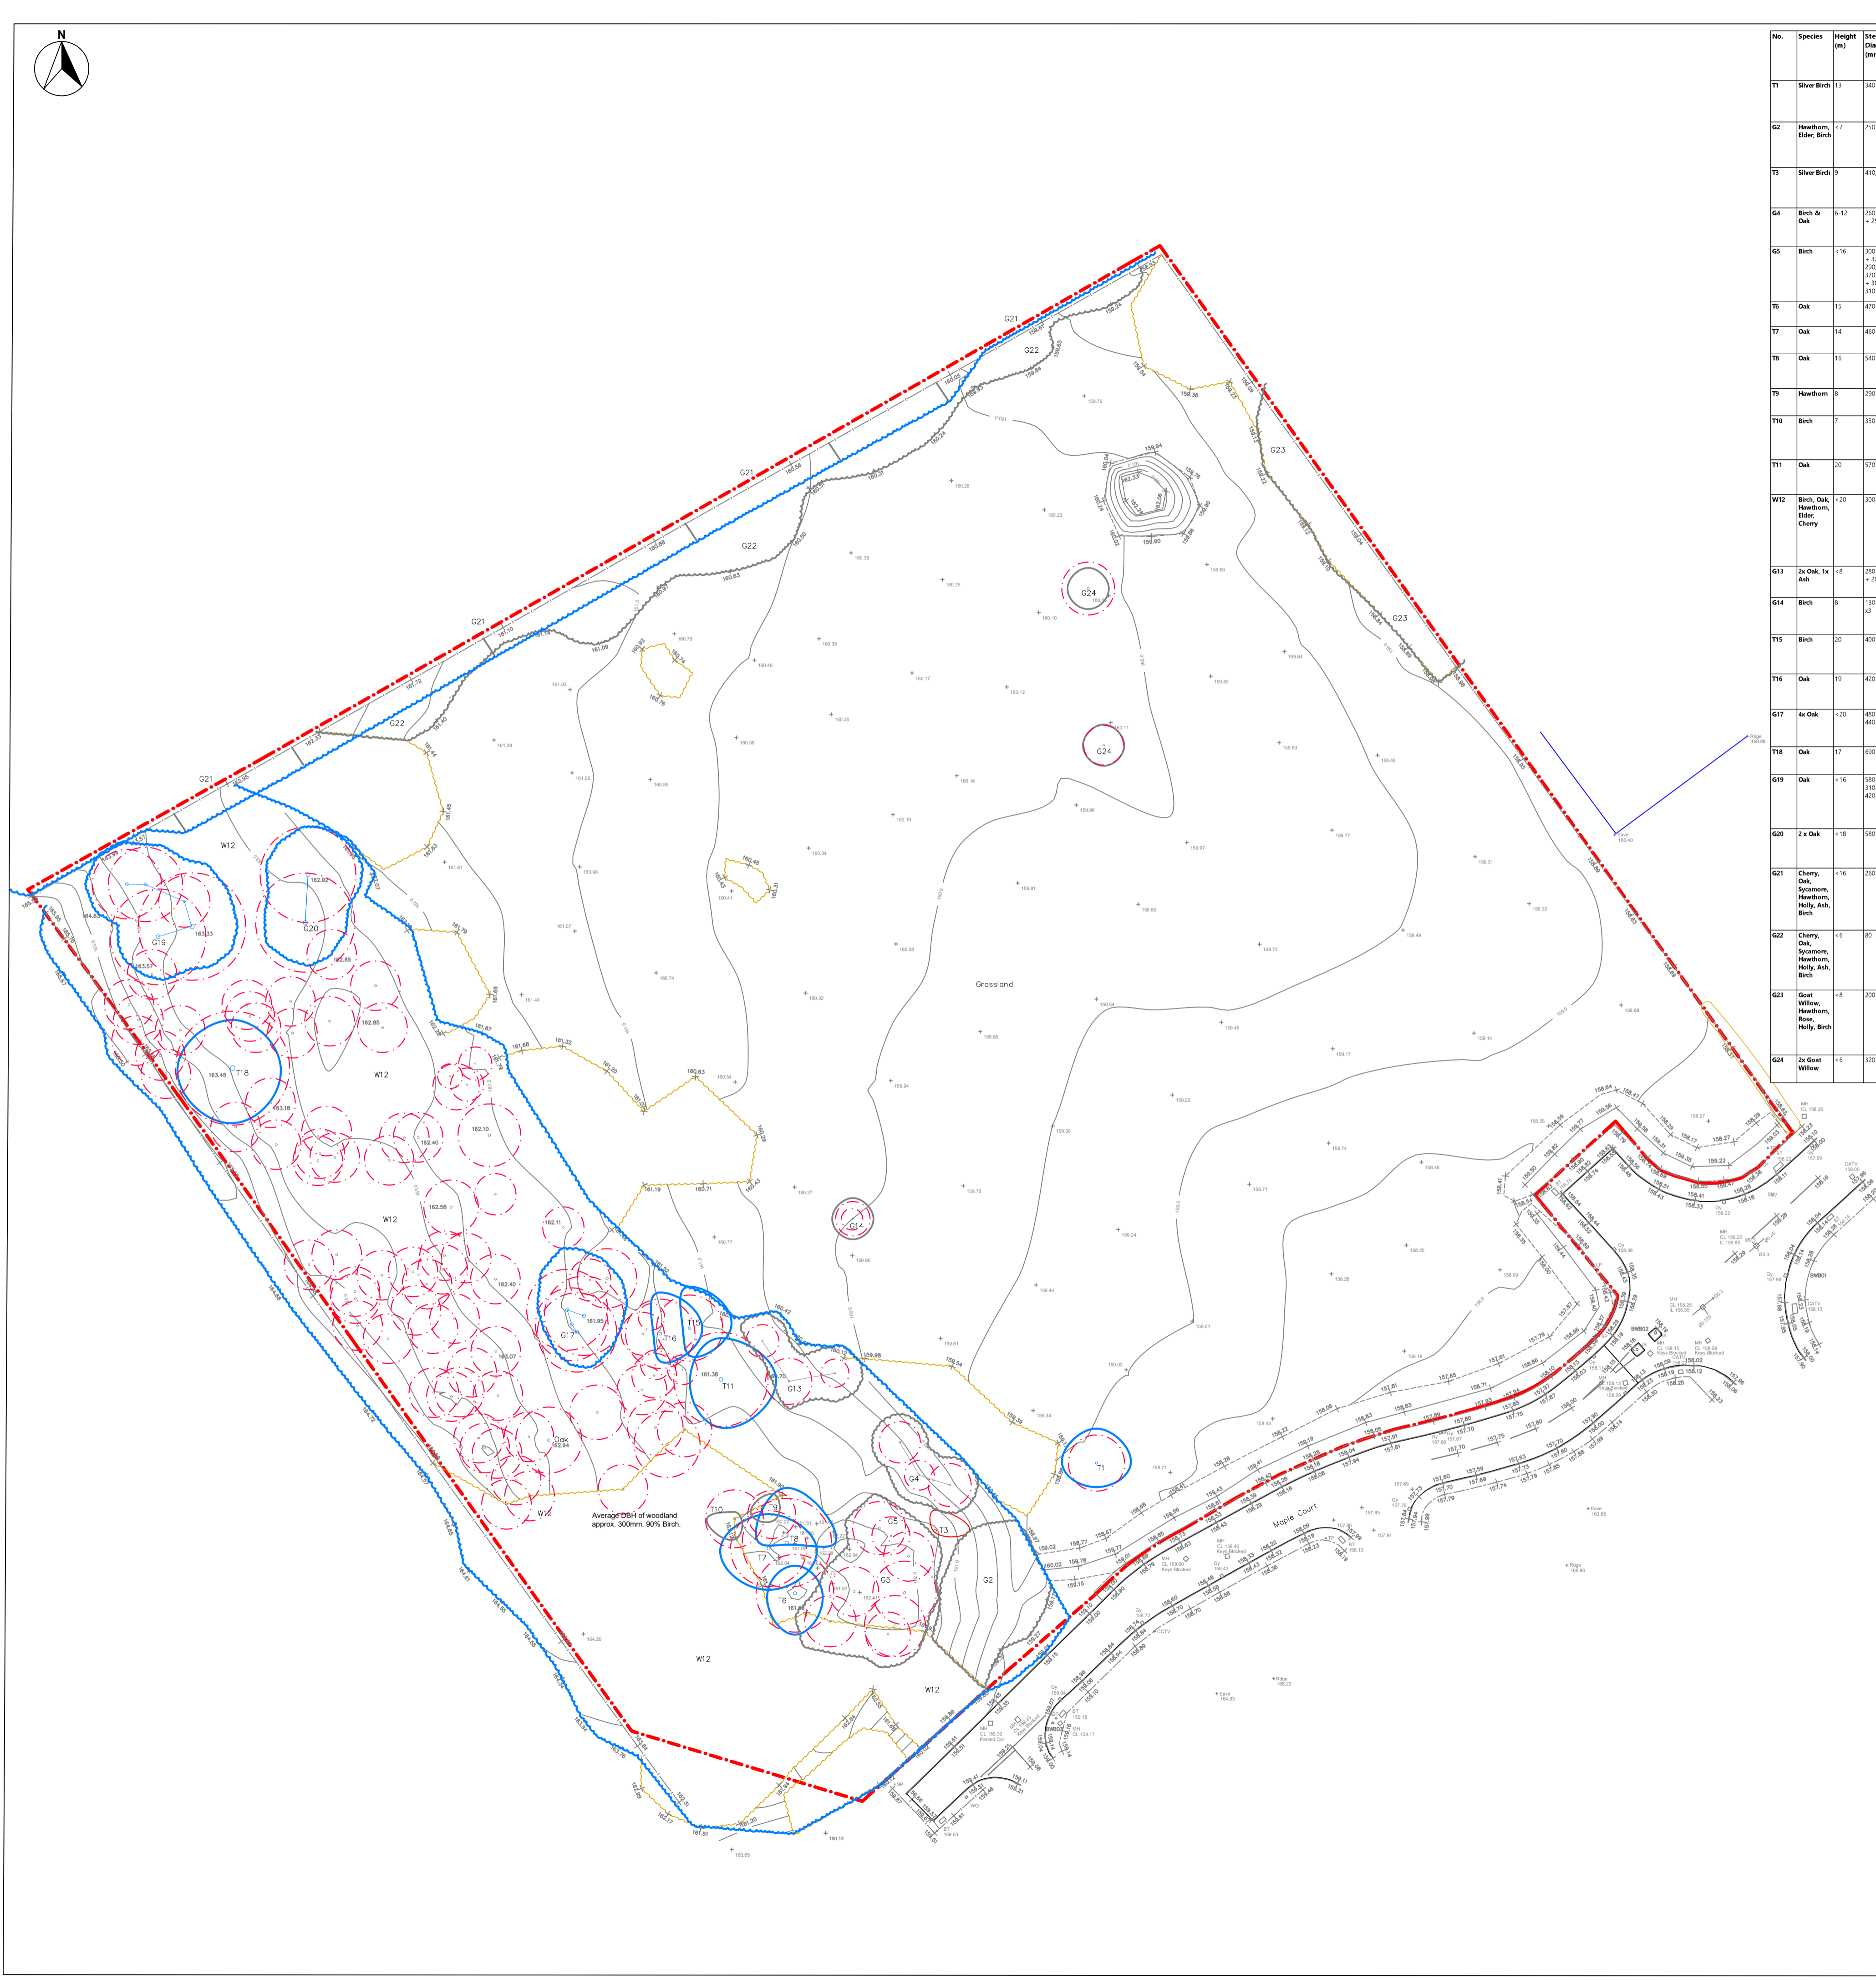
No.	Species	Height (m)	Stem Diameter (mm)	Spread (m)	Age Class	Height of Crown Clearance (m)	Ht of 1st Limb/Direction	Physiological Condition	Structural Condition	Preliminary Recommendation	Estimated Remaining Contribution (years)	Category Grading			
G1	Silver Birch	13	140	5	3.5	5	5	DM	0	3.5	Good	Single stemmed. Forked at 3.5m. Slight lean. Good shape and form. No major visible defects.	At present no action	20+	B1
G2	Hawthorn, Elder, Birch	<7	250	See Plan	M	0+	0+	Fair	Dense shrubby group. Reasonable shape and form. Not pruned to any extent. Limited individual value. The Birch has potential but is easily replaced. No major visible defects.	At present no action	20+	C2			
T3	Silver Birch	9	410, 170	3	0	5	0	DM	6	N/A	Poor	Thick main bole. Detach of main leader with decay and possible nest. Limited crown. Limited long term value.	At present no action	<10	U
G4	Birch & Oak	6-12	200 + 180 + 250	See Plan	SM	0+	2	Good	2x single stemmed oak with potential but easily replaced. Birch of reasonable shape and form. No major visible defects.	At present no action	40+	C2

G5	Birch	<16	300 + 230 + 320 + 200, 290 + 270 + 300 + 310	See Plan	SM	2+	3+	Fair	Some snapped out limbs. Reasonable shape and form but limited individual value and limited long term value.	At present no action	10+	C1			
T6	Oak	15	470	4	6	4	4	DM	2+	3+	Good	Single stemmed. Good shape and form. No major visible defects.	At present no action	40+	B1
T7	Oak	14	460	5	6	7	7	DM	2	3.5	Good	Single stemmed. Forked at 3.5m. Some stubs and deadwood but no major visible defects.	At present no action	40+	B1
T8	Oak	16	540	8	0	7	4	M	1+	2N	Fair	Single stemmed. Leaning to east and one-sided crown. Reasonable shape and form and complements T7. Deadwood and stubs.	At present no action	40+	B1
T9	Hawthorn	8	280	3	1	1	3	M	1	0	Good	Slightly buttressed. Upright form. Birch's nest noted. No major visible defects.	No action	20+	C1
T10	Birch	7	350	1	3	1	4	M	0	0	Poor	Single stemmed. Collapsed leader with new shoots from stem leader and one limb taken vertical form. Limited individual value.	At present no action	10+	C1

T11	Oak	20	370	6	7	8	4.5	M	2	3.5	Good	Single stemmed. Slight lean. Good shape and form. Some deadwood and stubs. No major visible defects.	At present no action	40+	B1
W12	Birch, Oak, Hawthorn, Elder, Cherry	<20	300 w/e	See Plan	SM	2+	2+	Fair	Woodland dominated by early mature birch with occasional oak and some understorey and younger trees. Some birch are beginning to detach with some dead stems and leaved out trees noted. Little open ground. Would benefit from new planting to improve woodland structure and age mix.	Look to plant up areas to improve species mix and provide tree cover to replace declining birch population.	40+	B2			
G13	2x Oak, 1x Ash	<8	280 + 170 + 200	See Plan	Y	0+	2	Good	3x single stemmed trees. Potential but easily replaced. No major visible defects.	No action	40+	C2			
G14	Birch	8	130 + 120 + 43	See Plan	Y	1+	2	Good	One single stem and one triple stemmed forming one crown. Potential but easily replaced. No major visible defects.	No action	40+	C2

T15	Birch	20	400	6	4	6	1	M	2+	6+	Good	Single stemmed. Good shape and form. Slightly one-sided but dense canopy. No major visible defects.	No action	20+	B1
T16	Oak	19	420	6	4	6	1	M	1.5	6+	Good	Single stemmed. Reasonable shape and form. Slightly one-sided. Some deadwood and stubs. No major visible defects.	At present no action	40+	B1
G17	4x Oak	<20	480+ 480+ 440+ 490	See Plan	M	0+	6+	Good	4 single stemmed trees growing together and forming one crown. Some deadwood and stubs. No major visible defects.	No action	40+	B2			
T18	Oak	17	690	7	8	7	8	M	1+	3+	Good	Good shape and form. Some deadwood and stubs. No major visible defects.	At present no action	40+	B1
G19	Oak	<16	580+ 650+ 310+ 450+ 420	See Plan	M	0+	3.5+	Good	Upright tree with column of decay up stem but good windward. Also bent over due to canopy of adjacent tree. Generally some deadwood and stubs. Good shape and form. Work well as a group.	Remedial prune over footpath.	40+	B2

G20	2x Oak	<18	580+ 600	See Plan	M	1.5+	3+	Good	2x single stemmed trees both with forked crowns. Good shape and form. Some stubs and deadwood. Minor ripped limbs.	Remedial prune over footpath.	40+	B2			
G21	Cherry, Oak, Spangnum, Hawthorn, Holly, Ash, Birch	<16	280	See Plan	SM	0+	3+	Good	Off site shelterbelt along mound running behind the boundary fence. Reasonable shape and form. Minor overhanging into site. No particularly large individuals. Potential.	No action	40+	B2			
G22	Cherry, Willow, Hawthorn, Holly, Ash, Birch	<6	80	See Plan	Y	0	0	Fair	Self sown and/or suckers from adjacent trees off site. Limited value and easily replaced.	At present no action	20+	C2			
G23	Goat Willow, Hawthorn, Rose, Holly, Birch	<8	200	See Plan	SM	0+	0	Good	Dense group of vegetation along edge of site adjacent to neighbouring building. Reasonable shape and form. Limited individual value and easily replaced. No major visible defects although root fully surveyed.	At present no action	20+	C2

G24	2x Goat Willow	<6	320+ 340	See Plan	SM	0	0	Good	2x dense, bushy trees. Even spread. Easily replaced. No major visible defects.	At present no action	20+	C2
