**204 SPARK LANE, MAPPLEWELL.**

**BAT REPORT.**

**Ref No: 260840**

1.1. A planning application has been submitted to extend and convert an existing garage / annex into a new dwelling at 204 Spark Lane, Mapplewell. The client is required to provide a preliminary bat roost assessment before the application can proceed.

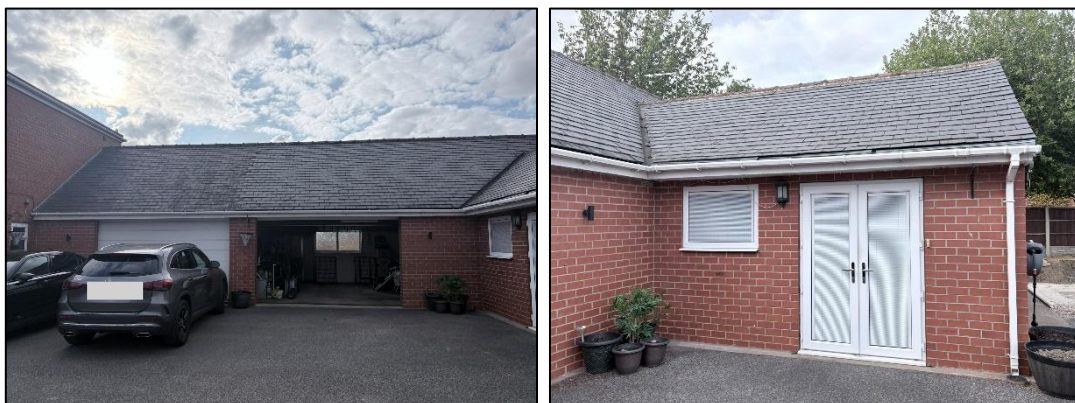
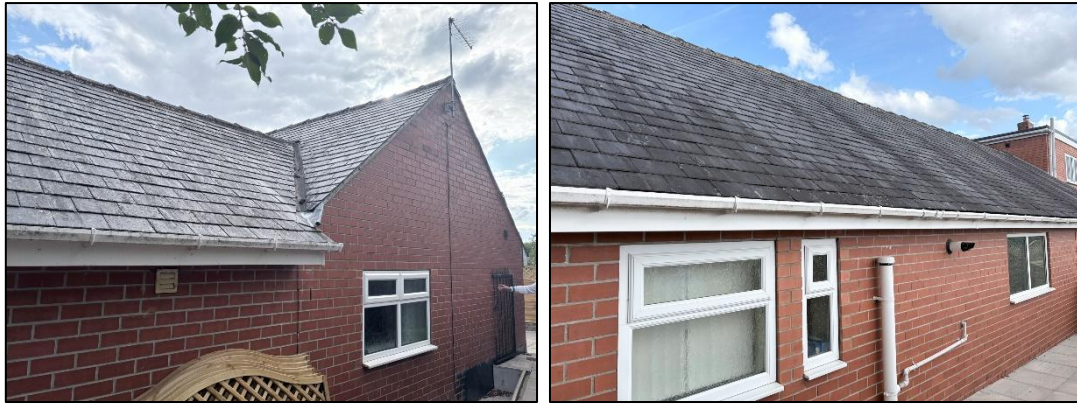
3.3.1. The garage and annex are single-storey, regularly used and well-maintained buildings.

3.3.2. The photographs below show the general nature of the externals of the building.

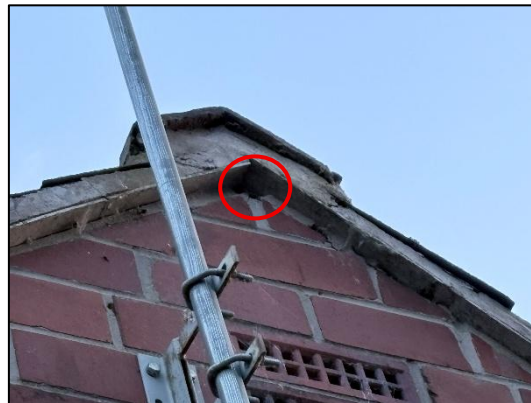
3.3.3. The walls are constructed from brick and are in excellent condition. The windows and doors have uPVC frames and are well sealed. One feature suitable for roosting bats was identified at the apex of the north gable end where there was a gap in the mortar at the very apex of the wall under the roof tiles. No other features suitable for roosting bats were identified in the walls. This feature is shown in the photographs below.

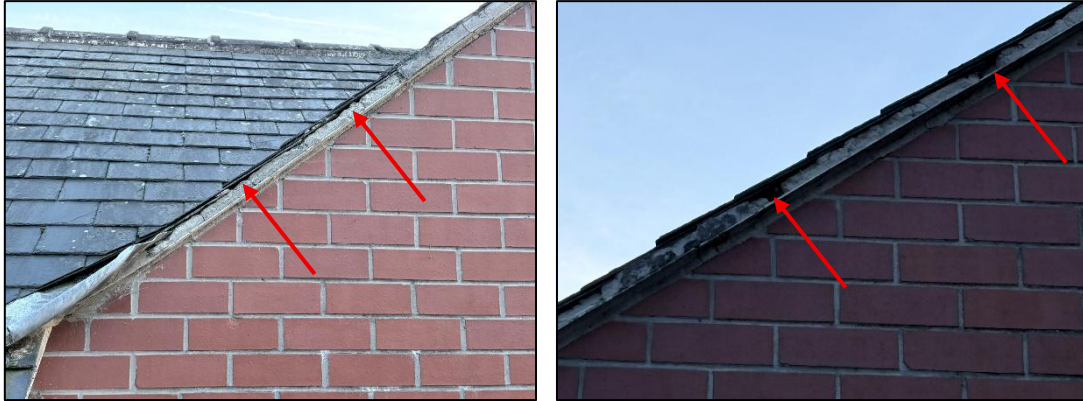
3.3.5. There are also some gaps under the ends of the roof tiles on the eastern and northern gable end that individual bats could take advantage of. These features are shown in the photographs below.

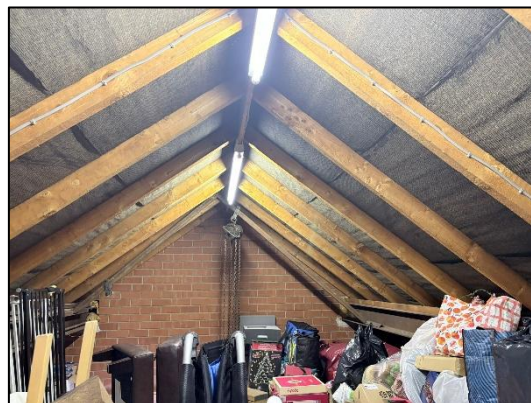
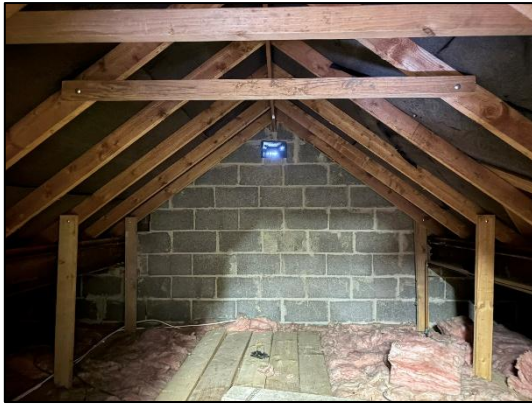
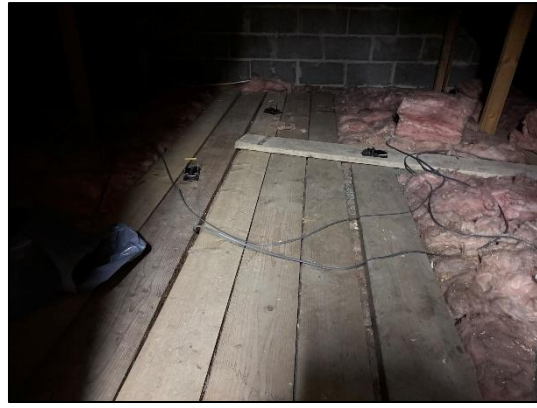
3.3.7. The internal loft space above the garage and half of the annex was accessed during the survey. It was found to be a purlin and rafter construction, approximately 2-3m in ridge to floor height, with artificial lighting in the section of loft over the garage. The underside of the roof tiles was found to be felt-lined, which was in very good condition with no rips or tears. There was no accessible loft space in the remaining part of the annex.

3.3.8. A thorough inspection for bat field signs was carried out internally and externally and no such field signs were identified. The lack of bat field signs inside the loft spaces suggest that it is highly unlikely that loft dwelling bat species utilise those spaces.

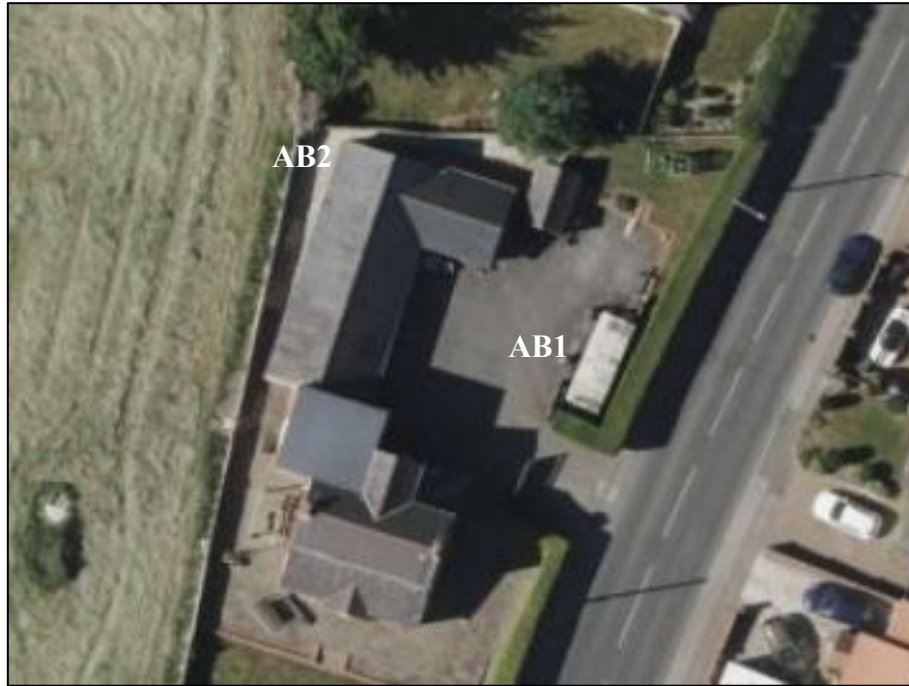
3.4.4. The surveyor moved around the survey area with the Batbox duet detector throughout the course of the survey to ensure all equipment was running correctly. The aerial photograph below shows where the Anabats (AB) were located throughout the survey.

3.4.10. Subsequent analysis of the Anabats confirmed one common pipistrelle call on Anabat 1 and nineteen common pipistrelle bat calls on Anabat 2.

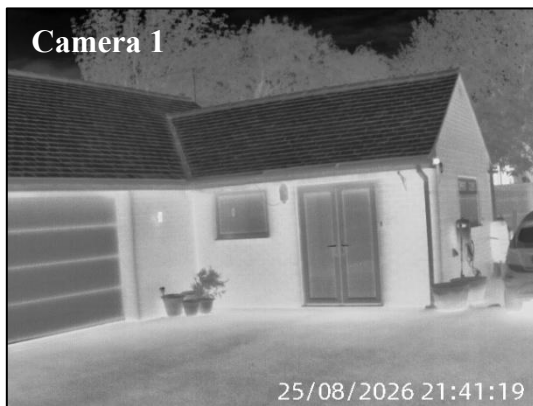
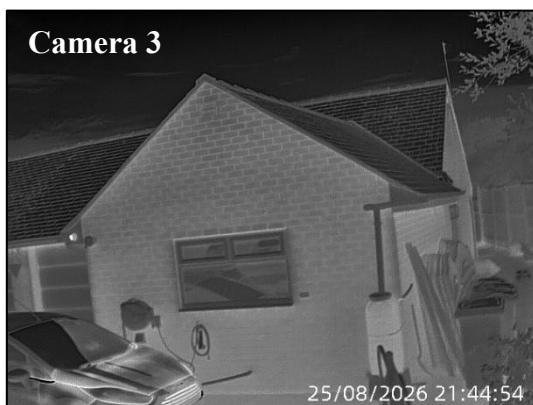
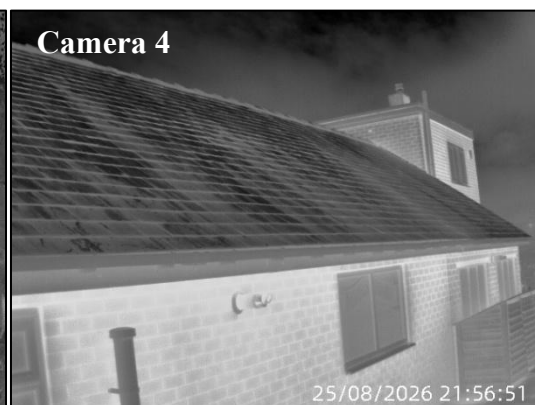
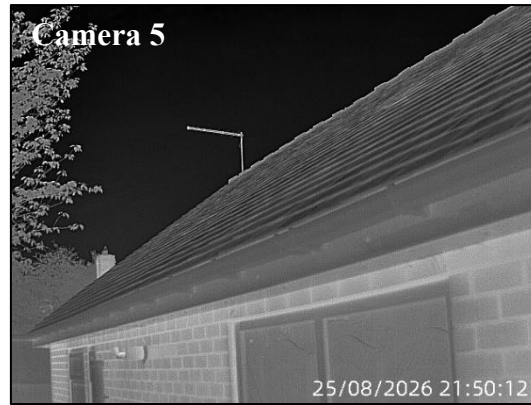
3.4.7. The photographs below show the view of each camera at the darkest point of the survey.

3.4.9. No bats were seen to emerge from the building throughout the survey. The video cameras were subsequently analysed and confirmed no bats emerged from the building during the survey.
