# Stainborough Castle, Wentworth Castle

## Bat Survey Report

27<sup>th</sup> February 2020

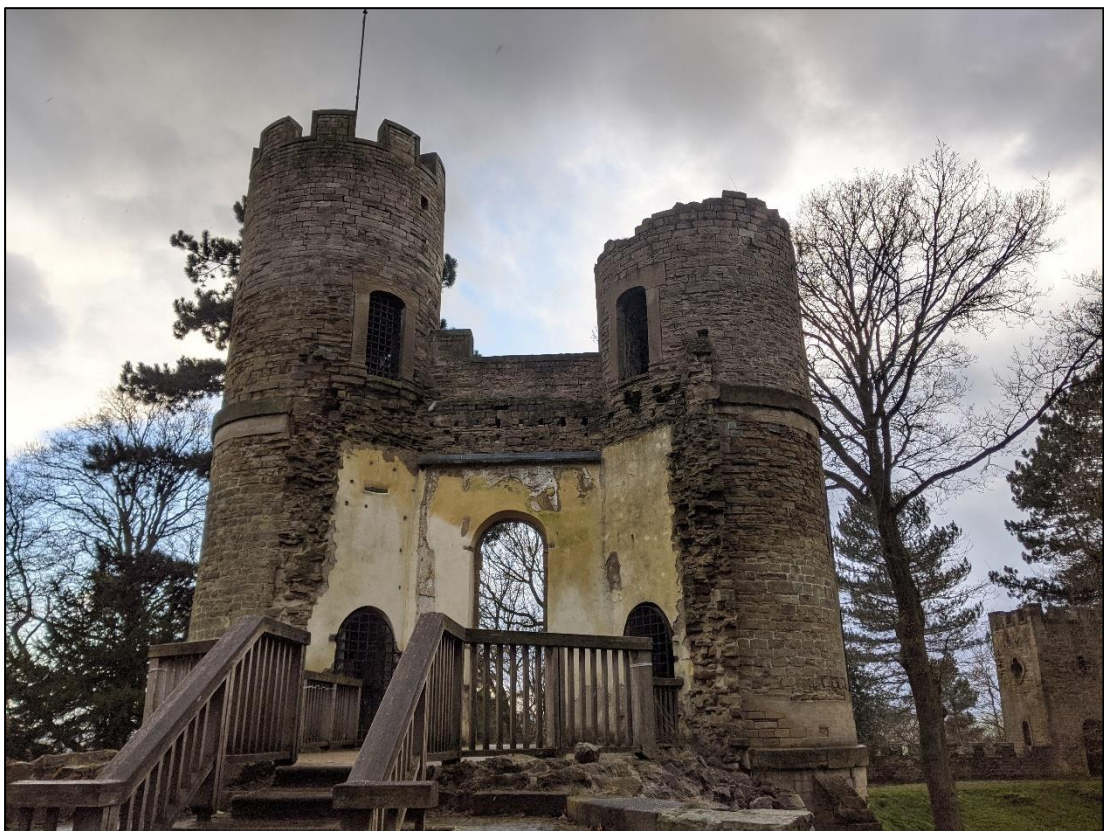
**Plate 2. North side of turrets GT1 and GT2**

- 5.2.4 The exterior of the turrets GT1 and GT2 includes mostly superficial gaps in masonry joints, with occasional deeper holes present. Deeper crevices were noted on the south side of GT2, within the area where the Natterer' bat roost was recorded in 2004 (Figure 2). Joints in this area were difficult to inspect from the ground due to their height. Numerous shallow crevices were present between masonry in the areas where a former wall has collapsed, or been removed, on the north side of turrets GT1 and GT2 (Plate 2). Bats may also roost within deeper crevices and voids between stone blocks on the turret exteriors.

- 6.3.5 If works to turret GT2, which supported a large Natterer's bat transitional roost in September 2004, are to commence in summer 2020 then some elements of re-pointing to the upper tower may not be possible. Under the precautionary working method, a pre-works nocturnal survey would take place to highlight any bat roosts present at the time of works. Nevertheless, it is recommended that works to GT2 avoid the late summer period, in order not to prevent bats returning to this previously recorded roost location.

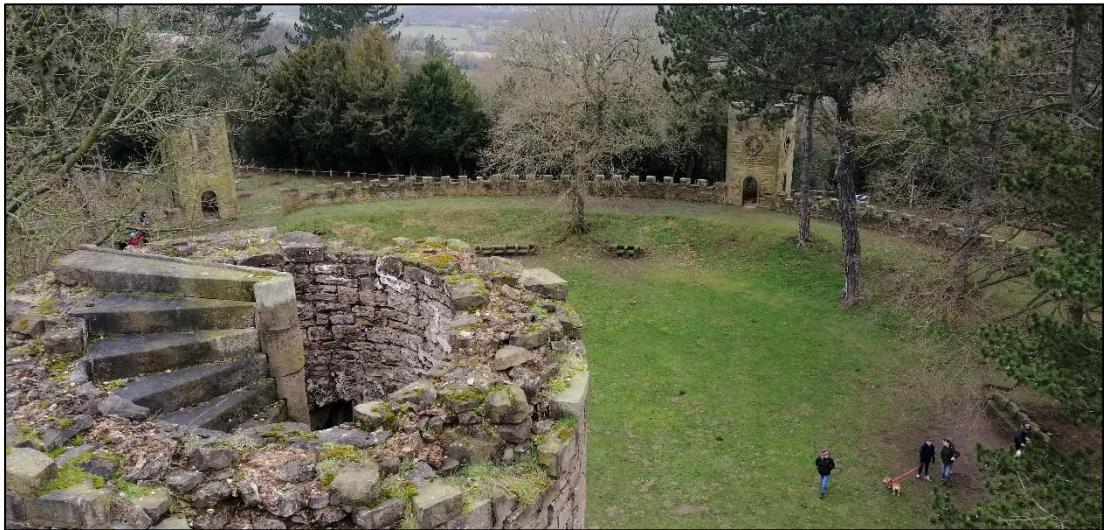
Plate 3. View from top of GT1, GT2 in foreground plus T2, T3 and curtain wall

- 5.2.6 Four square towers are present in the curtain wall (Plate 3). These are mainly two stories in height, with T4 also supporting a basement room. None of the towers have roofs and all have two door or window openings in each elevation. Pairs of wooden lintels are present above upper window openings and above door openings. Door openings connect the tower interiors to the open space enclosed by the curtain wall. A fire opening and associated flue is built into the wall on the north side of T4, with the basement room beneath this tower accessed from the outside of the curtain wall.
