## Water Vole Survey

Proposed Rabbit Ings Regeneration Scheme,  
Near Royston, Barnsley

On behalf of the City of Wakefield Metropolitan  
District Council and Yorkshire Forward

By WYG Environment

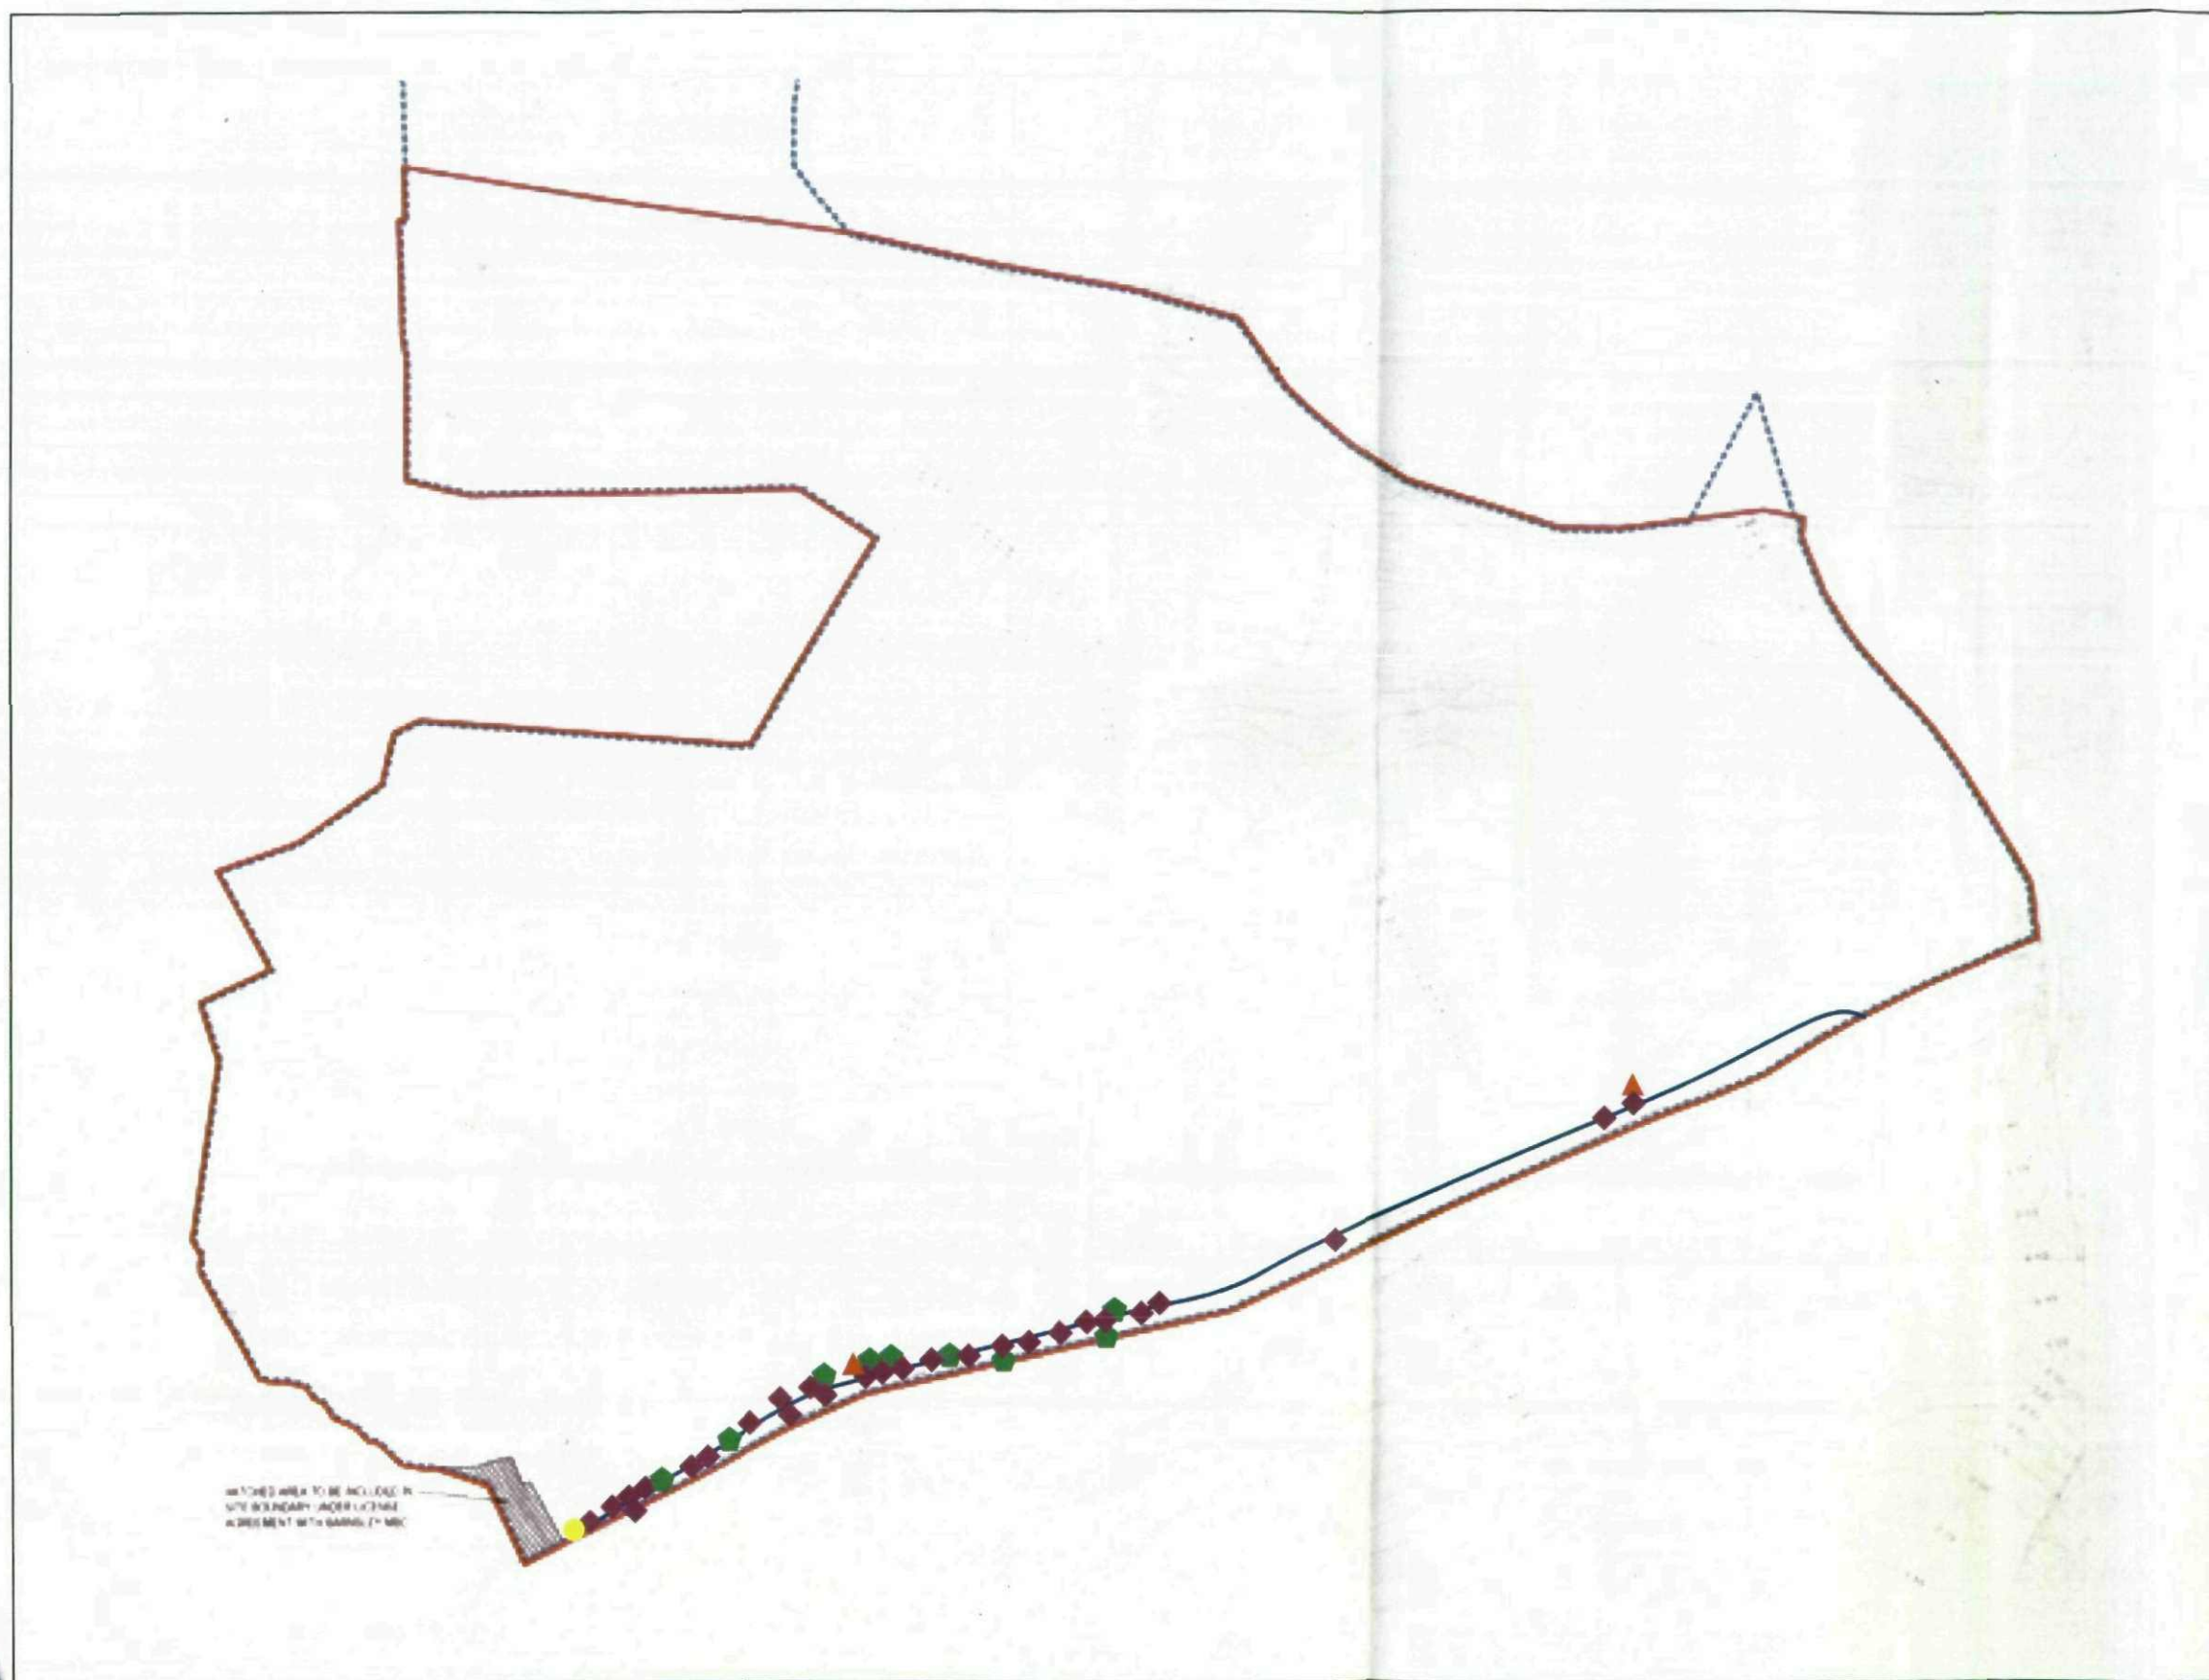
**PLAN 1**

It was evident during the water vole survey that Sandybridge Dyke supported water voles (Plan 1). Although target notes were centred on the south-western corner of the site (near the entry of the watercourse onto the Rabbit Ings site), they were also distributed more sparsely along the surveyed length of the watercourse. Evidence included signs of activity such as latrines, runs, paw prints, grazing lawns and burrows. Larger complexes (with 3 or more holes) were target noted at OS grid references SE 37854 11386, SE 37895 11412 and SE 38147 11485. In addition, an incidental record of water vole droppings was made at Pond 3 to the north of the Site's boundary on 13<sup>th</sup> August 2008.

Water Vole Survey Results
