Highways condition survey

Stairfoot Way/Bleachcroft Way Dilapidation Survey

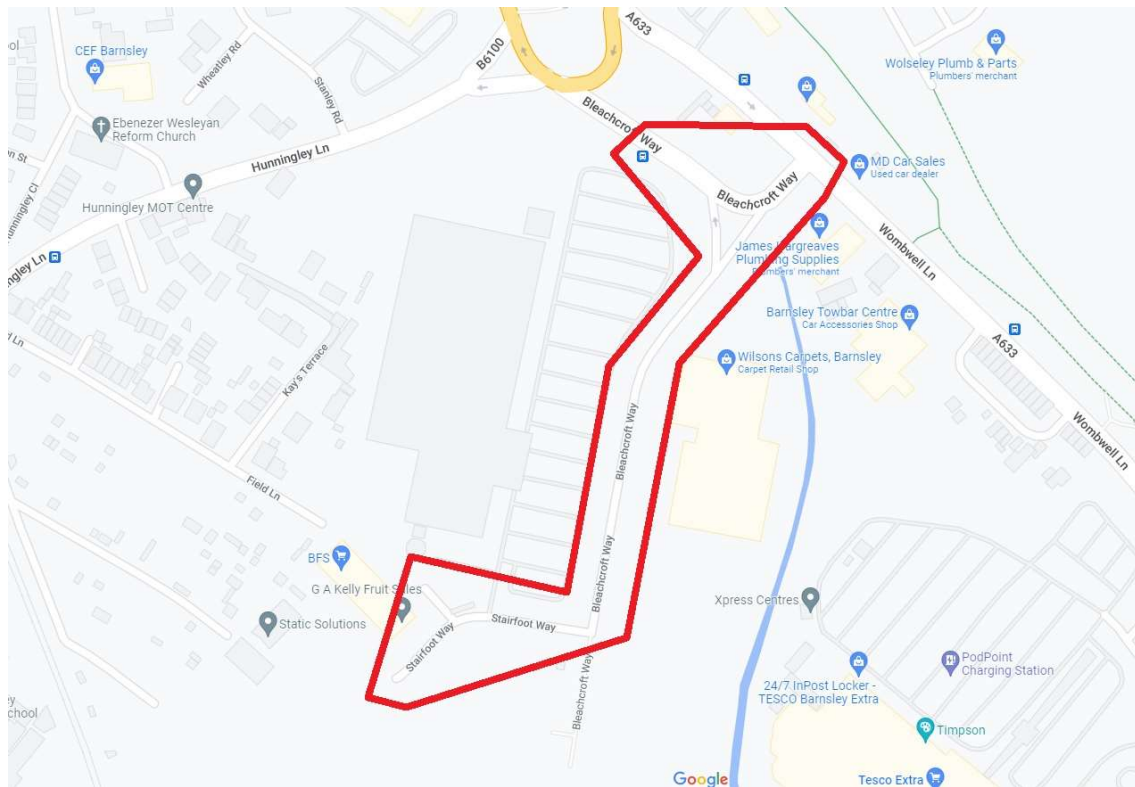
The roads assessed were Bleachcroft Way from the junction with Wombwell Lane, along Bleachcroft Way to the bus stop, the section of Bleachcroft Way past the junction with Stairfoot Way to the point it accesses the site and Stairfoot Way to the point it accesses the site, as shown outlined in red on the plan below:

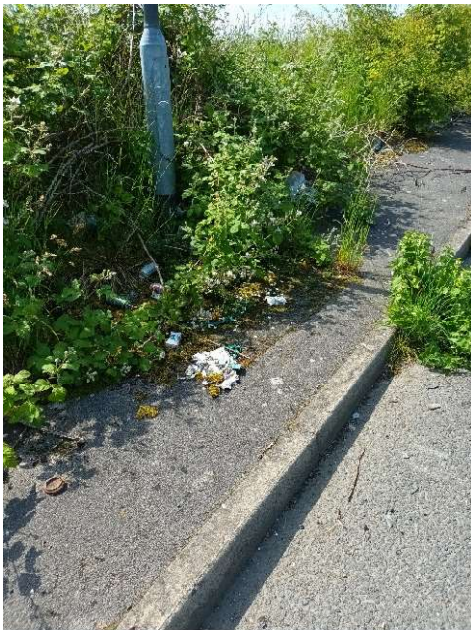
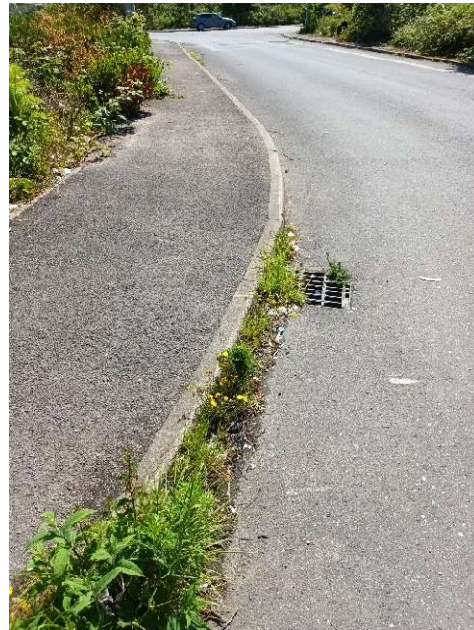
The area is overgrown with weeds growing in the channel, between the kerbs and in the footpath

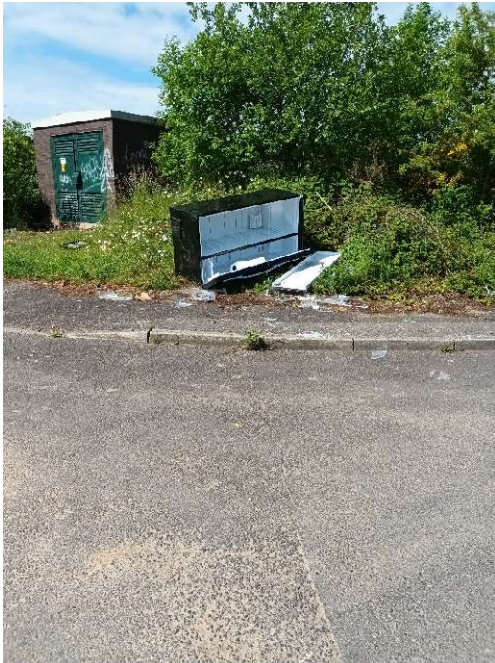
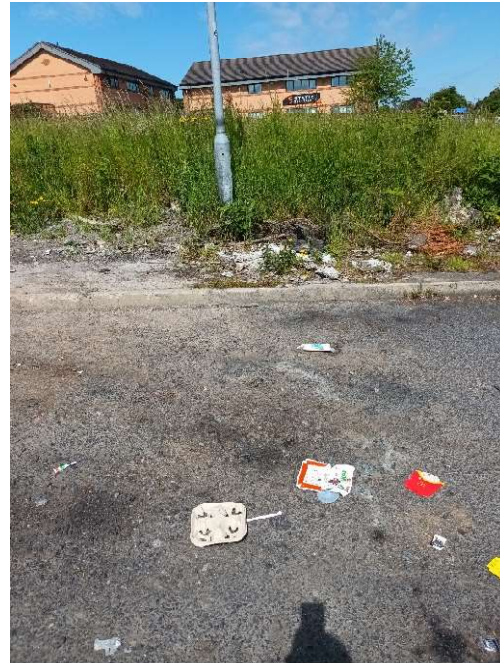
Fly tipping appears to be a common practice along this stretch of road with some set on fire causing damage to the road surface and kerbs

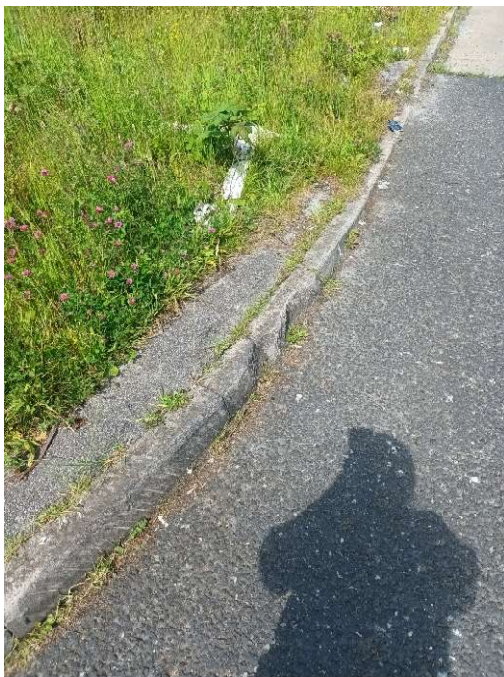
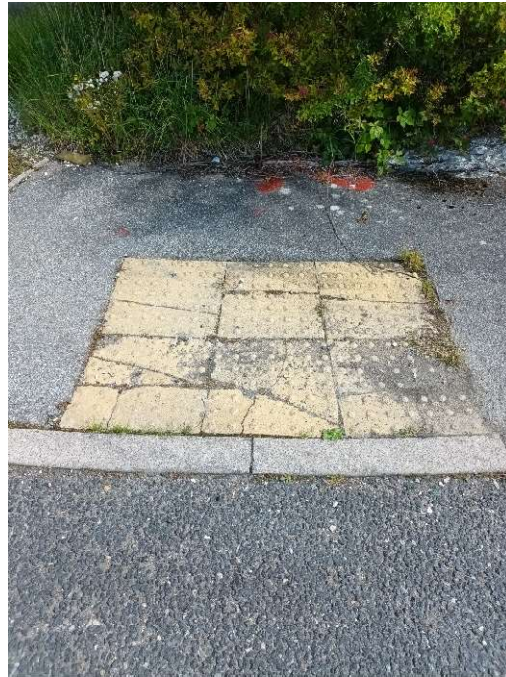
Kerbs and tactile paving have been damaged due to vehicles over running or parking on them and these have not been repaired or replaced

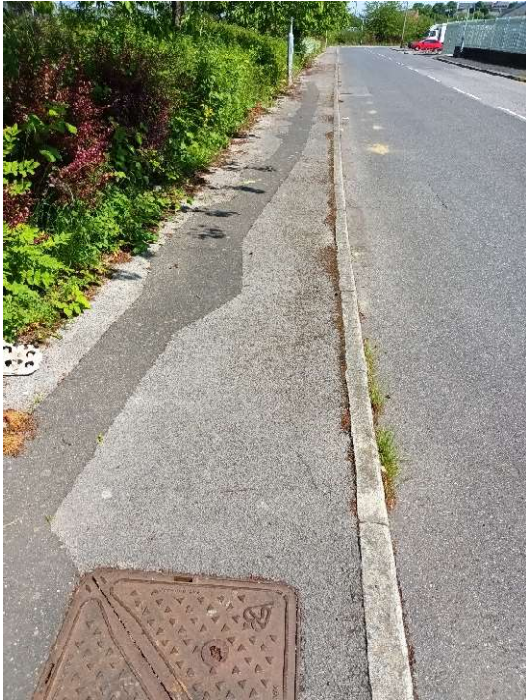
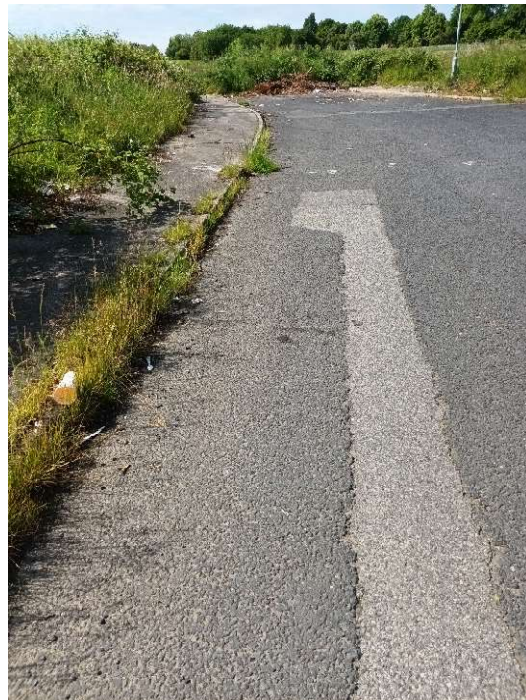
Service trenches have been dug and reinstatement of the surface has started to sink and fail

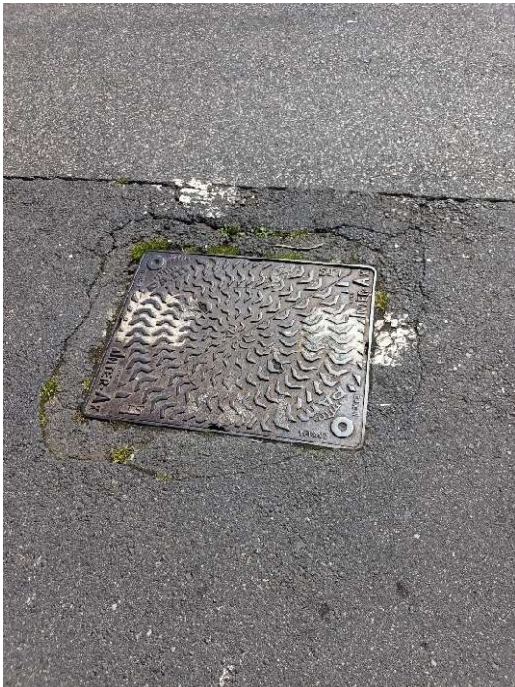
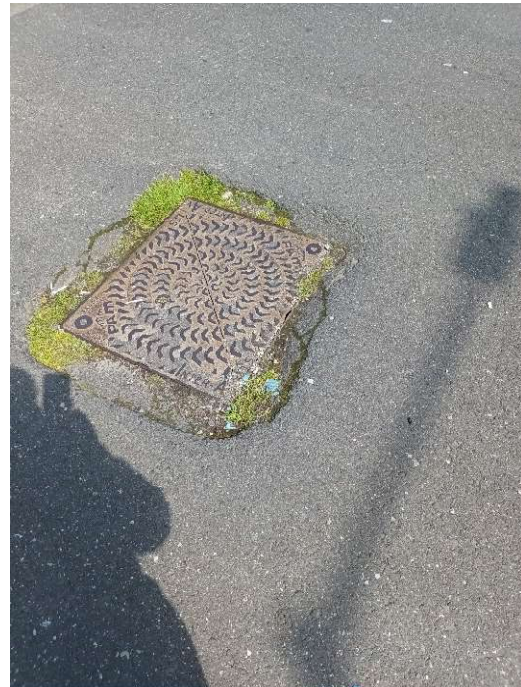
Many of the covers for both the sewers and other services are loose and damaged causing areas of the highway to fail around them

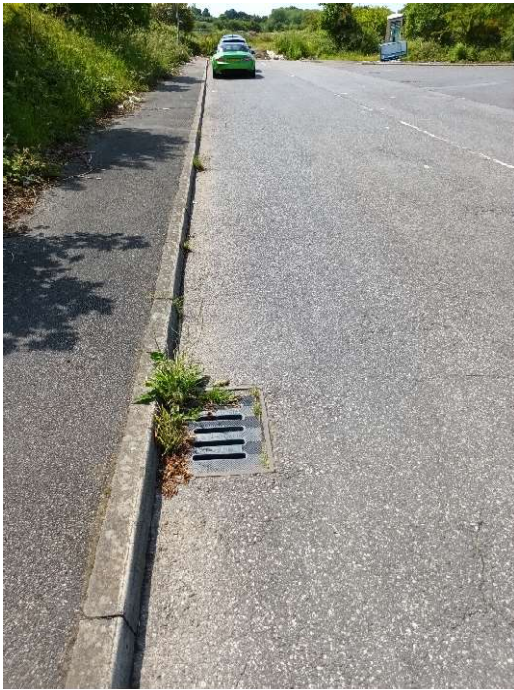
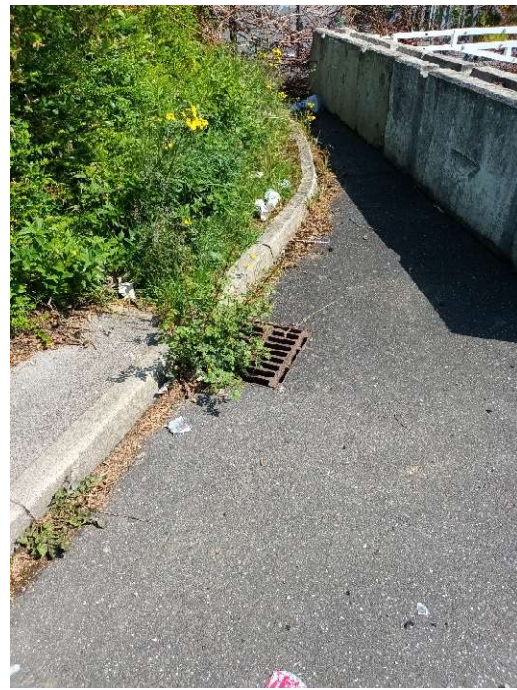
Gullies have not been maintained with a number of them being blocked with plants growing out of the gully grating to varying degrees.

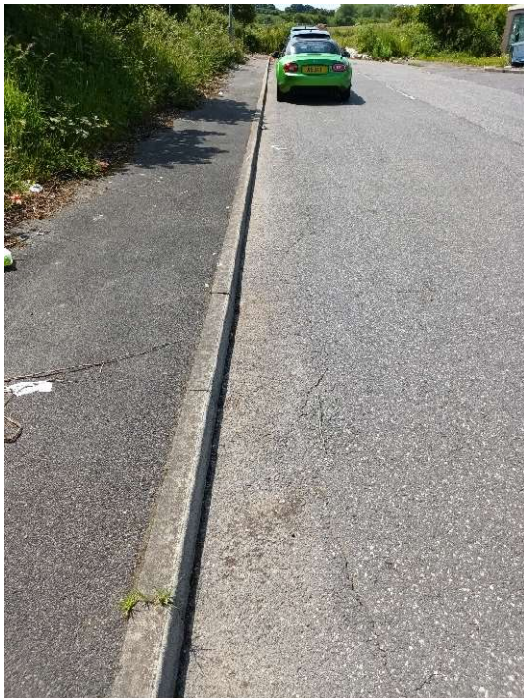
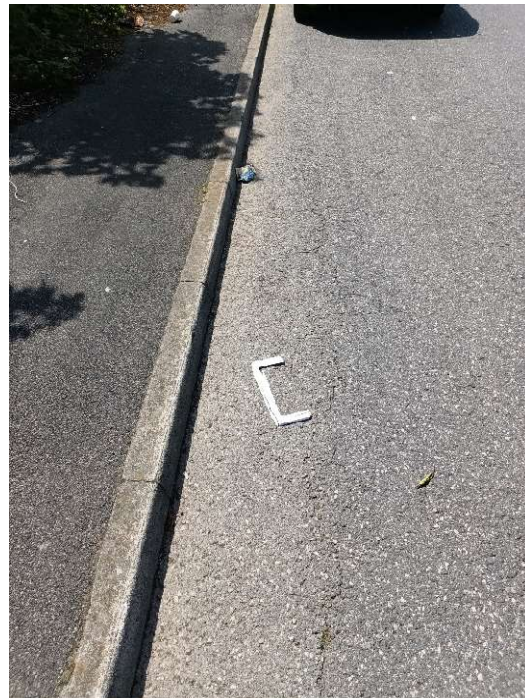
Cracking has started to appear in the surface course where it is failing or has already failed
