**Metrodome Leisure Complex  
Barnsley  
– BS 5837:2012 Tree Survey  
Barnsley Premier Leisure**

Report Title: **Metrodome Leisure Complex, Barnsley  
BS 5837:2012 Tree Survey**

Revision: **V1.0**  
Issue Date: **April 2019**  
Report Ref: **12739**

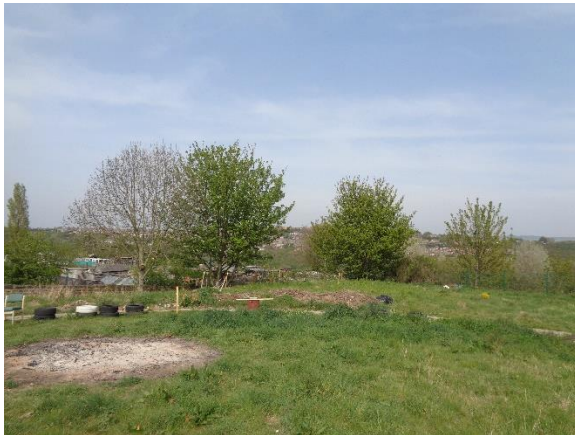
- 3.1.9 All the trees are semi-mature and none are of any great quality. The trees on the bank (T001 to T004) have suffered a degree of level changes within their RPA, though this appears to have little detrimental effect on their health.

**Plate 1:** T001 (l) to T004 (r) looking north

- 3.1.10 Trees recorded within the survey are not of any great quality. The trees growing on the slope (T001 to TG011) are unlikely to be affected by development within the allotment area due to their positioning and past soil level changes.

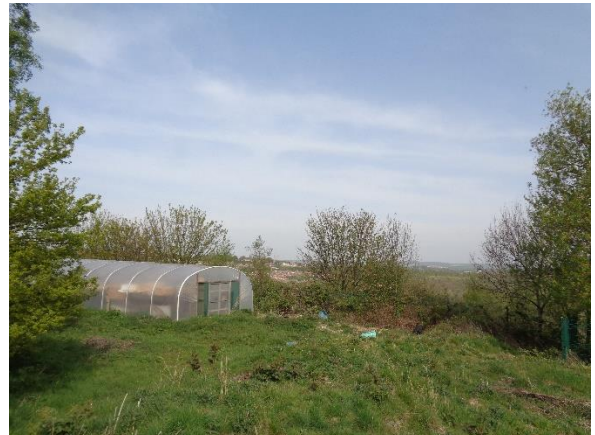
**Plate 2:** Eastern boundary looking NE, G011 centre

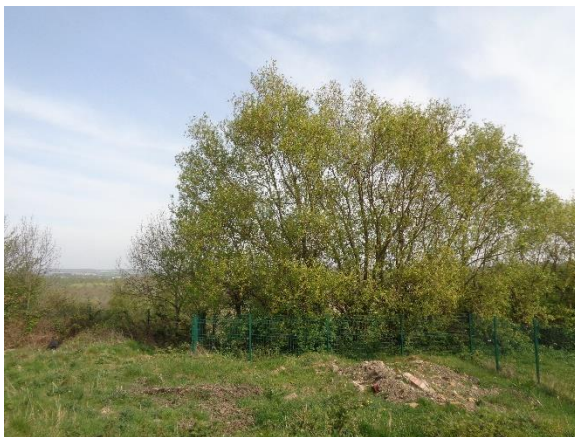
- 3.1.7 The crack willow T012 (*Salix fragilis*) forms the northern end of a short row of trees along the eastern boundary, and is typical of the species, being multi stemmed with a spreading habit.

**Plate 3:** Willow T012 looking east

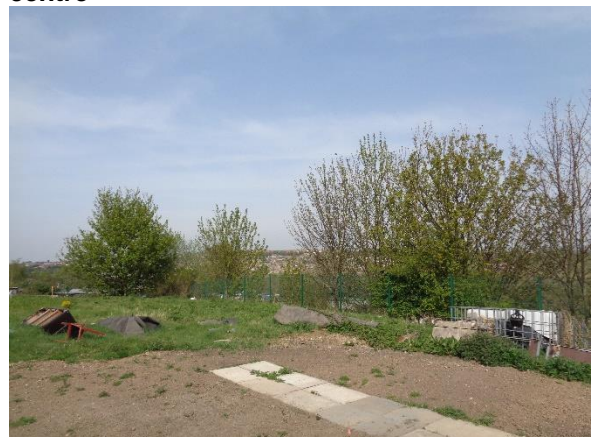
**Plate 4:** General view along eastern boundary, looking north T010 to T003 left

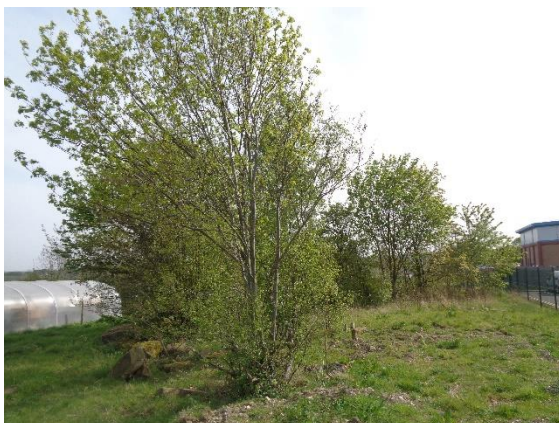
- 3.1.8 The central group (G013) contains a mix of amenity species with a number of large multi stemmed field maples (*Acer campestre*), which have possibly been coppiced in the past. This group appears to be mostly self-set trees, with the alder (*Alnus glutinosa*) in particular growing in a dense stand.

**Plate 5:** G013 looking south

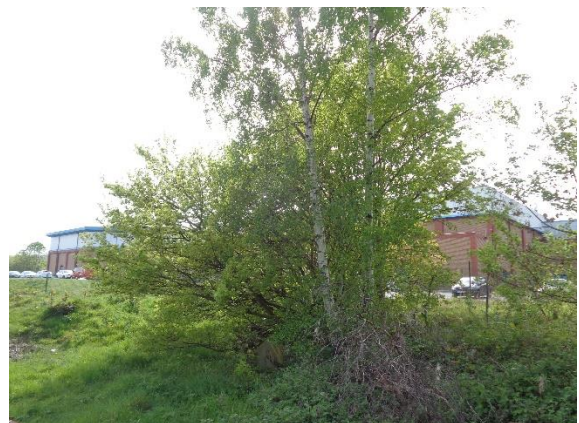
**Plate 6:** G013 looking west, with T014 at front of group
