Report No. 1898/1A

**GEOENVIRONMENTAL APPRAISAL**  
**of land at**  
**LITTLEWORTH LANE, LUNDWORTH**

**Prepared for**  
**HARRON HOMES LIMITED**

## LITTLEWORTH LANE, LUNDWOOD - SUMMARY OF GEOENVIRONMENTAL ISSUES

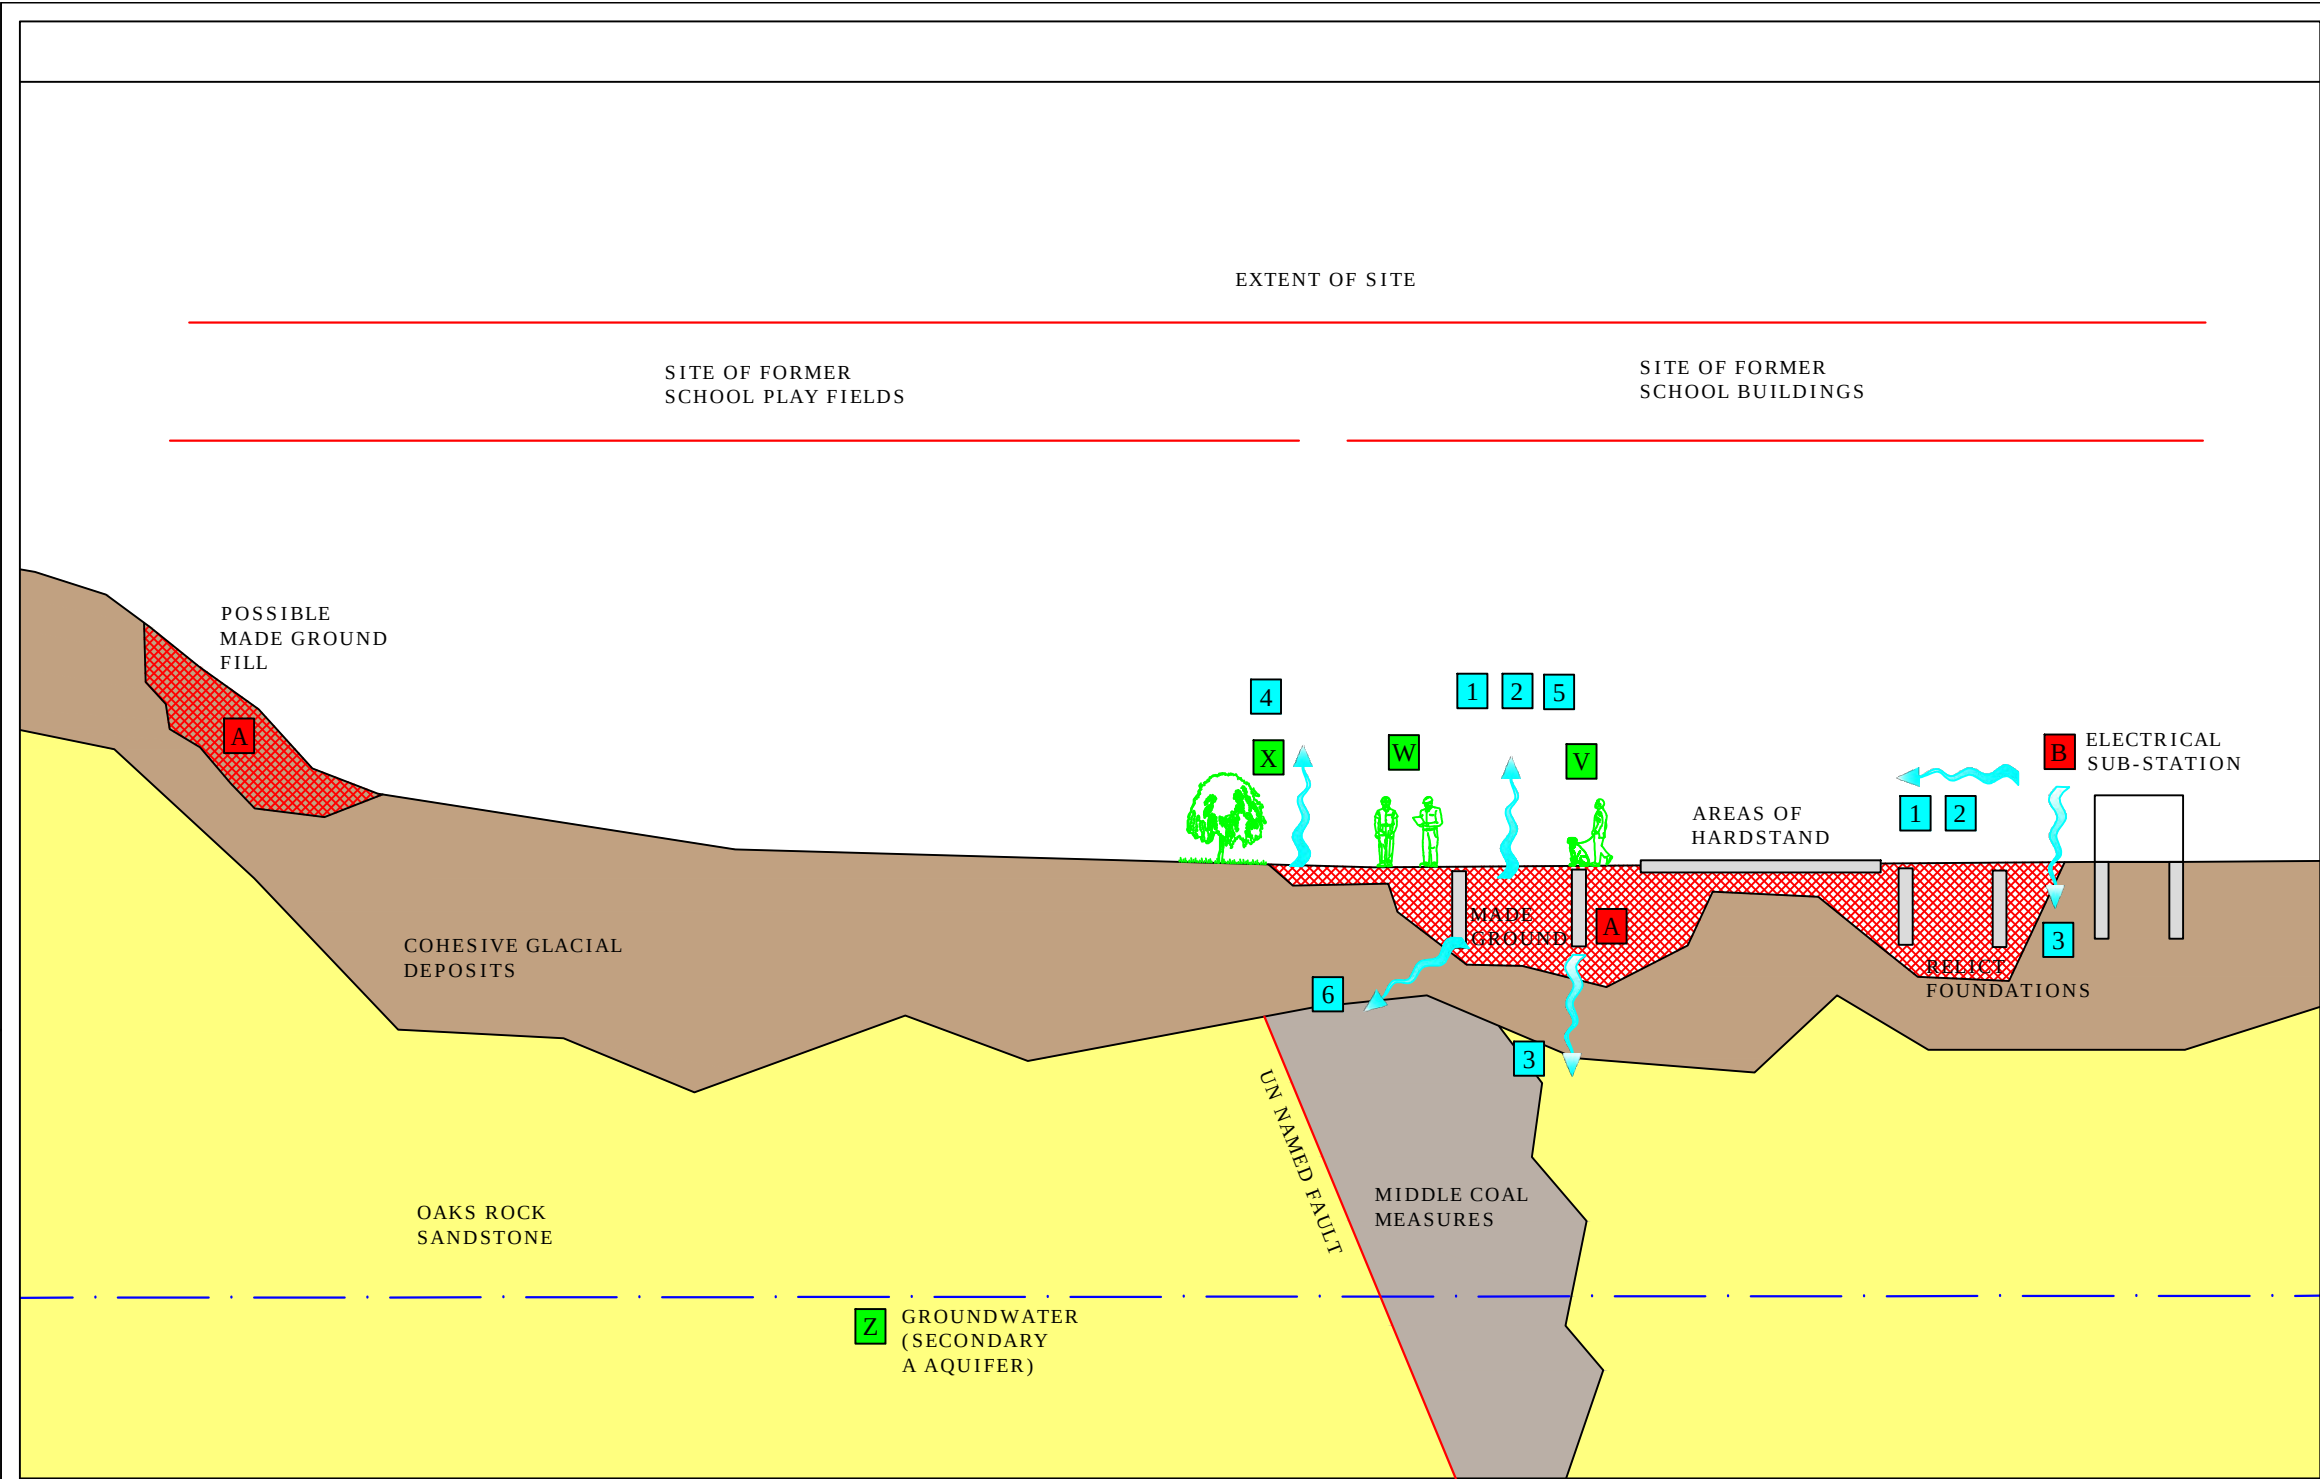
| Not to scale | | | | A3 | 1898/5 | |

| SOURCES | |
|---|---|
| A | MADE GROUND (INORGANICS) |

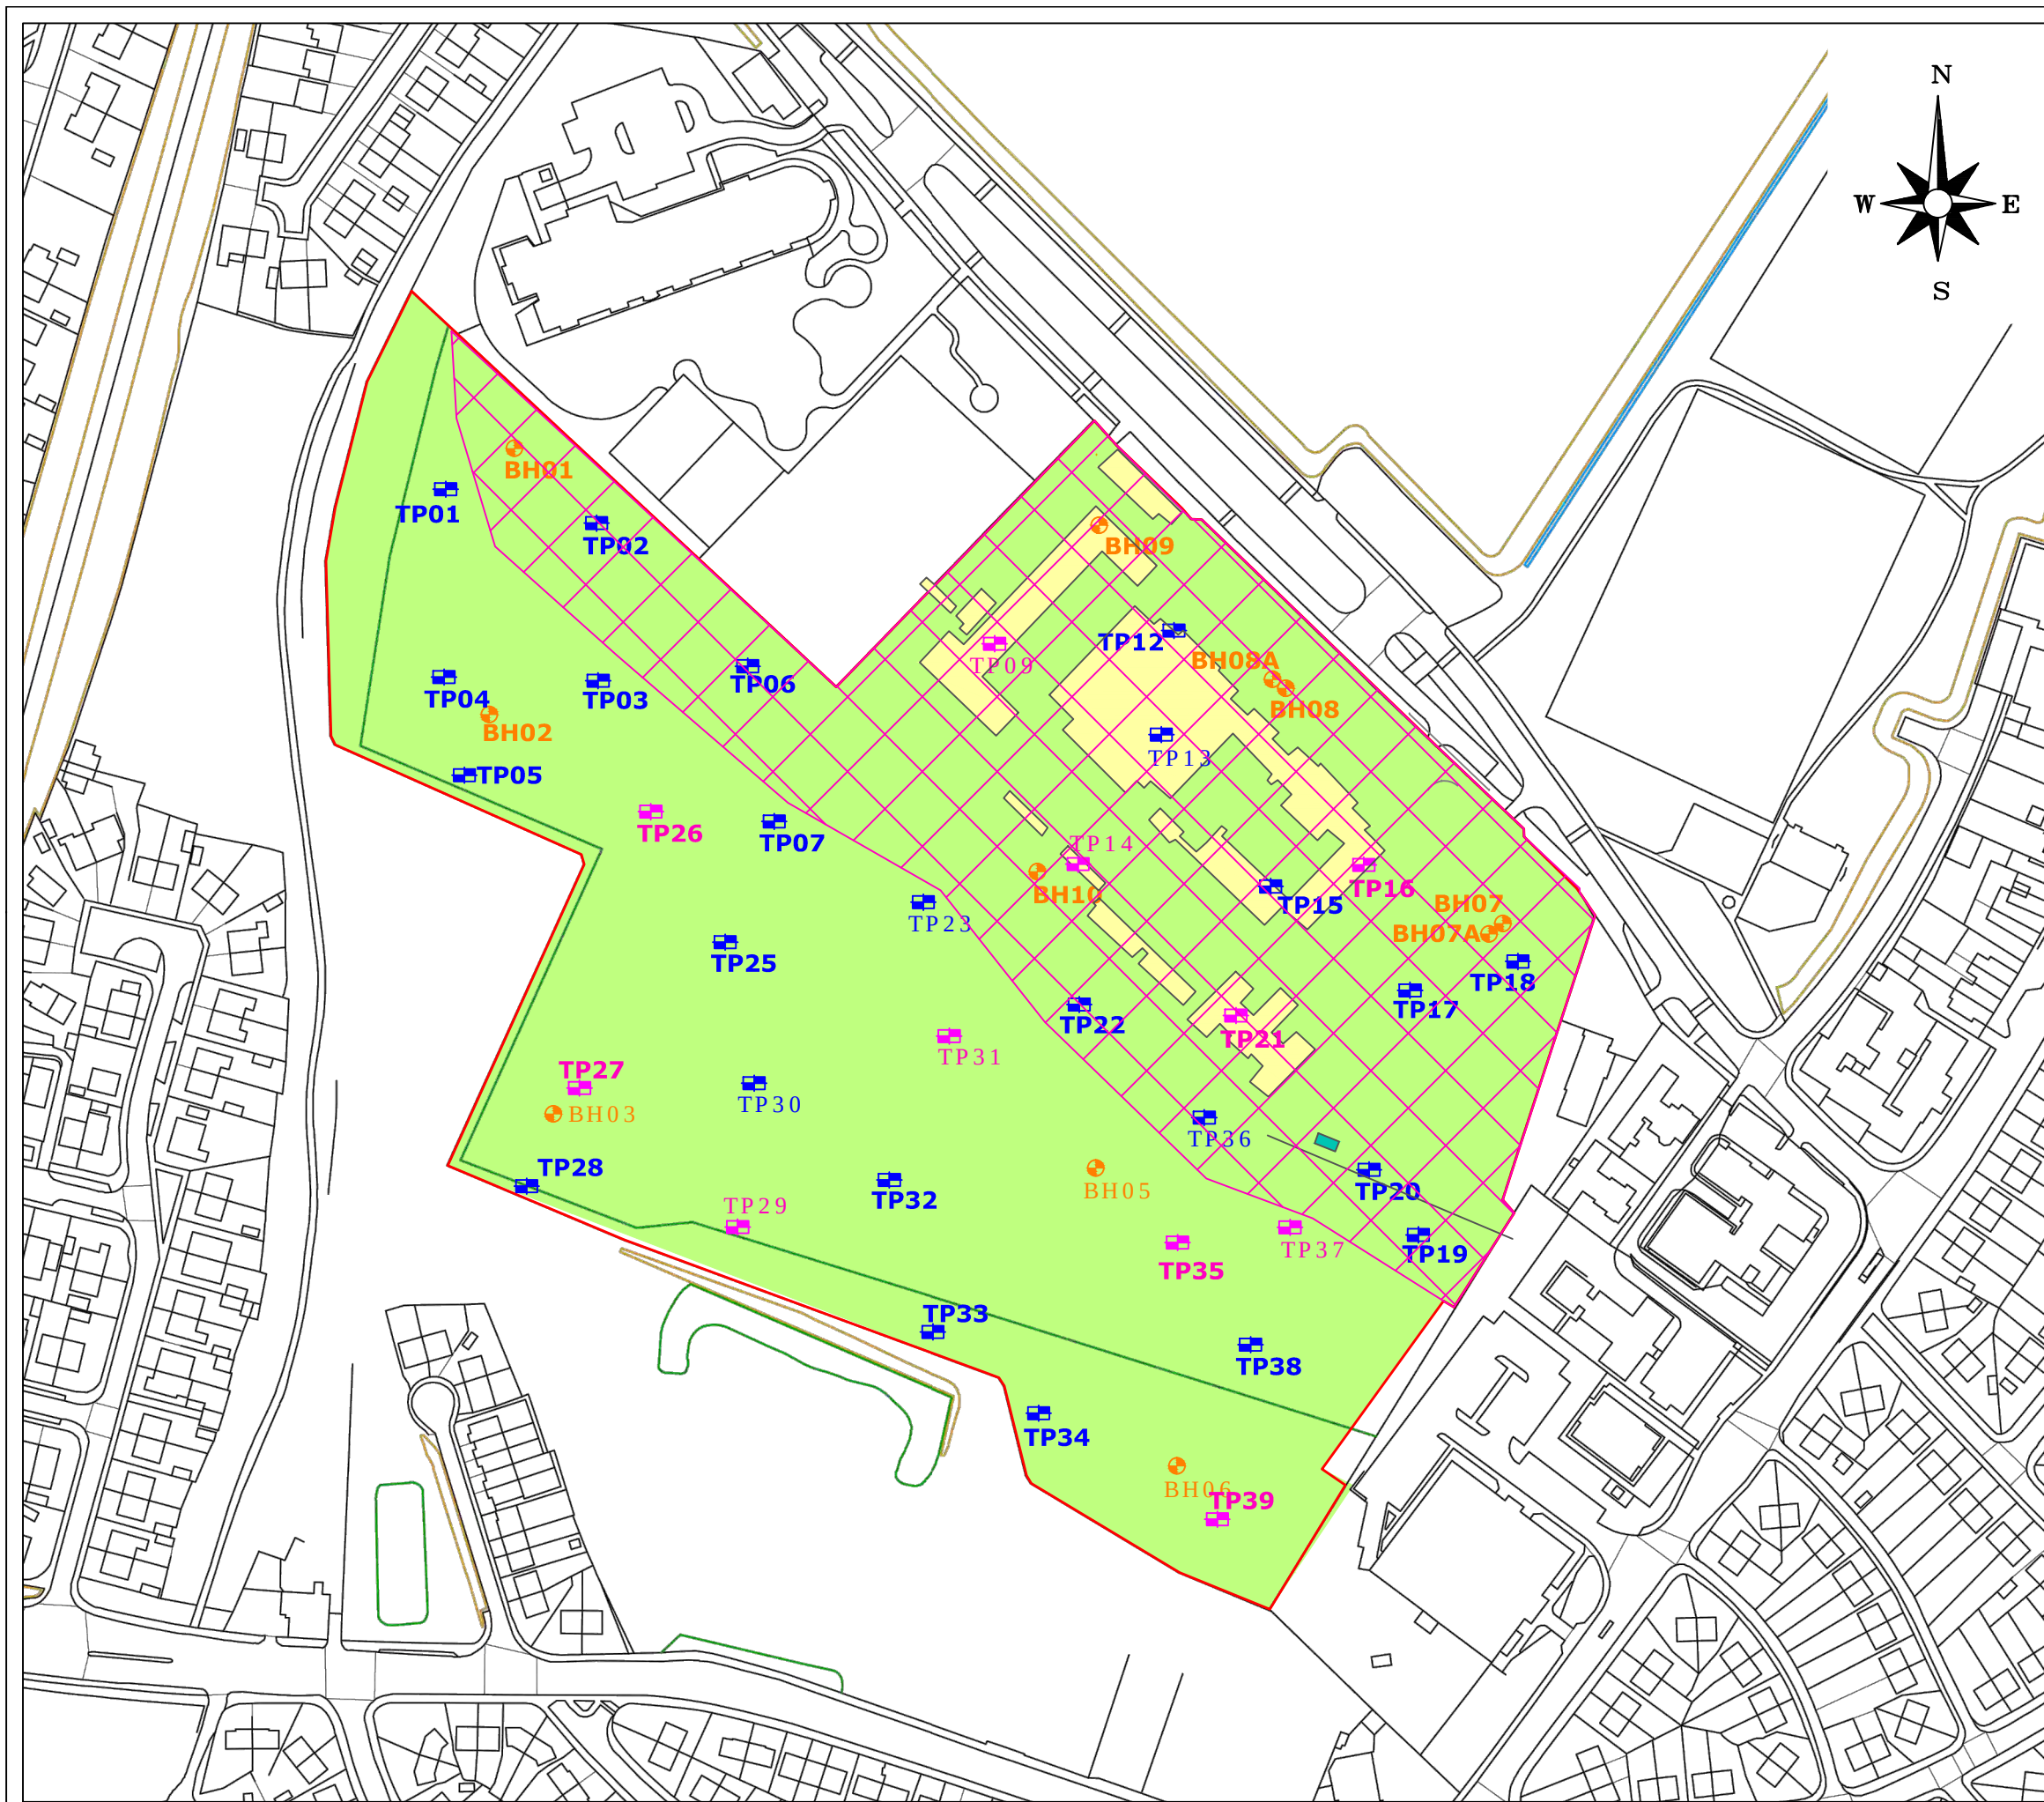
| <b>Drawing No.</b> | <b>Title</b> |
|---|---|
| 1898/6 | Exploratory Hole Location Plan |

- 7.3.1 It is apparent from a review of historical OS Plans (see Section 3) and the site visit that buildings have been present on about 25% of the site area. Drawing No. 1898/6 shows the footprints of the former structures.
- 7.3.2 Eight Trial pits have been excavated at locations where relict foundations were anticipated (based on superimposition of historical OS Plans).
- 7.3.3 Obstructions encountered in trial pits across the site are summarised below:

- TRIAL PIT LOCATION
- SOAKAWAY PIT LOCATION
- BOREHOLE LOCATION
- APPROXIMATE EXTENT OF MADE GROUND THAT REQUIRES SOIL COVER IN GARDEN AND LANDSCAPED AREAS
- APPROXIMATE SITE BOUNDARY

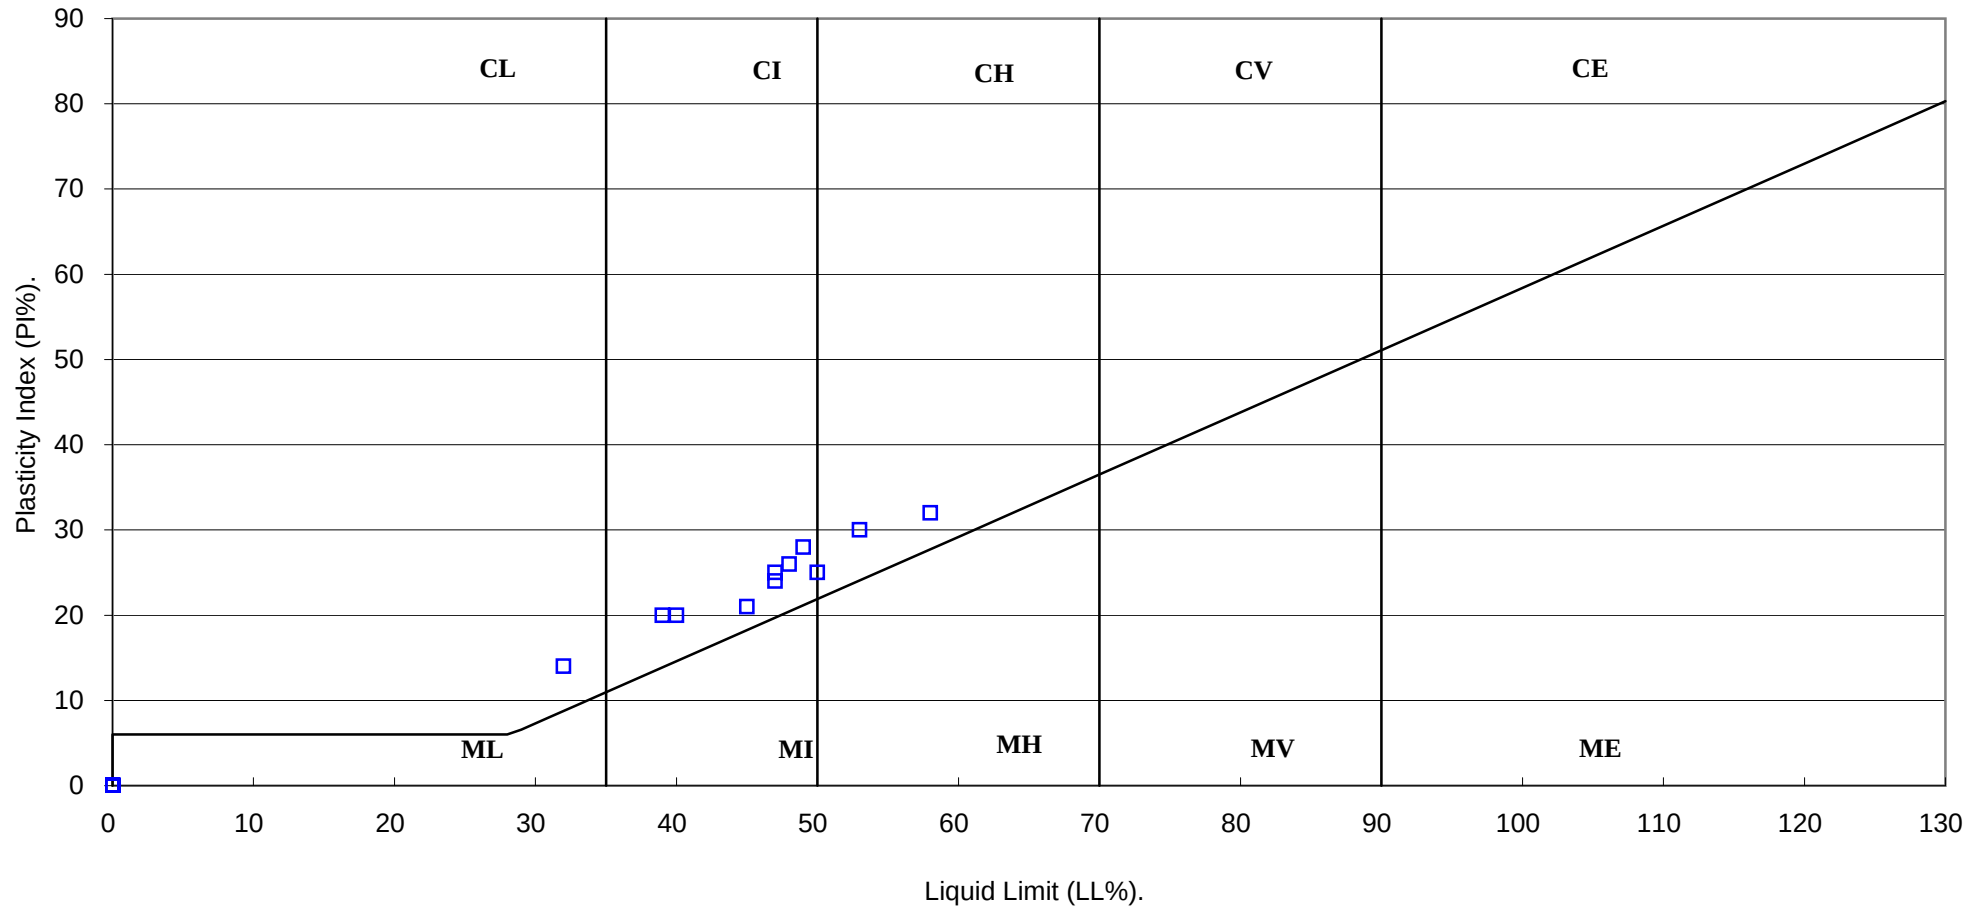
# PLASTICITY CHART FOR CASAGRANDE CLASSIFICATION.

(B.S.5930 : 1999)

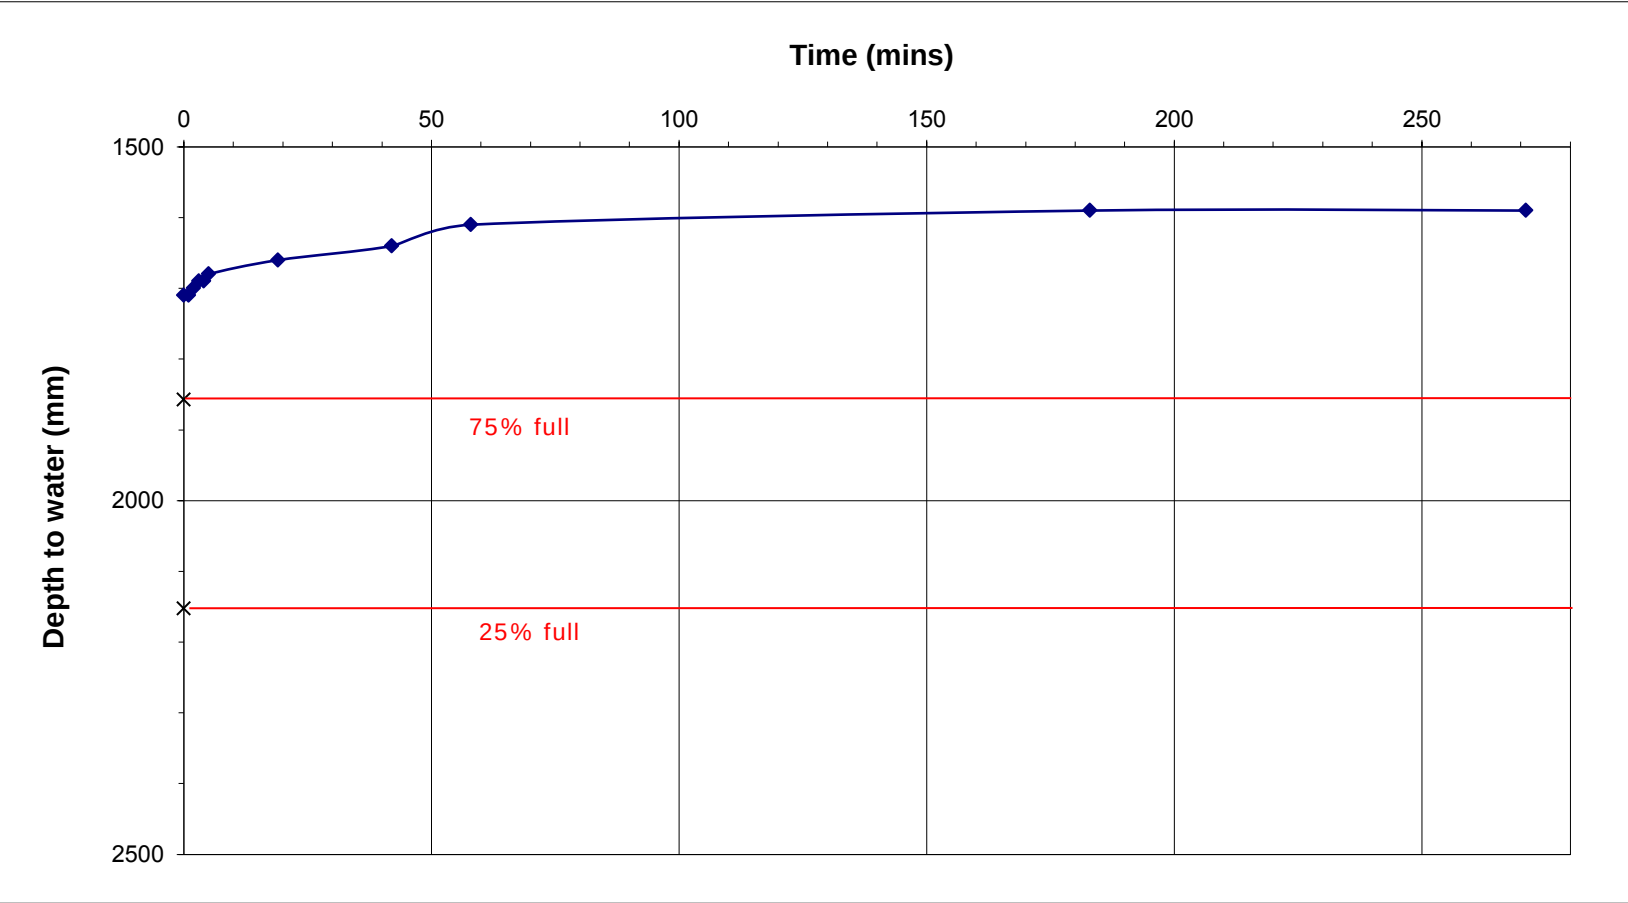
| Trial Pit No. | TP09 |

Test did not attain 25% Effective depth. Unable to calculate soil infiltration rate

# SOIL INFILTRATION RATE IN ACCORDANCE WITH BRE DIGEST 365: 1991

- 11.4.3 . BRE Digest 365 design takes into account the time of emptying the soakaway pit between 25% and 75% of its effective depth. The effective depth is calculated from the starting water level to the soakaway pit base.
- 11.4.4 However, none of the tests even reached the 75% effective depth and therefore infiltration rates could not be calculated.
- 11.4.5 Consequently, soakaways will not provide a suitable drainage solution for the discharge of surface water run-off at the site; there is likely to be a need for surface water balancing.

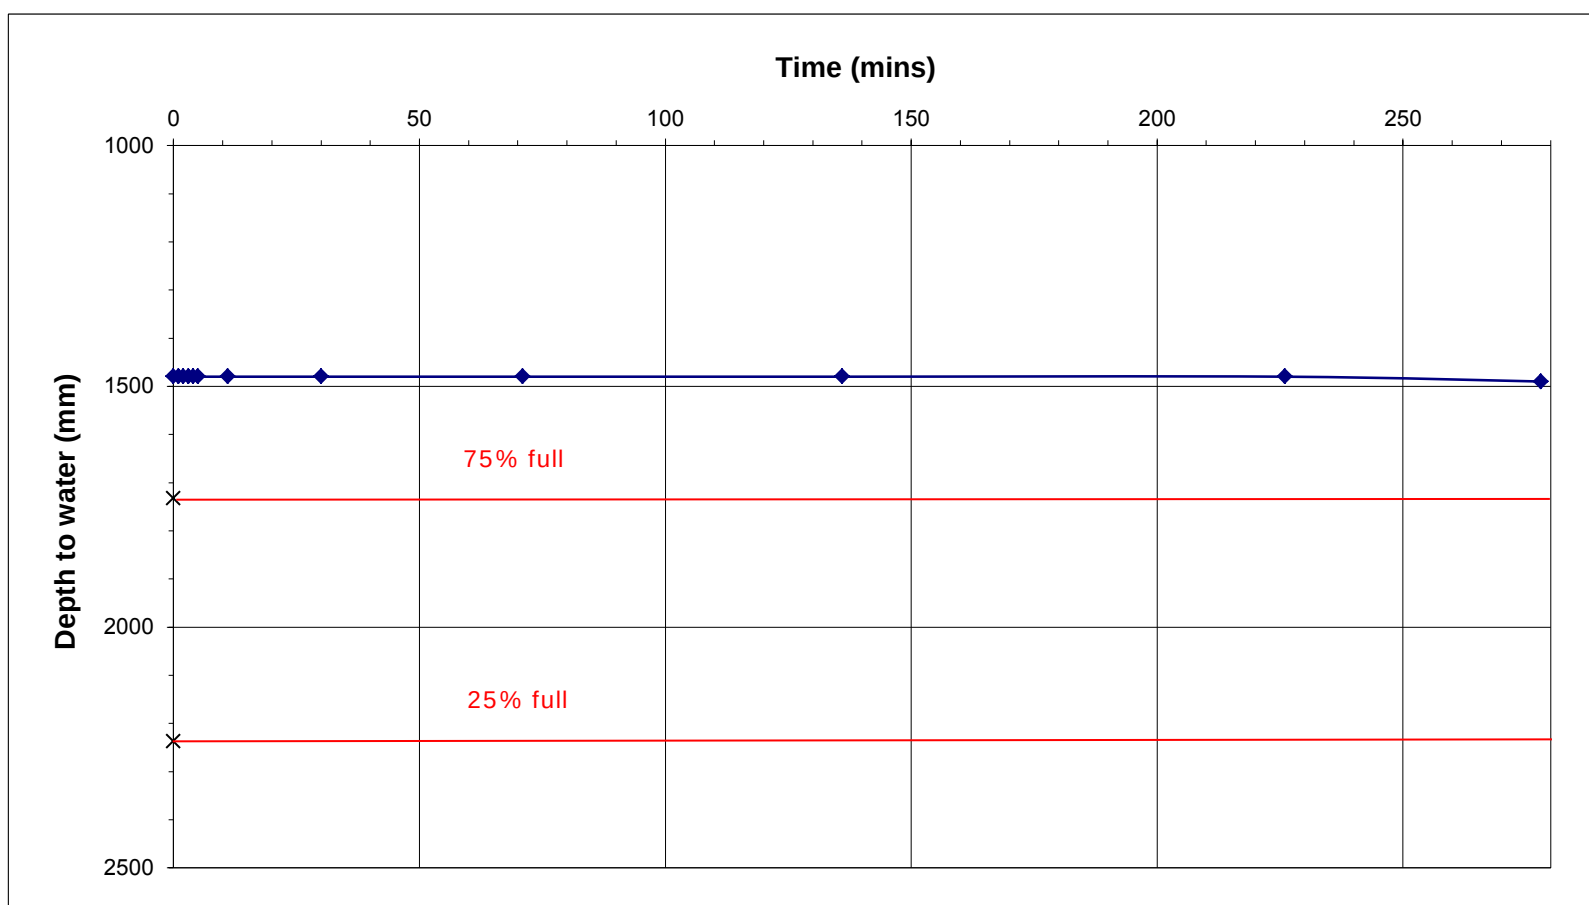
| Trial Pit No. | TP14 |

**Test did not attain 25% Effective depth. Unable to calculate soil infiltration rate**

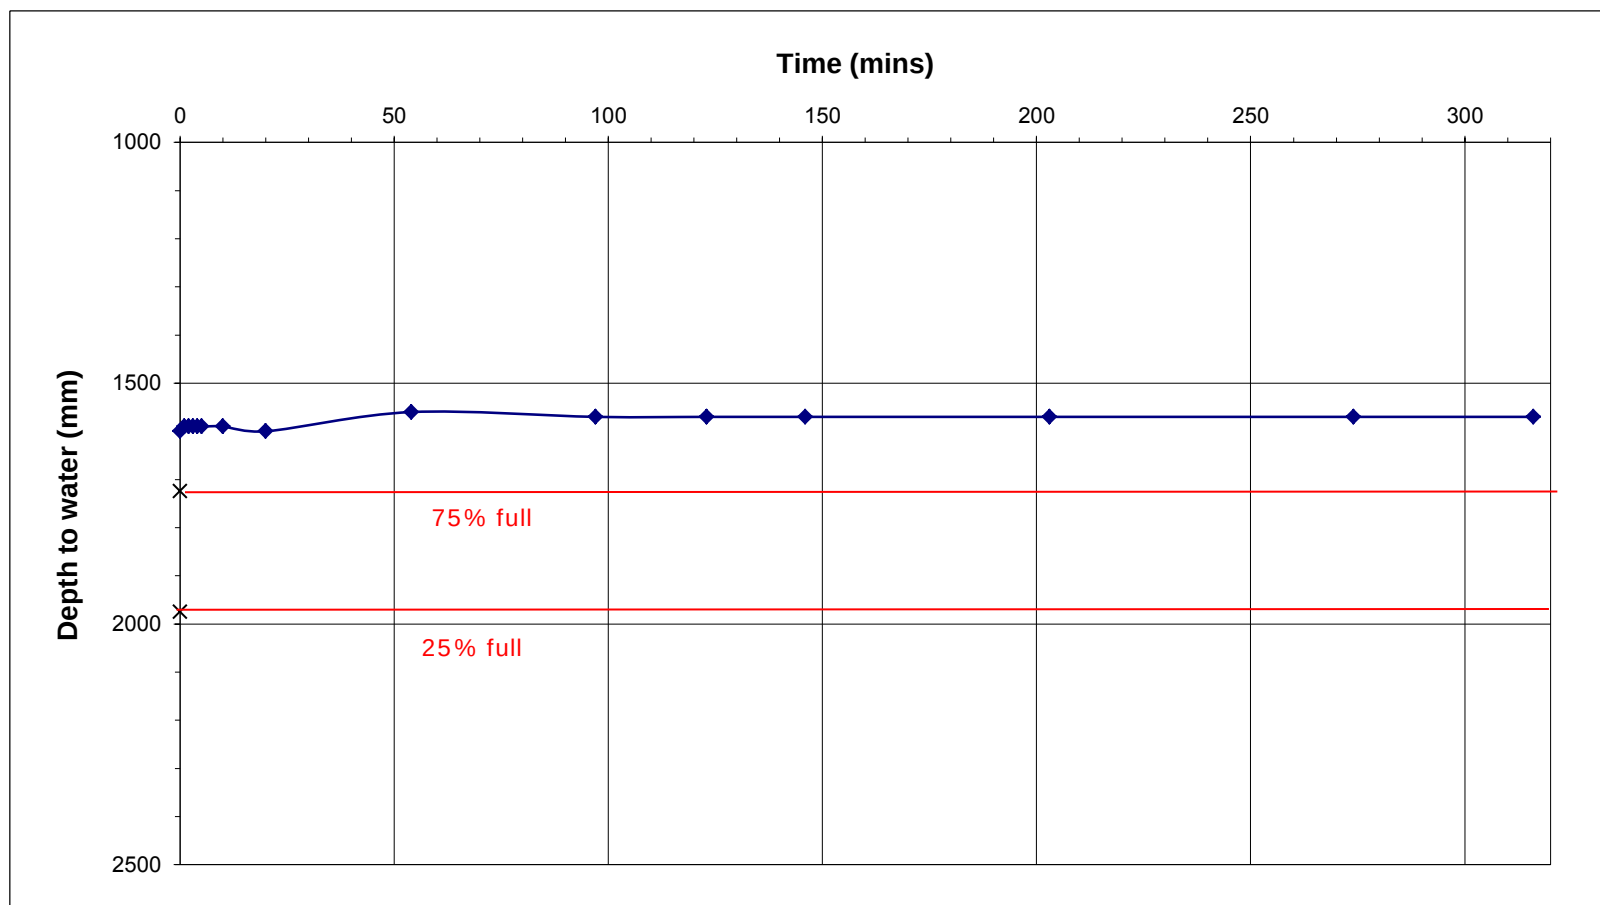
| Trial Pit No. | TP26 |

**Test did not attain 25% Effective depth. Unable to calculate soil infiltration rate**

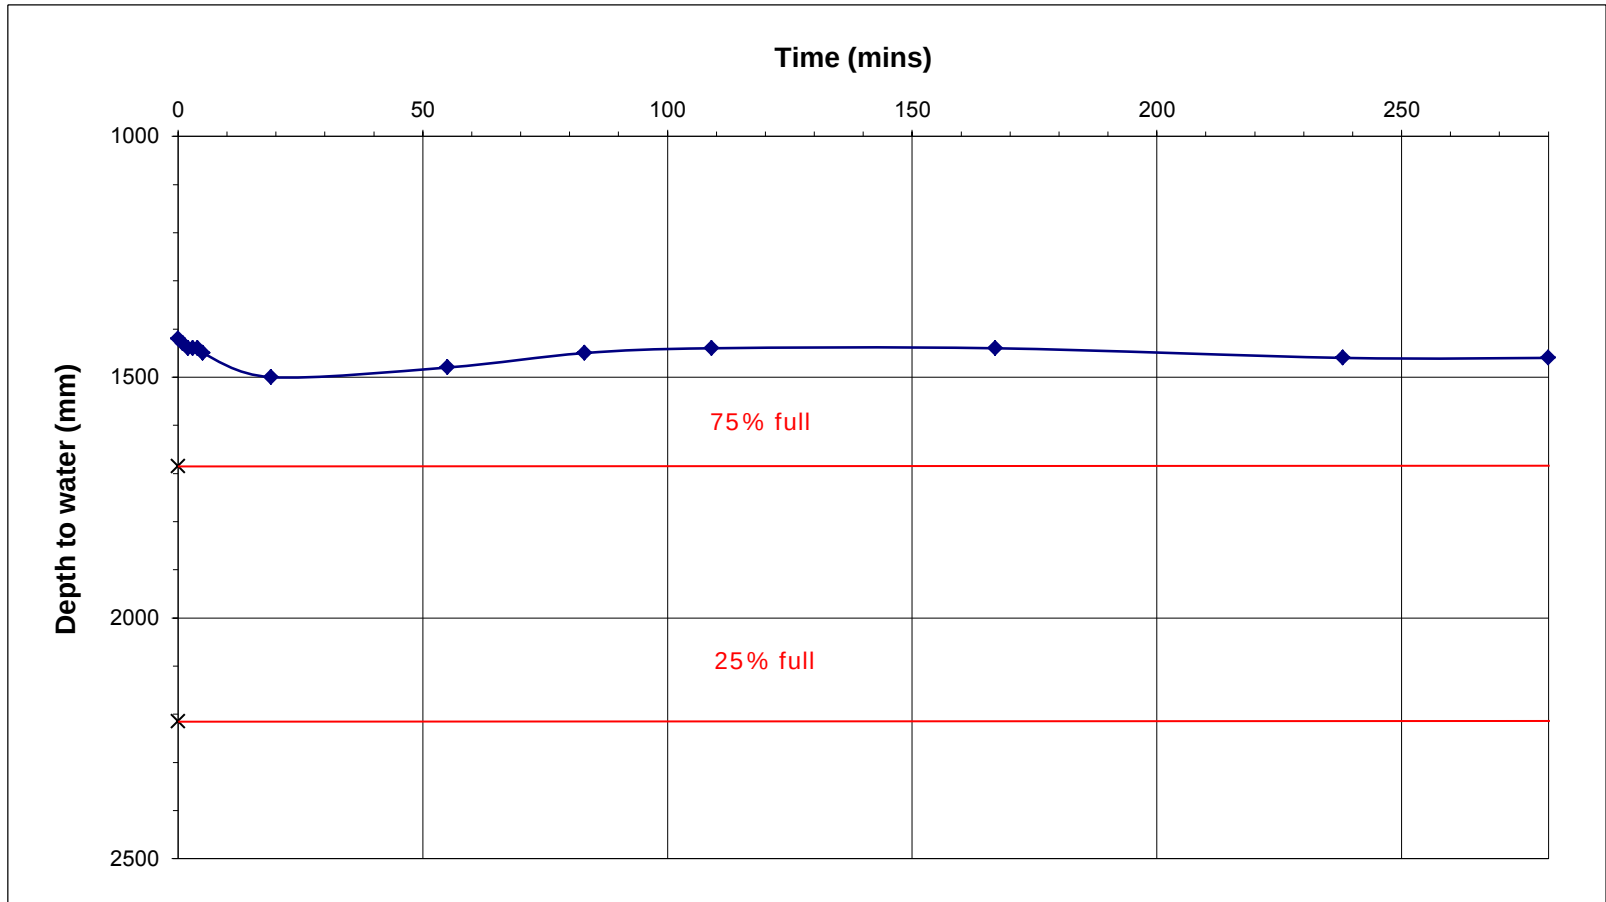
| Trial Pit No. | TP27 |

**Test did not attain 25% Effective depth. Unable to calculate soil infiltration rate**

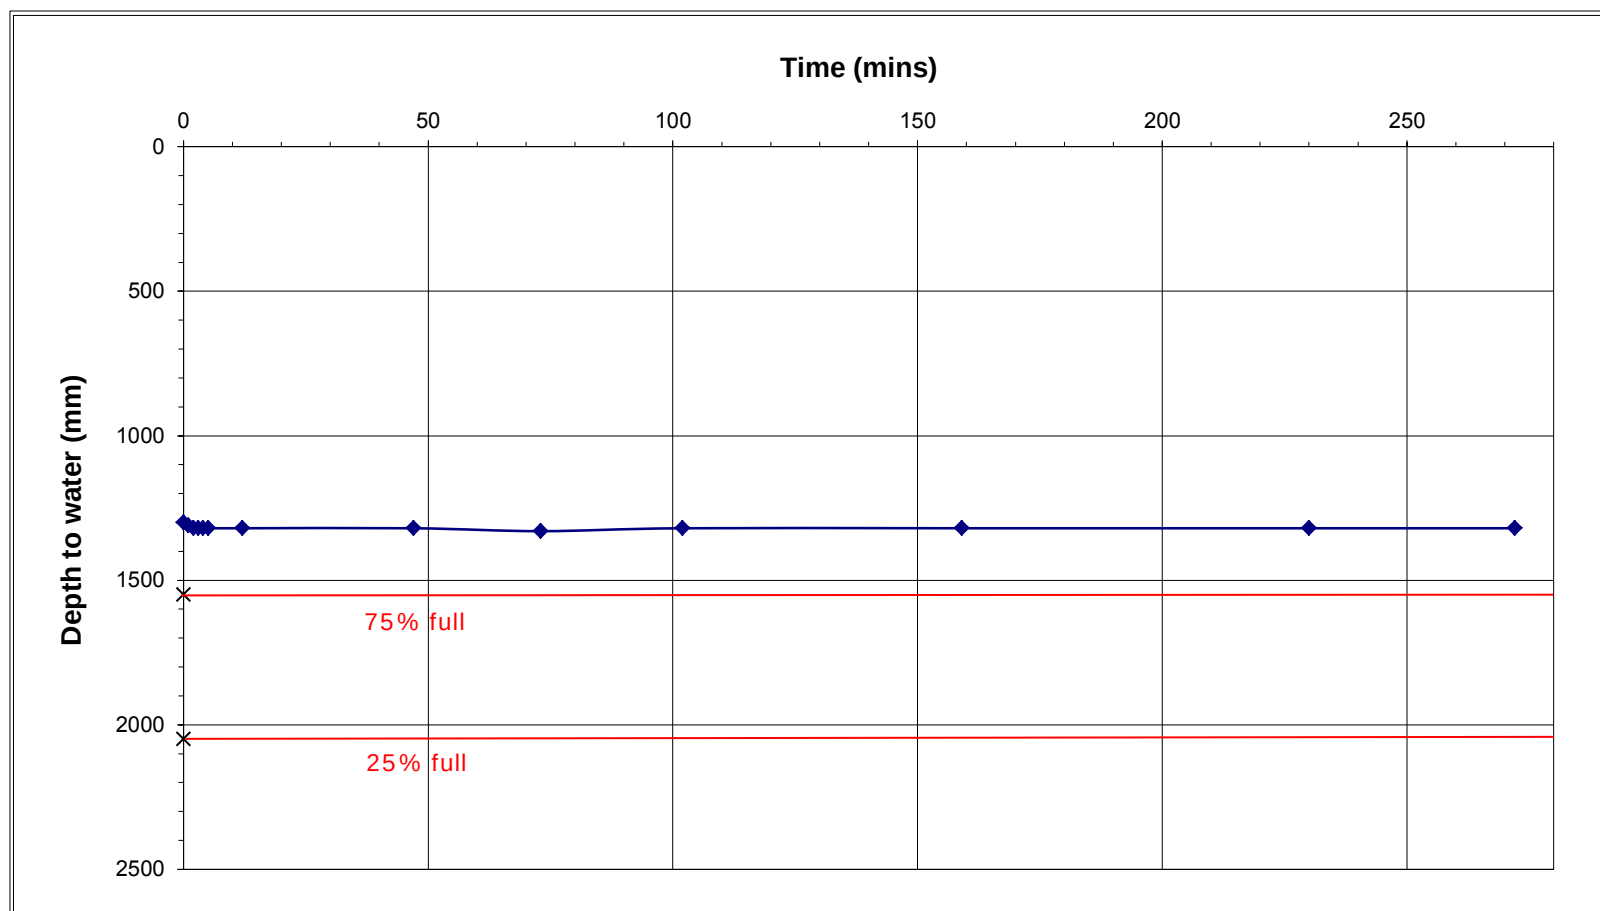
| Trial Pit No. | TP29 |

**Test did not attain 25% Effective depth. Unable to calculate soil infiltration rate**

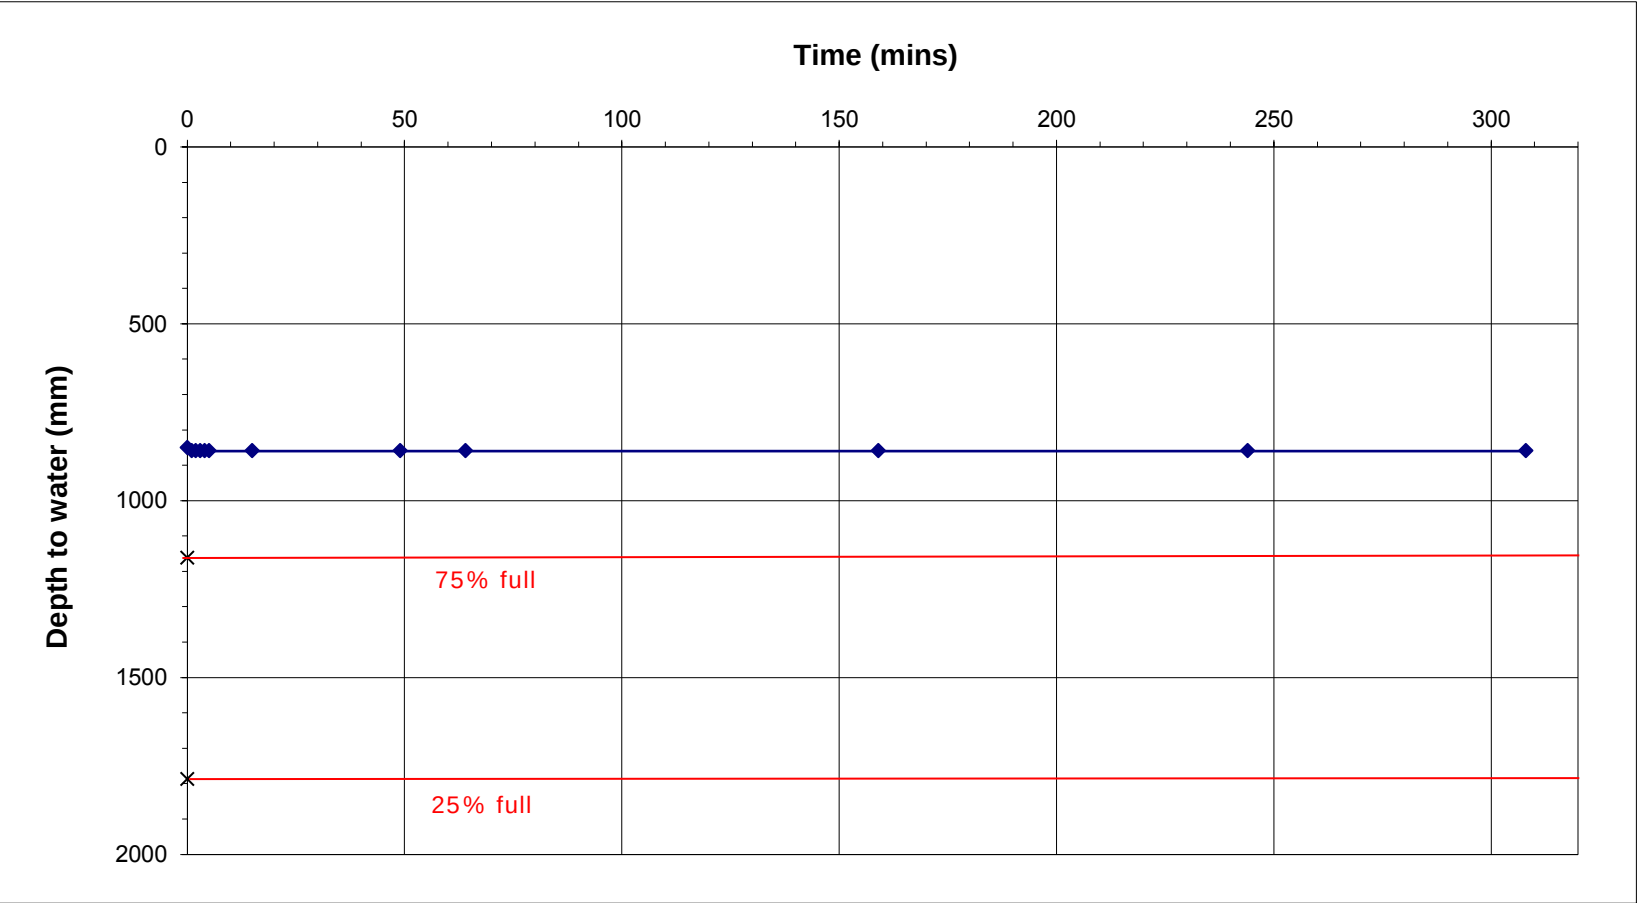
| Trial Pit No. | TP31 |

Test did not attain 25% Effective depth. Unable to calculate soil infiltration rate

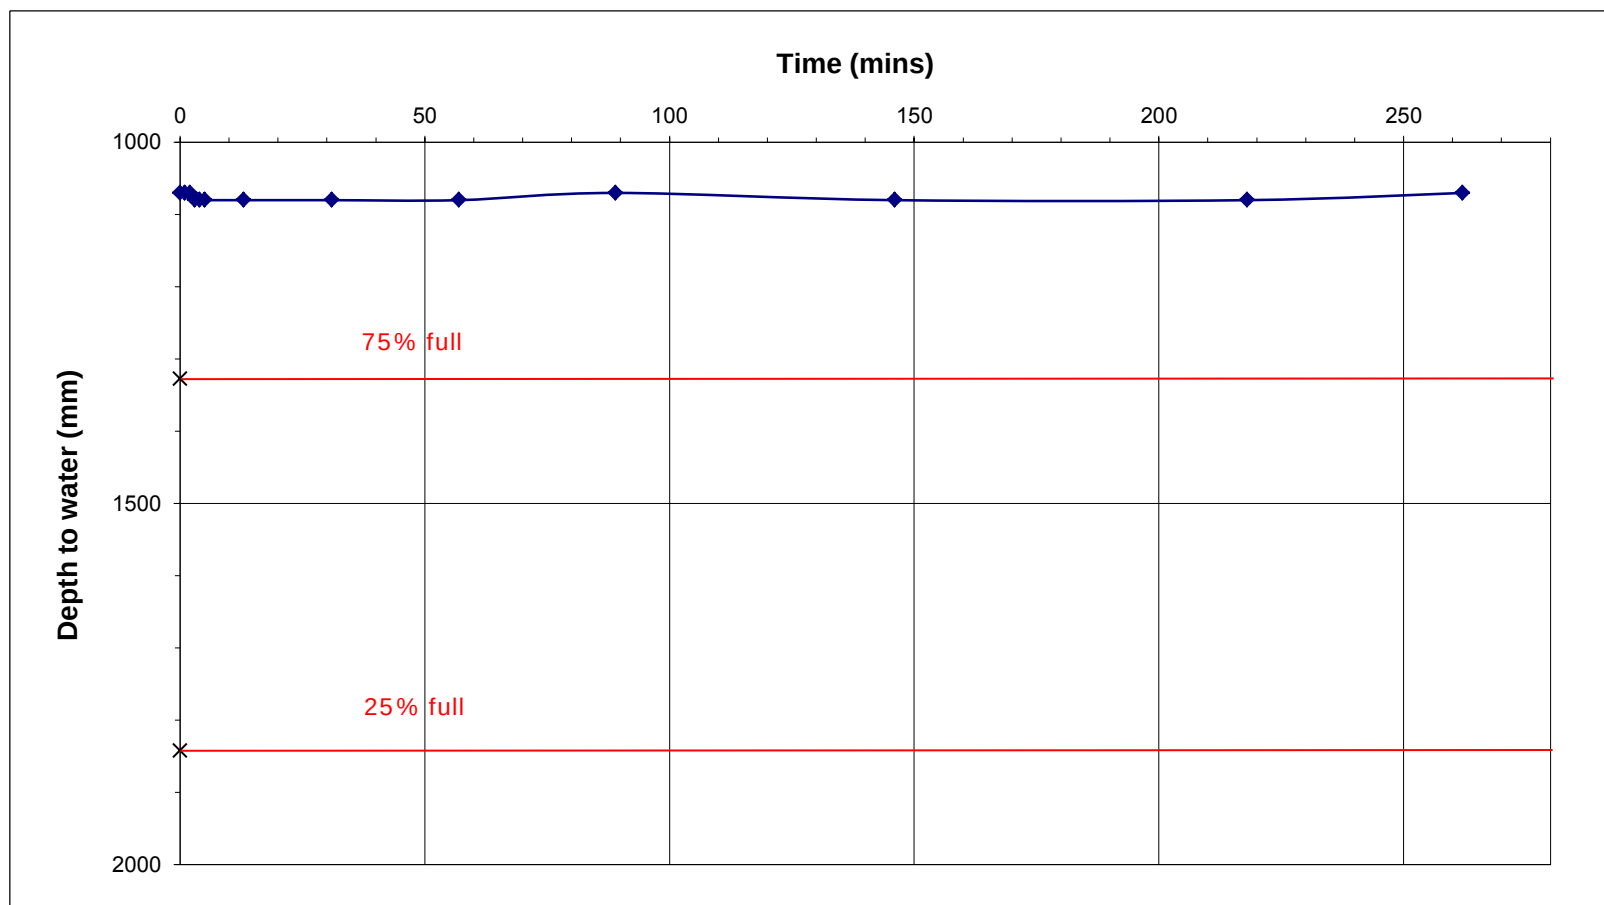
| Trial Pit No. | TP35 |

**Test did not attain 25% Effective depth. Unable to calculate soil infiltration rate**

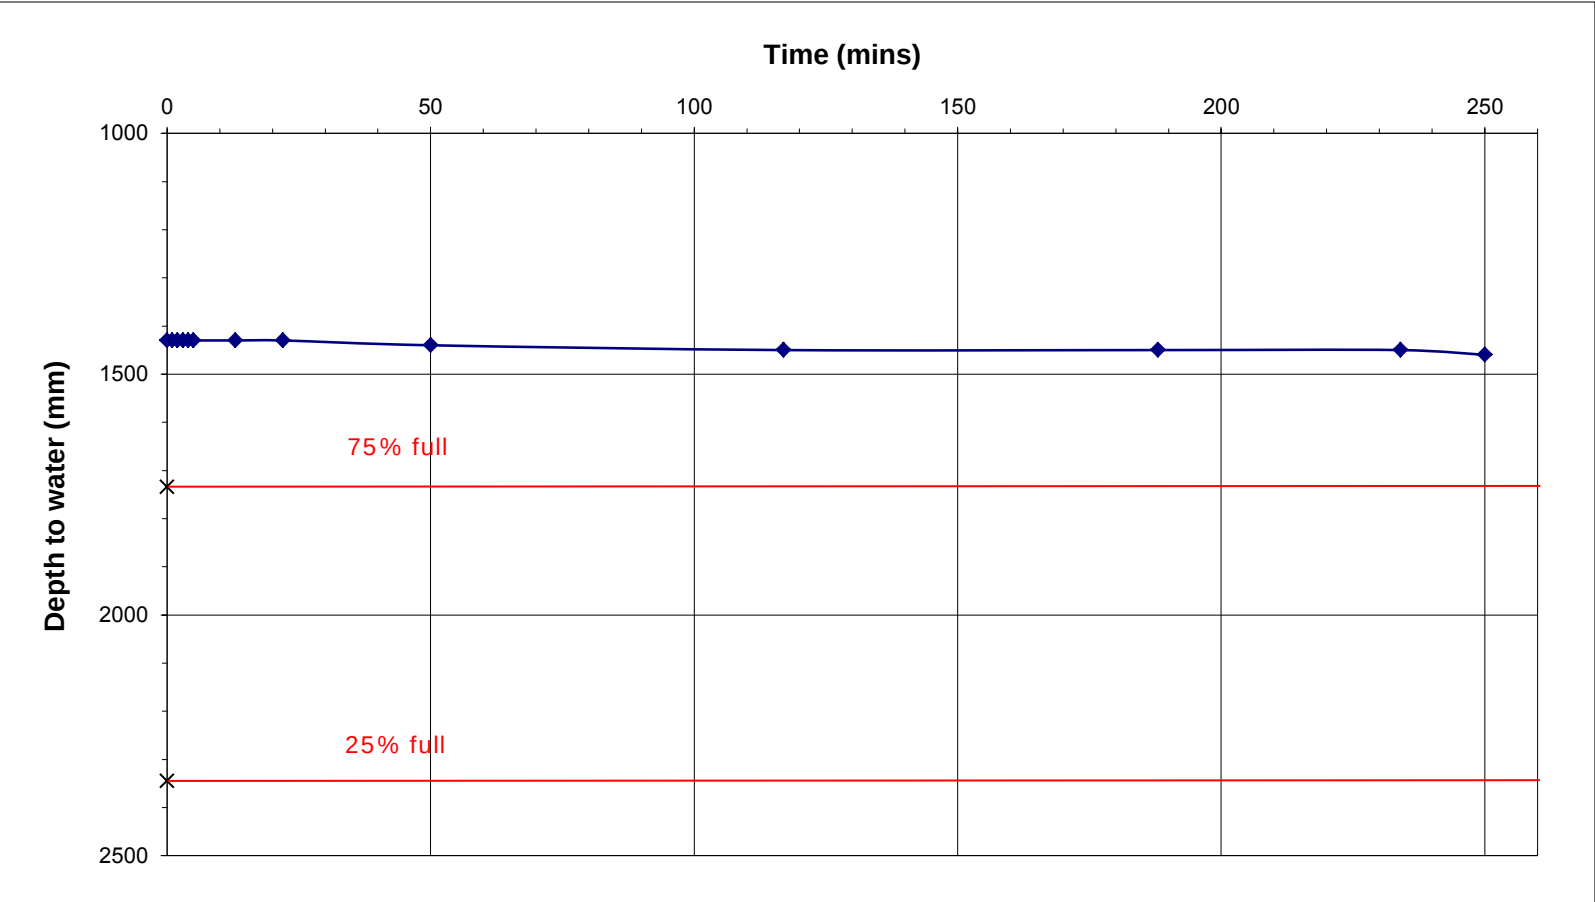
| Trial Pit No. | TP37 |

Test did not attain 25% Effective depth. Unable to calculate soil infiltration rate

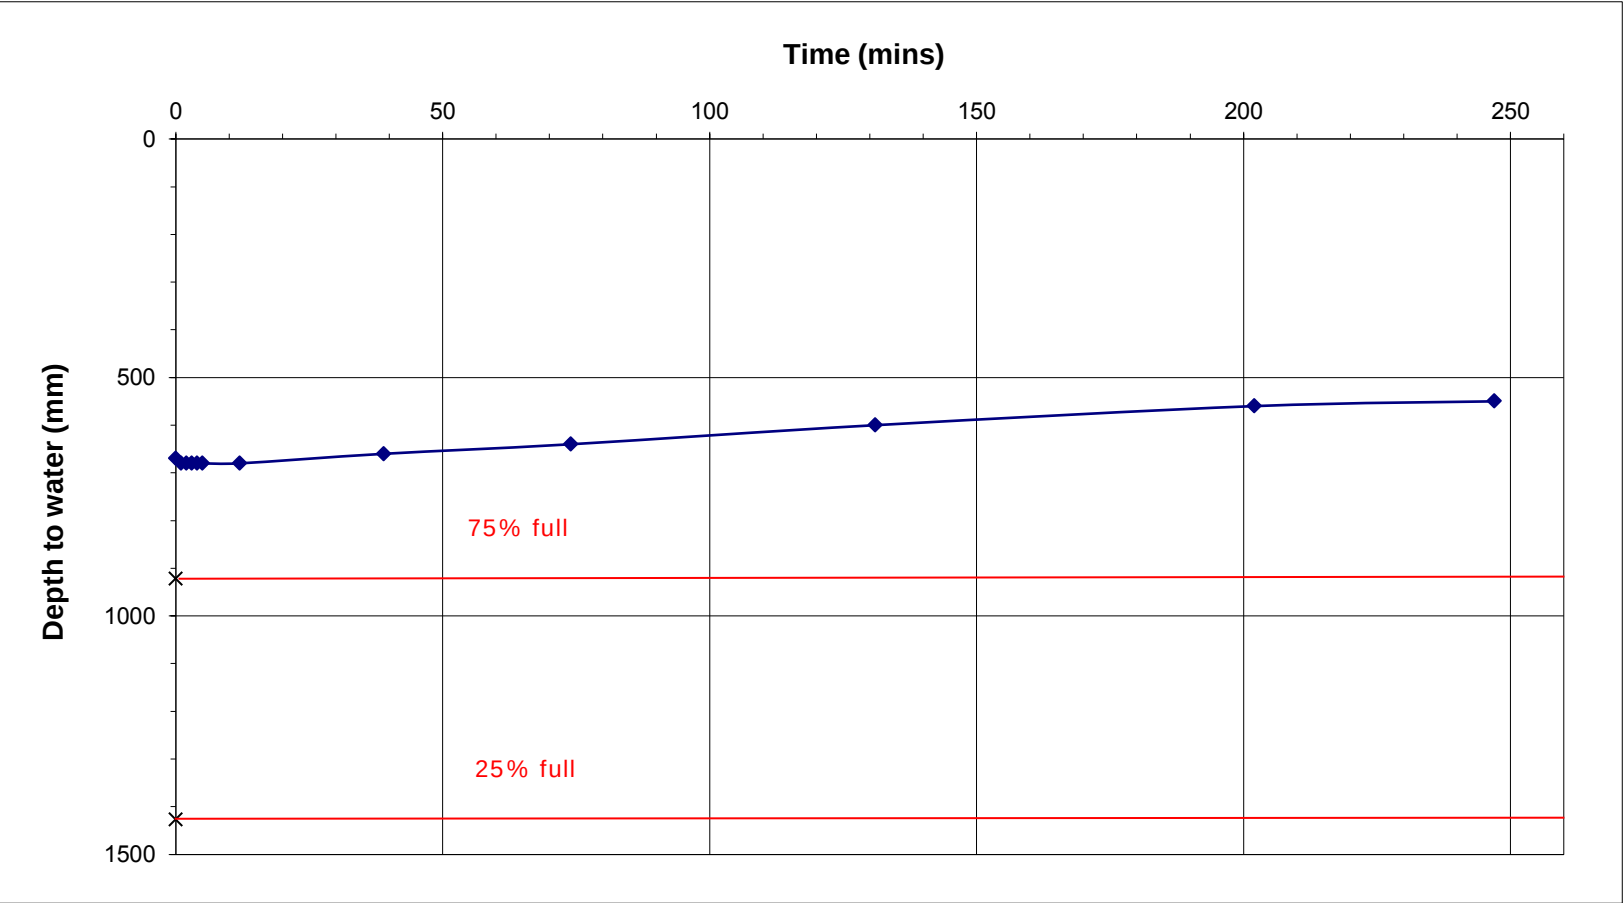
| Trial Pit No. | TP39 |

Test did not attain 25% Effective depth. Unable to calculate soil infiltration rate
