WORTLEY HALL, WORTLEY,  
SHEFFIELD, SOUTH YORKSHIRE

ARCHITECTURAL RECORDING OF ATTIC FLOORS

Report no: 2018/568.R01  
Version: Final  
Date: May 2018  
Author: Shaun Richardson & Ed Dennison

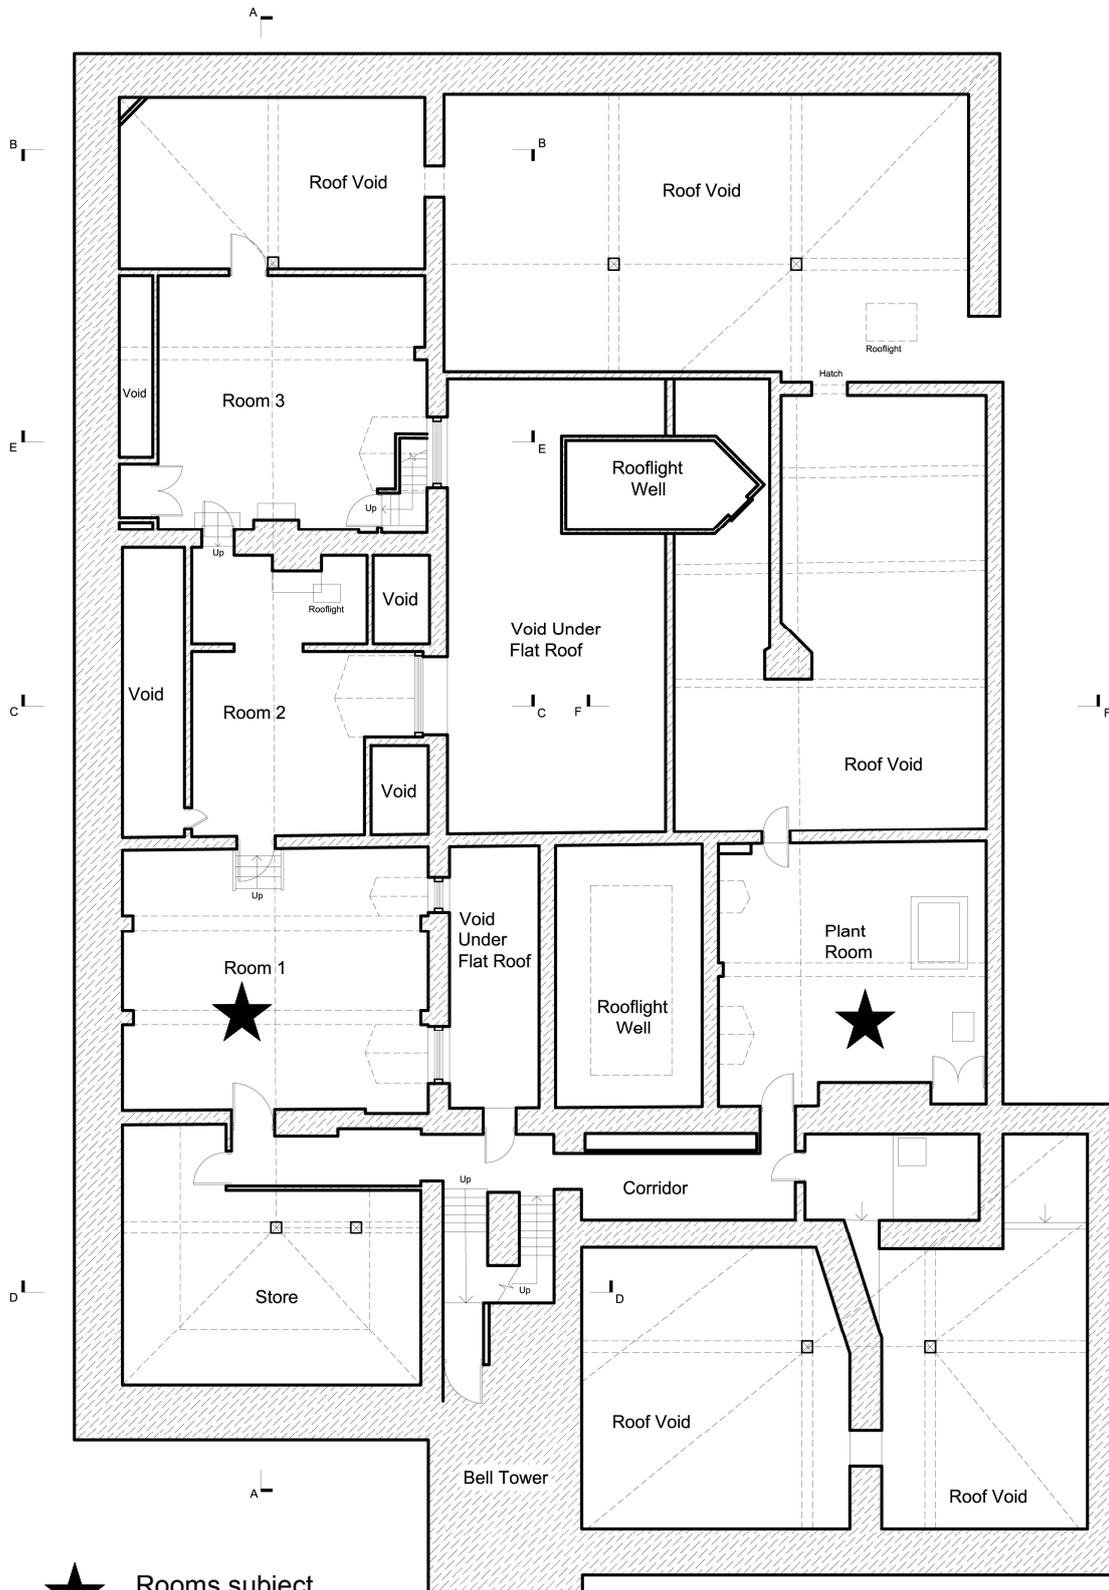
PROJECT		WORTLEY HALL ATTICS	
TITLE		ATTIC FLOOR PLAN AS EXISTING	
SCALE	AS SHOWN	DATE	MAY 2018
EDAS		FIGURE	2

★ Rooms subject to survey

- 3.4 Room 1 is sited on the west side of the attic floor, to the south of centre, above one of the principal first floor rooms (see figure 2). At the time of the survey, the only access to the room was from the corridor to the south, itself opening directly off the service stairs rising from the first floor. The room is rectangular in plan, with maximum internal dimensions of 7.30m east-west by 6.75m north-south. At the time of the survey, it was open to the underside of the roof ridge, but was formerly ceiled at the level of the roof truss collars (see below).

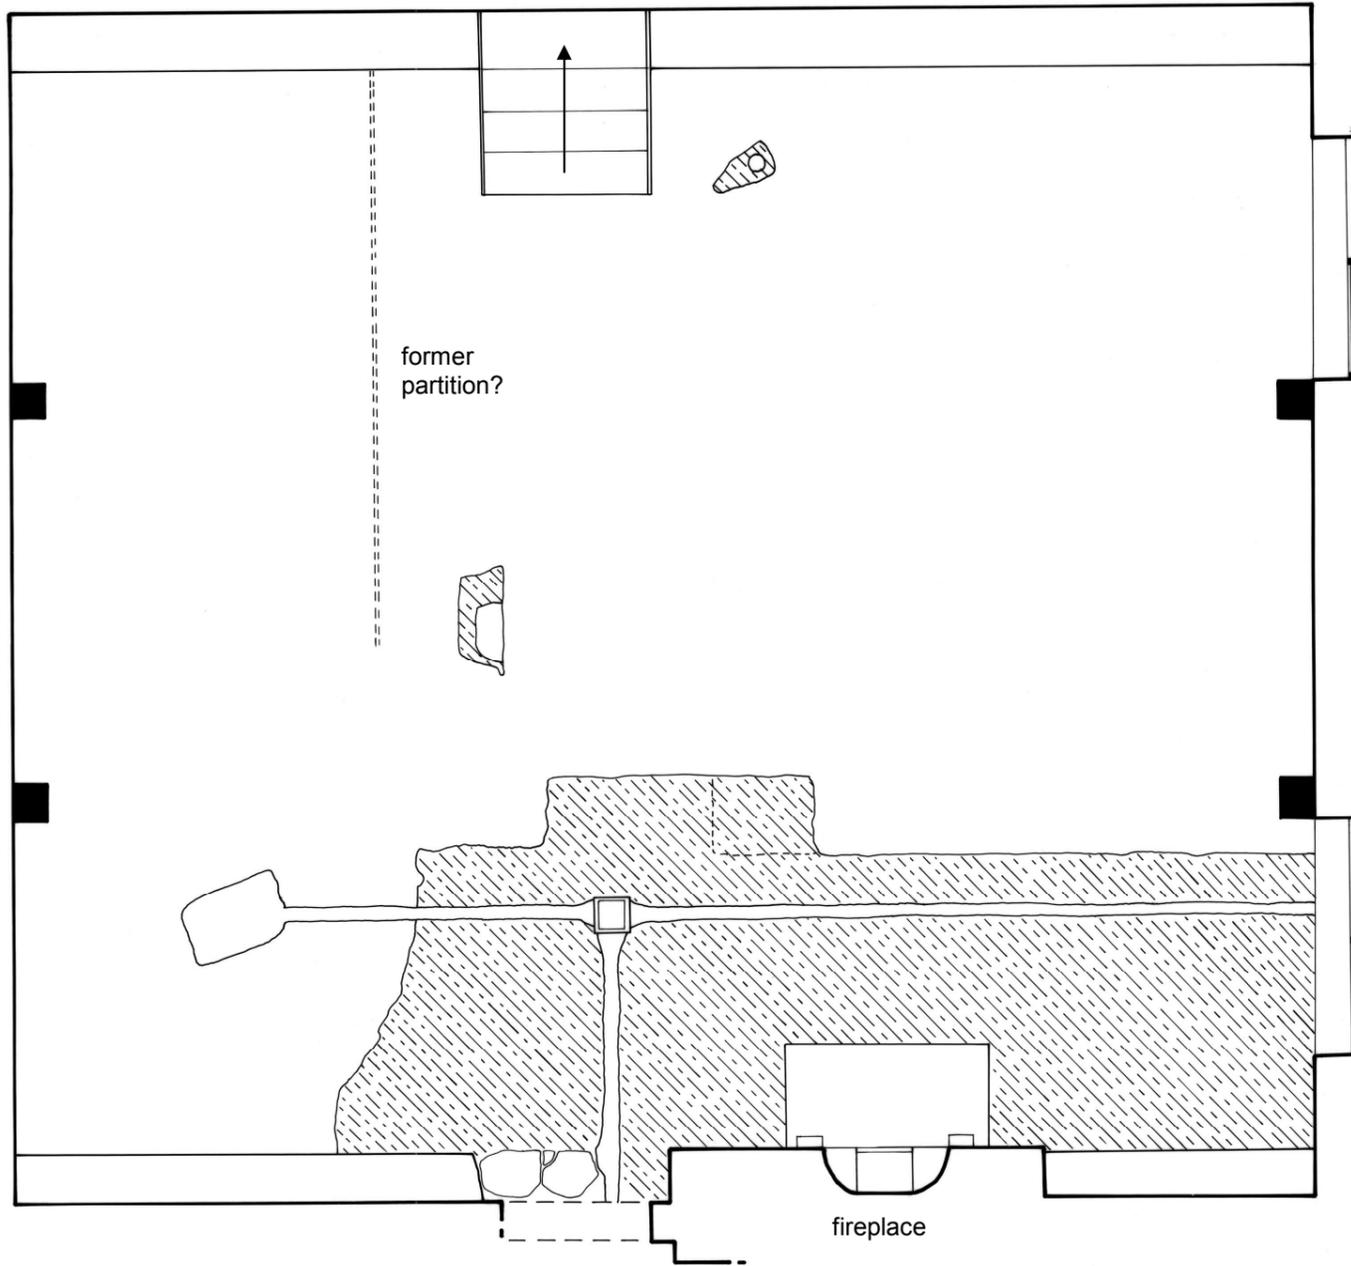
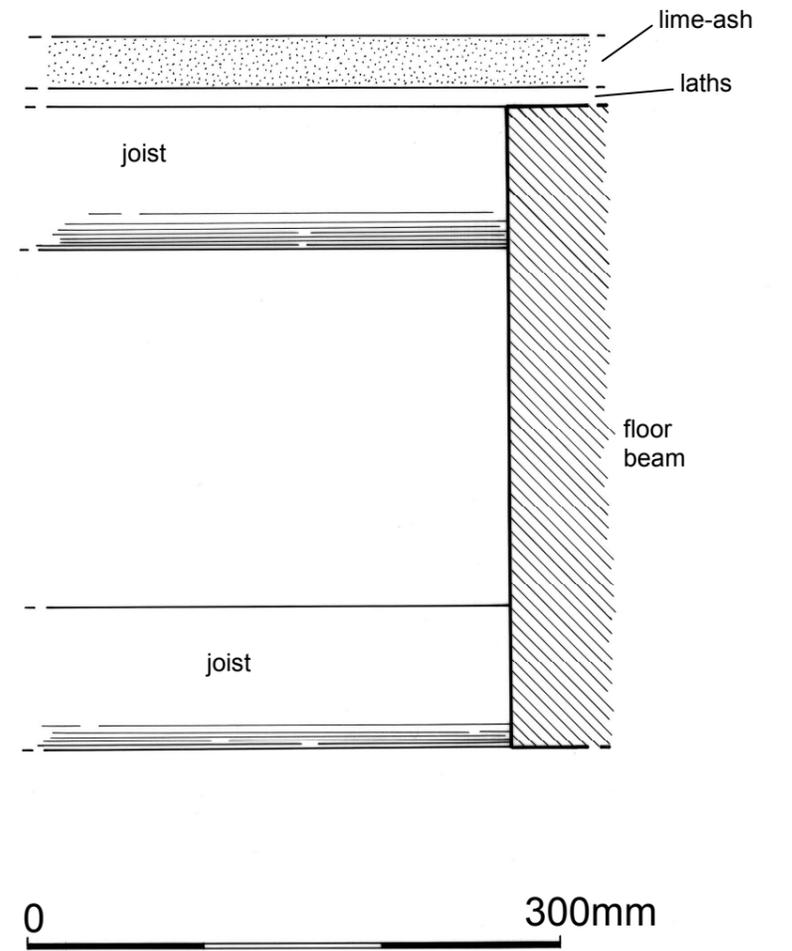
PROJECT		WORTLEY HALL ATTICS	
TITLE		ROOM 1 FLOOR DETAILS	
SCALE	AS SHOWN	DATE	MAY 2018
EDAS		FIGURE	3

- 3.5 The room preserves a lime-ash floor over the majority of its extent, although the floor has been subject to considerable repair and alteration, particularly along the southern side [*1/963-1/970*] (see plates 1 and 2). The lime-ash is typically 30mm deep, and laid over a bed of very closely spaced laths, typically 10mm deep [*1/003*]; it is suggested that the lime-ash may be a Victorian overlaying (Sheppard 2018, 16), presumably of an earlier, slightly shallower, lime-ash floor. The laths are fixed to east-west floor joists, themselves jointed to north-south floor beams; there is no evidence for a bed of reeds beneath the laths, as is often suggested to have been used in the construction of a lime-ash floor. The joists are on average 80mm deep, whilst the floor beams are 360mm deep. There is a second, lower, set of joists jointed to the base of the sides of the floor beams, which support the lath and plaster ceiling of the first floor room below; the gap or void between the floor and ceiling joists is some 200mm.

- 3.6 The survey noted no clear indication in the lime-ash floor of former room divisions or other features which may have since been removed, although a slight north-south aligned depression, 3.60m long, visible to the north-west part of the floor might mark a former partition. To the west of this feature, there are several shallow indentations in the surface of the lime-ash, some with a part-hexagonal or octagonal plan form, presumably marking where heavy objects have been placed

on the floor over a period of time [1/975] (see plate 3). As has already been noted above, the lime-ash floor has been subject to considerable repair along the southern side. Here, a section measuring a maximum of 5.50m east-west by 2.40m north-south has been replaced or repaired with sand cement screed [1/971]. This screed has in turn been cut through by three electricity cable runs, all diverging from a small square metal duct. There is a smaller, sub-rectangular, area of repair to the north of the main area of cement screed [1/974], and a small area of reddish-coloured patching or repair to the threshold of the doorway in the south wall [1/005].

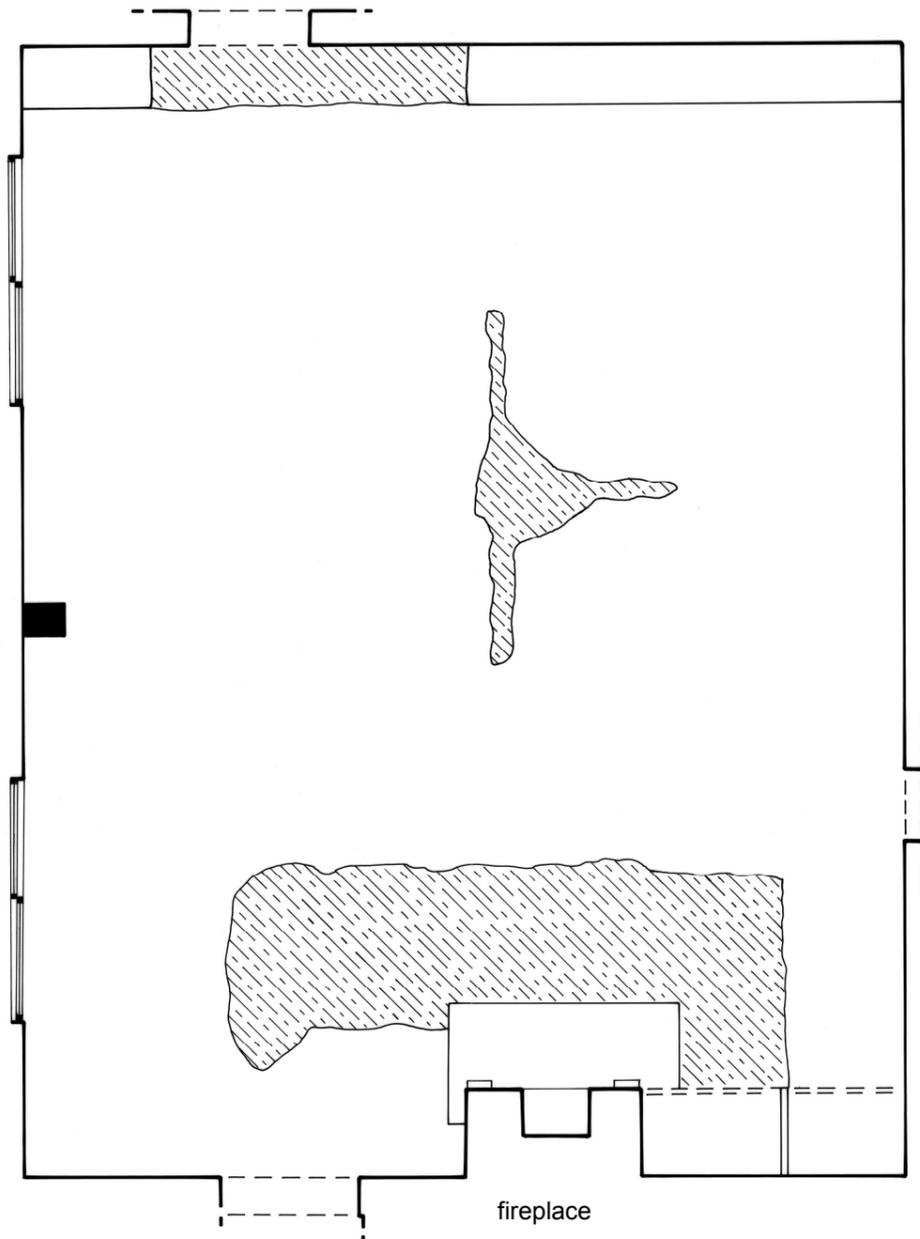
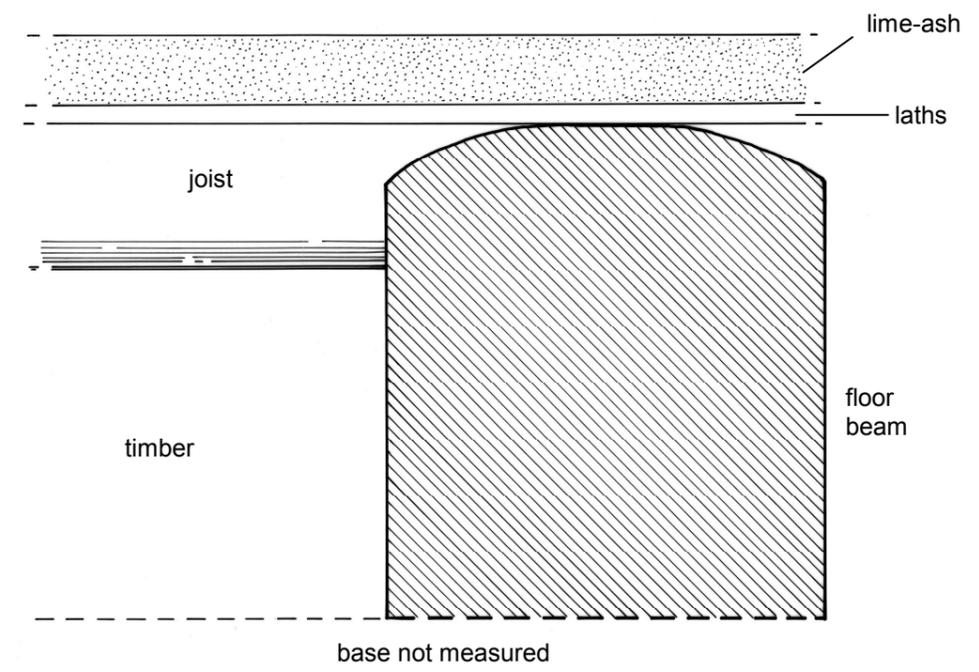
PROJECT		WORTLEY HALL ATTICS	
TITLE		PLANT ROOM FLOOR DETAILS	
SCALE	AS SHOWN	DATE	MAY 2018
EDAS		FIGURE	4

- 3.12 The room preserves a lime-ash floor over the majority of its extent, although the floor has been subject to considerable repair and alteration, particularly along the southern side and towards the centre [1/006-1/011] (see plates 7 and 8). The lime-ash is typically 40mm deep, and laid over a bed of very closely spaced laths, typically 10mm deep [1/023, 1/025] (see plate 11). The laths are fixed to east-west floor joists, themselves jointed to north-south floor beams; again, there is no evidence for the use of a bed of reeds beneath the laths. The joists are on average 80mm deep, whilst the floor beams are at least 280mm deep, although their lower parts are obscured by debris. The floor joists are set on more substantial east-west timbers (earlier joists?) which extend at least as far as the visible base of the beams. The survey noted no clear indication in the lime-ash floor of former room partitions or other features which have since been removed.

- 3.13 As has already been noted above, the lime-ash floor has been subject to considerable repair and alteration along the southern side and towards the centre. The southern section measuring a maximum of 3.10m east-west by 1.20m north-south has been repaired with sand cement screed. The sub-triangular area of screed to the central part of the floor is associated with electrical cabling, and has a series of small holes running to the north, east and south. Finally, there is a third strip of screed to the base of the north wall.

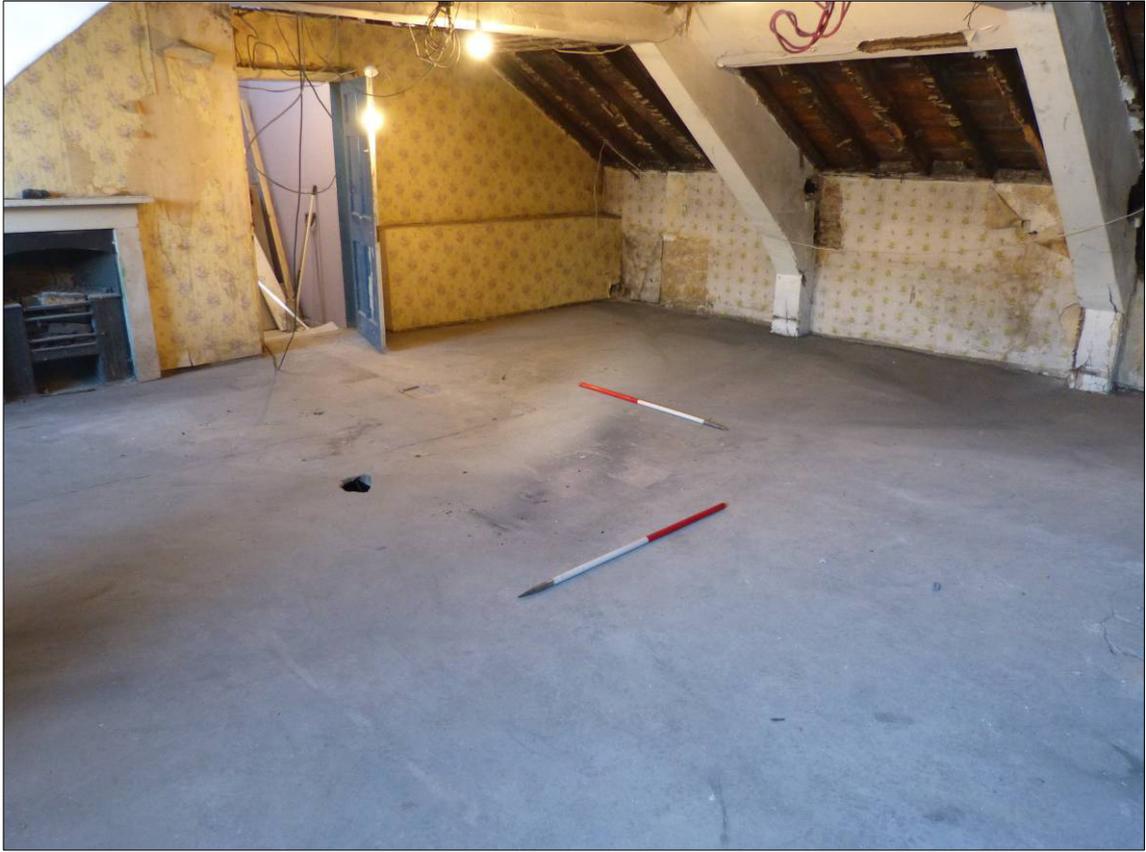
Plate 1: Lime-ash floor to Room 1, looking SW (photo 1/963) (2 x 1m scales).

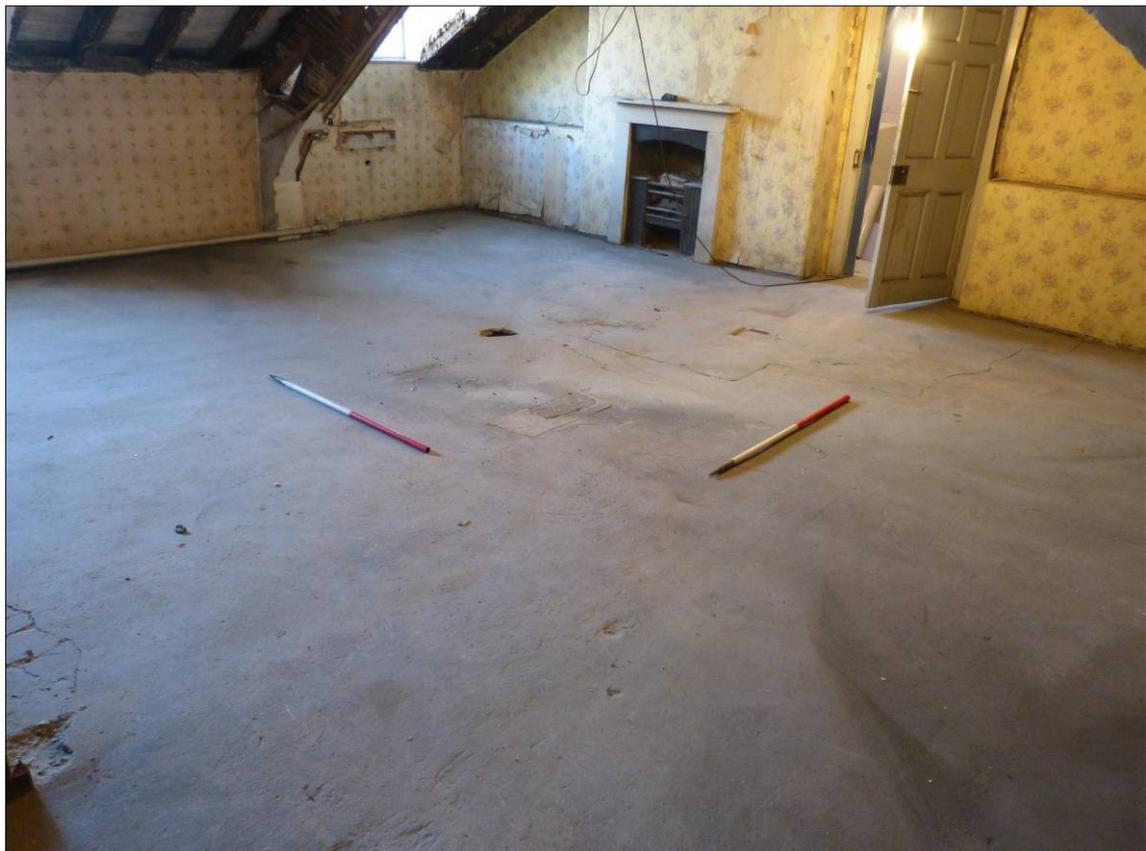
Plate 2: Lime-ash floor to Room 1, looking SE (photo 1/966) (2 x 1m scales).

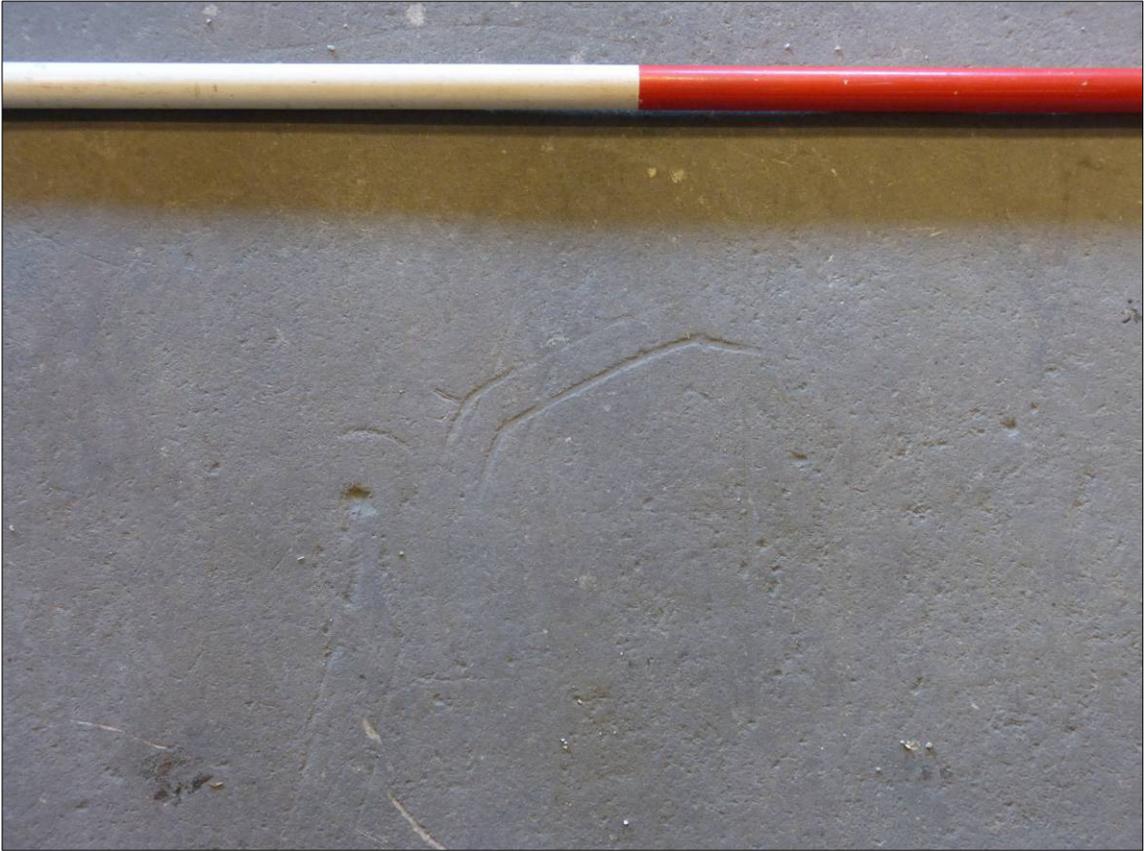
Plate 3: Indentation in lime-ash floor to Room 1 (photo 1/975) (1m scale).

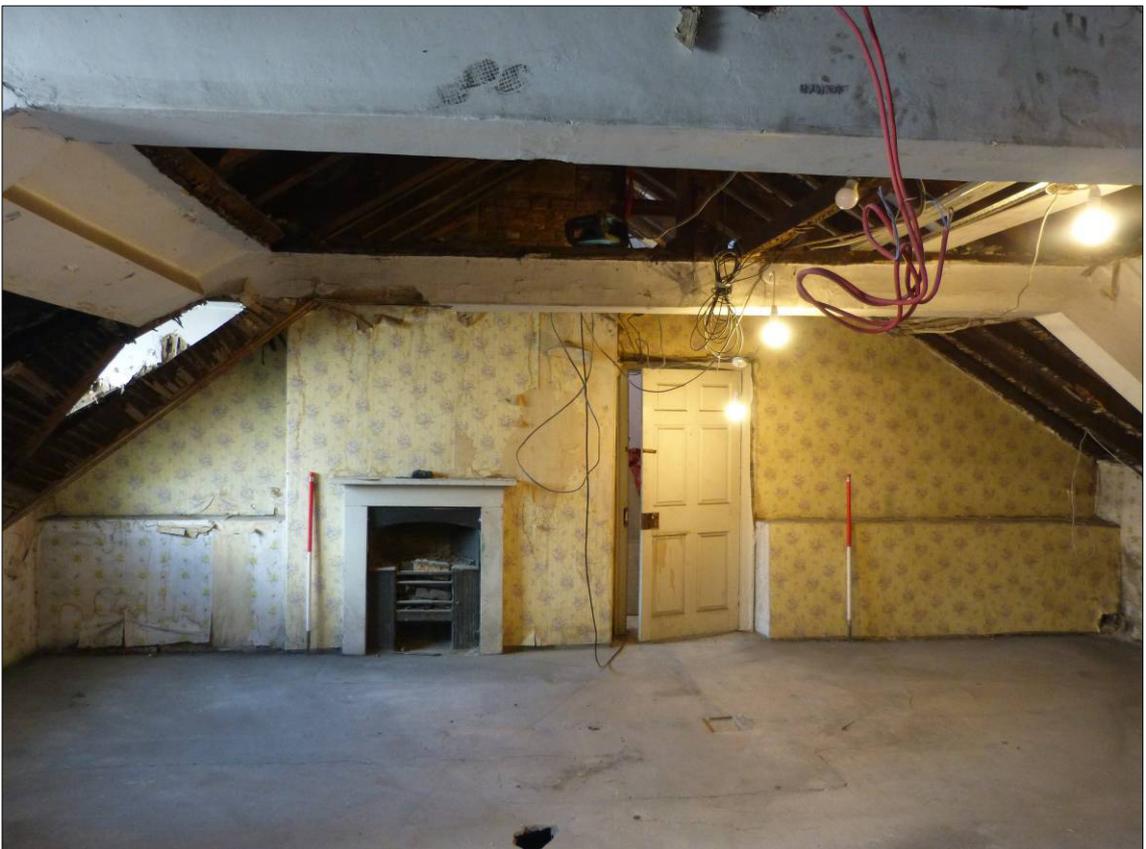
Plate 4: Room 1, south wall, looking S (photo 1/979) (2 x 1m scales).

- 3.7 The room is entered through the doorway in the south wall, which retains a 19th century door with six raised and fielded panels [1/980] (see plate 4). The doorway appears to have been cut through the thickened base of the south wall, formed by a wider partition wall rising up from the first floor. To the east of the doorway, there is a projecting chimney breast, housing a cast-iron grate with side hobs bearing a floral design, set within a plain surround with mantelshelf [1/976, 1/977, 1/979]. Above the former ceiling level, the chimney breast can be seen to be built from red handmade bricks (average dimensions 230mm by 115mm by 60mm) set with a lime mortar but not laid in any particular bonding pattern; there are also stone dressings where the chimney breast passes through the roof line [1/982]. The south wall, like the other three walls of the room, retains several different phases of decorative wallpaper, all dating to the second half of the 20th century (see plate 4).

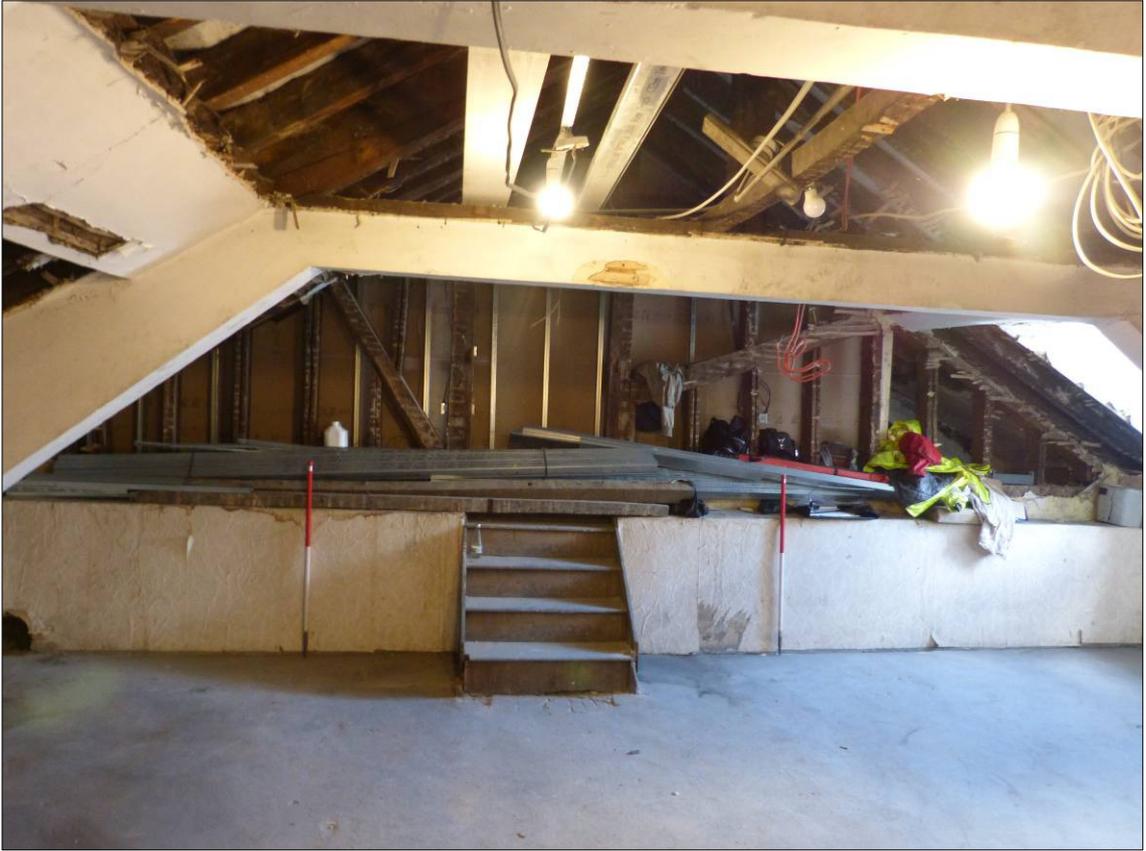
Plate 5: Room 1, north wall, looking N (photo 1/990) (2 x 1m scales).

- 3.8 The west wall is relatively plain; where the wallpaper has been stripped away, it has revealed mostly sandstone fabric, with some areas of brick. There is a horizontal timber built into the wall, the base of which is set c.0.50m above the level of the lime-ash floor [1/999, 1/001]. The east wall is also relatively plain, housing two window openings which are set within external dormers. Each window opening is fitted with a wooden, horizontal sliding-sash window, each sash having nine (three rows of three) panes set between narrow, moulded glazing bars [1/986-1/989]. The north wall, like the south wall, has a thickened base where a wider partition wall rises up from the first floor; a short flight of wooden steps mount the thickened base [1/990, 1/991] (see plate 5). The wall base supports a roof truss, originally of king-post form. The truss appears to have been of pegged softwood construction throughout. The king-post has a joggled foot and splayed head holding a diamond-set ridge-piece, and formerly supported a pair of raking struts to the principal rafters. Each principal supports a single trenched purlin, with the feet of the common rafters set against the wall plates; there is boarding above the common rafters. At a later date, the west raking strut was removed and a doorway created in line with the low wooden steps, with studs used to infill between the tie-beam and the principals [1/992, 1/993].

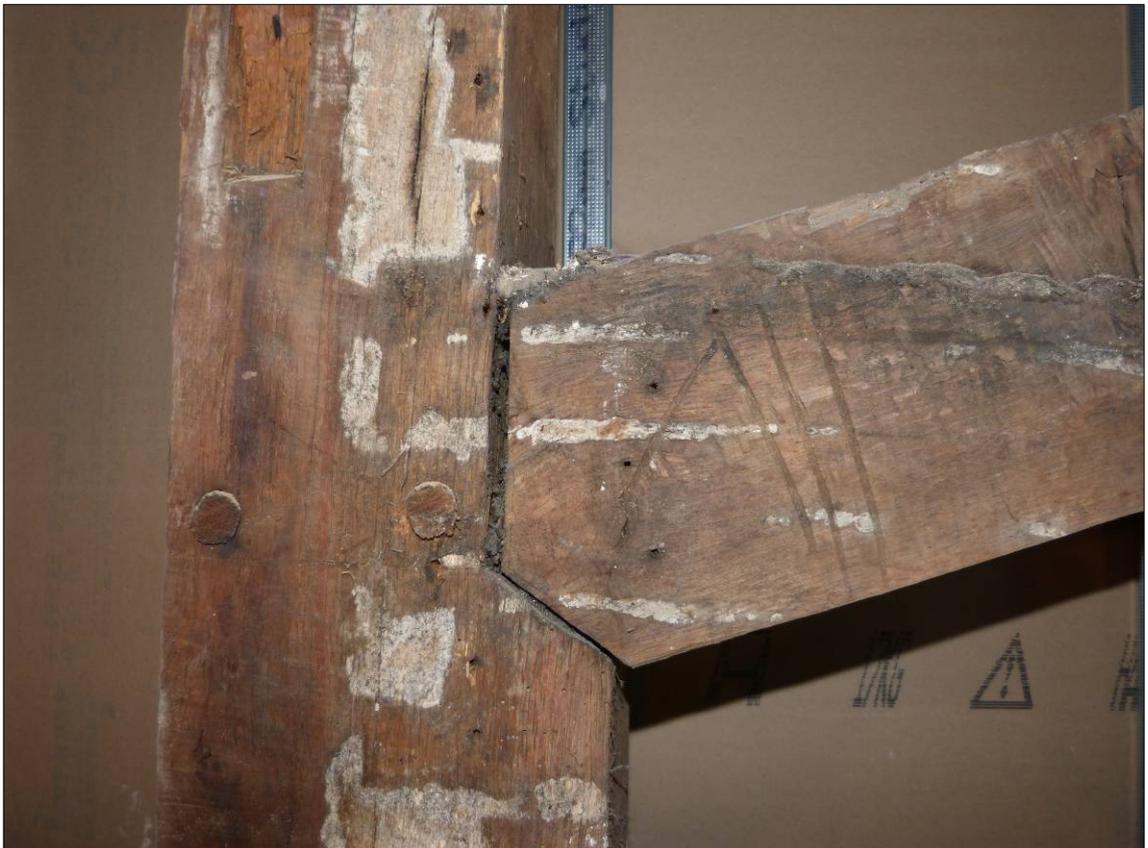
Plate 6: Room 1, carpenter's marks to truss in north wall, looking N (photo 1/994).

- 3.10 Although the two roof trusses and the truss in the north wall are of differing form, the visible carpenter's/assembly marks on the trusses suggests that they are all of

the same period. In the room to the south of Room 1 (marked as a 'Store' on the architect's as-existing plans; see figure 2), the truss is numbered 'XI'. There must be a truss numbered 'X' buried in the south wall of Room 1, as the southern roof truss is numbered 'VIII' [1/985]. There is no visible numbering to the northern roof truss, but it must form 'VIII', as the truss in the room's north wall is numbered 'VII' [1/994] (see plate 6). It therefore appears that the roof trusses in the southern part of the attic's west range are numbered sequentially in descending order from south to north.

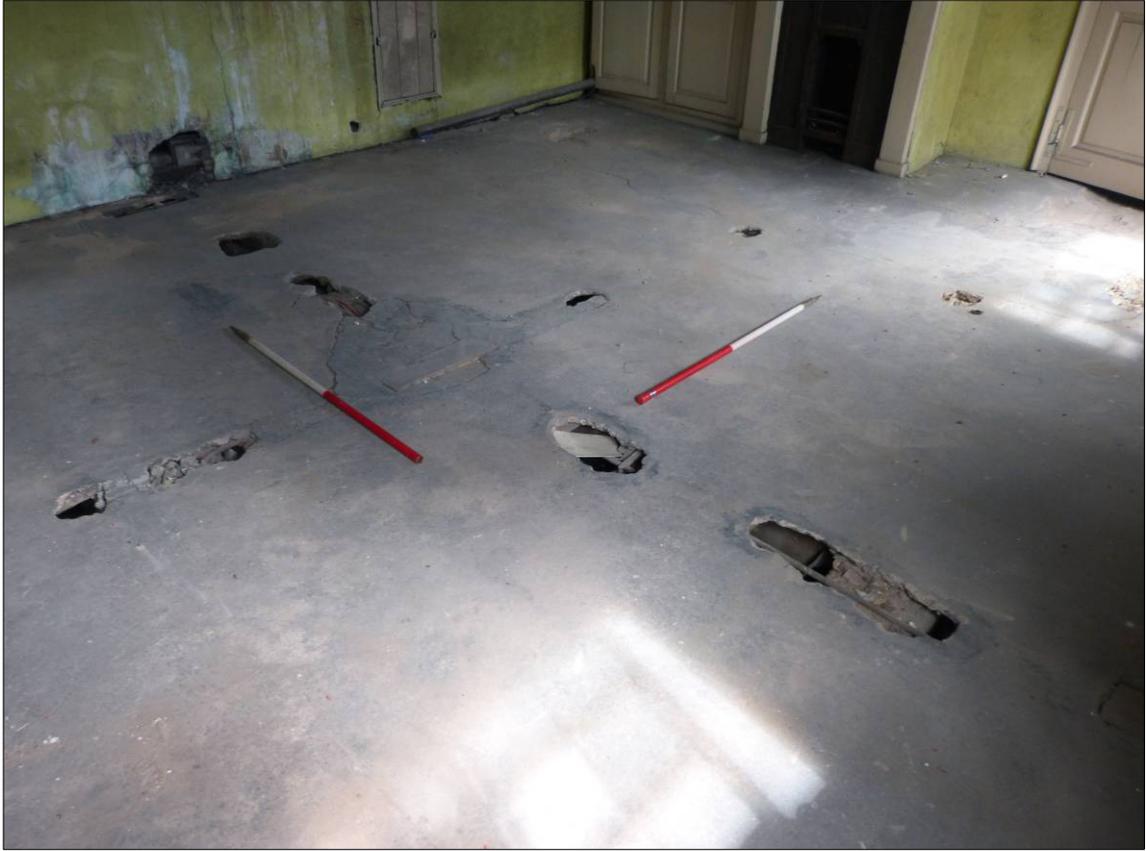
Plate 7: Lime-ash floor to Plant Room, looking SE (photo 1/007) (2 x 1m scales).

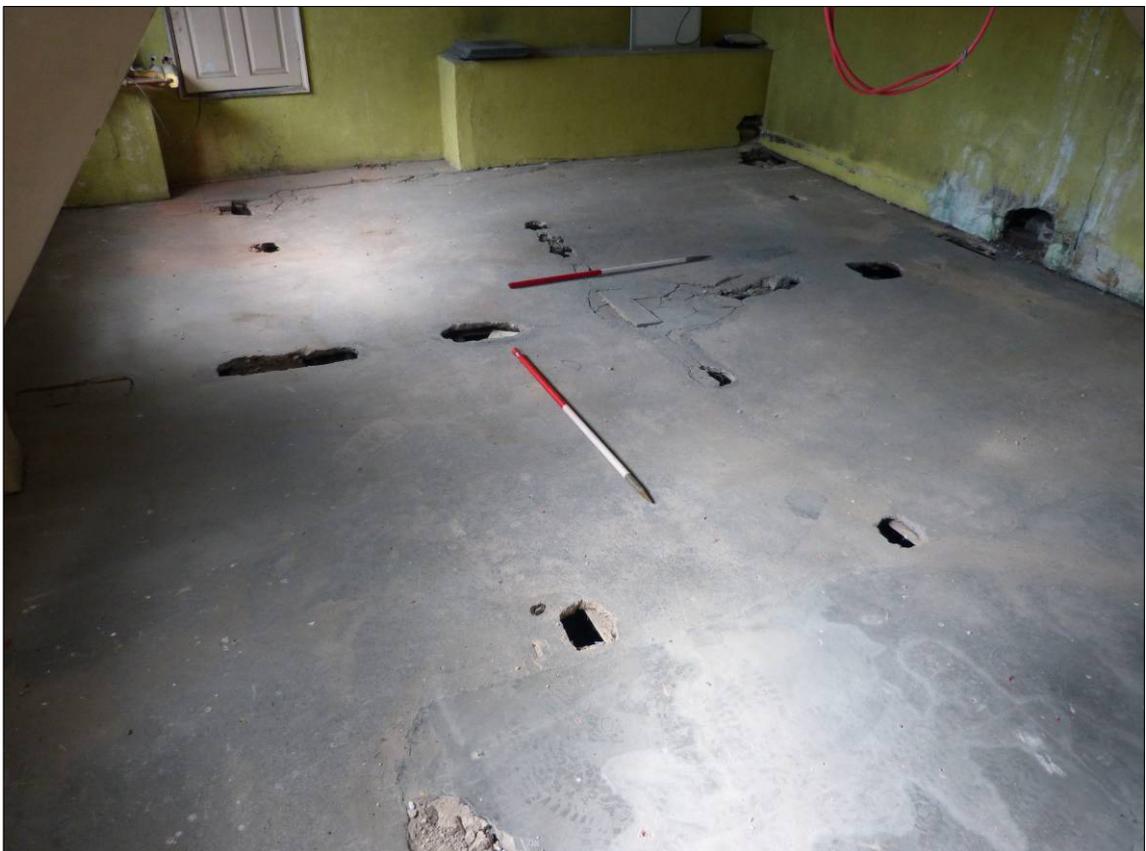
Plate 8: Lime-ash floor to Plant Room, looking N (photo 1/008) (2 x 1m scales).

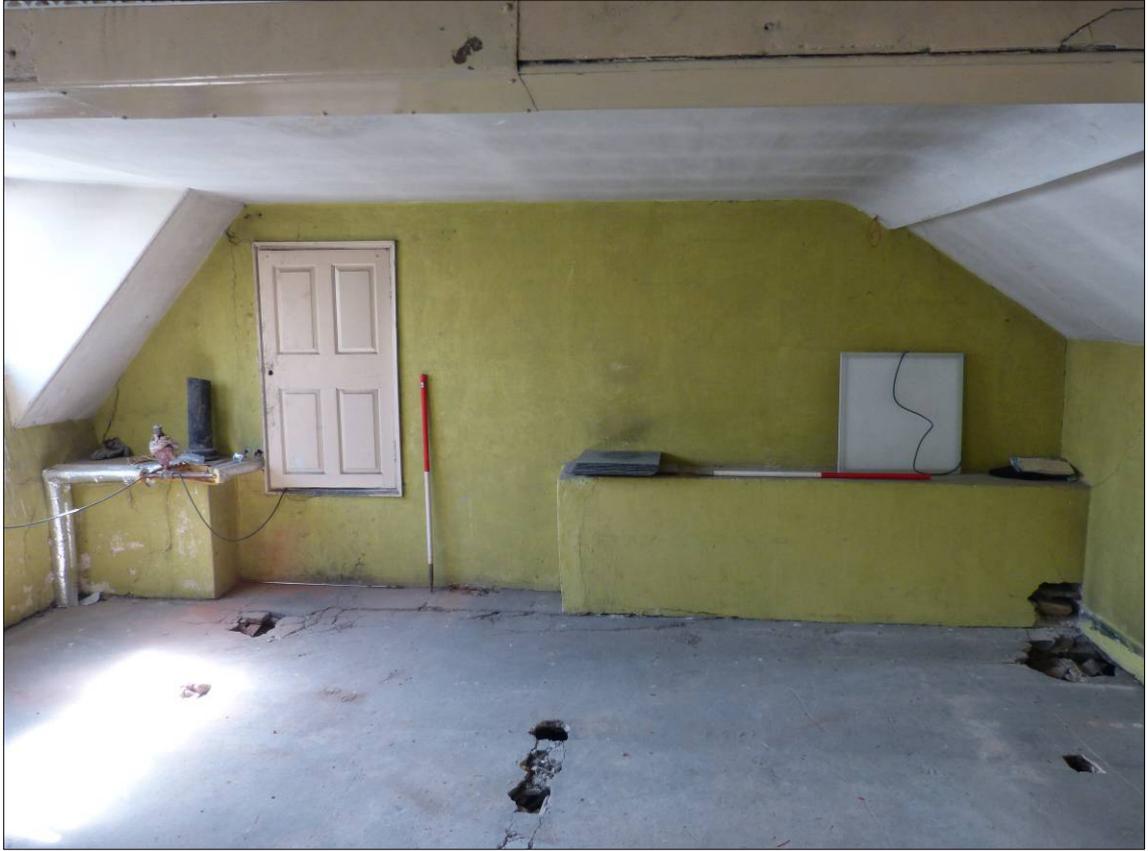
Plate 9: Plant Room, north wall, looking N (photo 1/011) (2 x 1m scales).

- 3.15 The east wall is plain, with a small doorway giving access to a roof void beyond [1/016]. The west wall is also relatively plain, housing two window openings which are set within external dormers. Each window opening is fitted with a wooden, horizontal sliding-sash window, each sash having nine (three rows of three) panes set between narrow, moulded glazing bars [1/013-1/015]. The north wall has a thickened base where a wider partition wall rises up from the first floor; a small

doorway in the wall gives access to the roof void beyond [1/011, 1/012] (see plate 9).

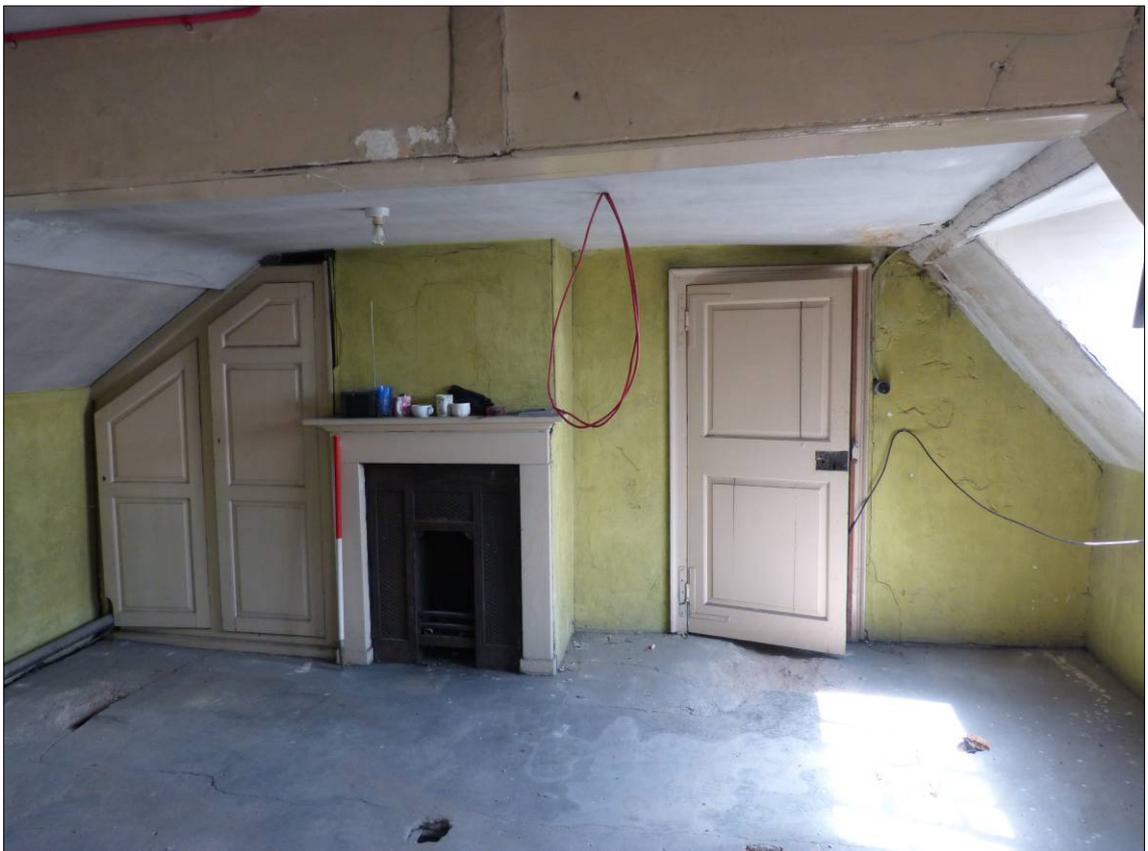
Plate 10: Plant Room, south wall, looking S (photo 1/020) (1m scale).

- 3.14 The room is entered though the doorway in the south wall, which retains a two-panelled door hung on L-shaped hinges of very late 17th or early 18th century appearance [1/021, 1/022], presumably re-used here (see plate 10). To the east of the doorway, there is a projecting chimney breast, housing a cast-iron grate with a fan design, set within a plain surround with moulded mantelshelf [1/017, 1/019, 1/020]. A fitted cupboard of probable early 20th century date is set to the east of the chimney breast [1/026, 1/027]. The south wall, like the other three walls of the room, is painted yellow.

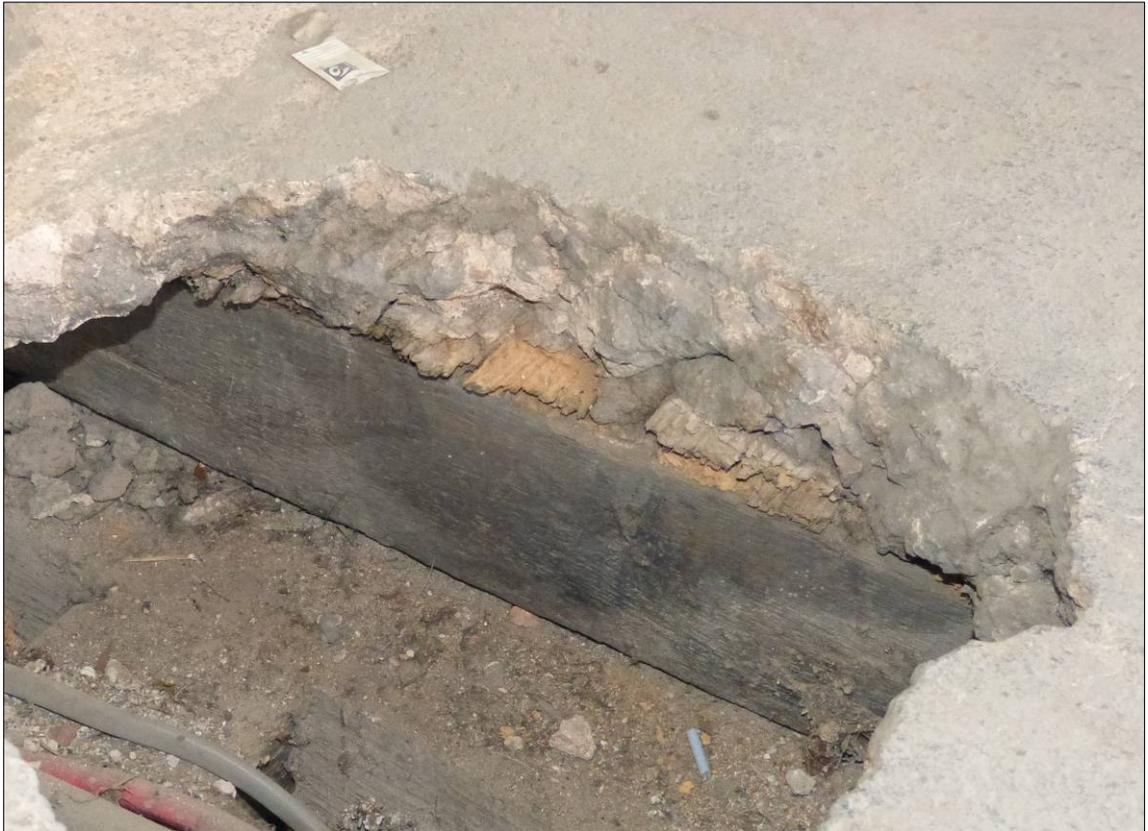
Plate 11: Plant Room, section through lime-ash floor (photo 1/025).
