# Cannon Hall Museum

Stable Block New Museum Shop and Cafe

Project number: 60627297  
AC/01

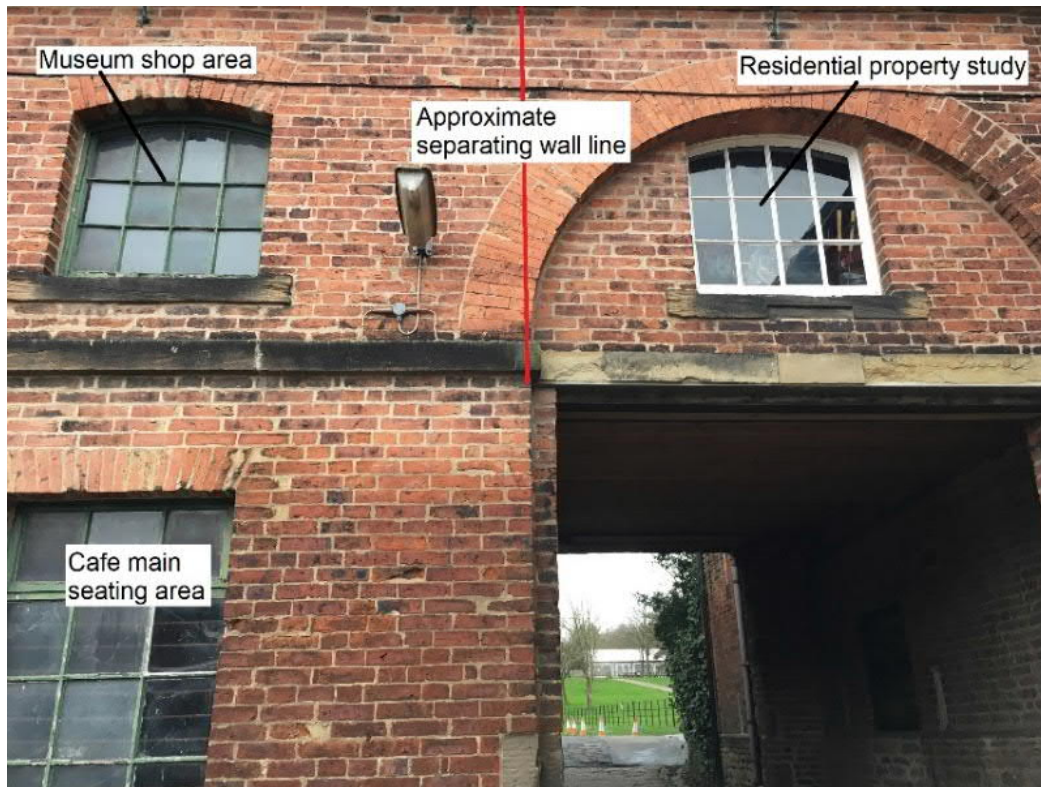
Figure 1: Courtyard elevation of stable block building and adjoining residential property

There is no separating wall at ground floor level due to the underpass to the stable courtyard. Elevations of the stable block and adjoining property are shown in Figure 1 and Figure 2.

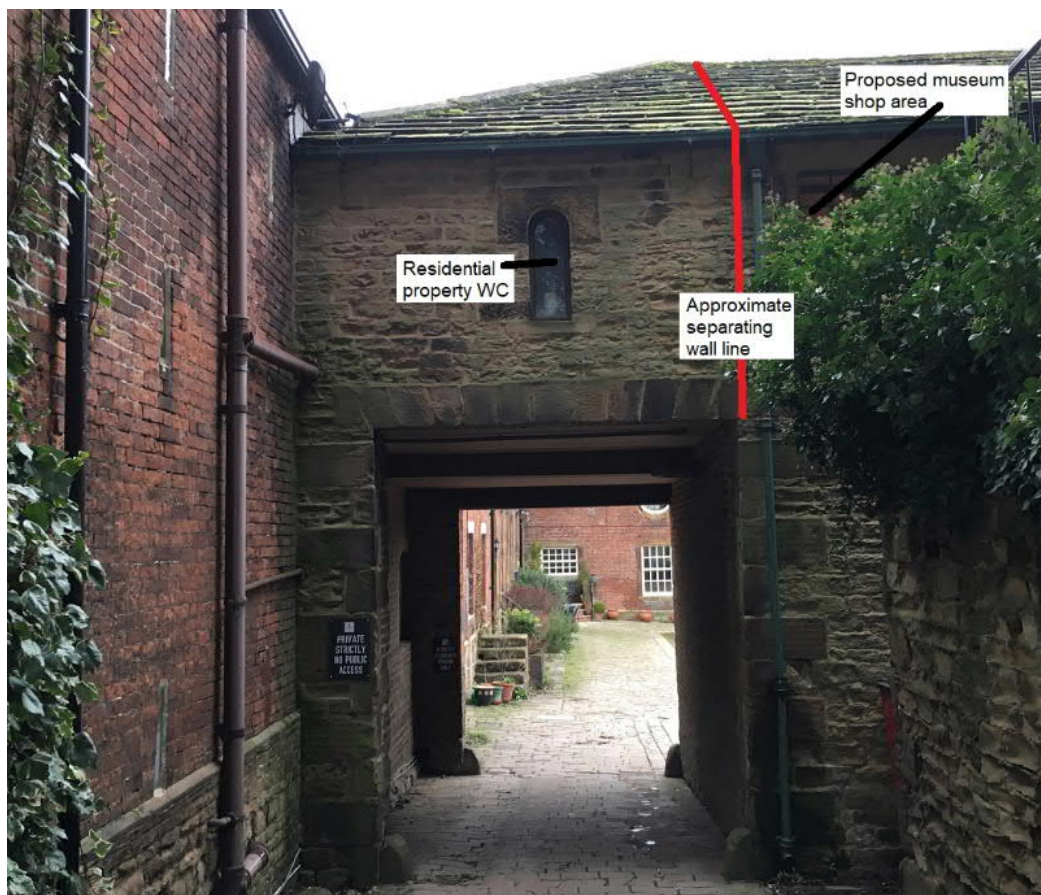
Figure 2: Western elevation of stable block building and adjoining residential property
