Geoenvironmental Appraisal

Land at Lee Lane, Royston

For Barratt Homes & David Wilson
Homes Yorkshire West

Report no: 2366/1

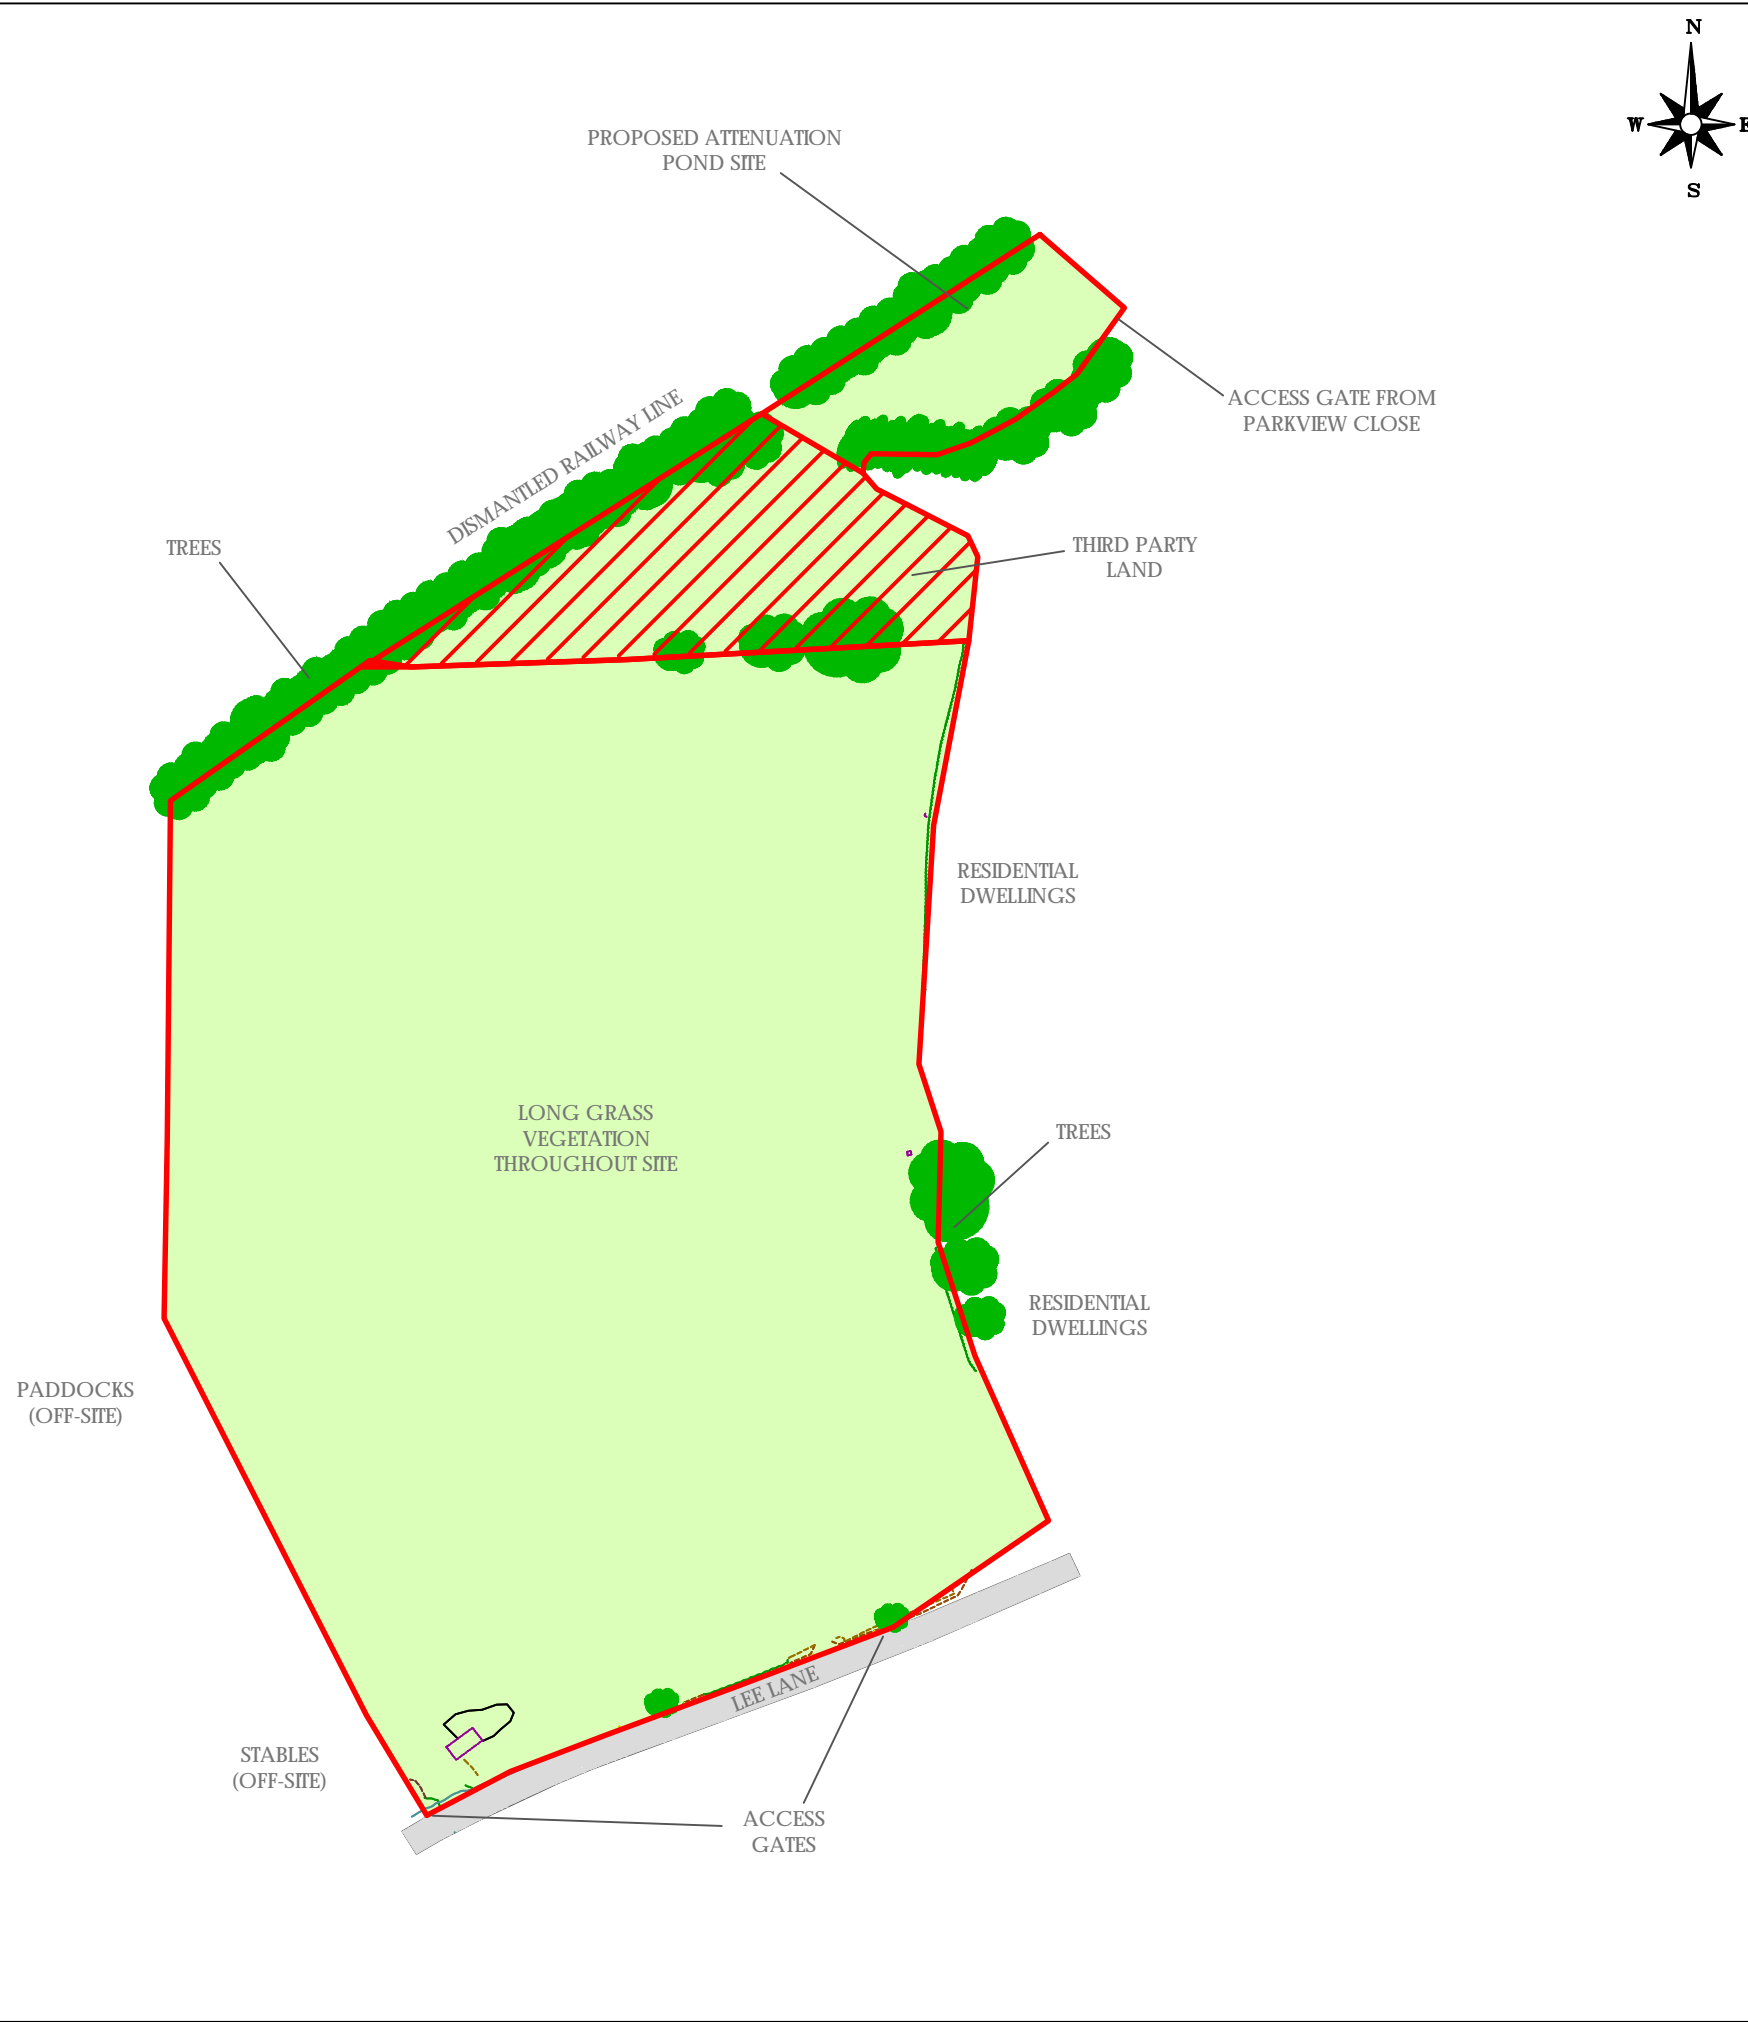
SITE FEATURES

- APPROXIMATE SITE BOUNDARY
- GRASS & OVERGROWN AREAS
- THIRD PARTY LAND
- TREES
- TARMAC HIGHWAY

2.2.2 The entire site is overgrown with thistles / nettles etc and appears not to be in use. Vegetation is particularly dense and overgrown in the south-west of the site area close to Lee Lane; an old horse feeder and domestic garden incinerator were noted in that location.

2.2.4 A few semi-mature trees were present on-site, notably three trees located on the northern boundary line. Some semi mature trees were noted along the outside of the eastern boundary at the rear of the residential properties. Mature trees lined the outside of the southern boundary where the site meets Lee Lane.

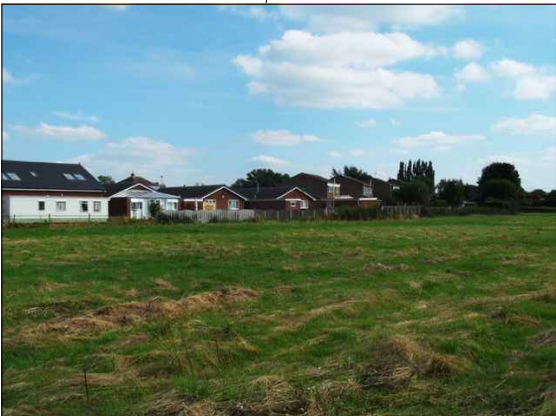
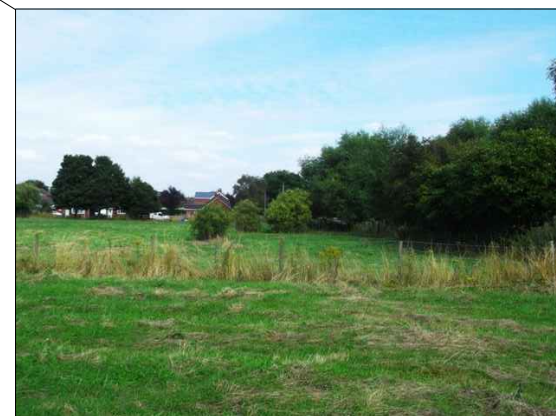
DRAWN	DATE	STATUS	
MC	19 07 16	FOR COMMENT	<input type="checkbox"/>
CHECKED	DATE	FOR APPROVAL	<input type="checkbox"/>
MJT	19 07 16	DRAFT	<input type="checkbox"/>
		FINAL	<input checked="" type="checkbox"/>
SCALE	SHEET	DRAWING NO.	REVISION
1:2000	A3	2366/3

- APPROXIMATE SITE BOUNDARY
- LOCATION & ORIENTATION OF PHOTOGRAPH
- GRASS AND PADDOCKS
- TREES AND SHRUBS
- TARMACADAM ROAD

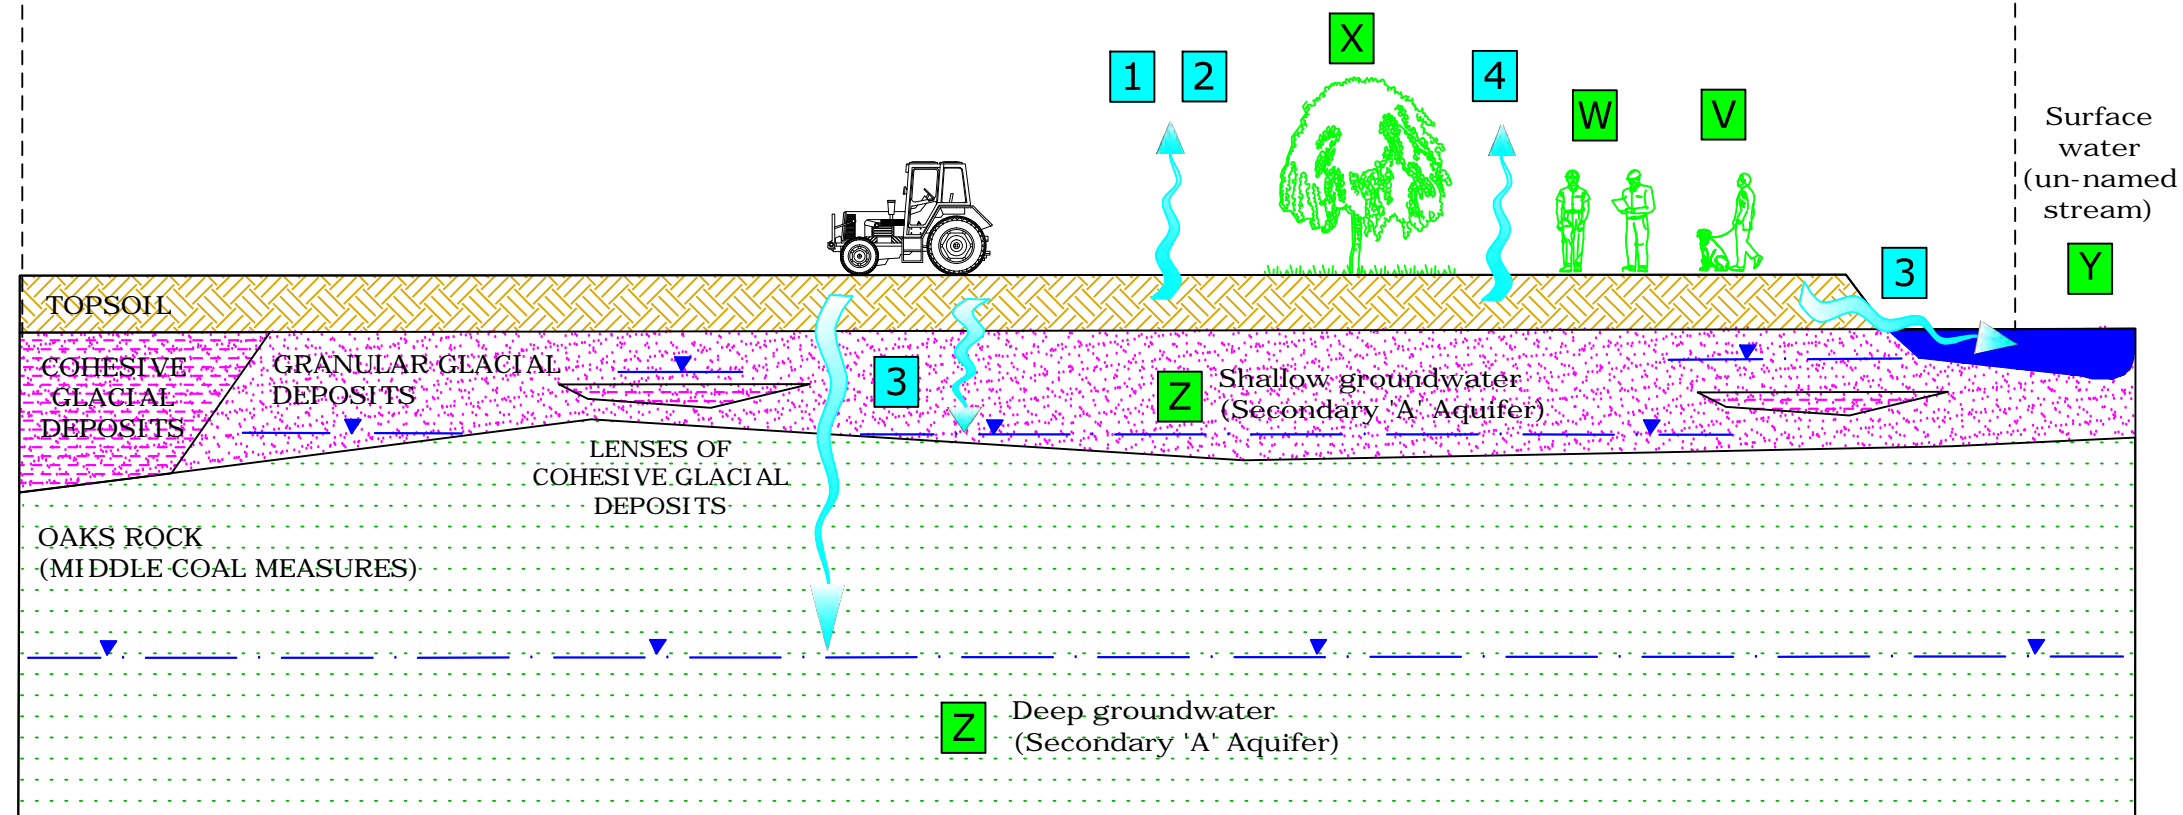
SCALE	SHEET	DRAWING NO.	REVISION
Not to scale	A3	2366/5

SOURCES	
A	AGRICULTURAL ACTIVITIES

PATHWAYS	
1	DERMAL CONTACT
2	INGESTION\INHALATION
3	LEACHING OF CONTAMINANTS
4	UPTAKE BY PLANTS

6.2.2 Historical plans show that the site has been occupied by arable farmland which is not considered likely to have caused significant ground contamination. Nonetheless, activities such as slurry spreading, the discharge of chemicals to ground, and unregulated burial have all occurred on farmland. Potential pollutants associated with farming activity might include any of the following:

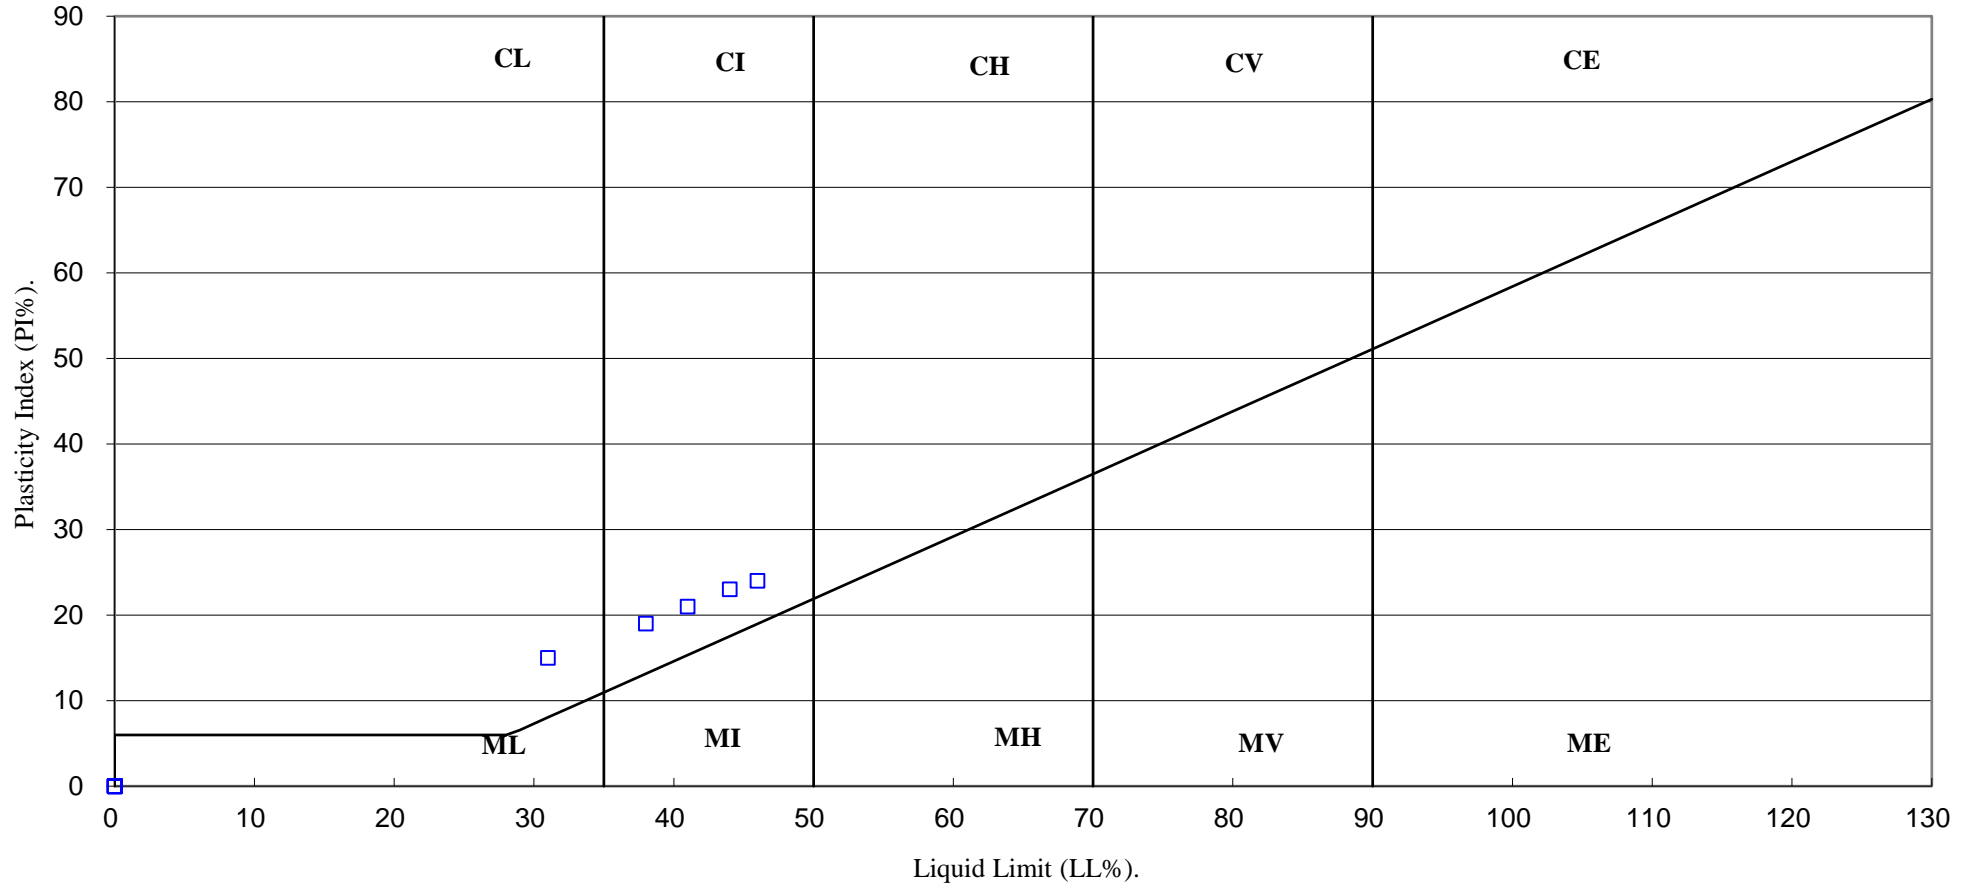
PLASTICITY CHART FOR CASAGRANDE CLASSIFICATION.

(BS5930 :2015)

Soil type	Moisture content range (average)	Range of Plasticity Indices* (average)	Shrinkability
Cohesive Glacial Deposits	16 to 29 (21)	15 to 24 (20)	Medium

13.2.2 For the purposes of foundation design, it is recommended that all cohesive soils be regarded as being of Medium shrinkability.
