**LAND AT JUNCTION OF BARNSELY ROAD  
AND HAIGH LANE, HOYLANDSWAINE.**

**PRELIMINARY ECOLOGICAL APPRAISAL.**

**Ref No: 210409.**

**Date: 27<sup>th</sup> April 2021.**

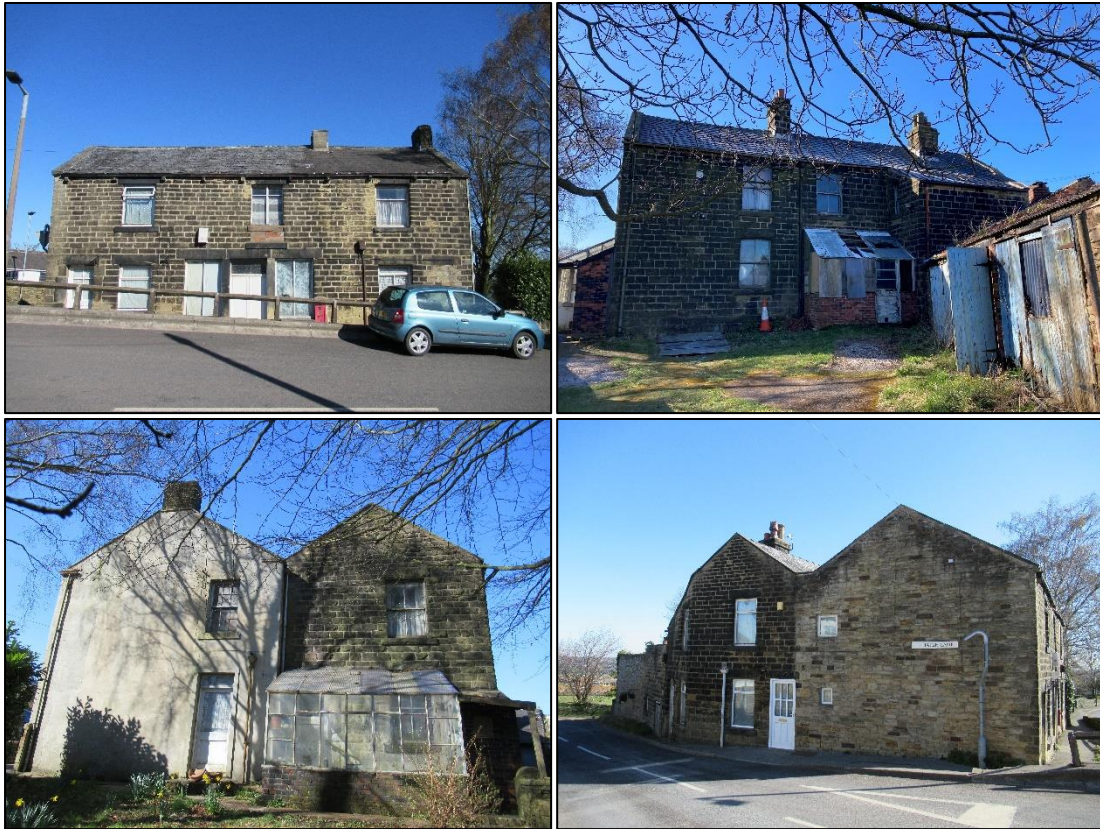
#### 3.4.4.1. Building 1.

3.4.4.1.1. This is two semidetached houses in one building, which is two storey with a double pitched slate covered roof and stone walls. There is a small single storey porch on the eastern end and another on the northern side.

3.4.4.1.2. The section of the building at the southwest corner is occupied and the rest is empty and disused.

3.4.4.1.8. Therefore, due to these few features this building is assessed as providing **low** potential for roosting bats.

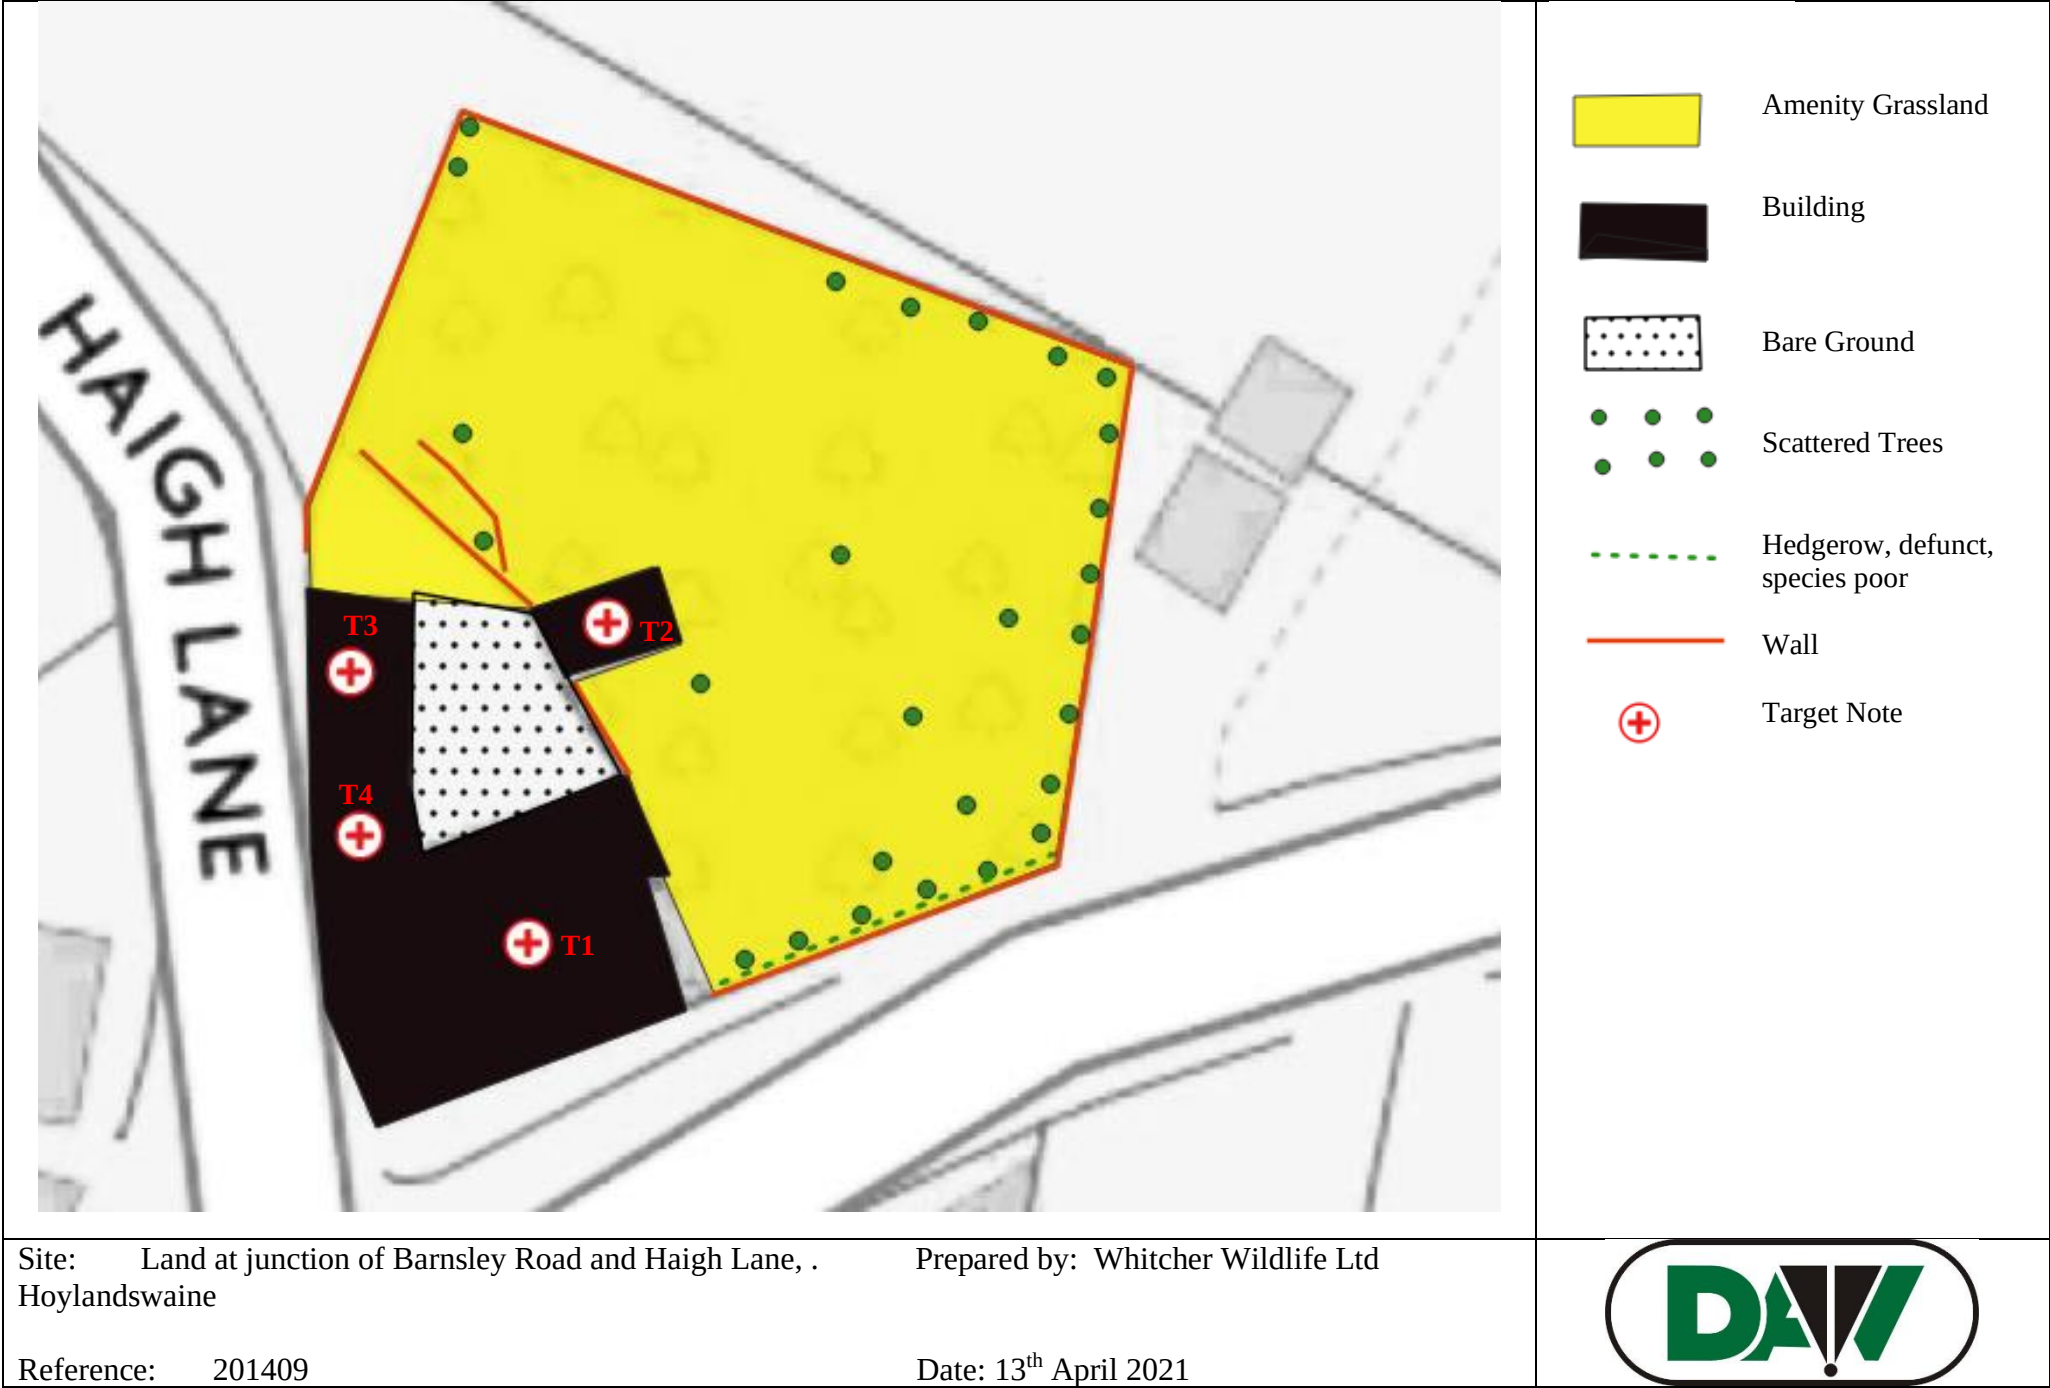
Appendix IV. ANNOTATED MAP OF THE SURVEY AREA.

**T1** – Building 1. Low bat roost potential.
