Ranah Stones Farm, Hazlehead
Bat and Barn Owl Survey Report
3rd January 2020

Document ref: MBE/BAT/2019/110/1				
Purpose and Description	Originated	Checked	Reviewed	Date
For Planning	R Bell MCIEEM <i>R Bell</i>	P Middleton MCIEEM <i>P Middleton</i>	R Bell MCIEEM <i>R Bell</i>	03/01/20

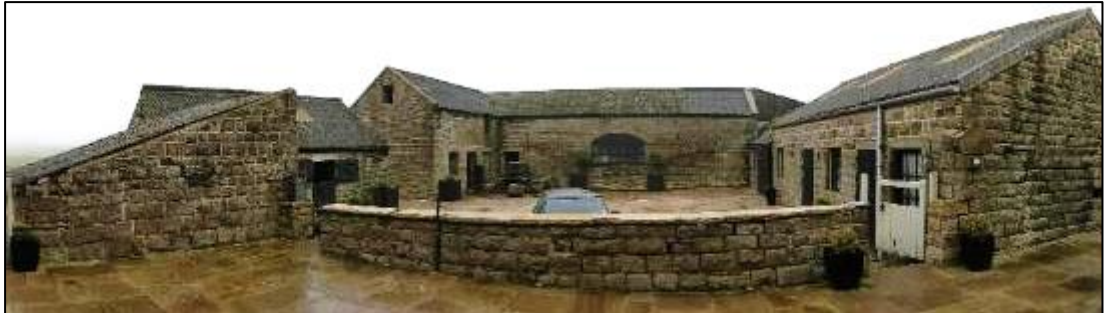
Plate 1. B1 on left of image, with B2 and B3 in centre and B4 on right

5.2.3 Building 1 (B1) comprises a late 19th Century single-storey outbuilding with solid stone walls and a sloping (mono-pitched) corrugated asbestos sheet roof (Plate 1). A single wooden door is present in the west elevation, with a single pane window in the south elevation.

elevations, with a crevice also present between the timber window frame and adjacent stonework. Internally the roof is suspended on timber joists with the building used as a store. In common with the exterior, numerous cracks lead into the stone walls from the interior of the building. Building 1 is considered to offer an overall low level of bat roost potential.

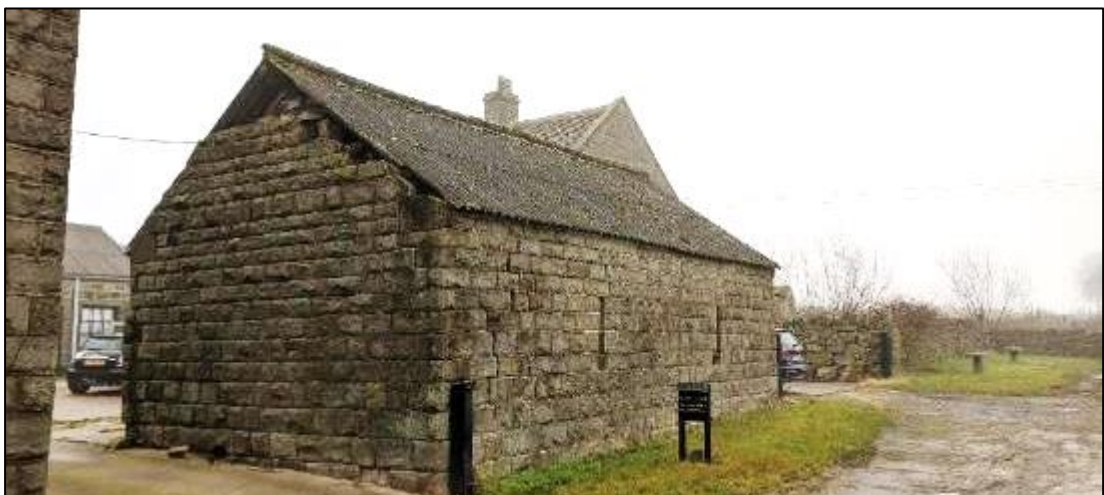
Plate 2. Southwest corner of B2

- 5.2.6 Externally B2 has numerous holes into the exterior of the stone walls across all elevations with part of the eastern gable missing at its apex (Plate 2), allowing easy potential access to the interior of the building for bats. An extended crack runs down the southern elevation.

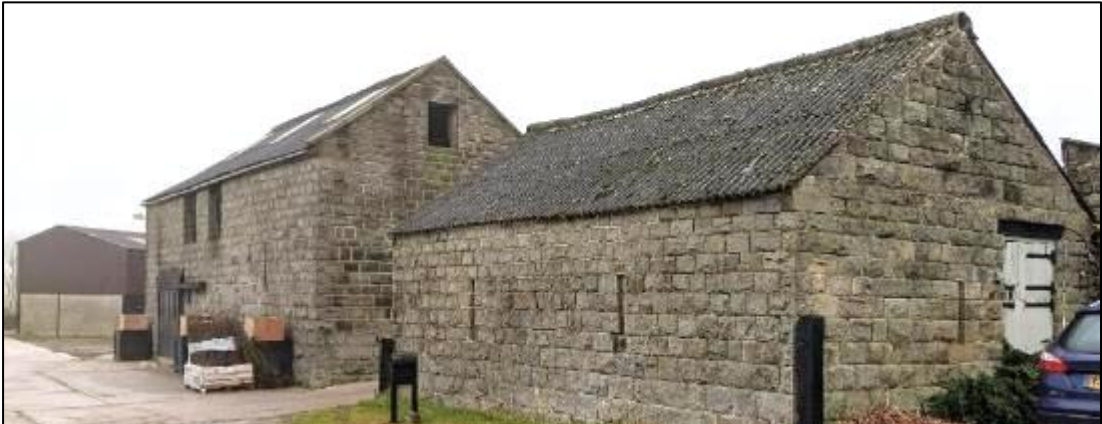
Plate 3. South and east elevations of B2 (right) and B3 (left)

- 5.2.7 Internally the roof is unlined and suspended on a king post truss, ridge beam, purlins and rafters (Plate 3) with white-washed walls. Cracks in the mortar joints of the masonry allow potential access for bats into the walls from the interior of the structure. The building was used to shelter goats at the time of survey with a disused swallow *Hirundo rustica* nest noted from the interior of the building.

- 5.2.9 Building 3 (B3) comprises a late 19th Century L-shaped two-storey height barn with solid stone walls and a pitched corrugated asbestos sheet roof (Plates 1, 3 & 5). Stone copings are present on north and east gables (Plate 3). Building 4 adjoins B3 on the latter building's north gable, whilst a modern steel framed barn adjoins B3 on its west elevation. Timber loading hatches are present at first floor level on north and south elevations, with sliding wooden doors on the south elevation (Plate 5). Single wooden doors are present on the north, east and west elevations with a large single pane window and arrow slit vents on the east elevation. An uncovered hatch shaped opening is present at first floor level in the east gable (Plate 3)

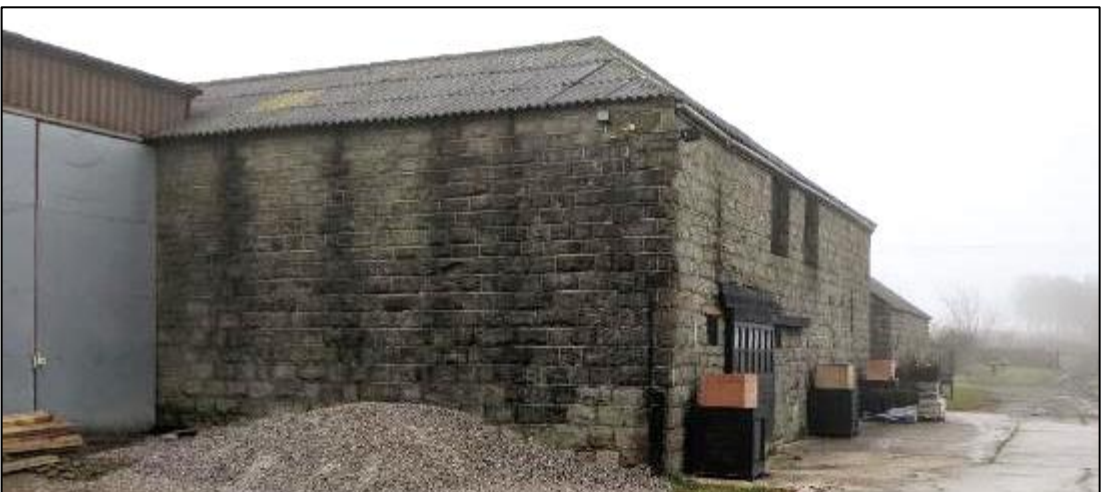
Plate 5. Southwest corner of B3

- 5.2.10 Bats and birds could potentially access the interior of B3 in numerous locations notably including the open hatch in the east gable, arrow slits in the east elevation, a hole in a hatch cover in the south elevation and missing window-panes on a north elevation window. A timber fascia board with a variable width gap behind (up to 50mm) is present on the south elevation behind which bats may roost, whilst bats could also access the interior of the solid stone walls via a number crevices between external masonry. There is also access to the wall plate on all building elevations, except the north gable.

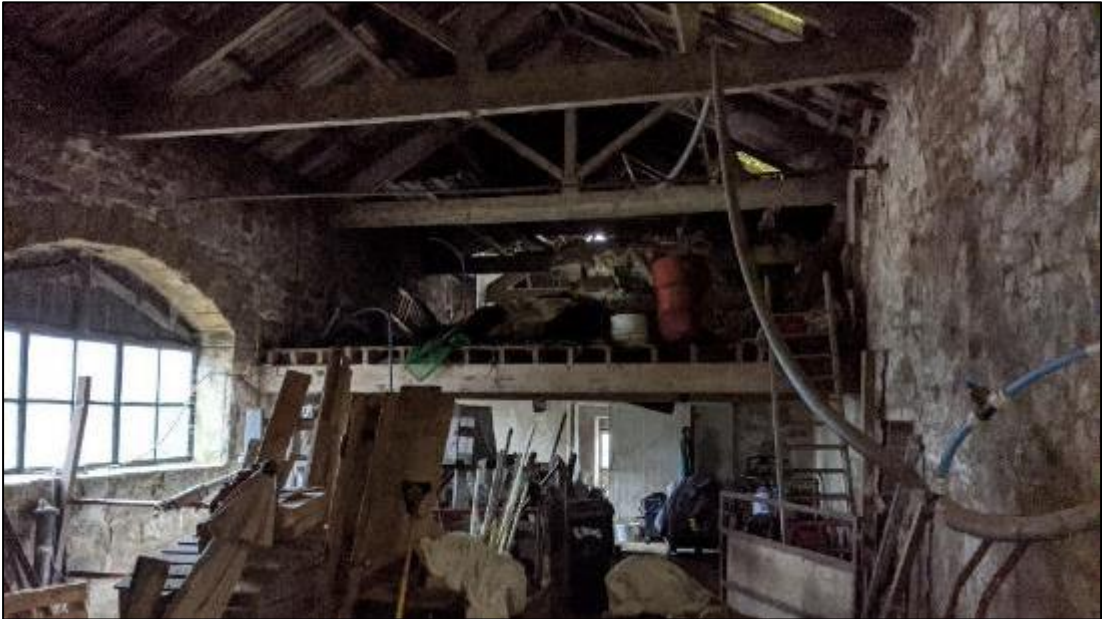
Plate 7. Looking south within B3

- 5.2.11 Internally the roof is unlined and suspended on king post trusses, a ridge beam, purlins and rafters (Plate 7). The southern section of B3 is two-storey with the remainder single storey. Potential bat roost locations in the barn interior include crevices between timber, stone and concrete lintels above doors and windows with cracks between internal masonry also providing potential access into walls.

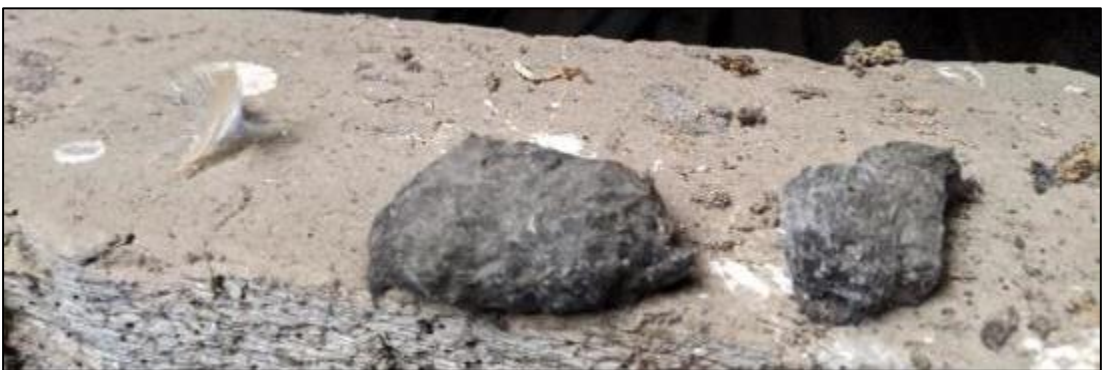
Plate 8. Two barn owl pellets in B3

5.2.12 Five barn owl *Tyto alba* pellets were recorded from the first floor below a roof truss on which the barn owl appears to roost, at the southwest corner of B3 (Plate 8). This has been classified as an occasionally used Active Roost Site, on the basis mainly of the number of pellets present. It appears the barn owl accesses the building via an adjacent hatch opening in the wall. No further evidence of bats or birds was recorded from B3, with all potential barn owl nest sites in both this building and all other surveyed buildings visually inspected. Building 3 is considered to offer an overall low level of bat roost potential.

- 6.1.3 A barn owl roost site was recorded from the first floor of B3. The barn owl appears to roost on the roof truss and has been observed flying into the building via a hatch opening at first floor level. Only five pellets were recorded and though considered an Active Roost Site (Shawyer, 2011), this location only appears to experience occasional use. All potential nesting locations in the surveyed buildings were subject to direct visual inspection and there are no indications of historic use of the building by nesting barn owl.
- 6.1.4 Disused swallow nests were recorded from B2 & B3, with the site owner's having observed regular annual use of these buildings. It is quite possible that other bird species also nest in the surveyed site buildings.

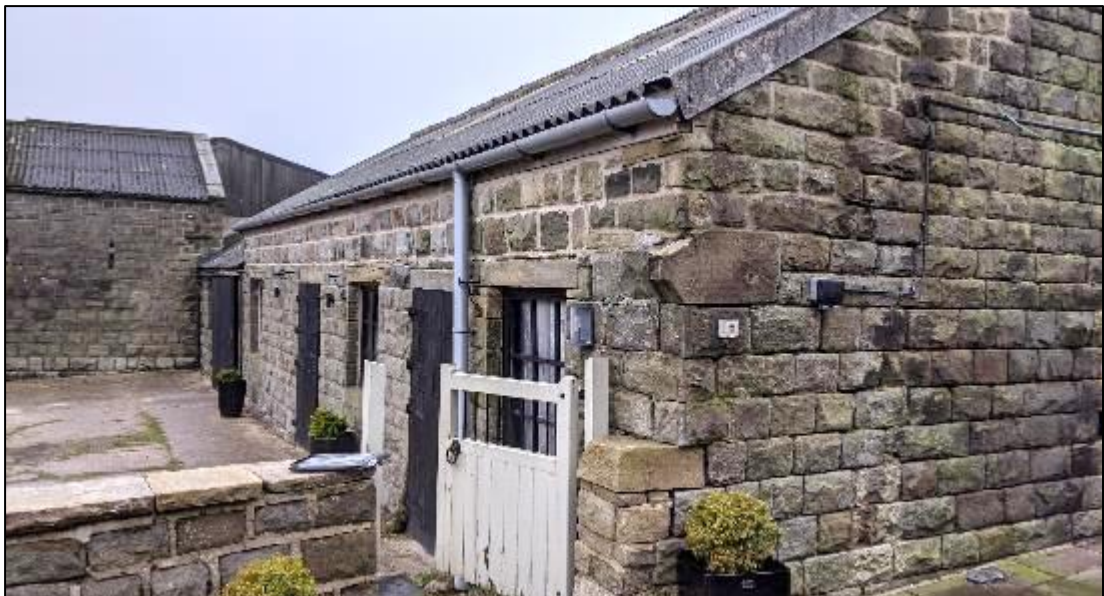
Plate 9. Southeast corner of B4

5.2.13 Building 4 (B4) comprises a late 19th Century single-storey barn with solid stone walls and a pitched corrugated asbestos sheet roof (Plate 9). The roof is 'stepped' down in middle (different heights) and asbestos verge capping is present on the east gable and at the central point where the roof drops in height. Single pane windows and stable doors are present in the south elevation, with a new timber wall plate having been fitted at the eastern end of B4.

5.2.14 Externally, there is a crevice present between the base of the timber wall plate and adjacent masonry on the south elevation, with other crevices between external stone-work also present. Several open windows in the south elevation allow potential bat and bird access to the interior of B4.

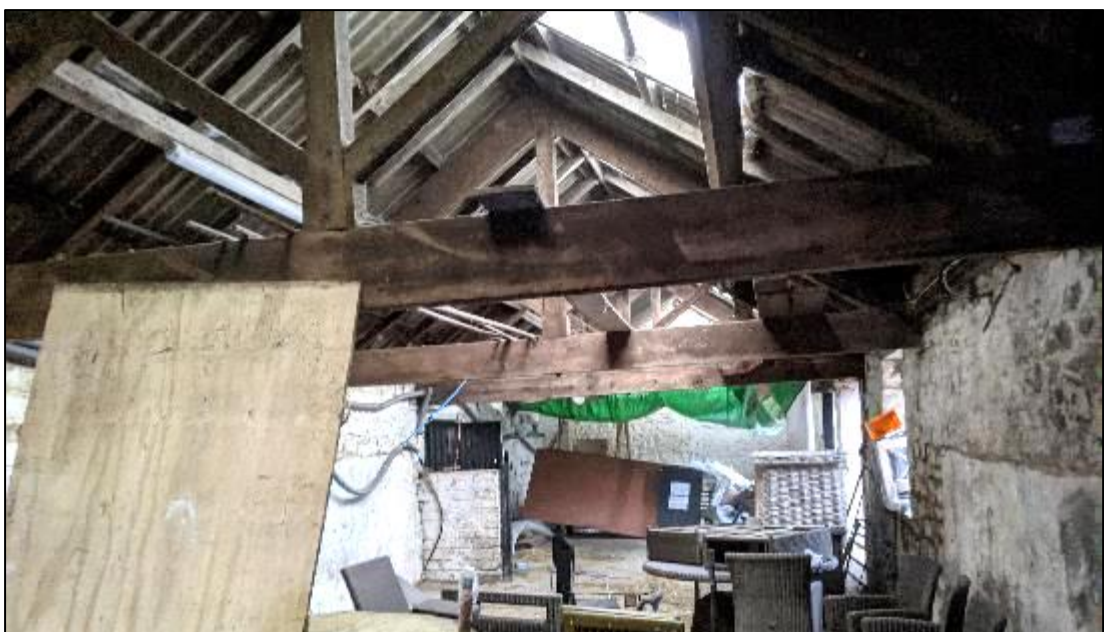
Plate 10. Looking towards B3 from interior of B4

5.2.15 Internally the roof is unlined and suspended on a king post truss, a ridge beam, purlins and rafters (Plate 10) with white-washed walls. Two stone dividing walls with gaps across the top separate internal rooms at the east end of B4. As with other stone buildings on site, holes in the mortar joints of masonry allow bat access into the walls.

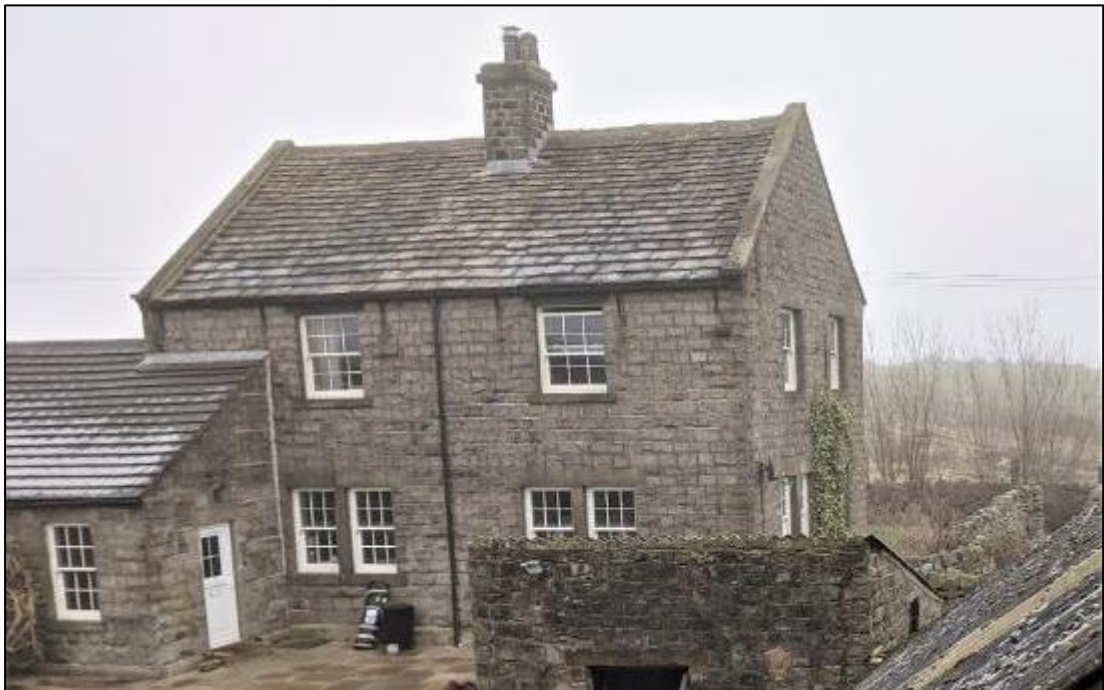
5.2.17 Building 5 (B5) comprises a late 19th Century single-storey extension to B6, with solid stone walls and a sloping concrete tile covered roof (Plate 11). A timber fascia board is present on the west elevation and the building has double glazed windows with uPVC frames. No features displaying significant bat roost potential were recorded from the exterior of this building. Internally a small roof void with a triangular cross section is present. B5 was considered to offer negligible bat roost potential.

Plate 11. The farmhouse with B5 the single storey section (left) and B6 the original two storey section (centre)

5.2.18 Building 6 (B6) comprises a late 19th Century two storey farmhouse, with solid stone walls and a pitched roof covered with stone slates (Plate 11). Stone copings are present on the north and south gables and the building has uPVC framed double glazed sash windows.

5.2.19 The main potential bat roosting feature noted from the exterior of B6 comprises crevices between the stone roof slates, with bats also potentially able to access the wall plate, behind the gutter.

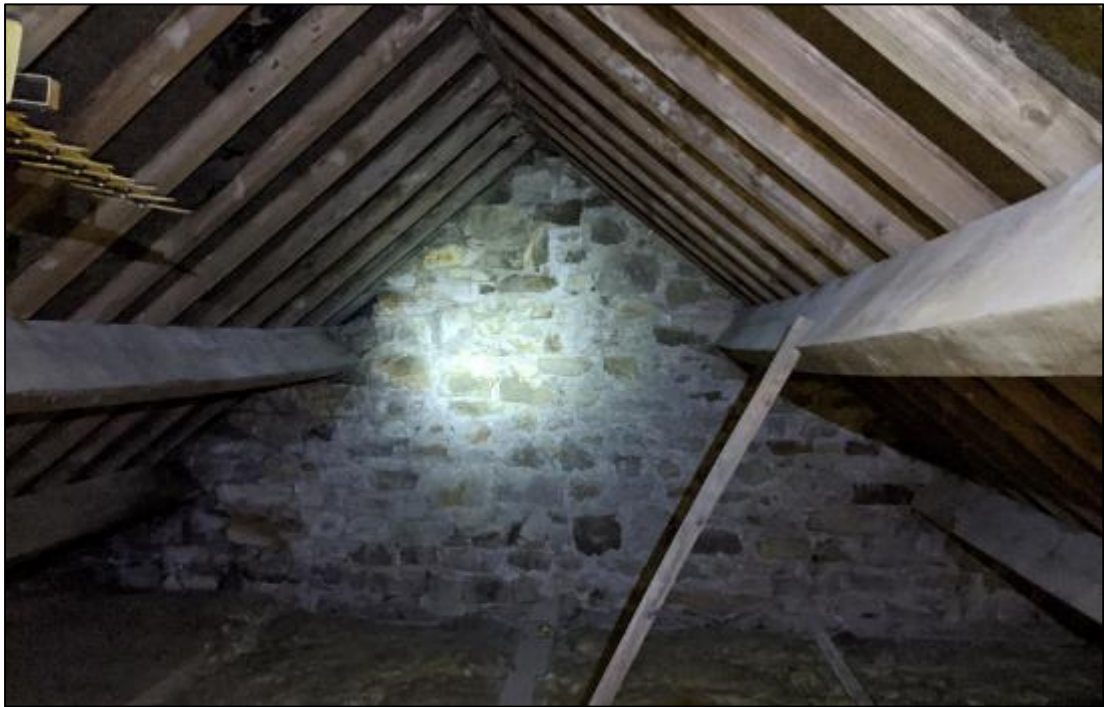
Plate 12. Interior of B6 roof void

5.2.20 Internally the roof is lined with Type 1F felt and suspended on a ridge beam, purlins, rafters and laths. Glass fibre insulation is present on the ceiling and the height from ceiling to ridge is 2.5m. No evidence of bats was recorded with the roof void quite heavily laden with cobwebs (Plate 12). Mouse *Mus musculus* droppings were present in the void. B6 is considered to offer moderate bat roost potential.

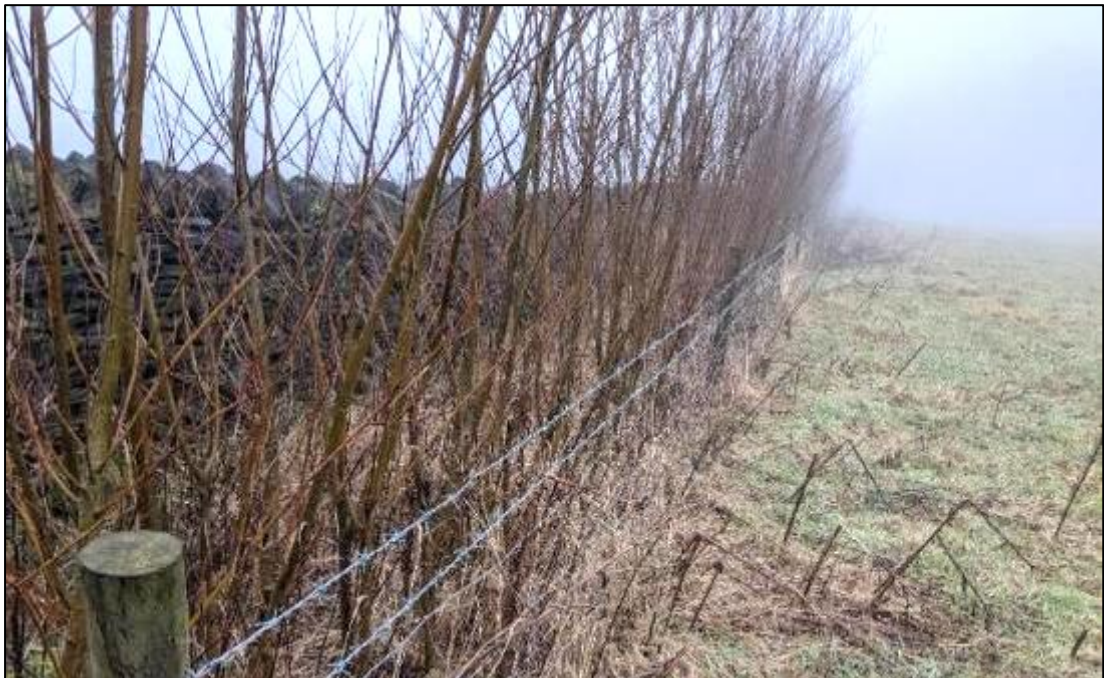
Plate 13. Line of hybrid willow growing against east side of wall, to north of junction between A616 Whams Rd and Ranah Stones Farm access track

5.2.21 To the north of A616 - Whams Rd and the driveway to Ranah Stones Farm the drystone wall has been recently planted with hybrid willow *Salix* spp. saplings on its east side, with species poor semi-improved rank grassland at the base of the willows saplings and along the bottom of an adjacent post and wire fence. This grassland

- 6.3.7 The line of hybrid willow to the north of the current Ranah Stones Farm access point will be lost during re-alignment of the wall. It is recommended that this tree line is reinstated using either a native willow species or alternative native species of tree or shrub.

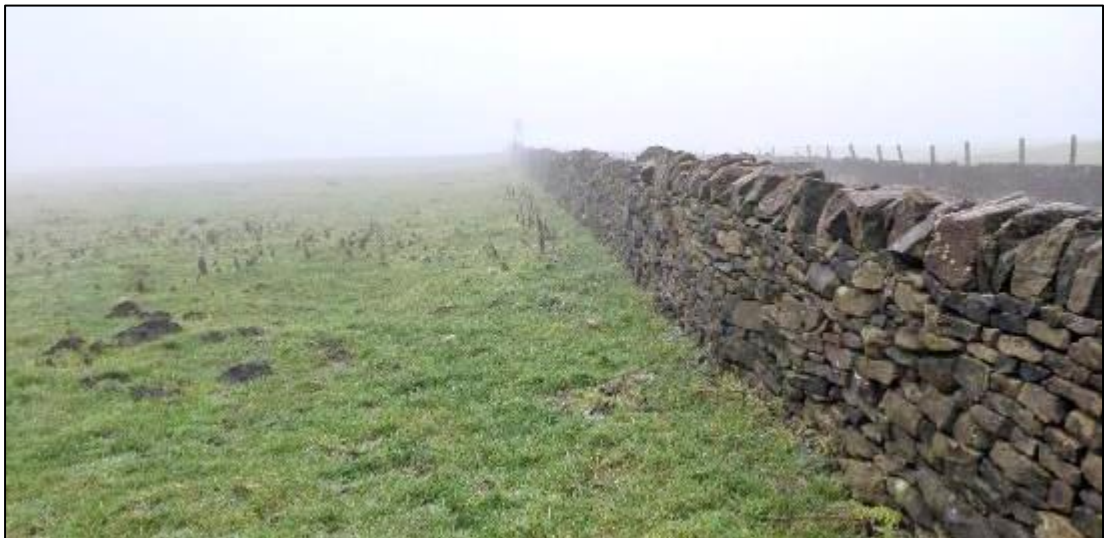
- 5.2.22 To the south of the access track's junction with the A616 - Whams Rd, the drystone wall is bordered by poor semi-improved grassland, with species recorded including frequent Yorkshire fog and perennial rye grass *Lolium perenne* together with occasional red fescue *Festuca rubra*. Herb species included frequent creeping thistle, occasional nettle *Urtica dioica*, cow parsley *Anthriscus sylvestris* and common chickweed *Stellaria media*. Again, the species present suggests nutrient enrichment in this area.

Plate 14. Semi-improved grassland beside wall to south of access track junction with A616 - Whams Rd

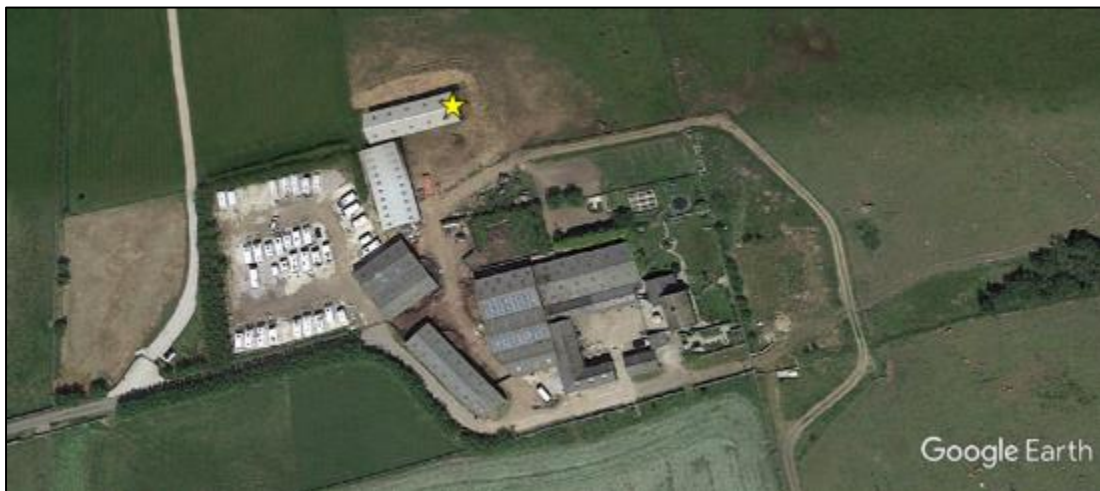
- 6.3.4 A barn owl nest box has been recently installed within the interior of a new barn at the north end of the farmstead (Figure 3). Access to the box is via a hole cut in timber boarding which forms the east gable of this barn. This box has not yet been used; however, a new hedgerow has been planted along the top of a bank close to the gable and it is hoped this will increase the likelihood of future usage. This box was inspected during the survey and it is considered that it offers a suitable alternative roost site to the existing roost site present in Building 3, which will be lost during the development.

Figure 3. Existing barn owl box location shown by yellow star
