# **STUD FARM, CARLTON, BARNSELEY, SOUTH YORKSHIRE: A HERITAGE STATEMENT AND IMPACT ASSESSMENT**

For: **YGI Limited**

**CS Archaeology**

**Project Number:** 85

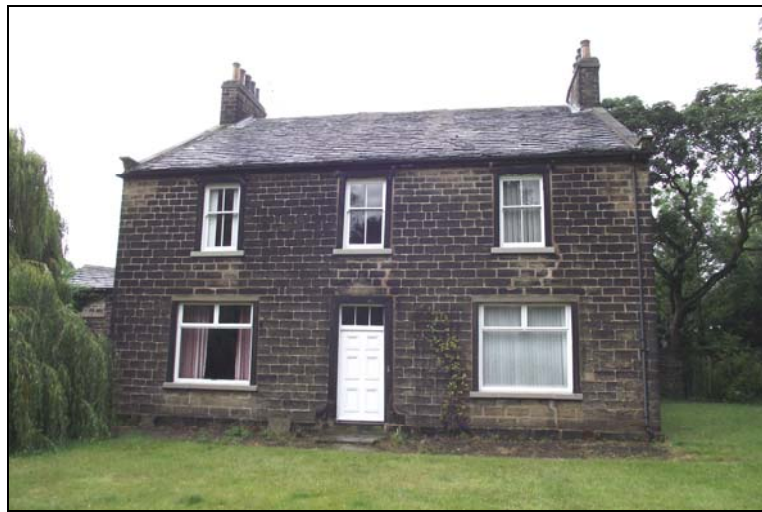
*Frontispiece: view of the front elevation of the farmhouse at Stud Farm, from the west.*

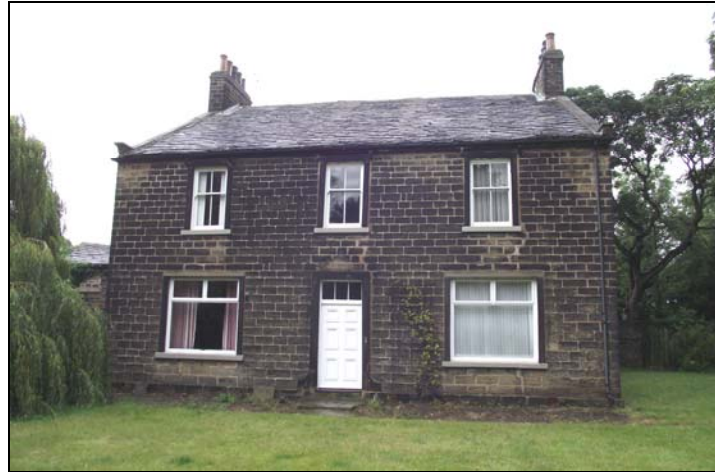
- 3.1 Both extant and non-extant historic buildings within and just outside the Proposed Development Areas (PDA) have been labeled A-I.
- 3.2 The farmhouse, Building A (Plate 1), was built in 1796 as evidenced by a date stone to the north facing semi-circular second floor window (Plate 2). The farmhouse is of double pile construction which unusually faces west. It features well coursed sandstone walls with ashlar cills and lintels under a flagstone roof. The lower walls feature a continual

stepped plinth. Decorative features include the front ashlar door surround with splayed door jamb, and use of semi-circular windows to the second floor.

**Plate 1:** the front (west) elevation of the farmhouse (building A) built 1796 and 'modernised in the 1960s/70s

- 5.2.1 The House (Building A) is in good general condition but is starting to suffer from water ingress to the walls and roof. Sustained maintenance is required in order to ensure its long term future. Though the house has been internally modernised during the C20th century there are still an array of original in situ features. The original access flows can also still easily be discerned. There is the potential for some original features to be lost during any renovation. Any impacts from proposed re-development and refurbishment could represent slight impacts to the heritage asset. Sympathetic renovation/restoration particularly regarding the two front windows would represent a positive benefit to the heritage asset.

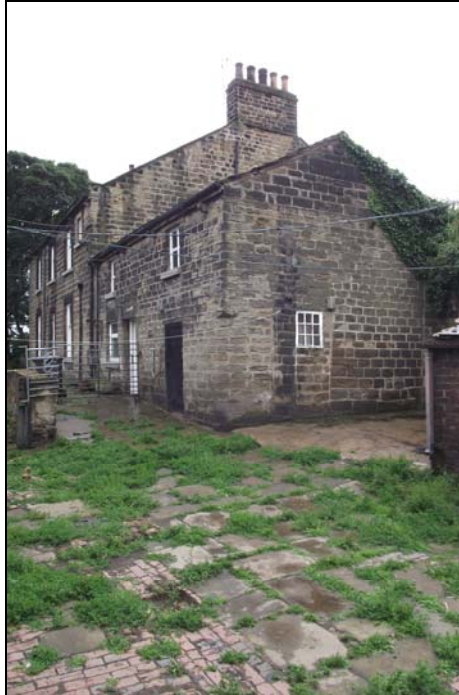
- 3.5 The gabled extension (Building B: Plate 3) at first appears to be a Victorian extension but irregularities in the stone work suggests a possibly earlier date. It most recently served as the Kitchen and had a first floor but the staircase has been removed (pers. comm. Mr Maw). There is a blocked doorway to the front north elevation. Internally the ground floor room has been largely modified, the first floor has more potential for original features but there was no access at the time of the survey.

**Plate 3:** the north and east elevations of the gabled extension (building B)

- 5.2.2 The gabled extension (Building B) has been subject to extensive modifications both internally and externally. The internal staircase has been removed and it was not possible to assess the first floor. The proposed refurbishment will impact possible original 18<sup>th</sup> century fabric, fittings and fixtures.

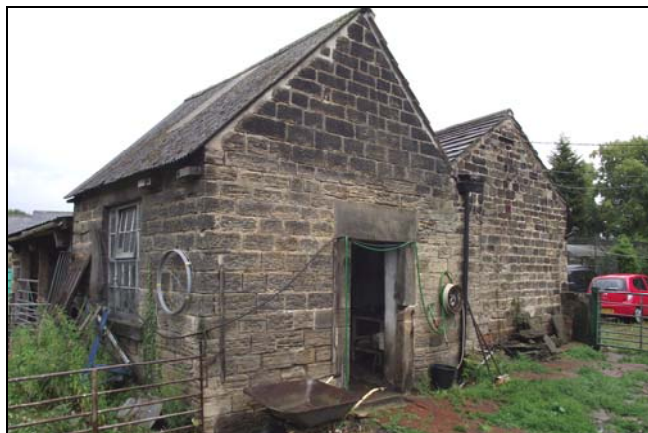
- 3.6 The Wash House/Shop (Building C: Plate 4). The Wash House survives largely intact and the internal boiler scars can still be discerned. The adjacent shop has been renovated and recently served as a farm shop for the local community so any internal features have been obscured. Externally there is an array of blocked doorways. The haphazard appearance of building C and cartographic information suggests that this originally formed part of a larger building, possibly a barn which shared the house's north south alignment.

**Plate 4:** the west elevation of the wash house and butcher's shop (building C)

- 5.2.3 The Wash house and Butcher's Shop (Building C) have been heavily modified. The wash house retains original features and is an important survival relating to the servicing of the house. No internal features are expected to be retained during the renovation.

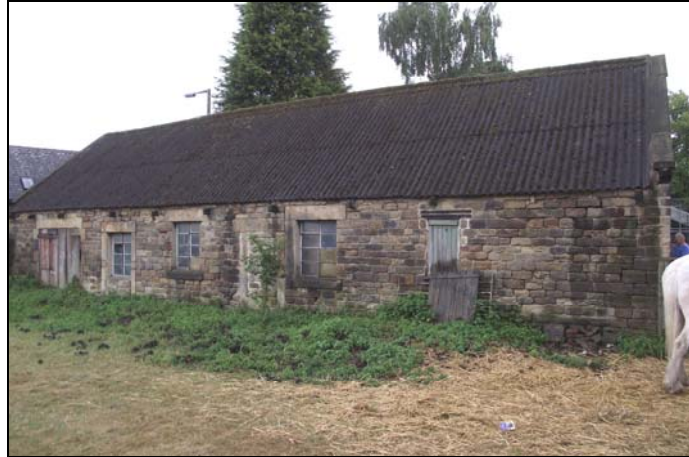
- 3.7 The Stable/Cartshed (Building D: Plate 5) represents the most recent building dating to the late 19<sup>th</sup> century. The north elevation in particular shows evidence for inserted late Victorian fenestration. During the late 20<sup>th</sup> century the internal walls have been largely removed, probably to allow for the storage of machinery.

**Plate 5:** the north elevation of the Stable/Cartshed (building D) largely dates to the late 19<sup>th</sup> century (prior to the fire)

- 5.2.4 The Stable/Cartshed (Building D) were greatly enlarged during the late C19<sup>th</sup> but may have originally featured a cart shed abutting the high street. Slight internal impacts are anticipated, particularly to the truncated cross walls. The external walls appear to be in good condition and with sympathetic treatment the building's agricultural origins as expressed by the original and inserted accesses and fenestration will endure and contribute to the sense of place.

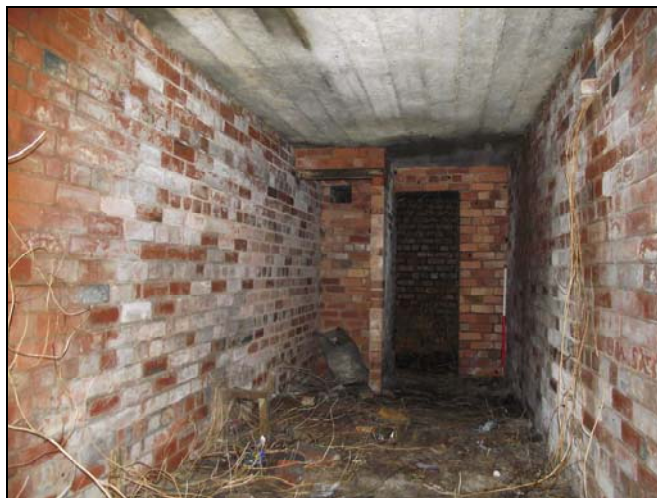
- 3.8 Known heritage assets that are no longer extant include two buildings first depicted on the tithe map of 1845 (apportionment 137). Building E is a substantial rectangular building and is aligned NNW-SSE. It faced west towards the high street, and probably represented a large agricultural barn. Just to the northwest of Building F, was the 'L' shaped building that probably served as the farmhouse and abutted the high street. The last known historic building G, was situated to the SE of the House, its function is unknown and may have served as a Stable/Cartshed since it was situated at the NW corner of a rectangular enclosure.
- 3.9 Following the Building Record of the farmstead (CS Archaeology 11/2012) a further building, a WWII air-raid shelter was re-discovered to the southeast of the farmhouse (Blg. A) in the vicinity of the main road.

**Plate 6:** the inside of the 1940-s air-raid shelter (Blg. J)

- 5.2.5 Buildings E, F and G, have been historically demolished and it is not anticipated that these will be impacted upon.
- 5.2.6 Slight impacts are envisaged to the settings of the two designated heritage assets (Buildings H & I) and a moderate/major impact will occur to the undesignated air raid shelter (Blg. J). The new buildings will be diminutive in scale and any impacts, particularly to the settings of Listed Buildings (Blgs. H&I) could be mitigated through sympathetic landscaping and planting.
