**LAND AT JUNCTION OF BARNSELY ROAD  
AND HAIGH LANE, HOYLANDSWAINE.**

**PRELIMINARY ECOLOGICAL APPRAISAL.**

**Ref No: 210409/Rev 1.**

**Date: 3<sup>rd</sup> June 2021.**

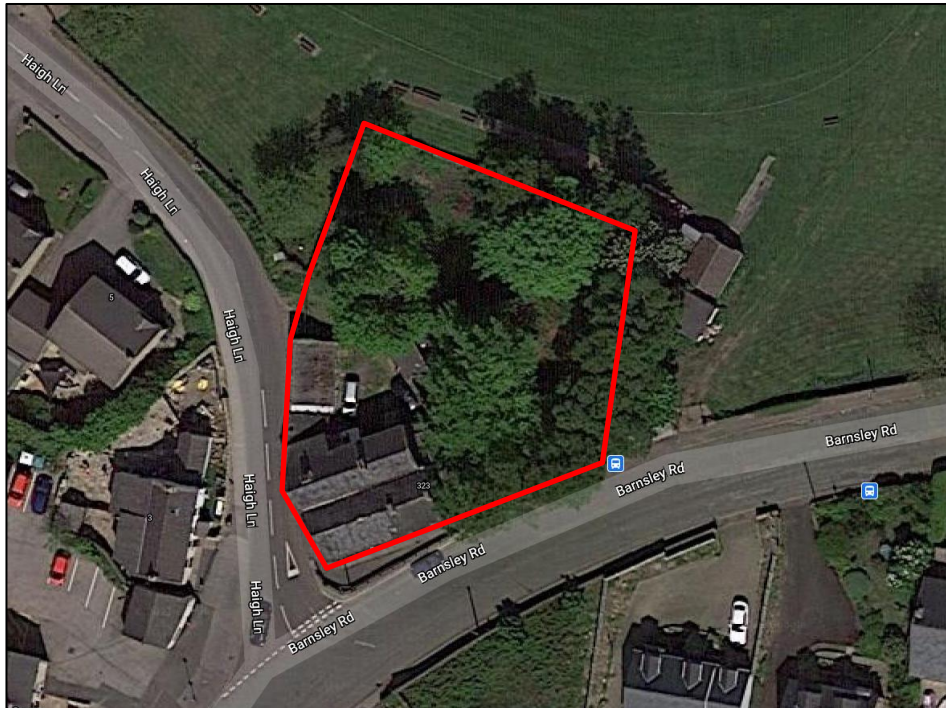
3.2.1. The survey area is two houses and gardens on the northeast corner of the junction of Barnsley Road and Haigh Lane in Hoylandswaine. The aerial photograph below shows the survey area.

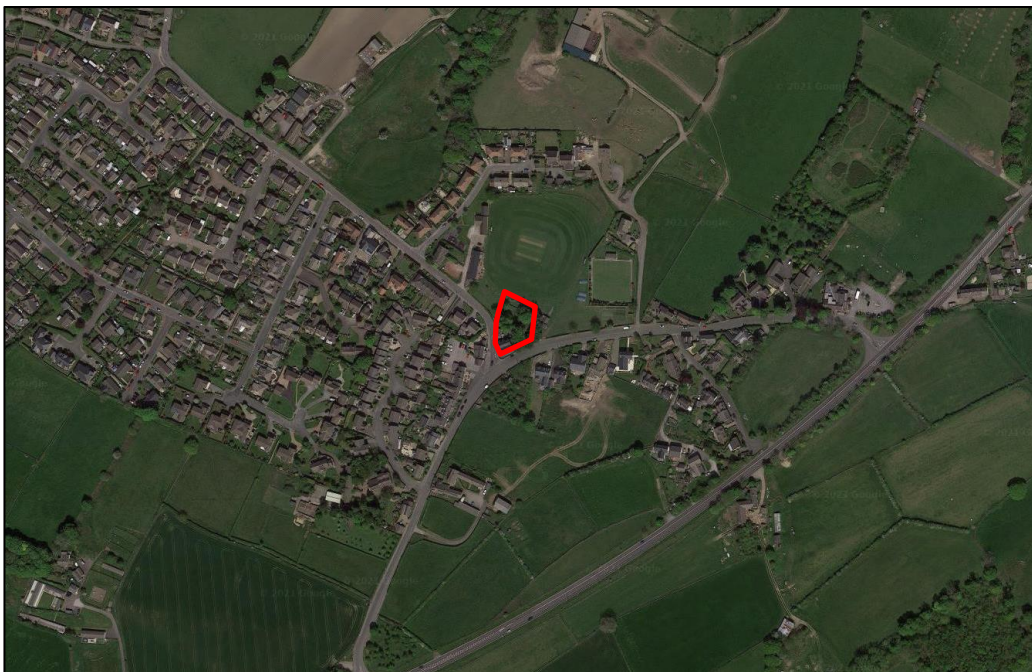
3.2.2. The aerial photograph below shows the survey area and wider surrounding area.

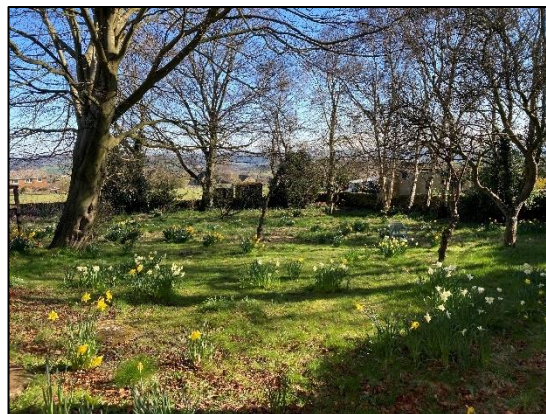
#### 3.3.2. Amenity Grassland

The majority of the site is lawn which contains perennial rye grass (*Lolium perenne*), annual meadow grass (*Poa annua*), dandelion (*Taraxacum officinale*), creeping buttercup (*Ranunculus Repens*), broad leaved willowherb (*Epilobium montanum*), dock (*Rumex sp.*), nettle (*Urtica dioica*), ivy (*Hedera helix*) with some bluebells (*Hyacinthoides non-scripta*) in the northeast corner, some raspberry (*Rubus idaeus*) in the northwest corner and clumps of daffodils (*Narcissus pseudonarcissus*) growing throughout the lawn.

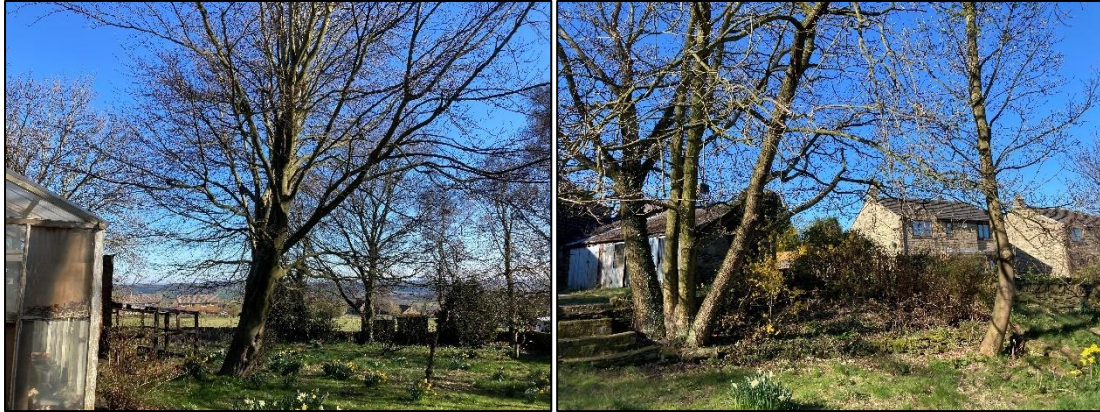
#### 3.3.3. Scattered Trees

There are a number of trees growing on the site, mainly around the site boundaries but some are growing within the site. All trees are semi-mature and are mainly silver

birch (*Betula pendula*) with some sycamore (*Acer pseudoplatanus*) and some small fruit trees that could not be identified.

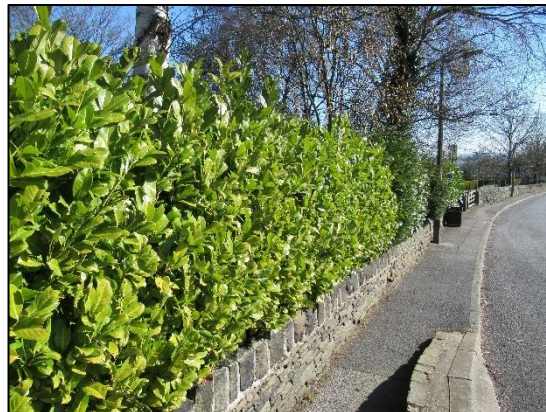
#### 3.3.4. Hedgerow, defunct, species poor

On the southern boundary to the east of the buildings is a well-managed hedgerow growing site side of the boundary wall, which is mainly laurel (*Prunus laurocerasus*) with some Leyland cypress (*Cupressocyparis leylandii*).

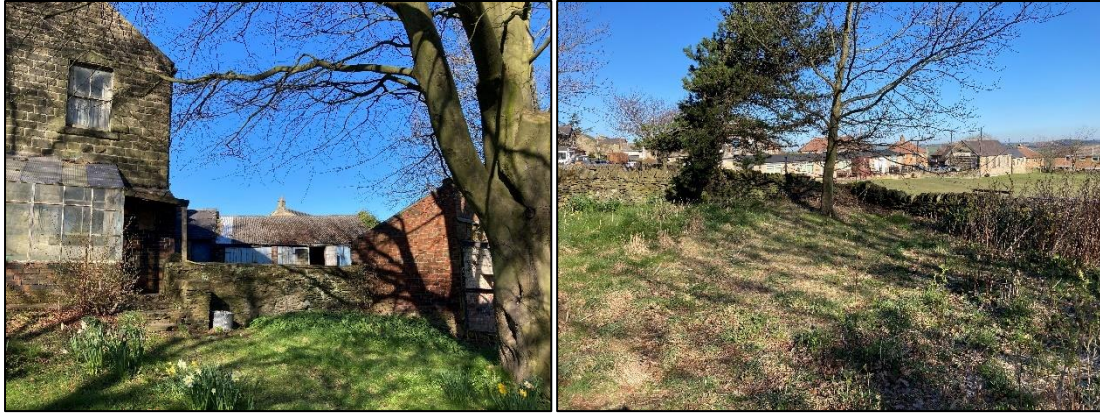
#### 3.3.6. Wall

There is a stone wall boundary all around the site and there are small sections of stone wall within the gardens.

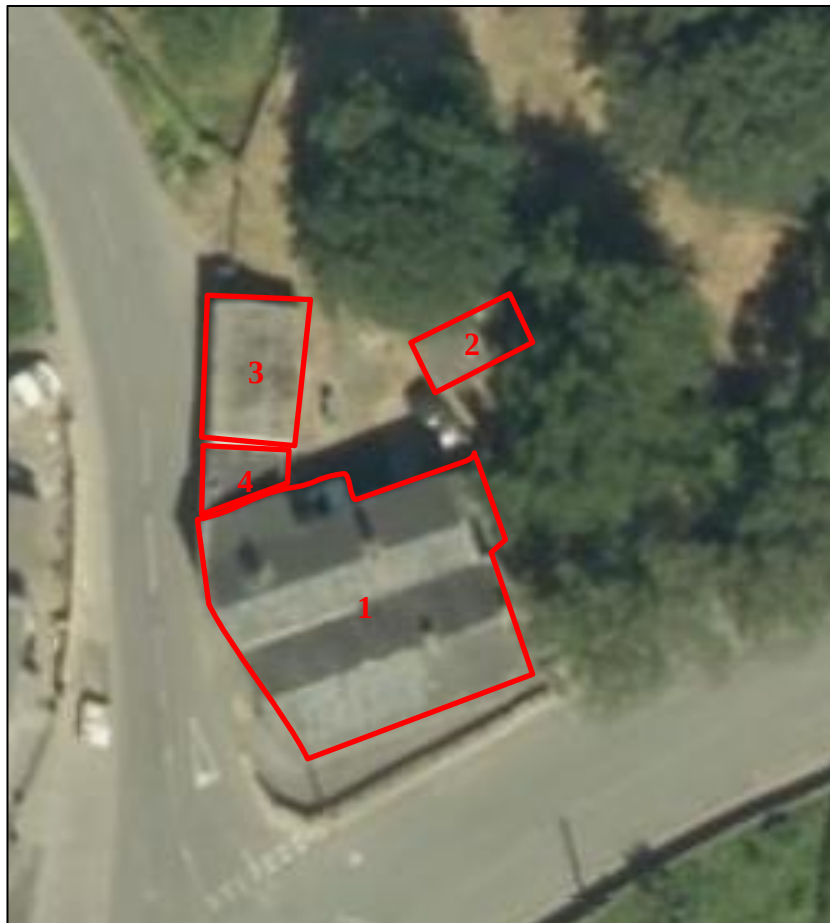
### 3.3.7. Building

There are several buildings on the site. These have been split into four, each given a number, and each described separately in section 3.4.4. below.

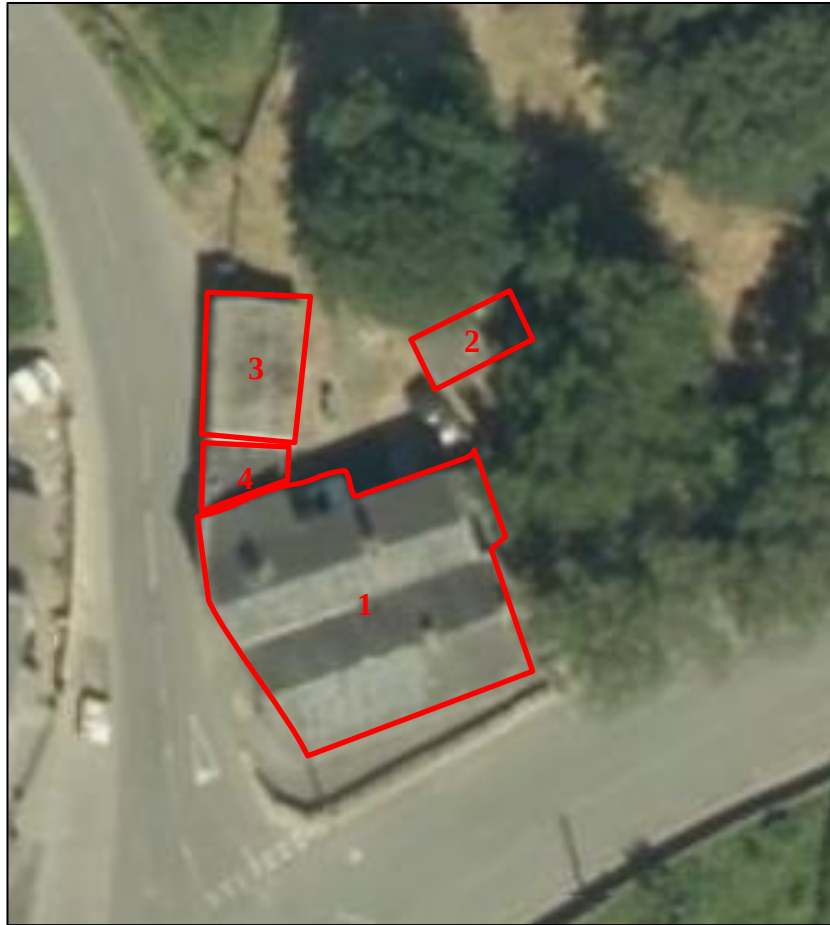
3.4.4. There are several buildings on the site. These have been split into four, each given a number, and each described separately below.

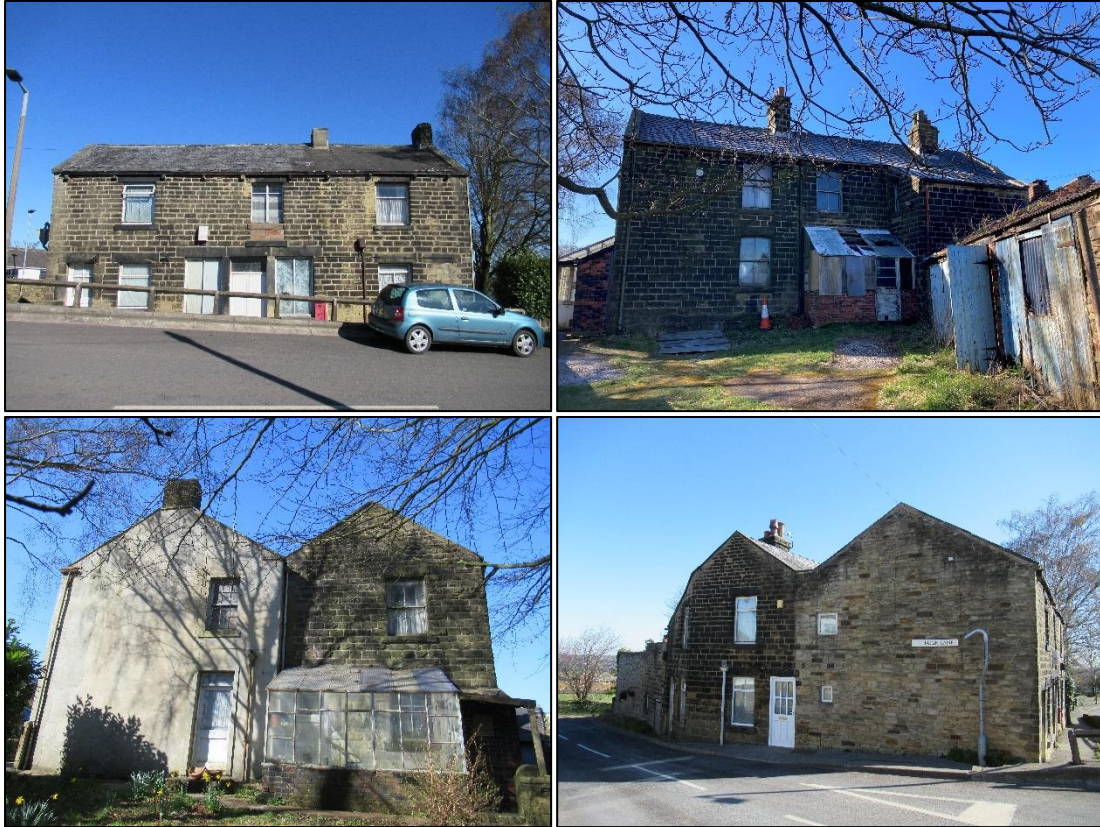
#### 3.4.4.1. Building 1.

3.4.4.1.1. This is two semidetached houses in one building, which is two storey with a double pitched slate covered roof and stone walls. There is a small single storey porch on the eastern end and another on the northern side.

3.4.4.1.2. The section of the building at the southwest corner is occupied and the rest is empty and disused.

3.4.4.1.8. Therefore, due to these few features this building is assessed as providing **low** potential for roosting bats.

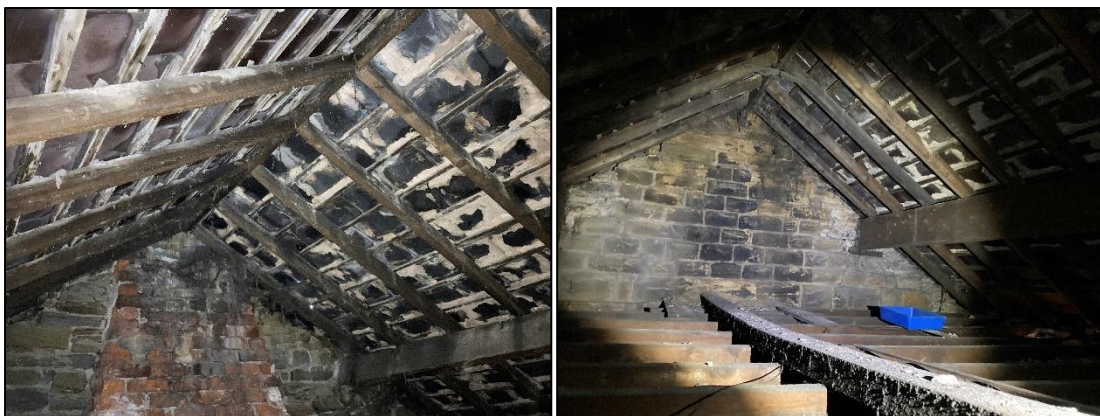
3.4.4.1.3. There are three loft spaces in the disused section of the building that could be accessed during this survey. In all loft spaces the roof has no lining and small gaps could be seen in the slates with small points of daylight shining through. The eaves in the loft spaces were well sealed with no daylight seen. An example of the lofts is shown below.

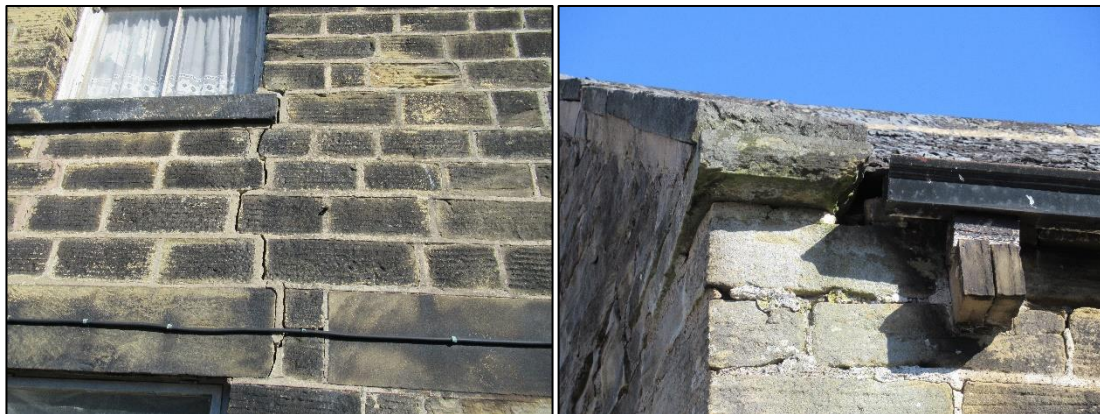
3.4.4.1.6. The walls of the building are generally in good condition. However, at the southern side towards the eastern end there is a crack in the stonework. This appeared to be narrow for most of its length but was wider at the top by the window sill. No staining was seen but the crack could not be thoroughly inspected.

3.4.4.1.7. At the western end of the southern elevation there was a gap between the coping stones and gutter. No staining was seen but the crack could not be thoroughly inspected.

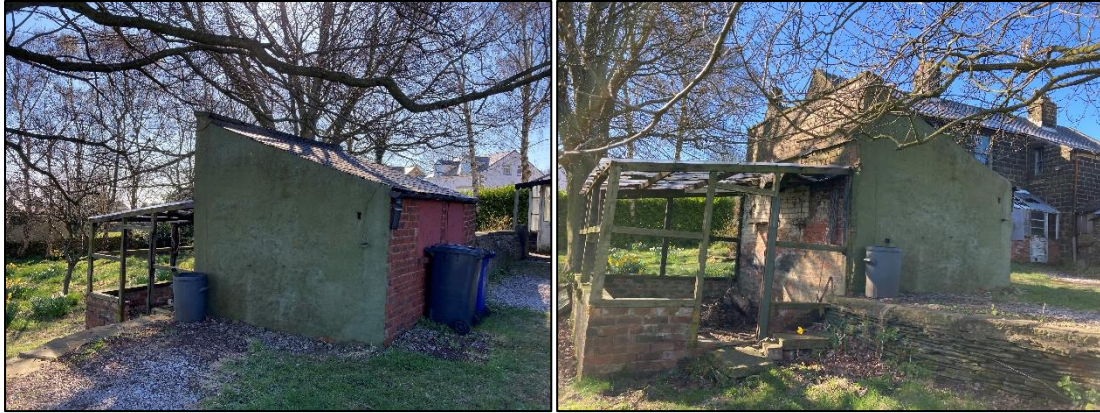
#### 3.4.4.2. Building 2.

3.4.4.2.1. This is a small outbuilding constructed with brick walls with the northern wall rendered. The building has a sloping slate roof with stone coping stones at the ridge. There is a window on the front, which was boarded up and a door on the front that was locked. There was no access inside this building. On the rear was what appeared to have been a lean to greenhouse with low brick walls, a wooded frame and a sloping clear plastic corrugated roof but there were no windows in this frame.

3.4.4.2.2. No bats or bat field signs were identified around the exterior of the building and the building is very well sealed. This building is assessed as having **negligible** potential for roosting bats.

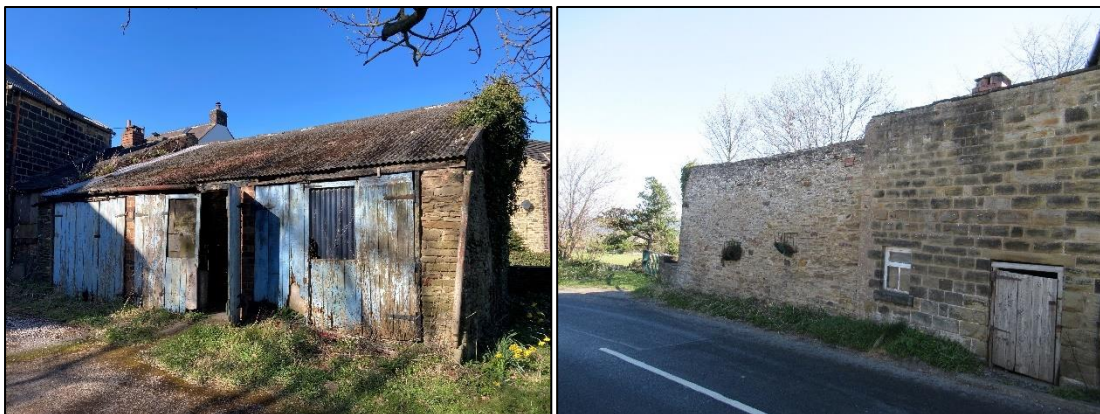
#### 3.4.4.3. Building 3.

3.4.4.3.1. This is a single storey garage building with three wooden double doors on the front. The building has stone walls with a sloping, corrugated cement sheet roof. Internally the building is one room with wooden roof beams and no lining below the corrugated sheets.

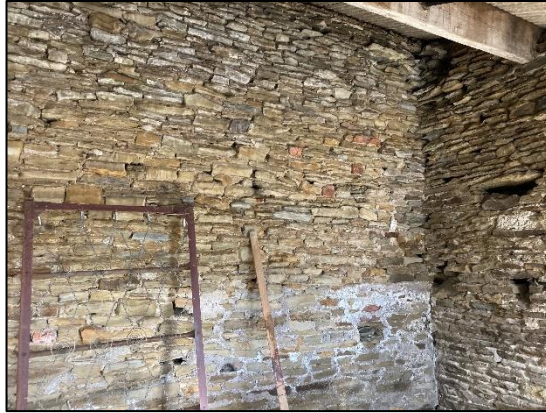
3.4.4.3.2. Internally there are numerous holes in the stone walls. Some had cobwebs present, some had old bird's nests or were blocked and some showed daylight. The gaps that could be accessed were inspected and no bats or bat field signs were found. However, some holes could not be thoroughly inspected and there were gaps around the garage doors to allow bats and birds access inside.

3.4.4.3.3. No bats or bat field signs were identified. However, due to the holes inside that could not be thoroughly inspected it is assessed that this building provides **low** potential for roosting bats.

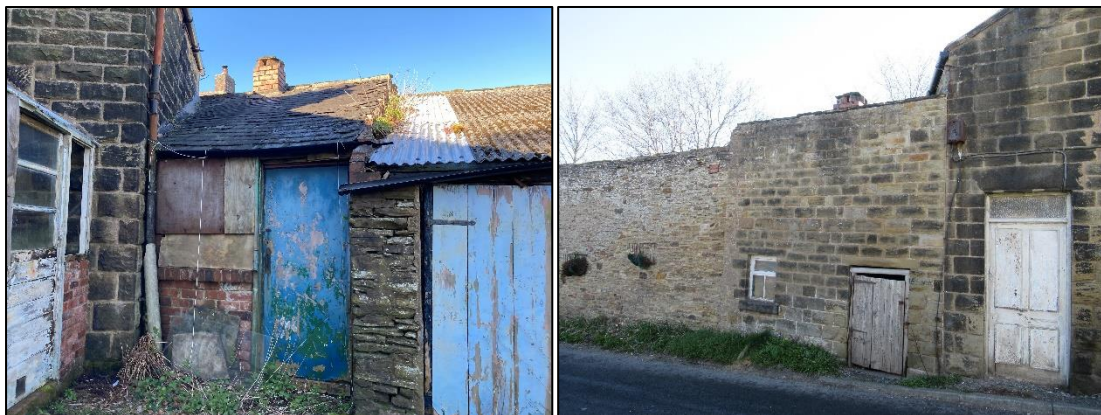
#### 3.4.4.4. Building 4.

3.4.4.4.1. This is a single storey building between Building 1 on the north and Building 3 on the south side. The building has a brick wall at the front and a stone wall at the rear with a sloping slate covered roof and a small brick chimney. The building has a boarded window at the front and the door is sealed. There was no access inside during this survey. At the rear is a small door leading to a small coal shed, separate from the rest of the building.

3.4.4.4.2. The building is generally well sealed, however, there is a gap in the northern gable end where there are some lifted slates and a small gap in the ridge. This building is assessed as having **low** potential for roosting bats.

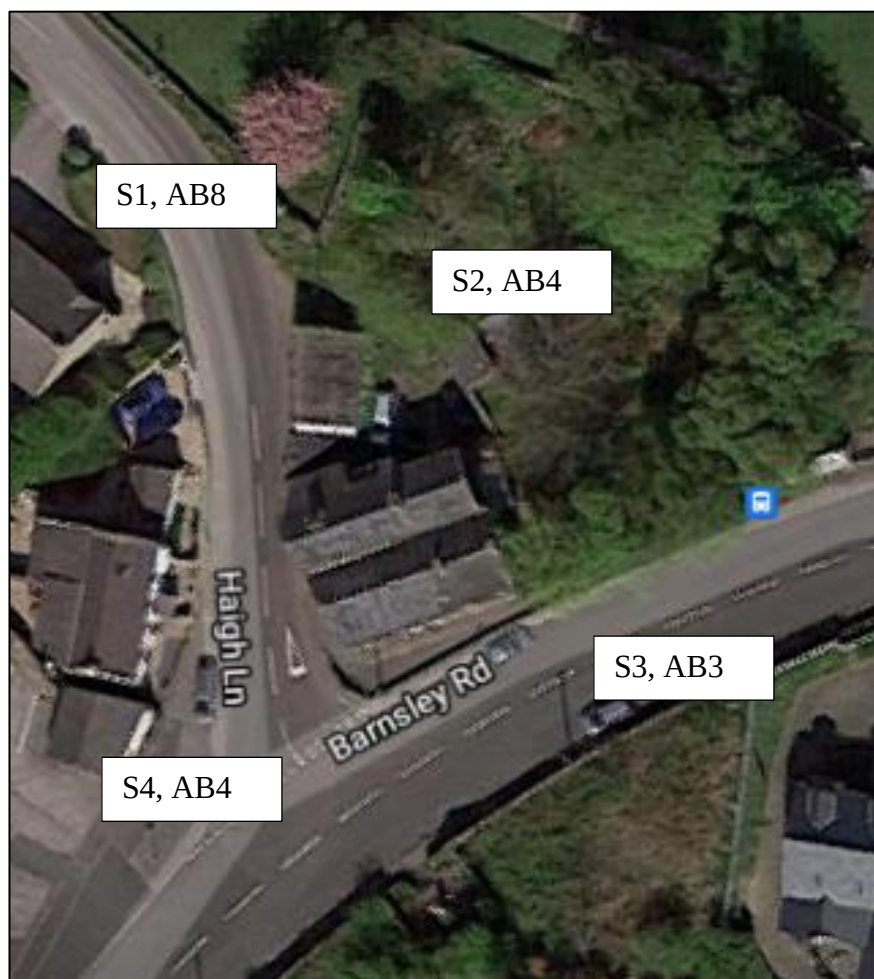
3.4.5.1.2. The four surveyors were positioned around the building in order to be able to view all aspects of the buildings simultaneously. Each surveyor was equipped with a Batbox Duet detector and a two-way radio for communications. In addition, two static Anabat recorders were deployed to record bat activity for subsequent computer analysis using Analook software. The positions of the surveyors (S) and the Anabat recorders (A) were as shown below.
