**Benwin, Darfield**  
**Bat and Bird Survey Report**  
**26<sup>th</sup> August 2021**

| Document ref: MBE/BAT/2021/23/02 | | | | |

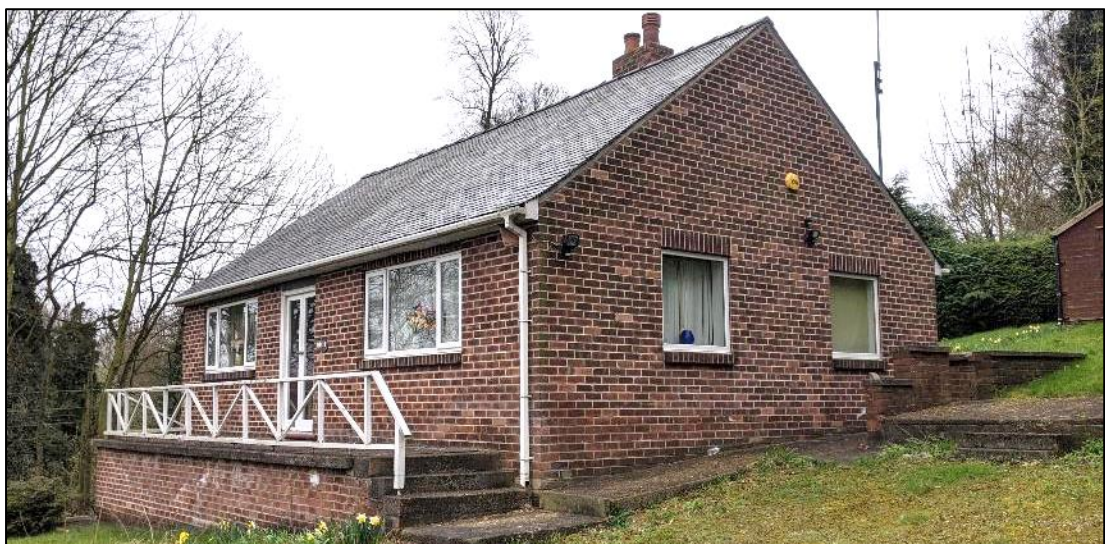
5.2.1 The dwelling comprises a brick-built 1960s bungalow with a pitched slate covered roof with clay ridge tiles and mortar-filled verges (Plates 1 & 2). A brick-built chimney extends through the roof. The dwelling has uPVC framed double-glazed windows, timber soffits and plastic guttering. A small low-height coal store with a flat concrete roof is built into the slope, immediately southwest of the dwelling.

**Plate 1. North corner of bungalow**

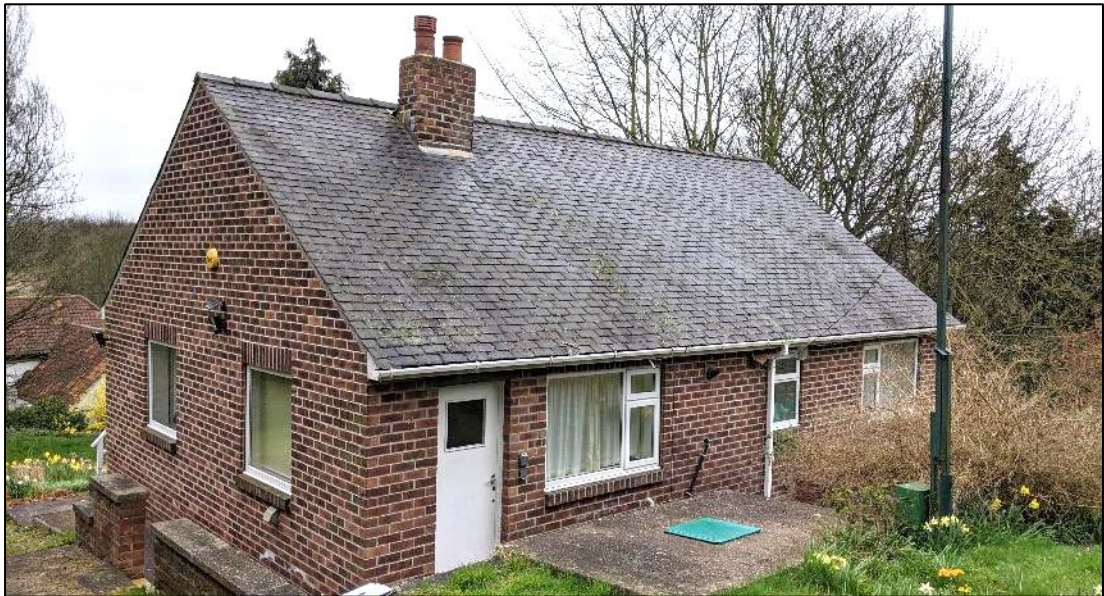
**Plate 2. West corner of bungalow**

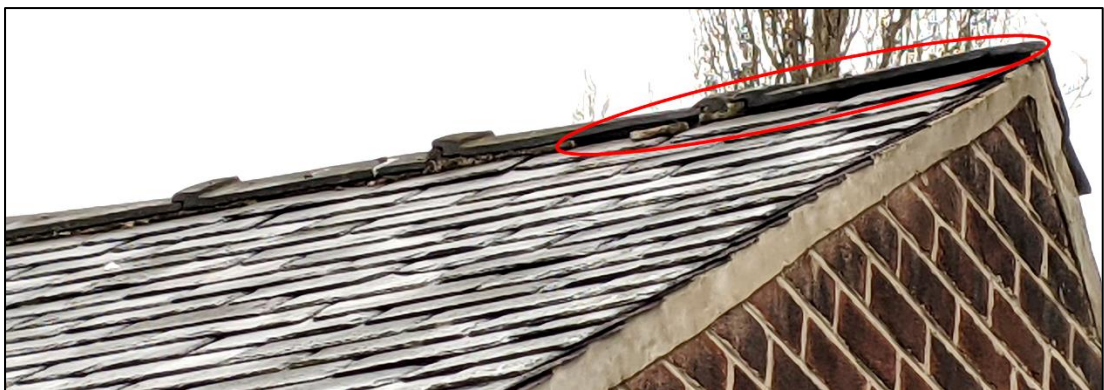
5.2.2 The exterior of the bungalow is in a fairly good state of repair with no missing mortar associated with gable verges and the soffits largely devoid of features. It was however noted that bedding mortar was missing from several locations beneath the ridge (Plate 3), presenting the opportunity of bats entering the ridge tunnel (area between ridge tiles and ridge beam) to roost. In addition to potential bat access points beneath ridge tiles, flashing at the base of the chimney is also lifted in places.

**Plate 3. Missing ridge mortar adjacent to southeast gable**

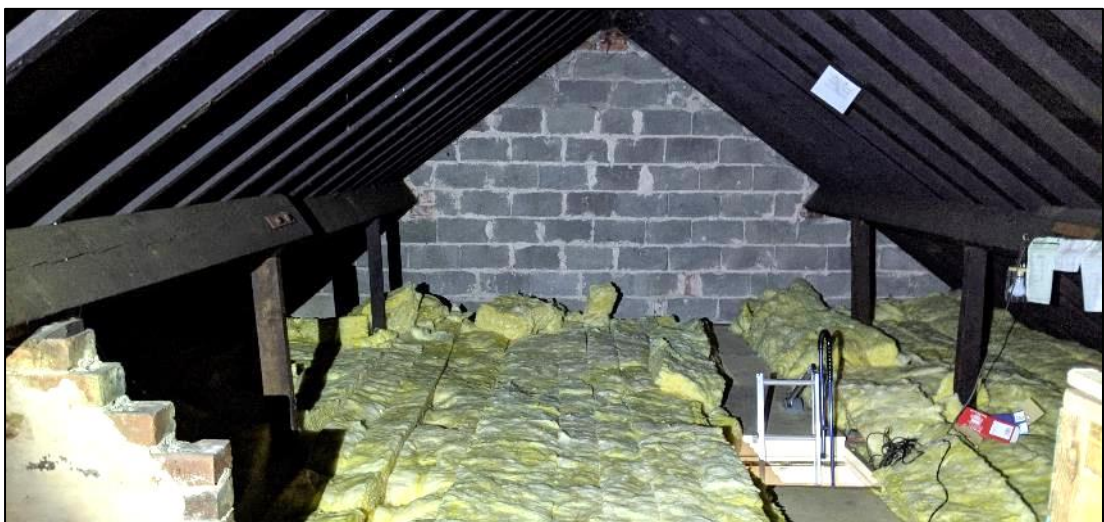
- 5.2.3 Internally the roof is lined with hessian backed Type 1F bituminous felt and suspended on purlins, rafters, a ridge beam and laths. The roof void is 2.5m high the ceiling is lined with 200mm of glass-fibre insulation (Plate 4). The brick chimney extends through the roof void. No signs of bat presence were noted from the roof void with this area generally quite clean and easily inspected with the exception of some light cobwebbing and several clusters of harlequin ladybirds *Harmonia axyridis*. The felt is in good condition and no light can be seen entering the void from outside.

**Plate 4. Roof void of bungalow**

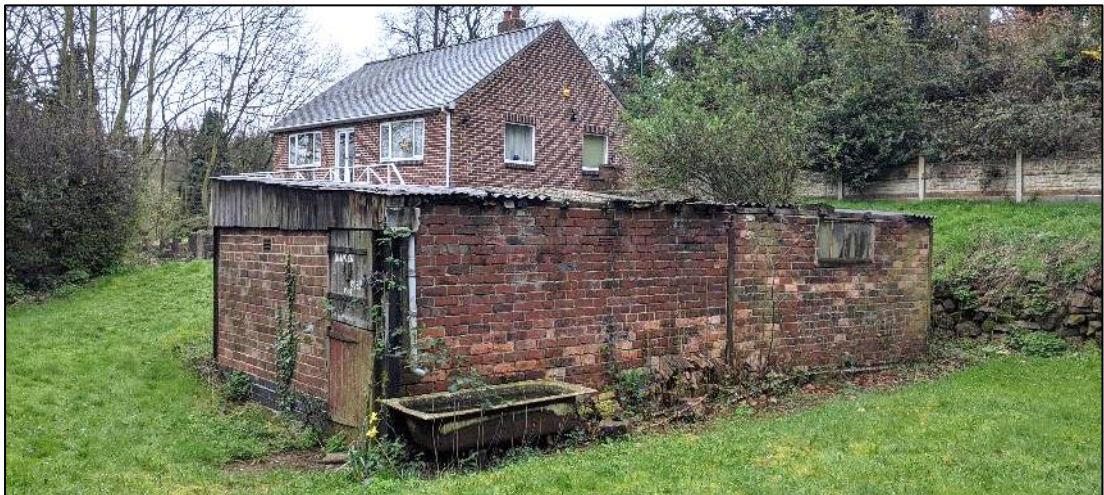
- 5.2.4 The outbuilding comprises a single-skin brick-built structure with a gently sloping (mono-pitched) corrugated metal-sheet covered roof which is partly collapsed. Timber cladding is present at the top of the side elevations, with a timber stable door also present. A single metal-framed single pane window is located in the northwest elevation (Plate 5).
- 5.2.5 No features offering more than negligible roost potential were recorded from the exterior of the outbuilding.
- 5.2.6 Internally the outbuilding roof is unlined and suspended on timber beams, though it is partly collapsed (Plate 6). No evidence of roosting bats or nesting birds was noted within the outbuilding and no potential roost features were noted.

**Plate 5. North corner of outbuilding**

- 6.3.3 Demolition of the outbuilding and any tree removal should either be undertaken outside the main bird nesting period (March-August), or preceded by a nesting bird check.

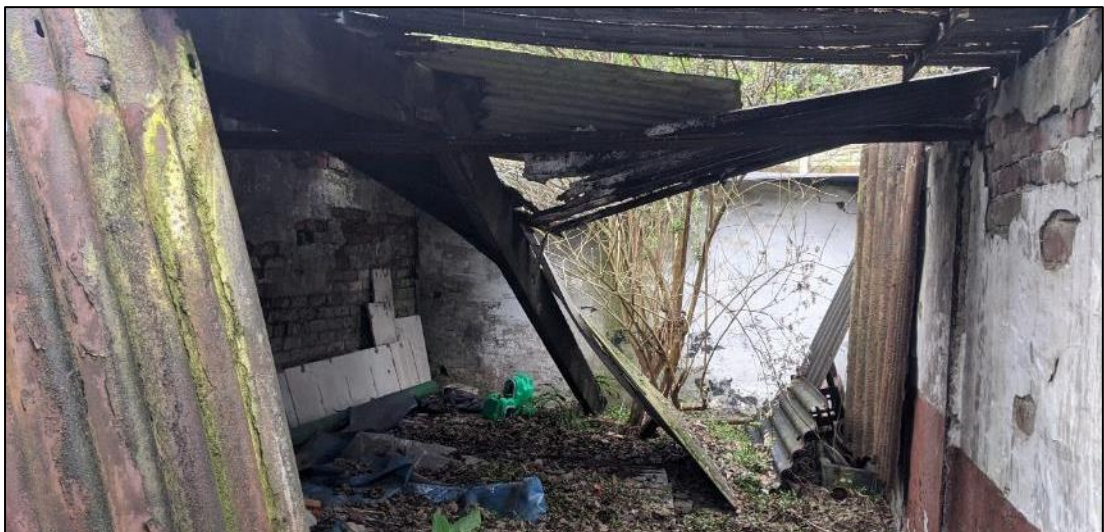
**Plate 6. Interior of outbuilding**

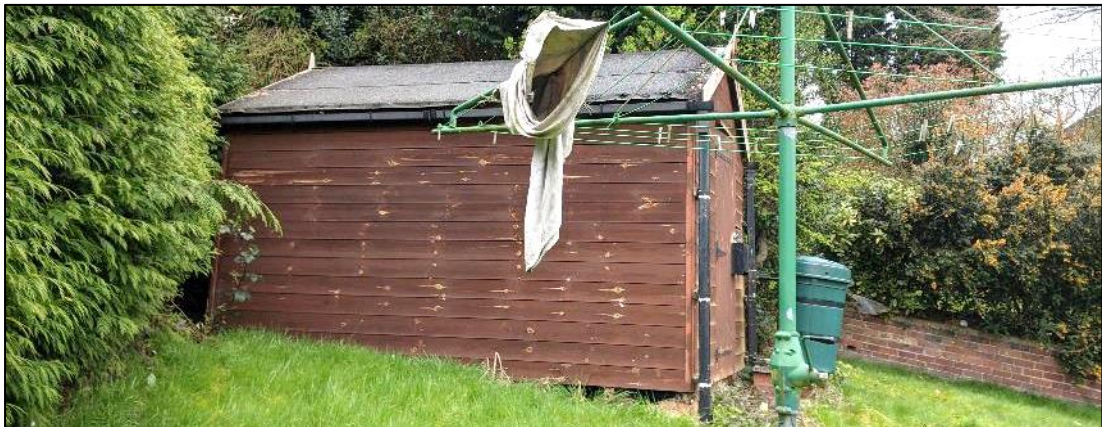
- 5.2.7 A simple timber shed with a pitched felt covered roof and timber barge boards is located at the western end of the site (Plate 7).
- 5.2.8 No building features offering more than negligible bat roost potential were recorded from either the exterior or interior of the shed with no evidence of bat roosting recorded from this building.

**Plate 7. Southeast elevation of shed**
