Barnsley West Link Road Highway Improvements

Road Safety Audit: Stage 1

Report Produced for:	Strata Sterling Barnsley West Ltd
Report Produced by:	Jonathan Birkett
Report Dated:	19 May 2021
Report Reference:	MAL/BWLRRSA1Rev0
Road Safety Audit Team Leader:	Jonathan Birkett

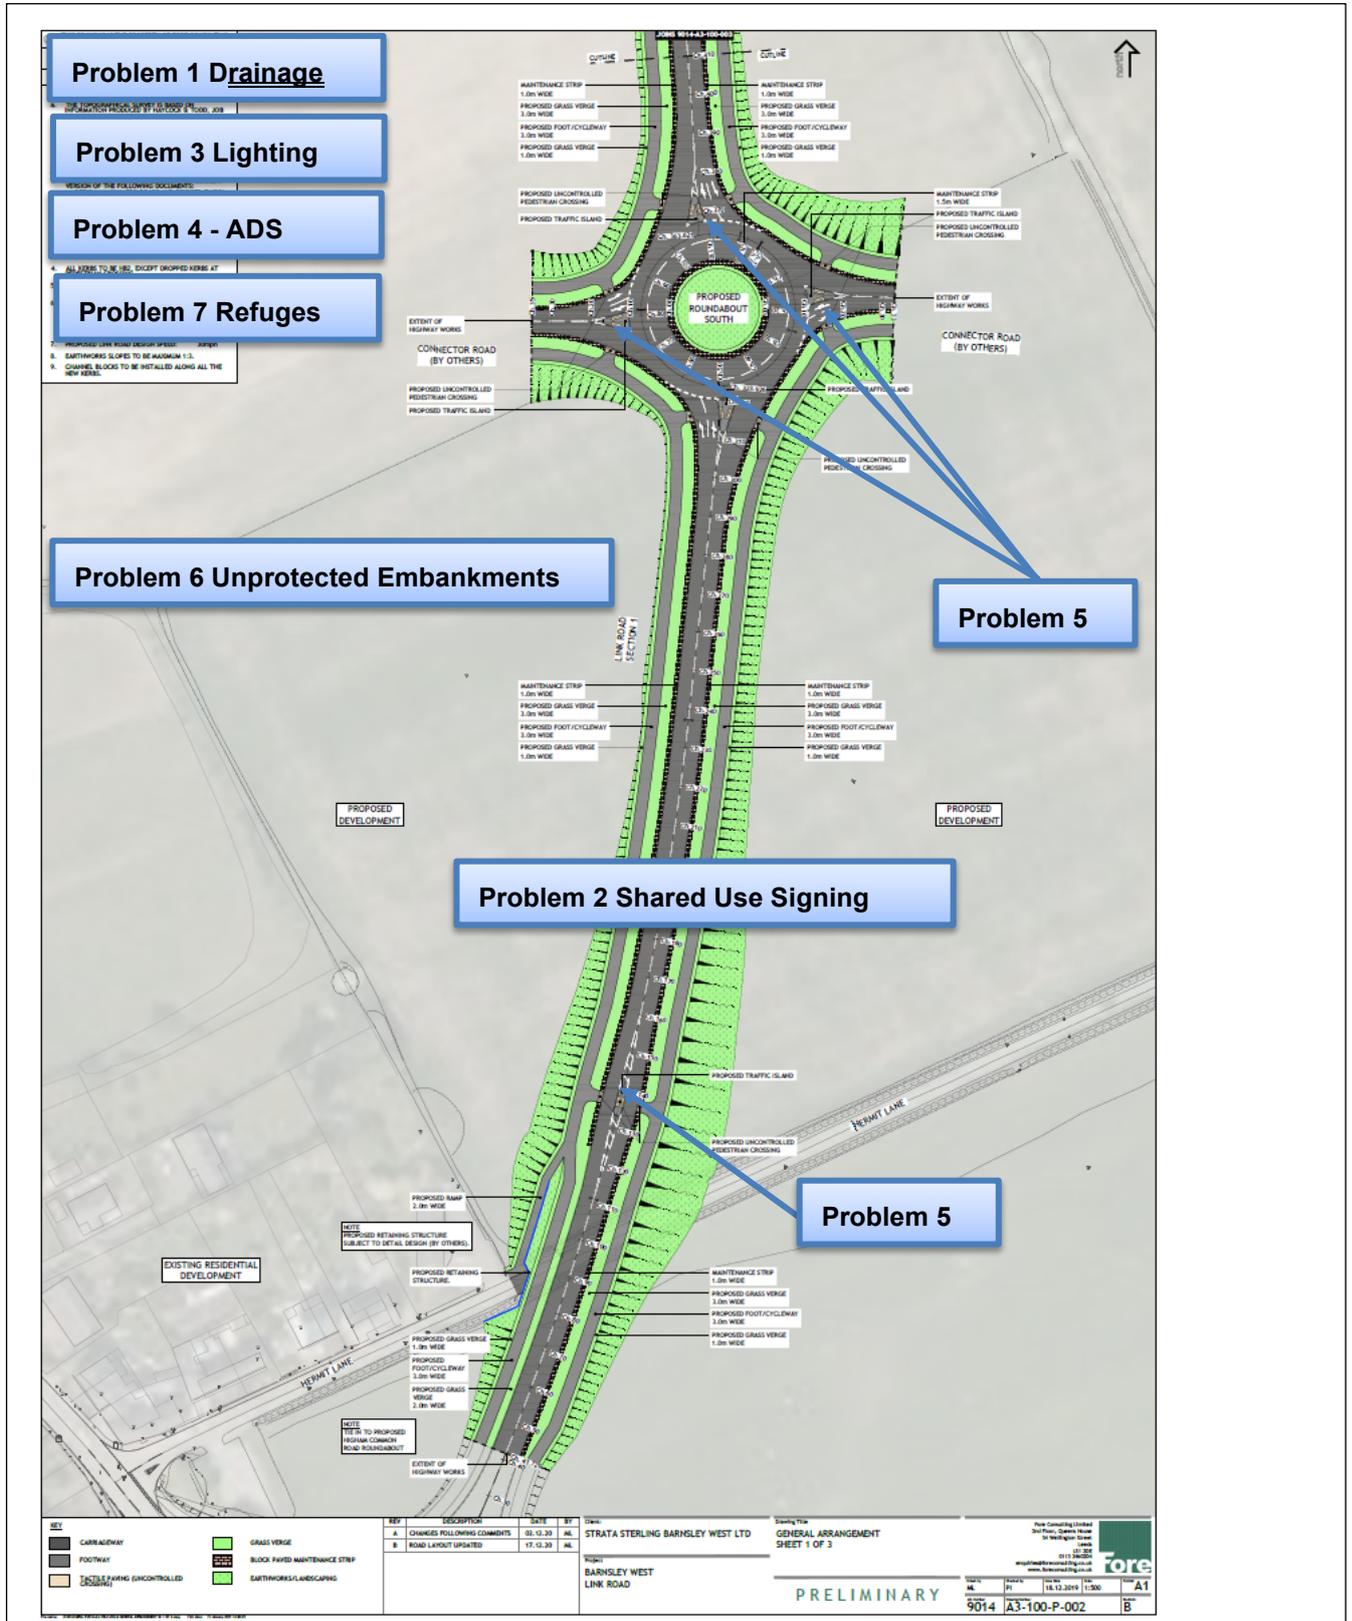
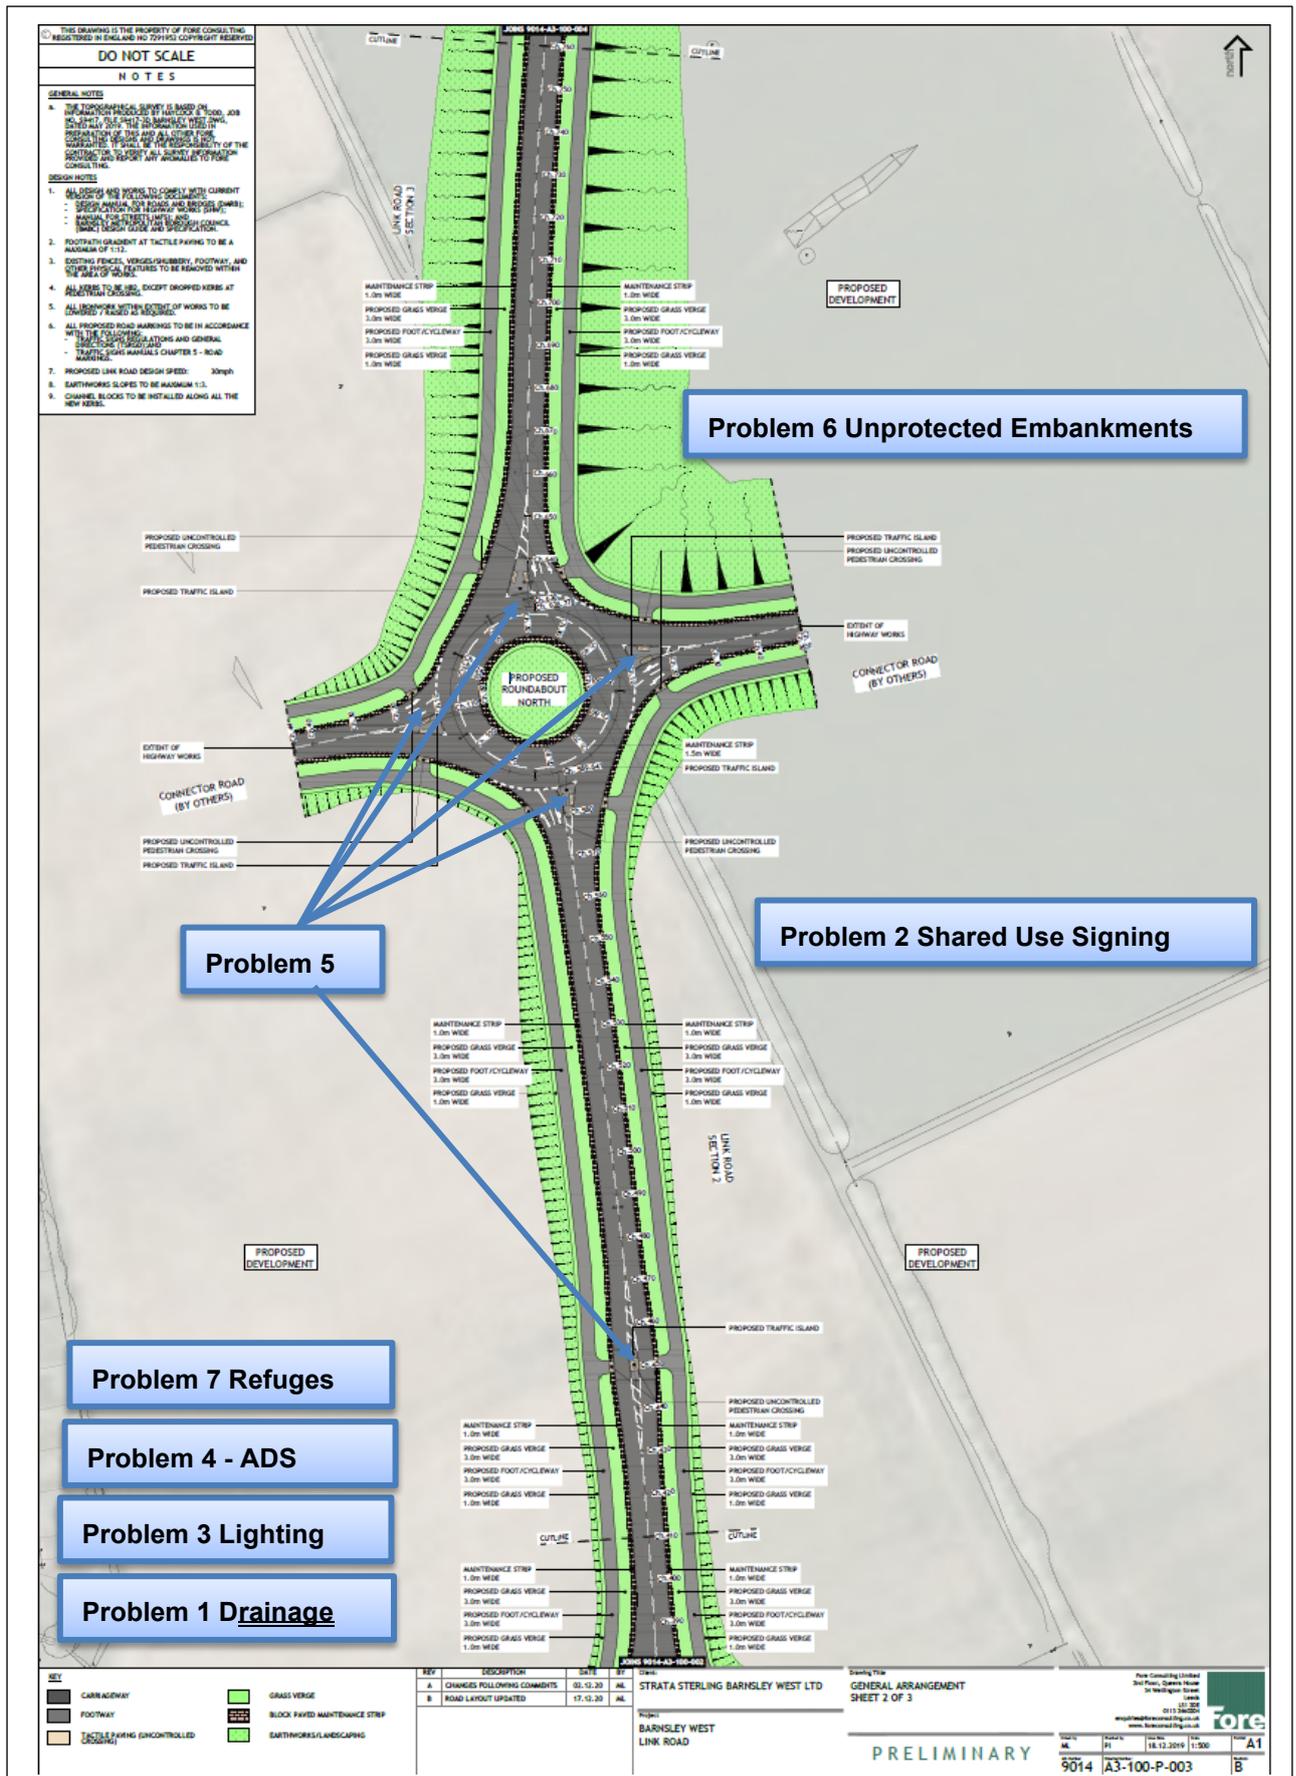
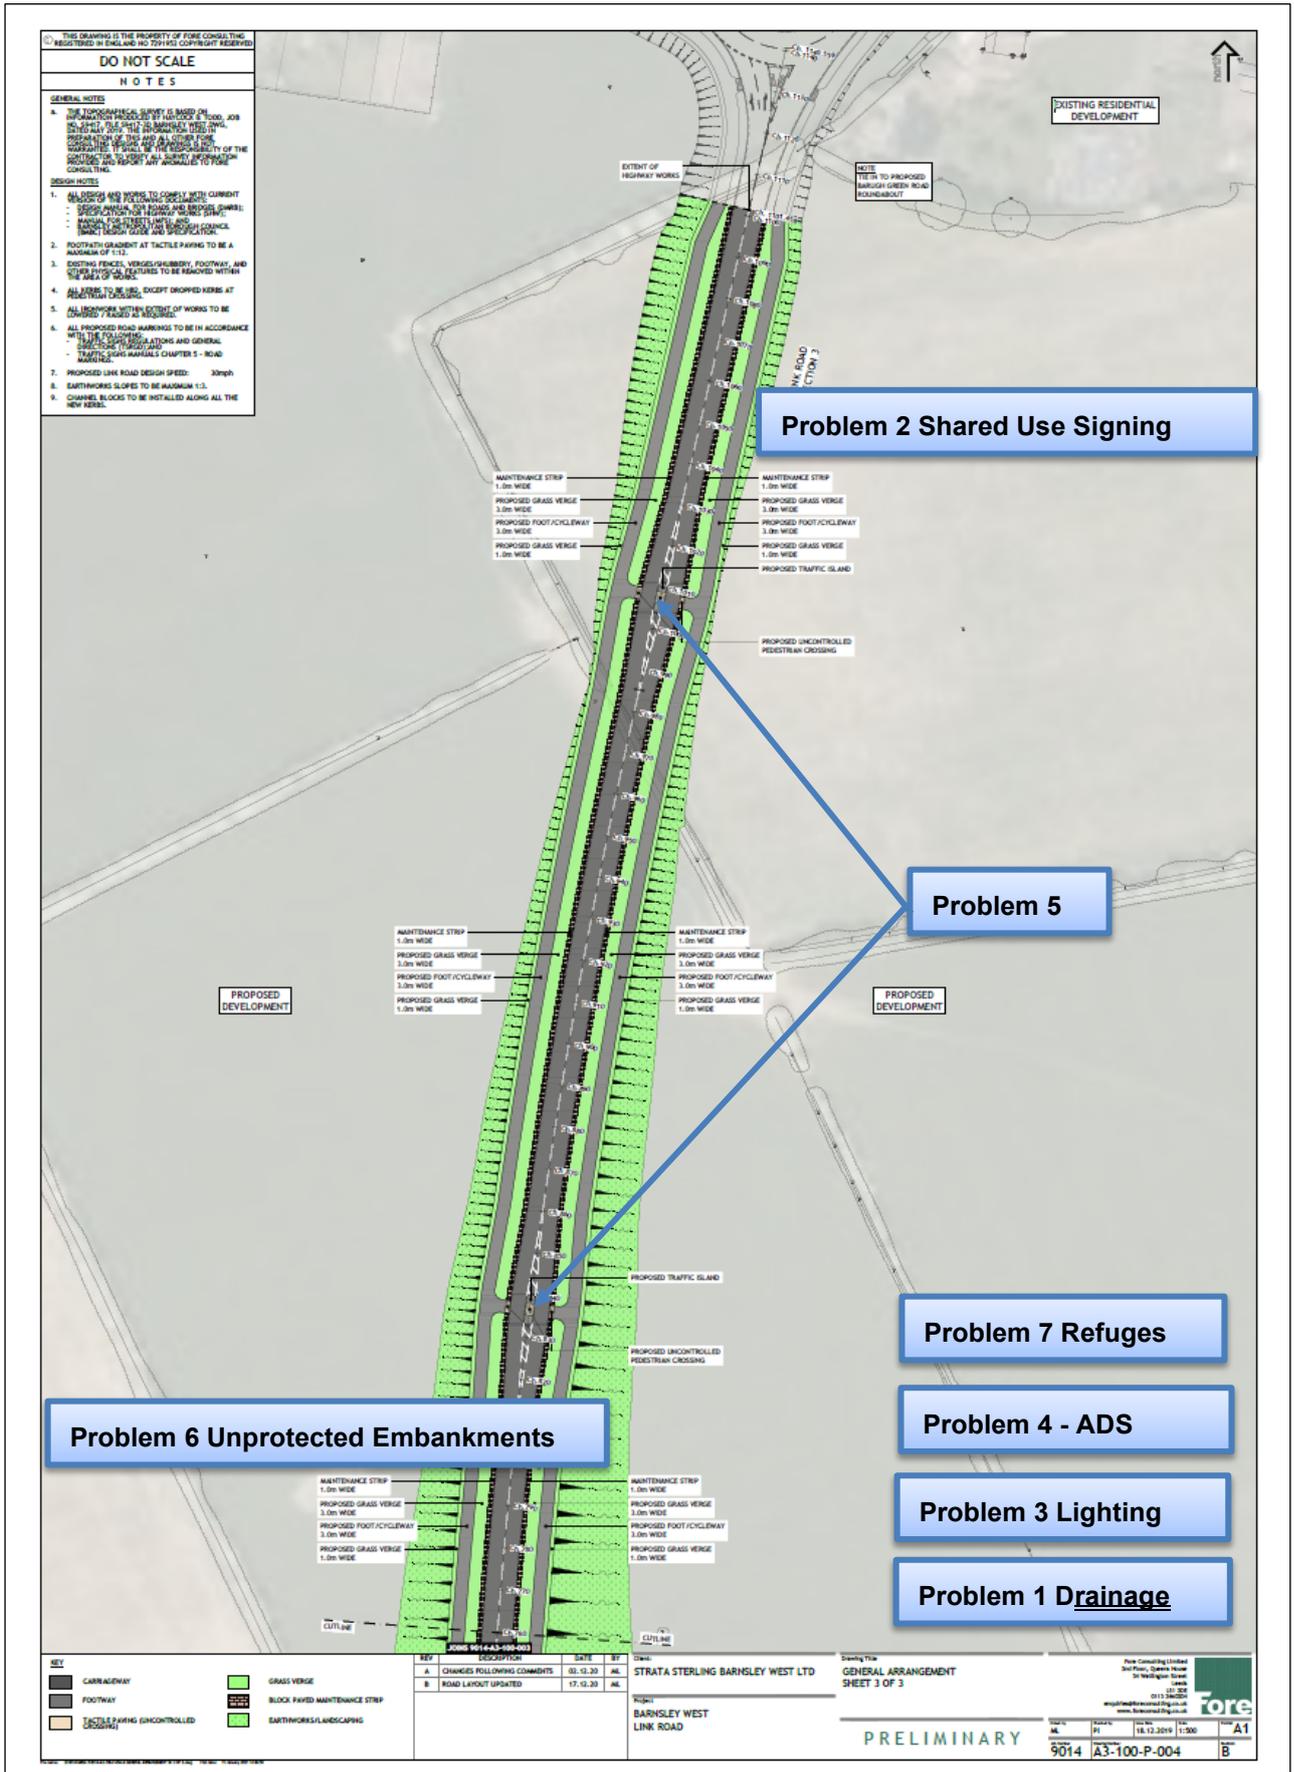
Appendix 2 – Problem Location Plans

PROBLEM		1
Location:	New link road.	
Summary:	Inappropriate drainage may lead to ponding water resulting in loss of control type collisions.	
<p>A new link road with two new roundabouts is proposed, as part of the works the link road will connect into two new roundabout, one at Higham Common Road to the west and Barugh Green Road to the east, thus changes to the exiting carriageway will be made and therefore drainage will need to be altered to reflect this.</p> <p>Ponding water can result in an increased risk of loss of control type collisions and at certain times of year and standing water will freeze resulting in sheets of ice. Vehicles manoeuvring in the turning could lose control resulting in an increased risk of collisions.</p>		
RECOMMENDATION		
Provide appropriate drainage at all locations where new carriageway are proposed.		
PROBLEM		2
Location:	Crossing points and shared routes.	
Summary:	A lack of signing could result in an increased risk of pedestrian/cycle collisions.

<p>Numerous uncontrolled crossing points and shared facilities are proposed along the link road and at the two roundabouts.</p> <p>Where pedestrians and cyclists are using shared and single use facilities, it is recommended that signing is provided to adequately inform pedestrians and cyclists of the status of the routes. Inadequate signing could lead to an increased risk of pedestrian/cycle collisions.</p>		
RECOMMENDATION

PROBLEM		3
Location:	Link road	
Summary:	Inappropriate levels of lighting can lead to an increased collision risk.	
<p>The drawings provided do not clearly show if any street lighting is proposed along the link road. The scheme will include significant changes with carriageway widening and new layouts. This may result in the carriageway and NMU crossing points being in shadow leading to possible conflicts during the hours of darkness.</p>		
RECOMMENDATION		
Ensure that suitable lighting provision is provided

PROBLEM		4
Location:	Link road	
Summary:	Lack of advanced signing on the link road can cause drivers to become confused resulting in an increased risk of lane change and shunt type collisions.	
<p>No advanced signing has been shown on the drawings. Without suitable signing drivers will become confused resulting in an increased risk of sudden lane changes and shunt type collisions.</p>		
RECOMMENDATION		
Provide advanced directional signing on all approaches to the roundabout.

PROBLEM		5
Location:	All splitter islands	
Summary:	Lack of suitable signing on the splitter islands can increase the risk of vehicle loss of control as well as NMU/vehicle collisions.

<p>Pedestrian splitter islands are proposed at the two new link road roundabouts and at four locations along the link road. The drawings do not show any “Keep Left” bollards which should be located on the islands. A lack of suitable signing on the islands could lead to vehicle loss of control and NMU/vehicle collisions.</p>
<p>RECOMMENDATION</p>
<p>Provide suitable signing on all the pedestrian splitter islands.</p>

PROBLEM		6
Location:	Link Road.	
Summary:	Unprotected embankments will increase the risk of NMU injuries.	
<p>The drawing provided shows that in a number of locations embankments are proposed at the rear of the new shared facilities running along the Link Road. Unprotected embankments will increase the risk of NMUs falling down the embankments increasing the risk of injury.</p>		
RECOMMENDATION		
Provide appropriate fencing between the shared facilities and embankments.

PROBLEM		7
Location:	Link Road.	
Summary:	A lack of suitable cycle crossing facilities could increase the risk of cycle/vehicle collisions.	
<p>The drawings of the link road and associated roundabouts show a significant number of uncontrolled crossing. All these crossings are shown as pedestrian crossings. It is likely that these will be used by cyclists as well. The Audit Team were concerned that from the drawings provided the pedestrian refuge islands do not look wide enough to accommodate a cyclist safely.</p> <p>CD195 Paragraph E/4.5 and E/4.6 indicate that the crossing width/refuge width should be the same width as the shared facility which is 3m. In addition, the total depth of the refuge must also be of sufficient depth to accommodate a cyclist safely and is set at 3m.</p> <p>A lack of suitable cycle crossing facilities could increase the risk of cycle/vehicle collisions</p>

Provide suitable signing informing pedestrians that they are entering the shared cycle/footway facility.

RECOMMENDATION
Provide refuge islands that can safely accommodate all pedestrian and cycle users.
