# Desk study & mining risk assessment

## Land at Lidgett Lane & New Road, Pilley For Redrow Homes Ltd

Report no: 2222/1

Date: October 2015

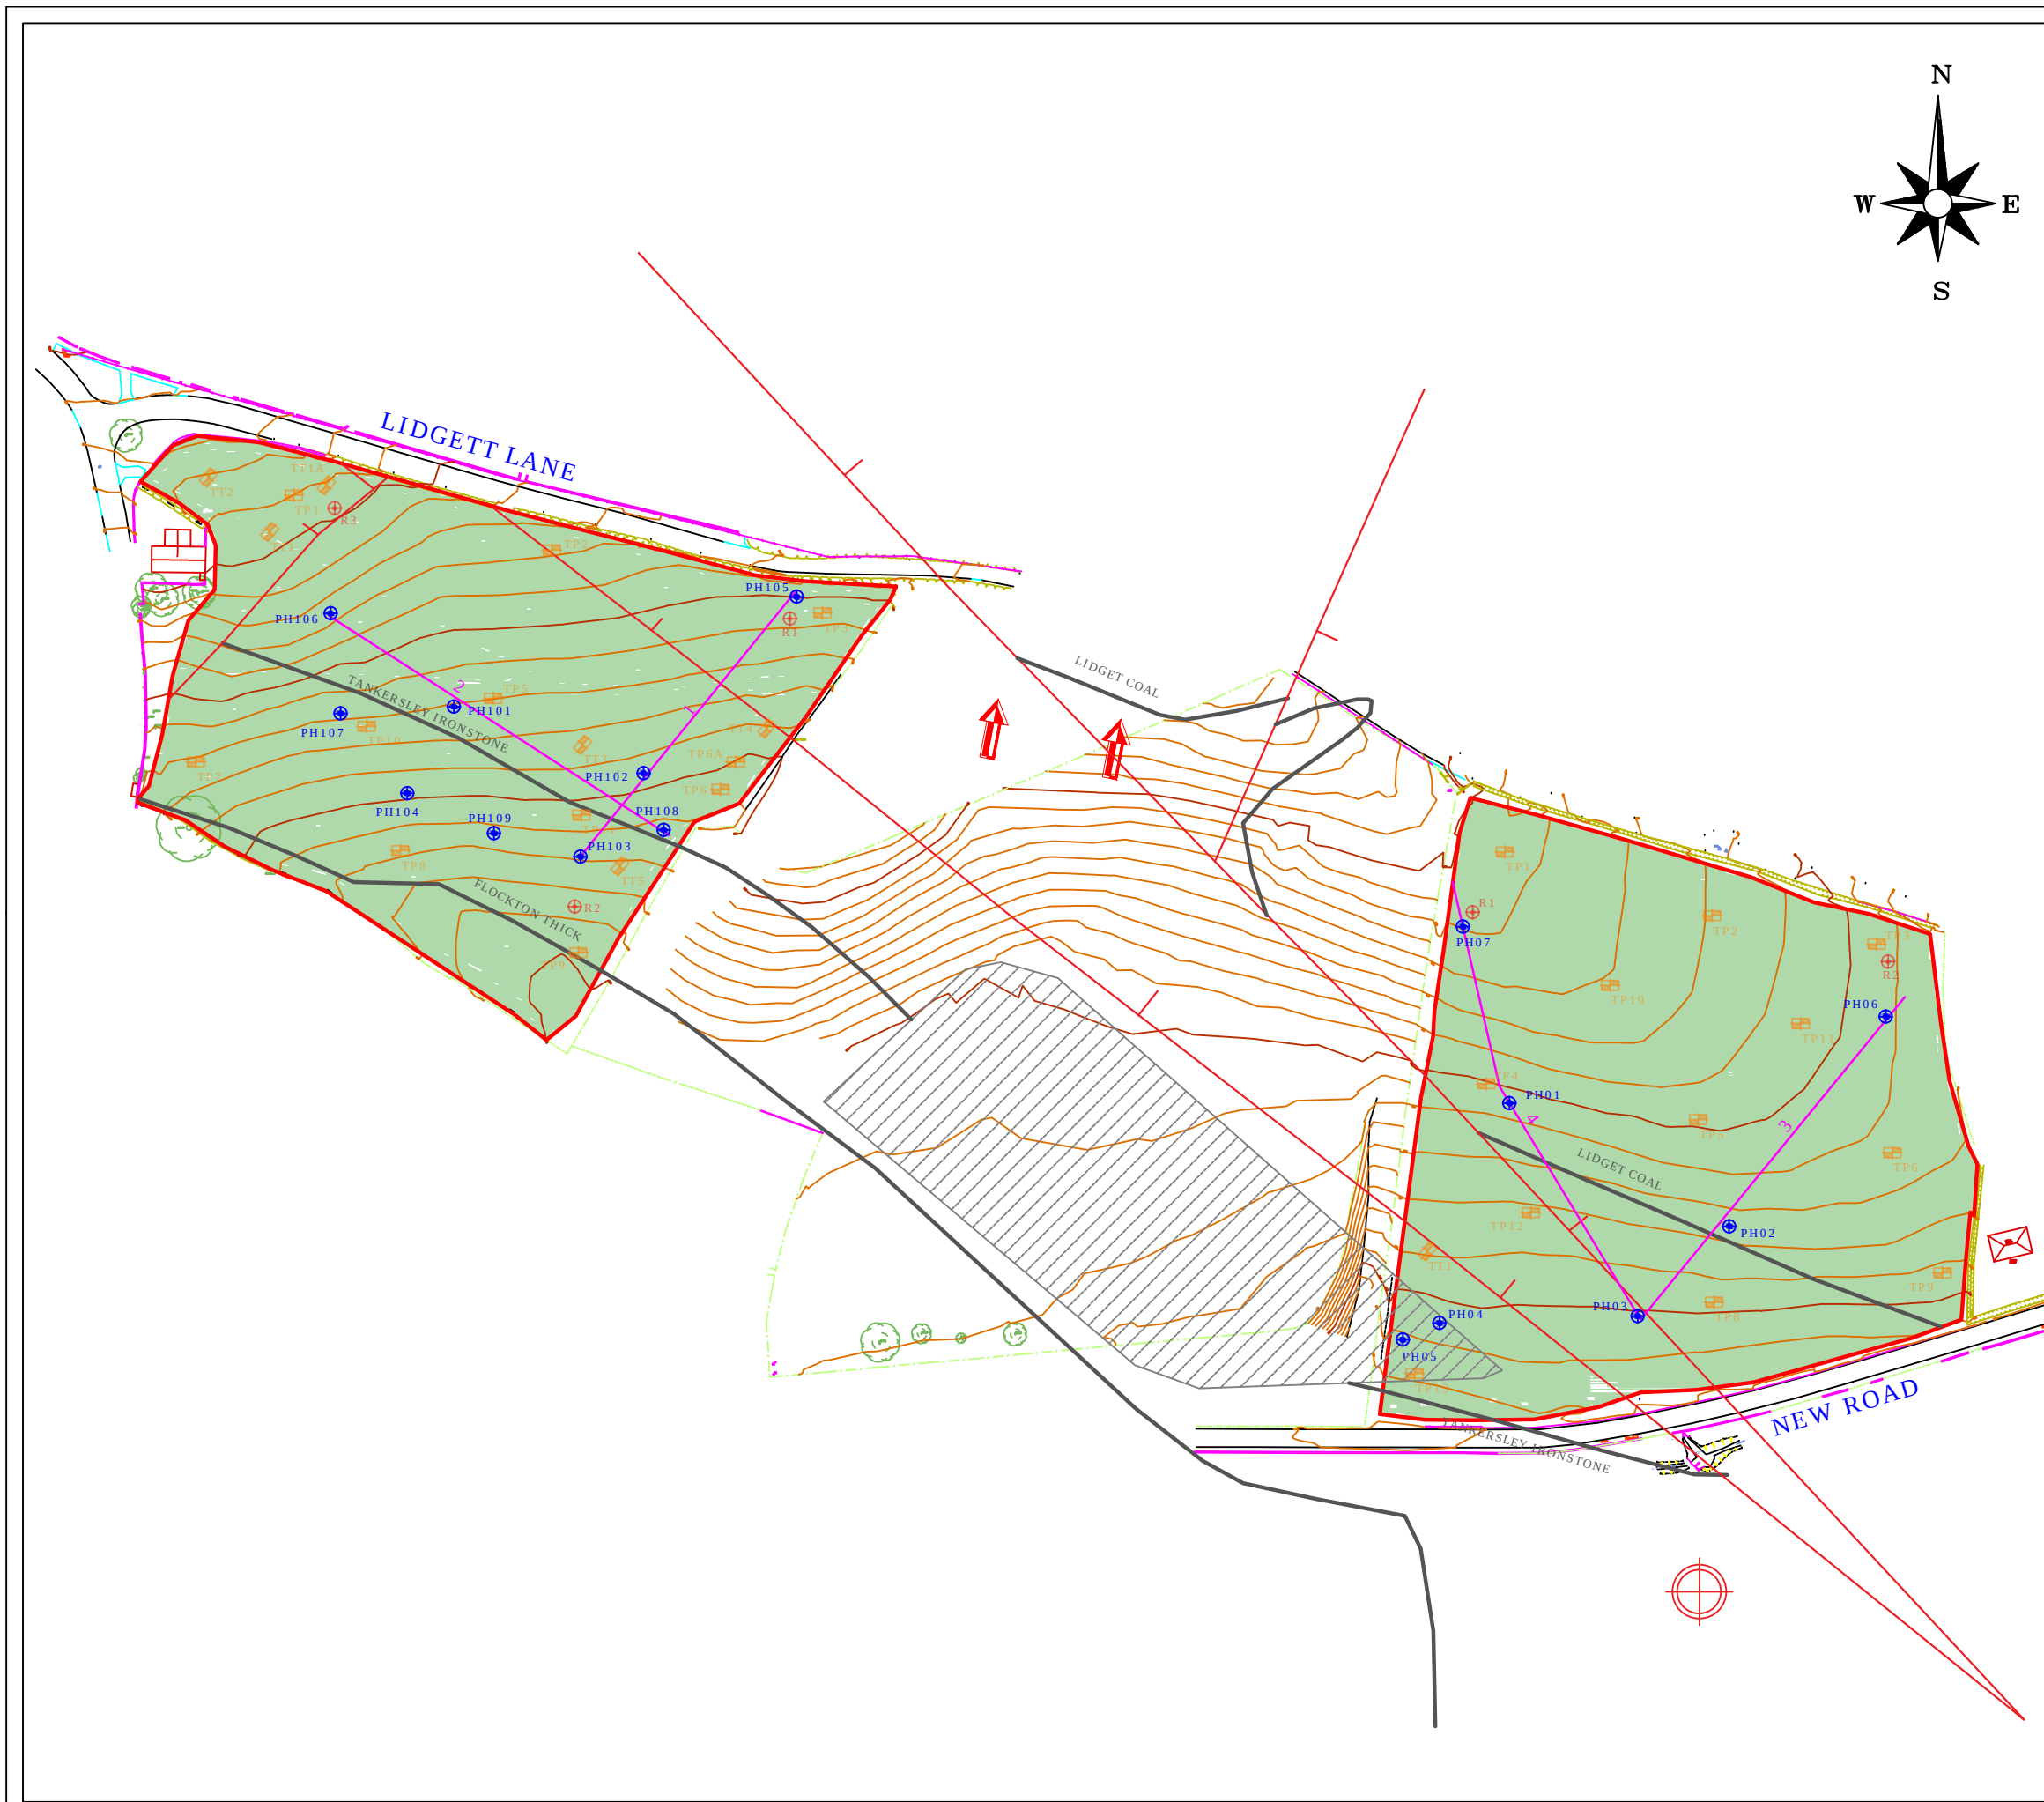
| 1:2,000 | A3 | 2222/6 | |

- APPROXIMATE SITE BOUNDARY
- COAL OUTCROP
- FAULT
- FORMER OPENCAST
- ADIT
- SHAFT
- CODA PROBEHOLE
- CODA TRIAL PIT LOCATION
- LITHOS PROBEHOLE
- X-SECTION LINE

- 6.1.2 CoDa's exploratory hole records are present in Appendices F to I, and ground conditions are summarised in the table on pages 12 & 13.
- 6.1.3 Exploratory hole locations are shown on Drawing 2222/6 presented in Appendix B. It should be noted that the locations of TP6A and TT1A in the western parcel are unknown and are therefore not shown on Drawing 222/6.

- 8.3.2 The locations of the exploratory holes, along with those advanced by CoDa, are shown on Drawing 2222/6 in Annex A. Cross sections, based on Lithos' probeholes are present in Annex B, the corresponding cross section lines are shown on Drawing 2222/6.
- 8.3.3 Ground conditions encountered in the probeholes are summarised in the table below, which also includes the findings of CoDa's investigation:

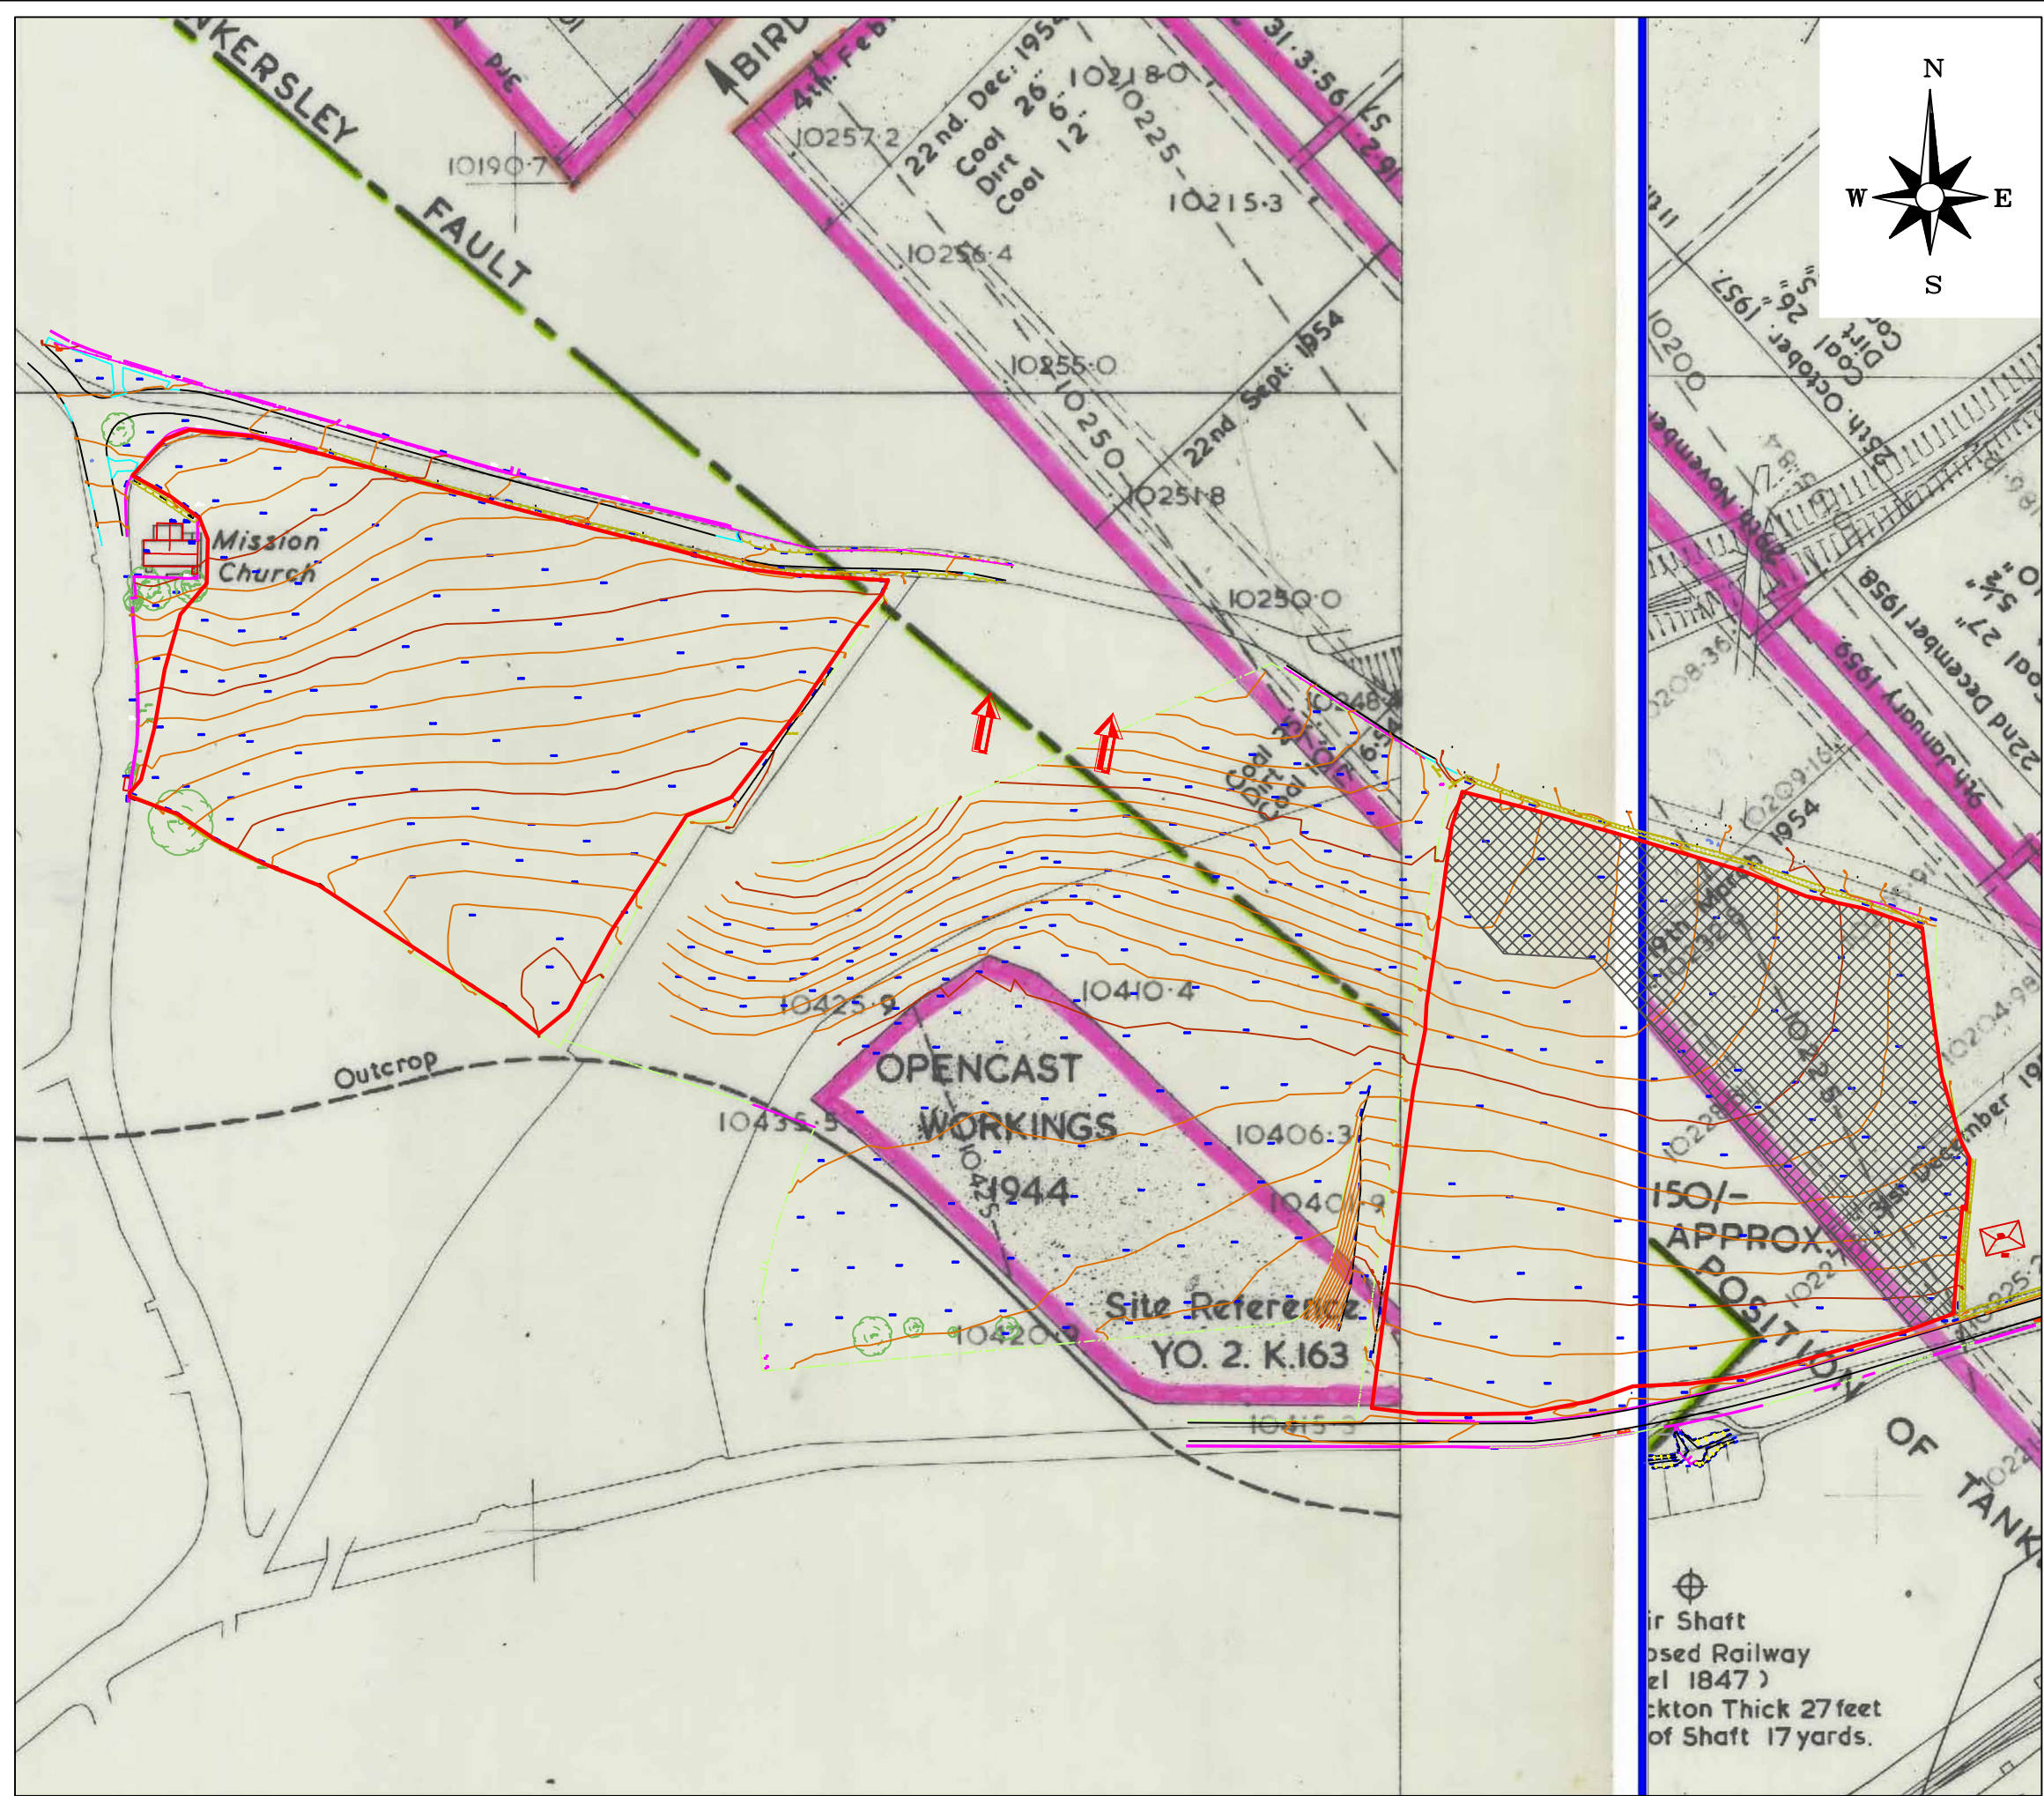
| SCALE | SHEET | DRAWING NO. | REVISION |
|---|---|---|---|
| 1:2,000 | A3 | 2222/9 | |

- APPROXIMATE SITE BOUNDARY
- ▨ EXTENT OF WORKINGS

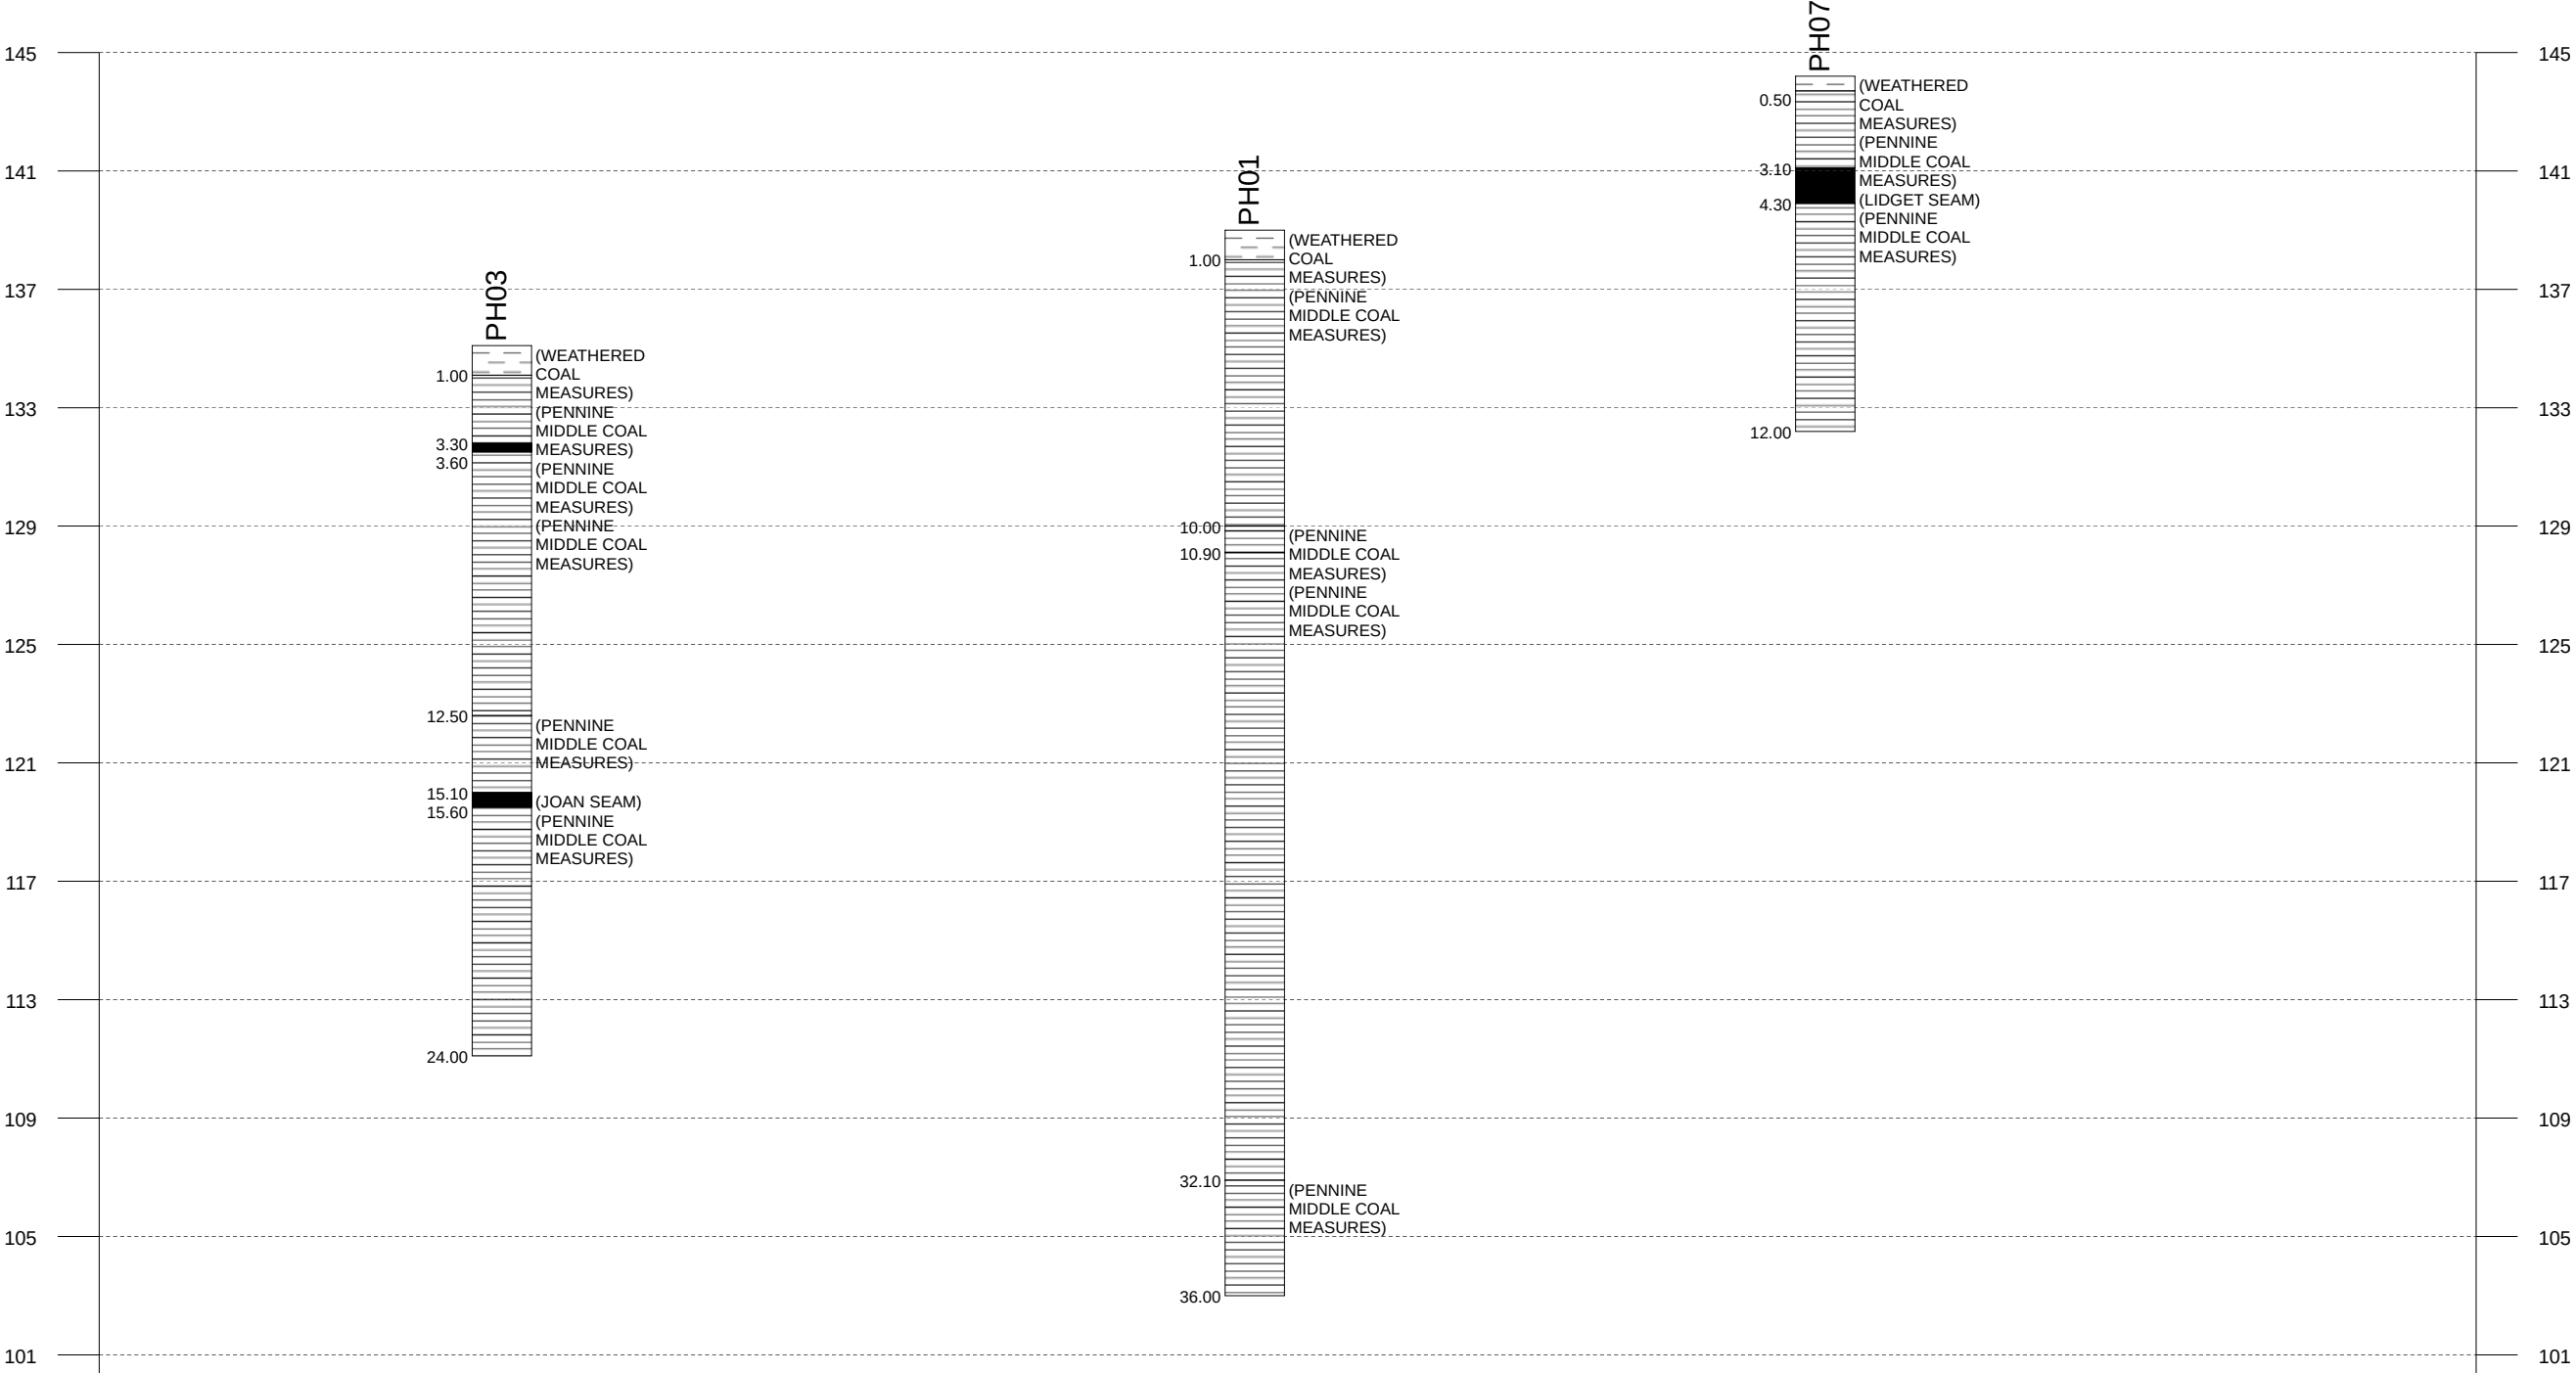
**Appendix L**  
**Lithos Cross Sections**

- CLAY
- MUDSTONE
- COAL
