# **Phase 2 Site Investigation Report**

## **Land off Edmunds Road, Worsbrough, Barnsley**

### **Hadfield Developments**

Report Title: **Phase 2 Site Investigation Report  
Land off Edmunds Road, Worsbrough, Barnsley**

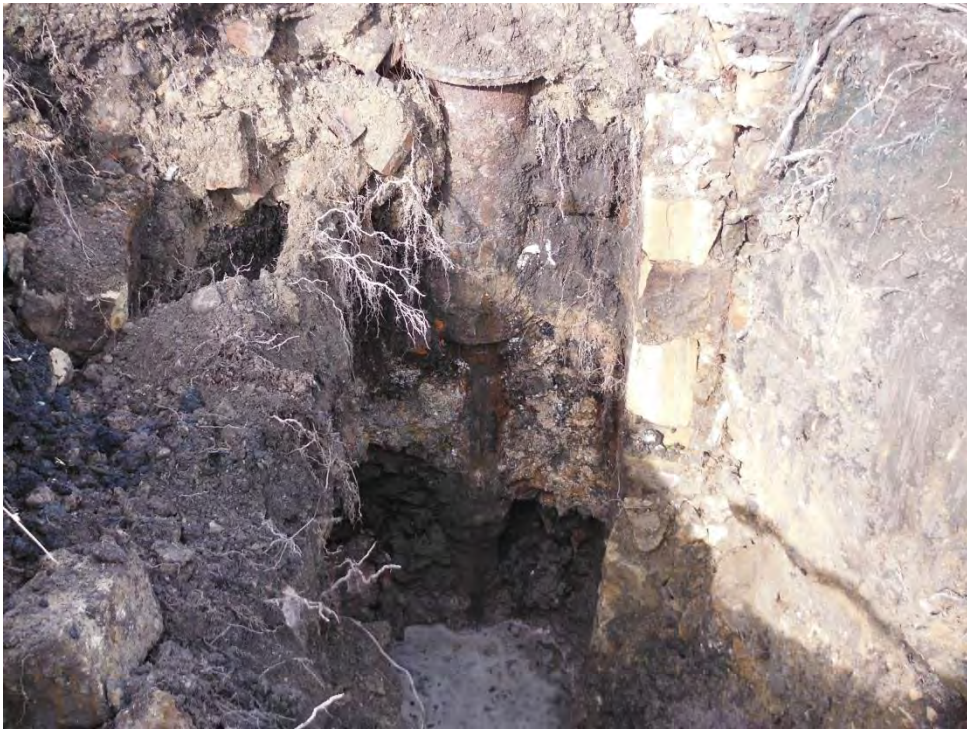
Trial pit TP02, facing west. Intact wall to former 'well' visible to right, with intact vertical iron pipe in centre of photograph.

- 4.3.5 Coal tar contamination was noted within the made ground in trial pit TP03A.
- 4.3.6 A lead pipe was encountered within trial pit TP02 (0.7m), which appeared to contain traces of tar and / or hydrocarbons.

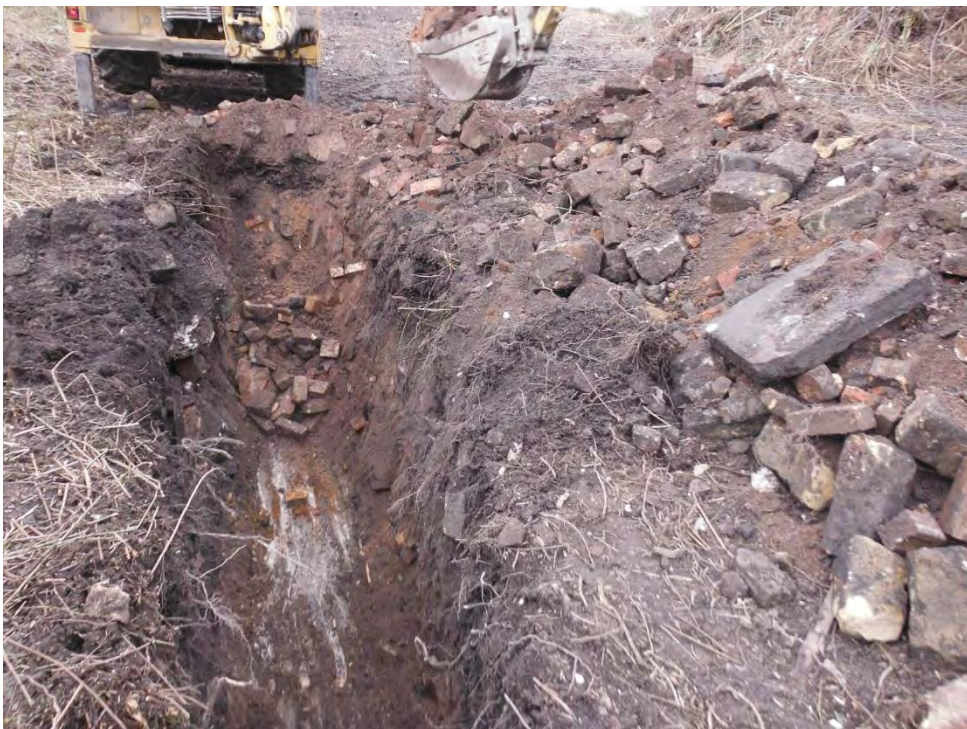
Trial pit TP03, facing east. Intact concrete slab visible at base of trial pit.

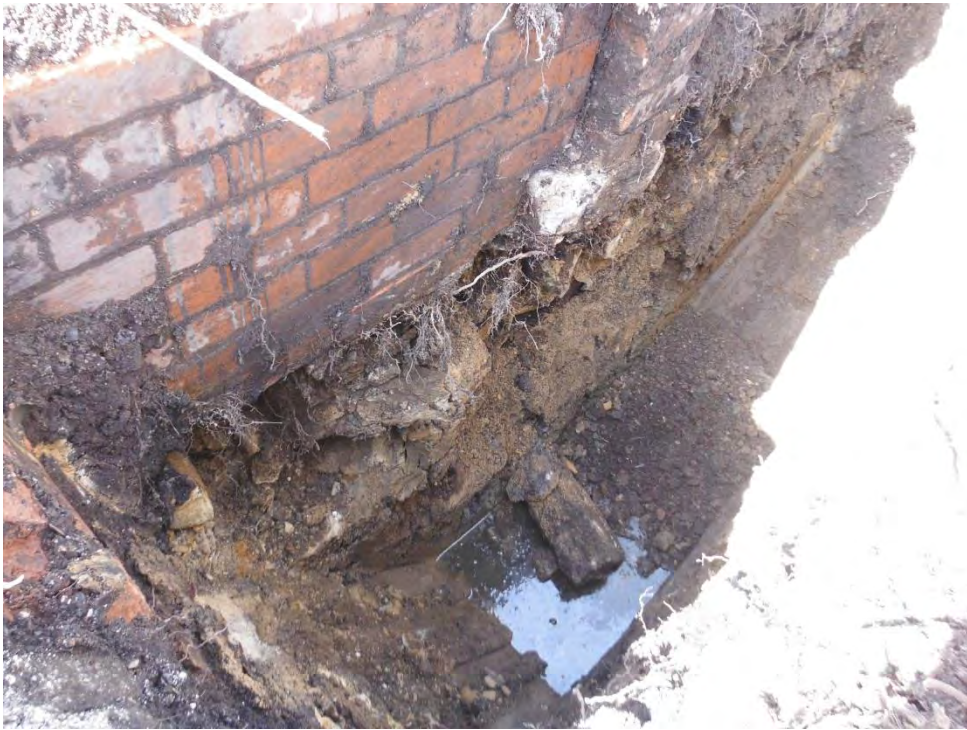
Trial pit TP04, facing south-west. Intact brick wall in area of former purifier house.

- 4.3.7 Perched groundwater within the made ground identified within trial pit TP04 was noted to be oily.

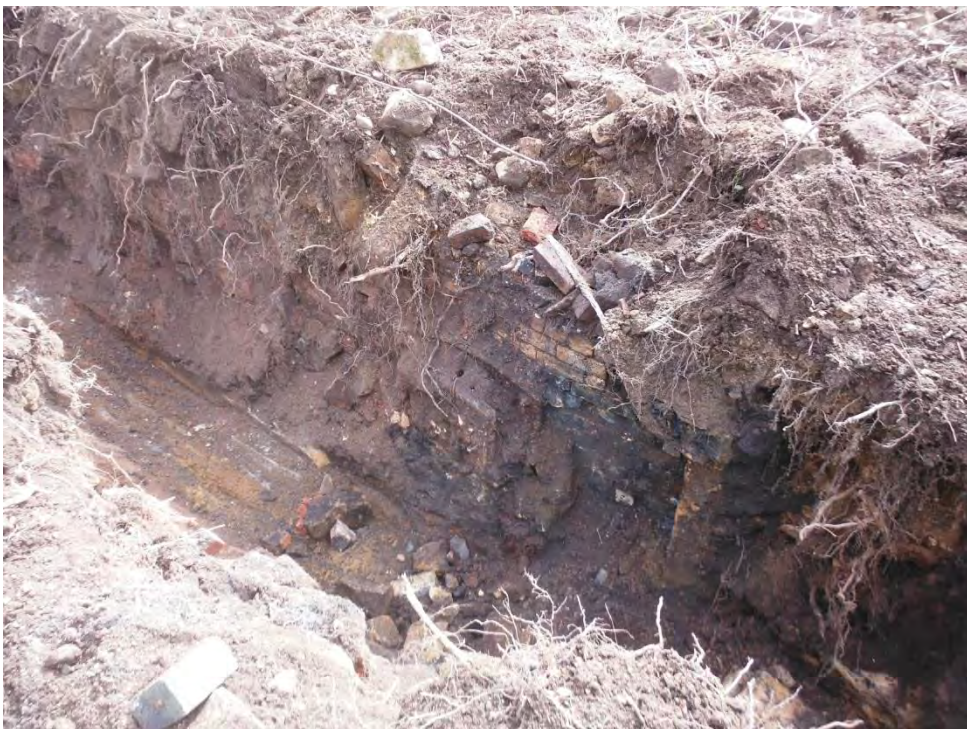
Trial pit TP03, facing south-west. Intact brick furnace / retort wall and iron door in centre of photograph.

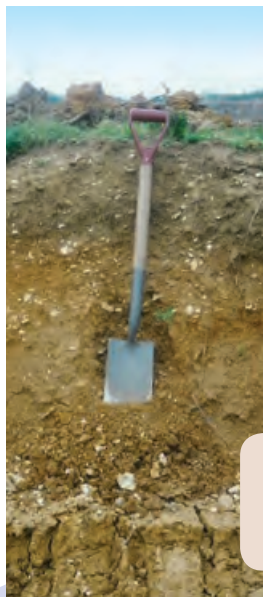
*Typical soil profile*

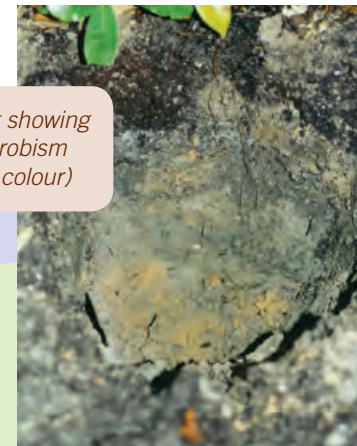
*Trial pit showing anaerobism (grey colour)*

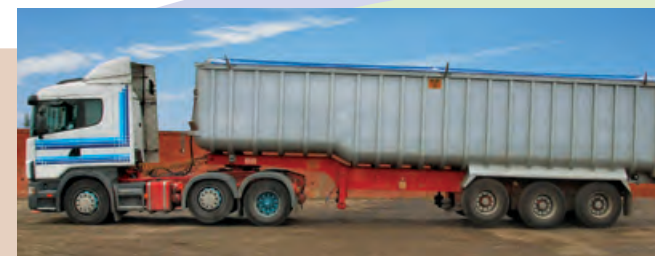
**Gross weight:** 44 tonne  
**Net weight:** 29 tonne  
**Width:** 3.2 metres  
**Length:** 12.8 metres  
**Height:** 4 metres

*Deliveries tend to be made by 29 tonne articulated, or 20 tonne rigid trucks*
