# **PHASE 1 CONTAMINATED LAND RISK ASSESSMENT - EXISTING BARN (BUILDING 1) RESIDENTIAL CONVERSION**

Hill End Farm, Hill End Road, Mapplewell, Barnsley, S75 6DU

**Report Ref:** TH/Hill End/Bldng1/ClassQ/PHASE1/03/June2022/v01

**20<sup>th</sup> June 2022**

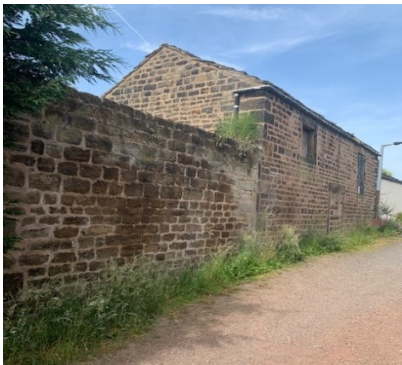
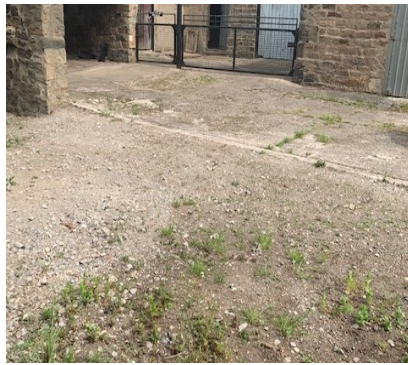
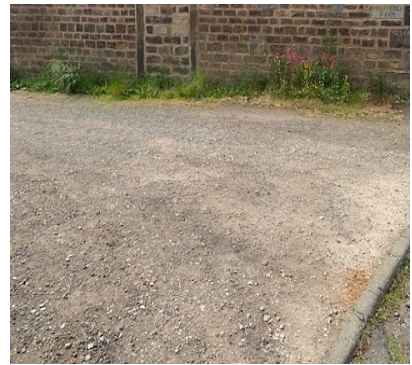
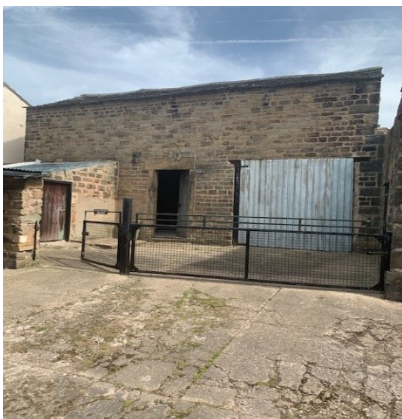
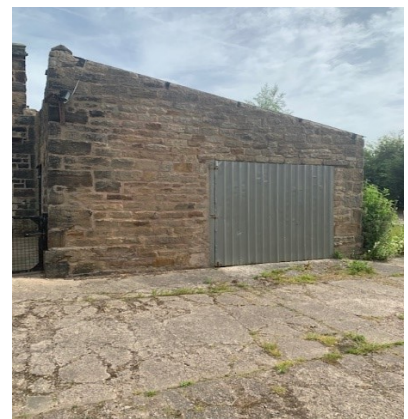
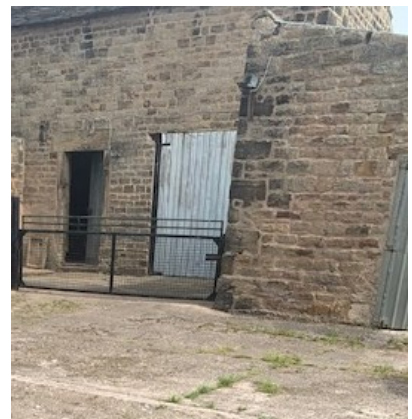
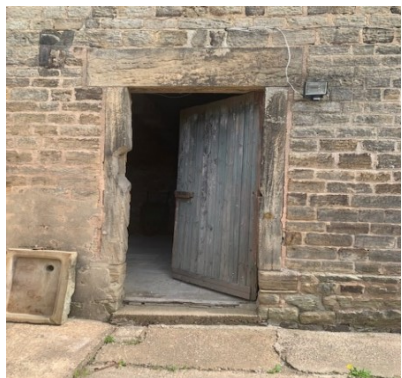
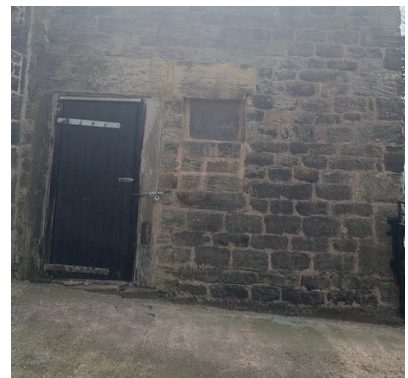
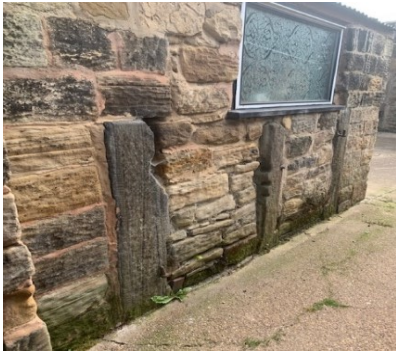
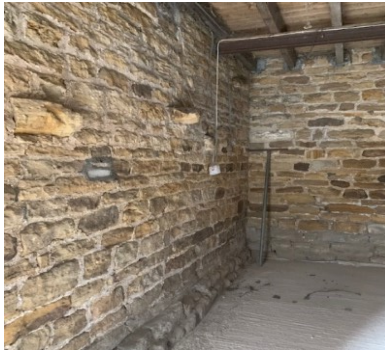
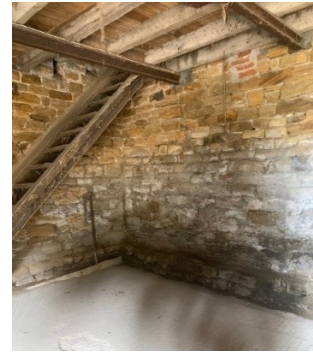
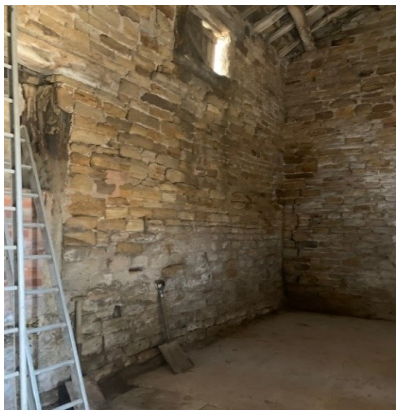
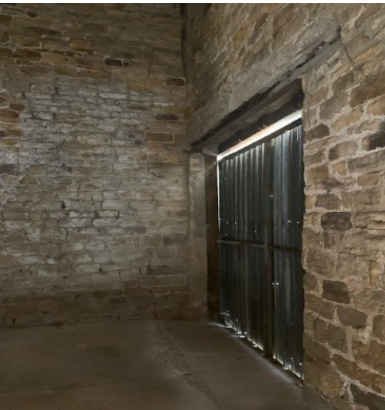
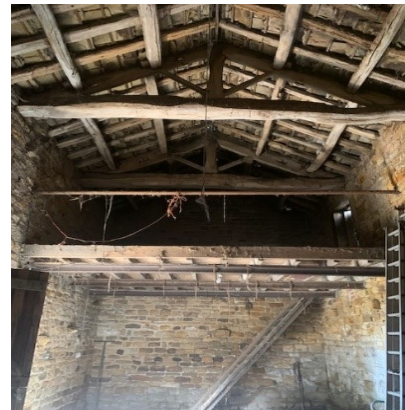
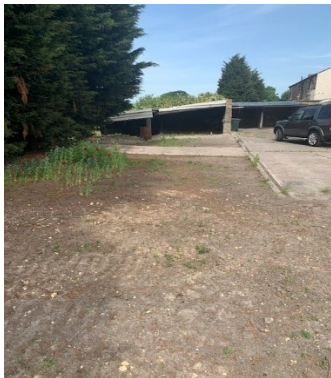
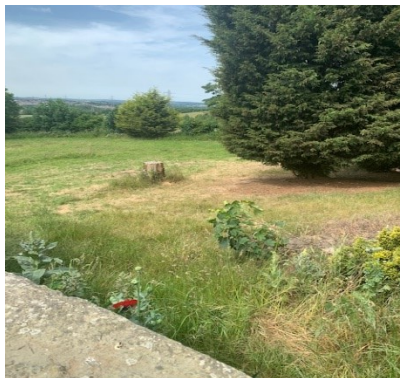
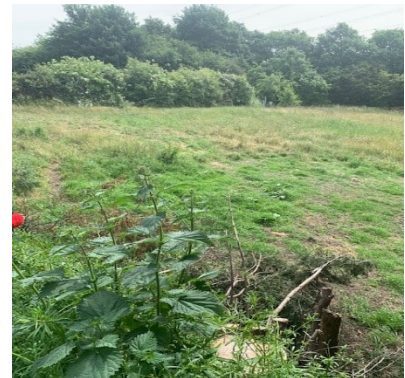
#### 4.5 Photographic Record

- No evidence of asbestos was observed during the site inspection.

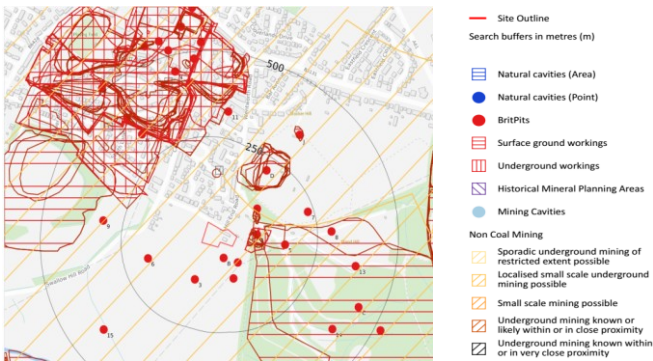
| <b>Coal Mining - YES</b> | <p>The site is located within a coal mining area as defined by the Coal Authority. There numerous conspicuous entries featured in the Geo-insight report(s) within 250m of the site relating to former coal mine related industrial activities:</p> <p>— Site Outline<br/>Search buffers in metres (m)</p> <ul style="list-style-type: none"> <li>Natural cavities (Area)</li> <li>Natural cavities (Point)</li> <li>BritPits</li> <li>Surface ground workings</li> <li>Underground workings</li> <li>Historical Mineral Planning Areas</li> <li>Mining Cavities</li> </ul> <p>Non Coal Mining</p> <ul style="list-style-type: none"> <li>Sporadic underground mining of restricted extent possible</li> <li>Localised small scale underground mining possible</li> <li>Small scale mining possible</li> <li>Underground mining known or likely within or in close proximity</li> <li>Underground mining known within or in very close proximity</li> </ul> |
