Homelea, Bolton upon Dearne

Bat Survey Report

11th September 2023

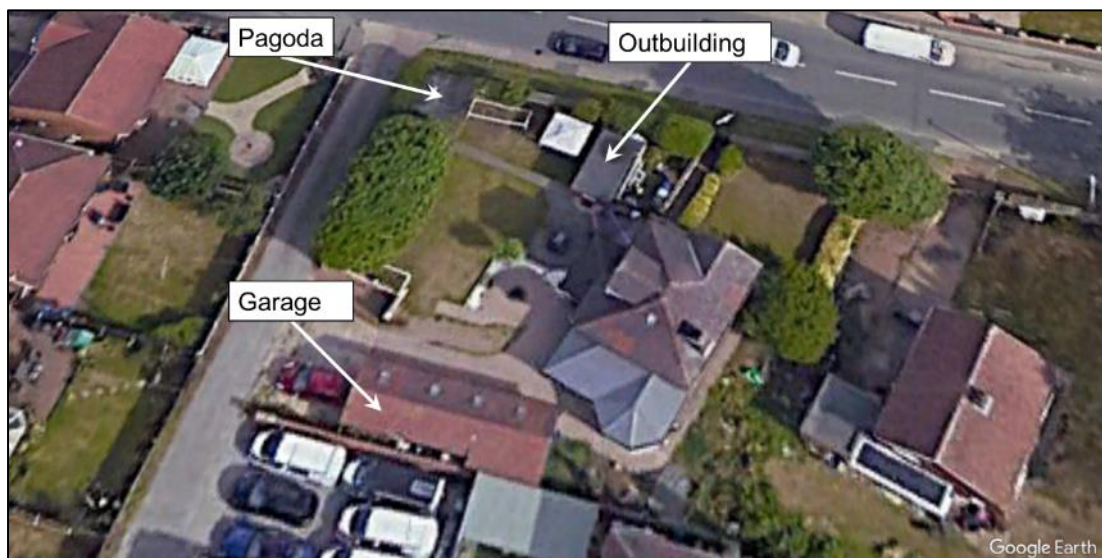
Figure 2. Building layout

5.1.1 No signs of bat presence were recorded from the surveyed buildings. The buildings were considered to display negligible bat roosting suitability. The layout of site buildings is shown in Figure 2.

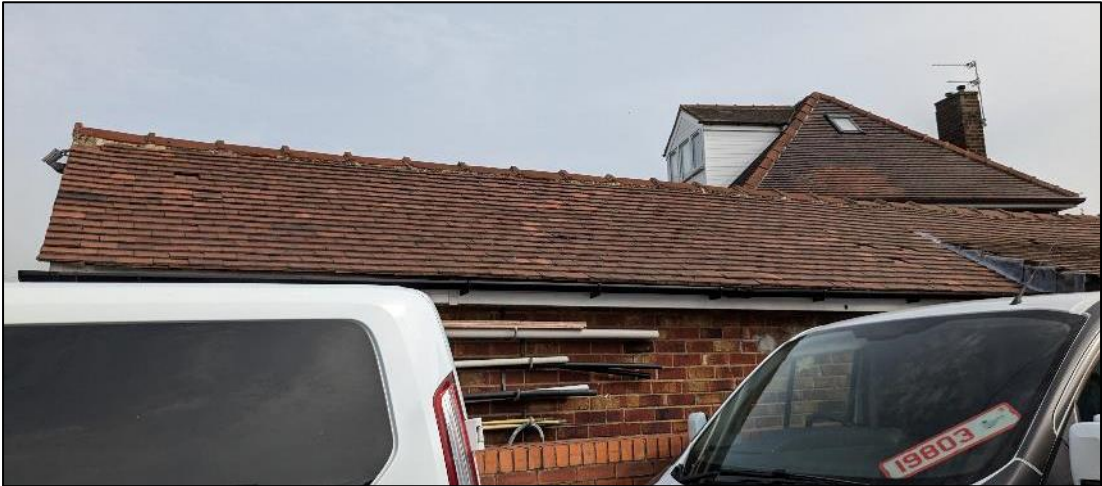
Plate 2. South pitch of garage roof

- 5.1.3 The garage comprised a single storey brick-built structure with a dual-pitched clay plain tile covered roof (Plates 1 & 2). The structure was used partially for storage and partially as an extension of living space. The garage had plastic soffits and barge boards. An up-and-over door was present on the west gable with several double-glazed plastic-framed windows and plastic doors present on the north elevation. Skylights were present in the north pitch of the roof.

- 5.1.4 In terms of potential bat roosting features, a single plain tile was missing on the south pitch. This location could be subject to close inspection (Plate 3), with no signs of bats seen and the space cobwebbed. There was also a 1.2 cm wide crevice between the barge board and wall on the east gable, which could be fully inspected.

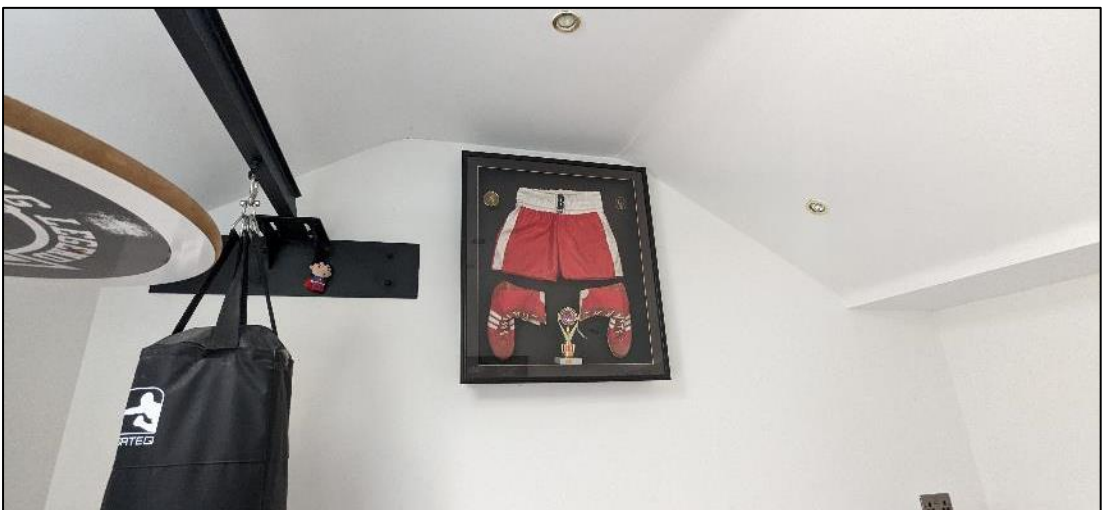
Plate 4. Interior of garage

- 5.1.5 Internally the roof was vaulted with no access to a very small (less than 0.5 m high) void at the roof's apex (Plate 4).
- 5.1.6 No signs of bats were recorded from any location on the garage, and it was considered to display negligible bat roost suitability.

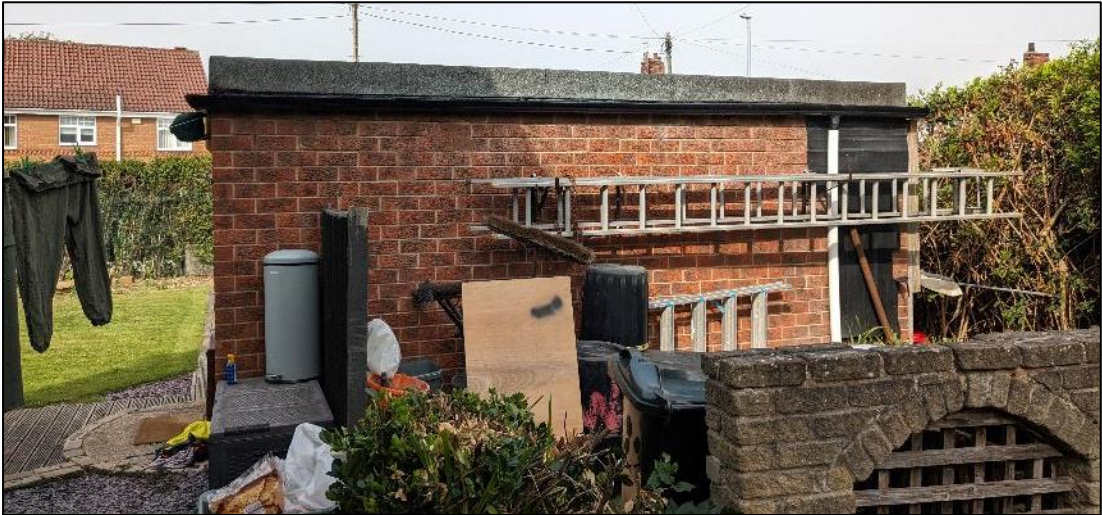
Plate 5. Southeast elevation of outbuilding

- 5.1.7 The outbuilding comprised a single-storey brick-built unit with a felt covered flat roof and a plastic door in the southwest elevation (Plates 5 & 6). Plastic gutters were present.
- 5.1.8 No potential roosting features were noted from the building's exterior. The interior was inspected with no voids present.
- 5.1.9 No signs of bats were recorded from any location on the outbuilding, and it was considered to display negligible bat roost suitability.

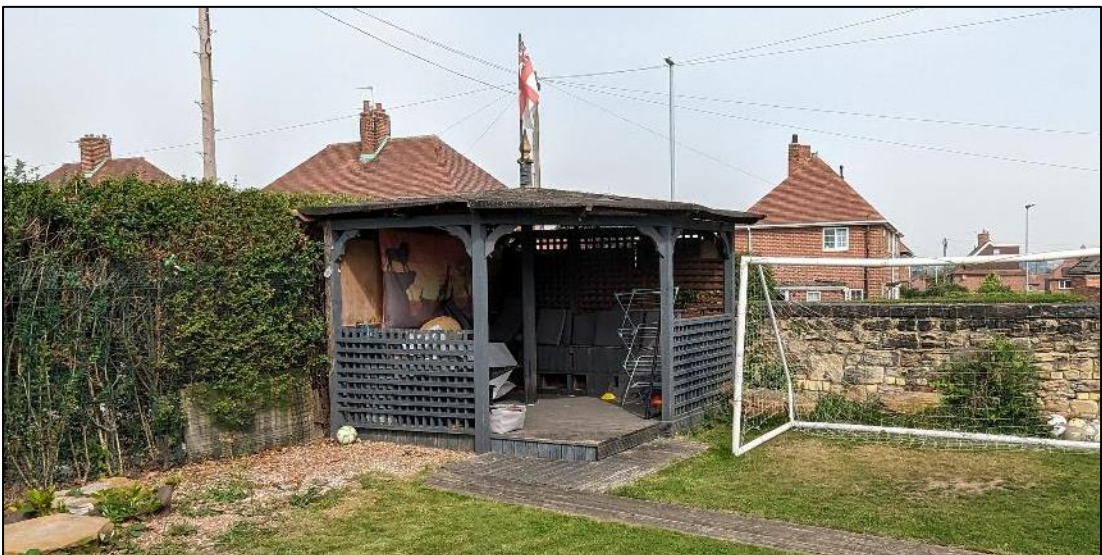
Plate 7. Pagoda

- 5.1.10 An open-sided wood framed pagoda with a gently sloping felt covered roof was present in the northwest corner of the garden.
- 5.1.11 No potential roosting features were noted from the building's exterior. No signs of bats were recorded from any location on the outbuilding, and it was considered to display negligible bat roost suitability.
