## Bat Survey

Cliffe Farm

Cubley

## **Report of Bat Survey Cliff Farm, Cubley.**

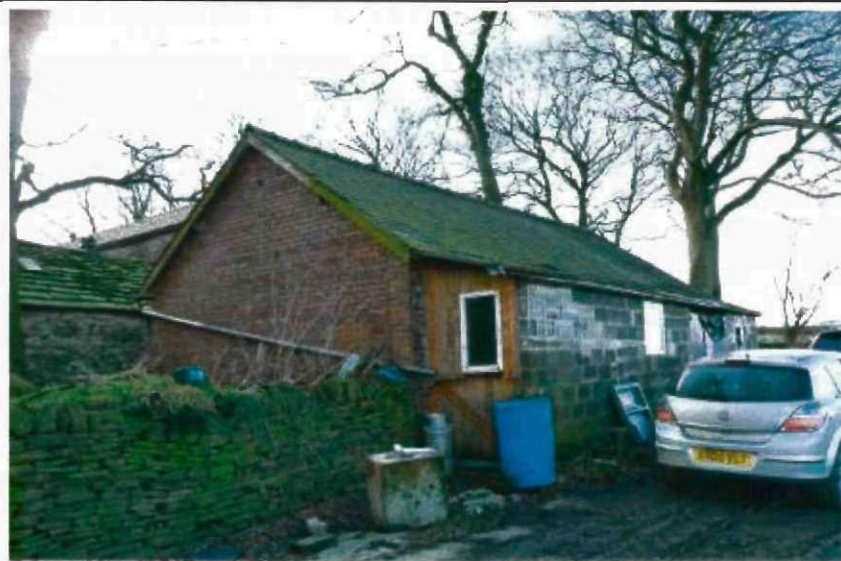
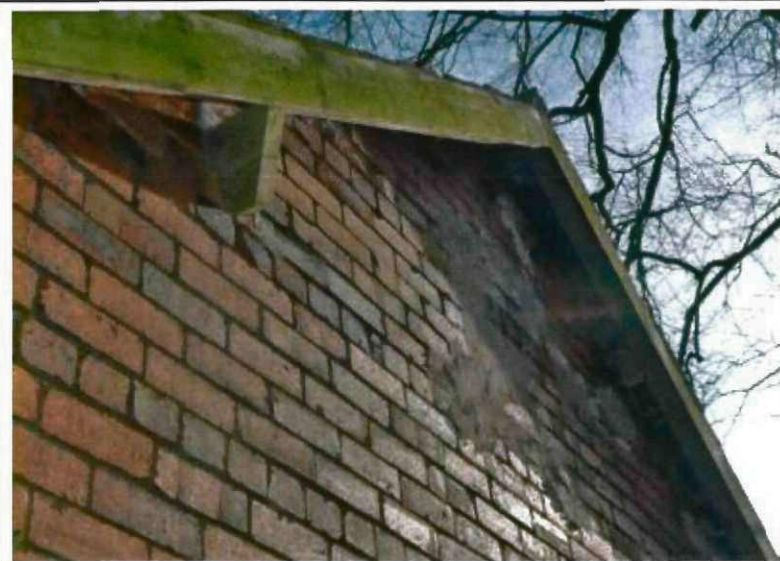
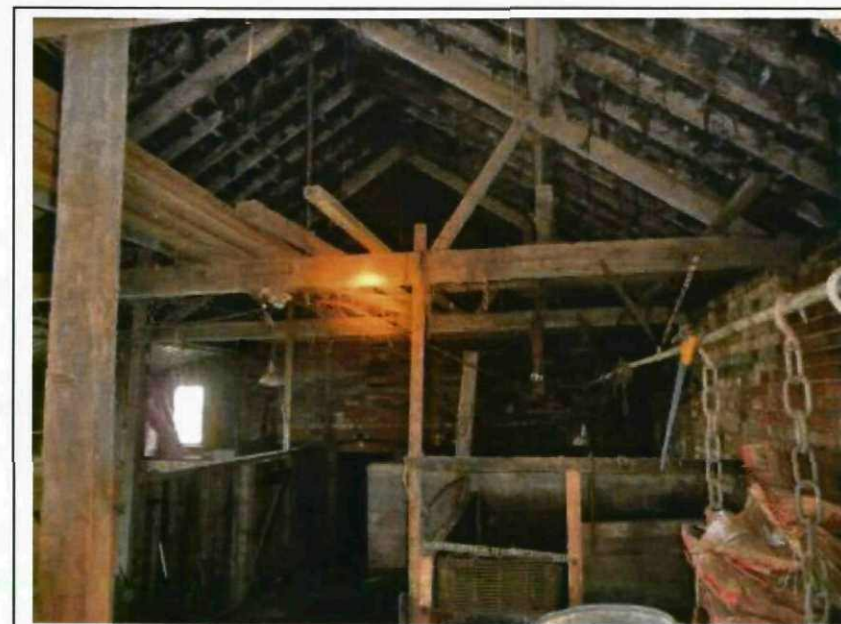
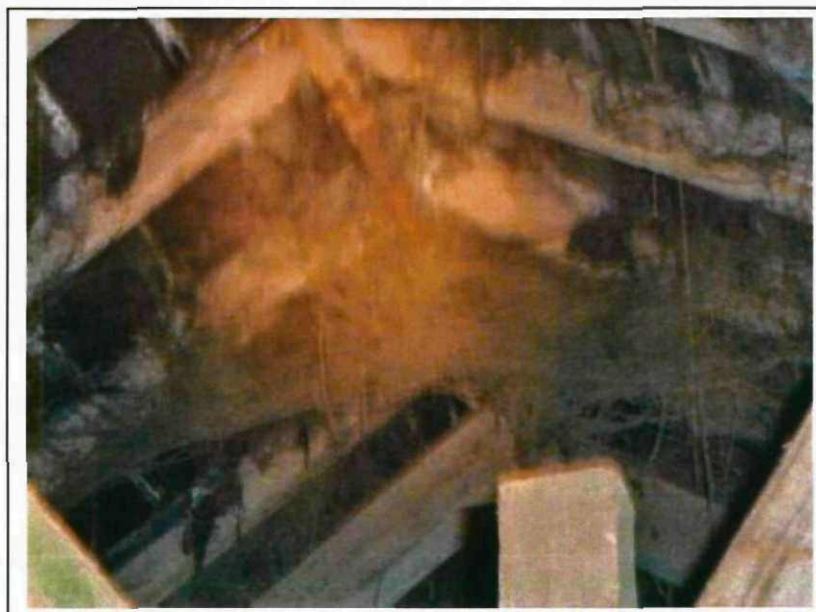
**FIG 6**

| Ref | Description |
|---|---|
| F | <p>Single-storey brick barn with a blue slate roof. A lean-to on the front wall had brick walls with profile steel roof sheets. The gables had timber fascias with large gaps behind, potentially allowing access to crevices under the roof although no signs were found.</p> <p>Internally the building was open to the underside of the roof with no underfelt. The ridge and inside gables were exceptionally cobwebby indicating that bats were very unlikely. (Fig 6)</p> |

| F – Brick Barn | Roost unlikely- gable verge gaps probably too large for bats. Internal roof very cobwebby. |
