**Former Co-Op Pioneer Building, Peel Street,  
Barnsley**

**Ecological Survey Report**

**May 2010**

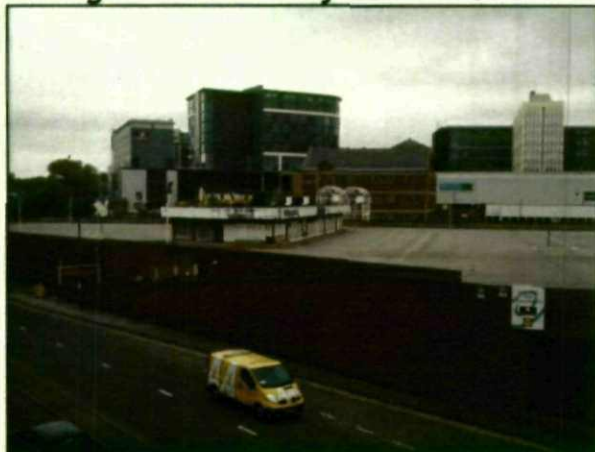
The building is constructed in red brick and concrete. The western 'half' of the building comprises a two-storey car park with a ramp leading to the upper (roof) level. The former shop space is located on the ground floor of the eastern 'half' of the building. The whole of the roof level is occupied by a car park, with the exception of a flat-roofed projection in the centre, which houses the escalator access to the shop floor, below (see Figure 1).

**Figure 1: View of the roof top car park looking across West Way from Pitt Street.**

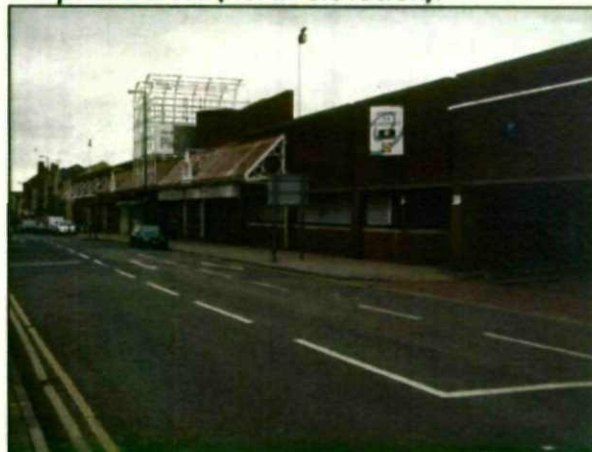
The northern frontage of the building abuts the pavement along Peel Street (see Figure 2) and most of the southern elevation abuts West Way (see Figure 3). To the west of the building, with access from both Peel Street and West Way, is an area of hard standing which formed the supermarket goods delivery area (see Figures 4 and 5). Although predominantly bare concrete this area does support some vegetation, which has seeded in cracks both around the perimeter and in the centre. This vegetation includes ragwort *Senecio jacobaea*, herb Robert *Geranium robertianum*, ribwort plantain *Plantago lanceolata*, red valerian *Centranthus ruber*, butterfly-bush *Buddleja davidii*, false oat-grass *Arrhenatherum elatius*, ash *Fraxinus excelsior* and sycamore *Acer pseudoplatanus*.

**Figure 2: The Peel Street shop frontage and car park access (north elevation).**

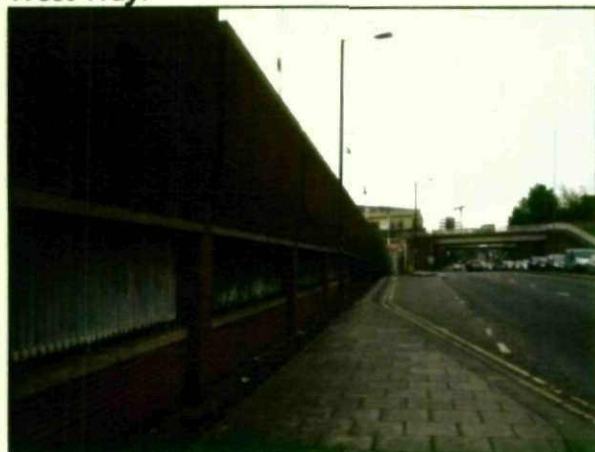
**Figure 3: View of the south elevation on West Way.**

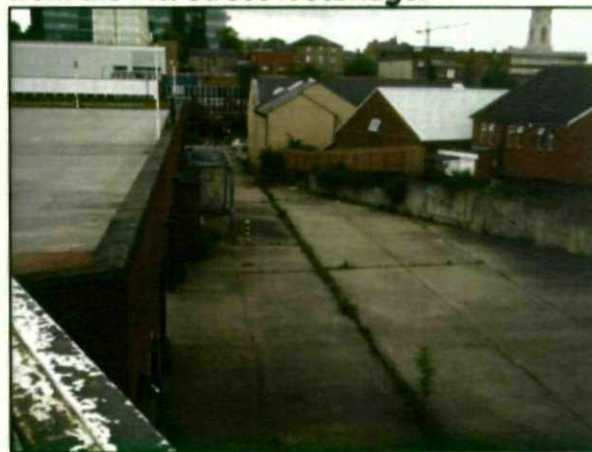
**Figure 4: View of the goods delivery area from the Pitt Street footbridge.**

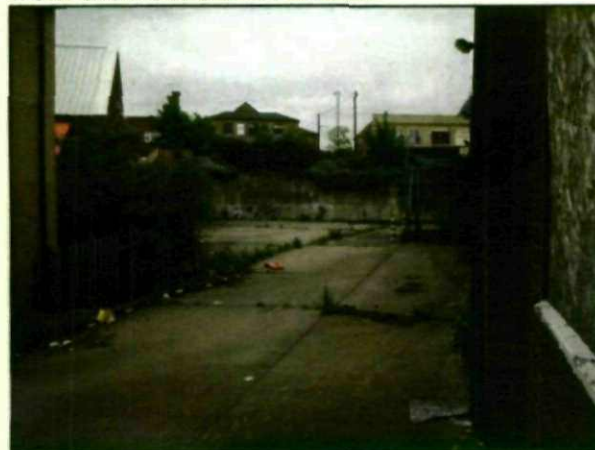
**Figure 5: View of the goods delivery area from the Peel Street access.**

The boundary with Pitt Street, to the southeast, is formed by a concrete and stone retaining wall. The top of this wall supports ornamental shrubs and trees including cherry *Prunus* sp. and *Berberis* sp. (see Figures 5 and 6). A footbridge connects the roof top car park with Pitt Street at the top of the retaining wall (see Figure 7).

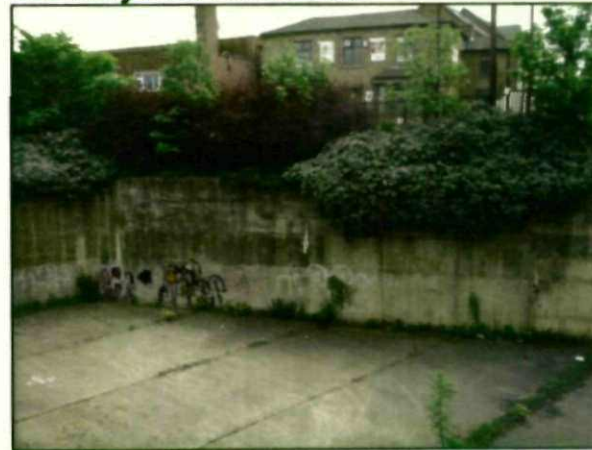
**Figure 6: The retaining wall which forms the boundary with Pitt Street.**

The dense ornamental planting along the top of the retaining wall with Pitt Street (see Figure 6) supports several pairs of nesting house sparrow *Passer domesticus*.

Removal of the dense vegetation on top of the retaining wall at the southeast corner of the site is likely to result in the destruction of active house sparrow nests if undertaken during the bird nesting season (mid-March to end-August). This would be an offence under the legislation set out above. Removal of this vegetation would also result in the loss of future nesting opportunities on site.

It is recommended that the dense ornamental planting on top of the retaining wall in the southeast corner of the site (see Figure 6) is retained as this provides habitat for nesting house sparrow, which are a UK BAP and Red List species. If this vegetation does need to be removed, it is recommended that this is undertaken outside of the nesting season, between September and February, in order to avoid destroying active house sparrow nests. The area should then be re-planted with similar vegetation.

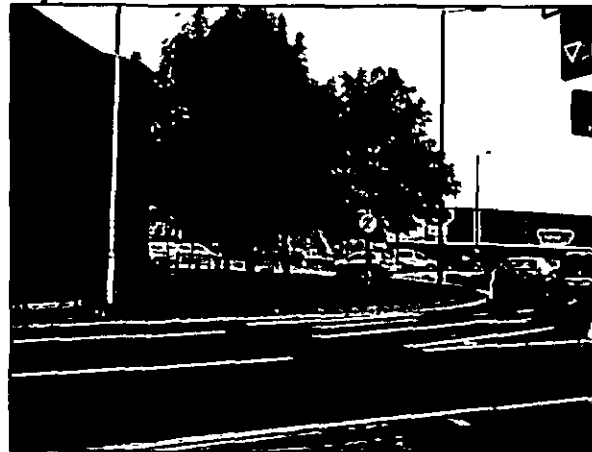
The western site boundary, which overlooks Town-end Roundabout, supports a small area of amenity managed grassland and four young Norway Maple trees *Acer platanoides* (see Figure 8). A flowerbed against the western elevation of the building supports further ornamental planting, including cherry and hazel *Corylus avellana*.

**Figure 8: Amenity grassland and trees adjacent to Town-end Roundabout.**

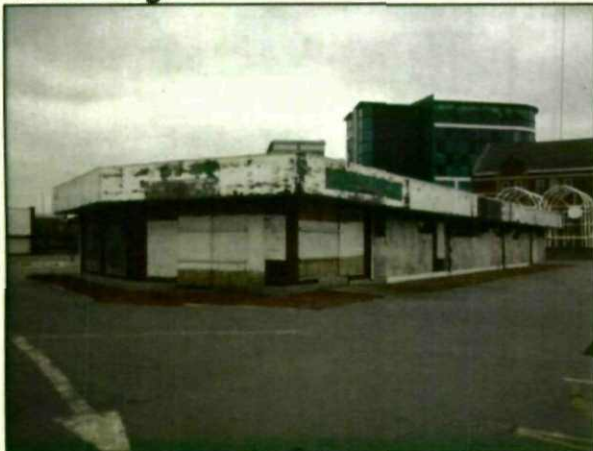
No roof spaces are present. The top of the escalator well at the centre of the building is surrounded by large boxed eaves (see Figures 9 and 10). There are no gaps between the soffits and external walls of the building (a typical location in which bats roost). There are holes in the external corners of the boxed eaves on the south elevation. However these are not considered suitable for roosting bats. No evidence of bats was found inside the building.

**Figure 9: The escalator well in the centre of the building.**

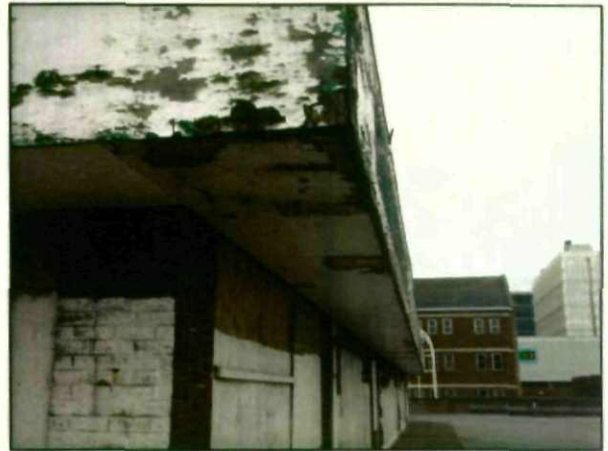
The holes in the boxed eaves on the south elevation of the escalator well (see Figure 10) may be suitable for nesting birds. However, there was no evidence to suggest that nests were or ever have been present.

**Figure 10: A gap in the boxed eave of the escalator well.**

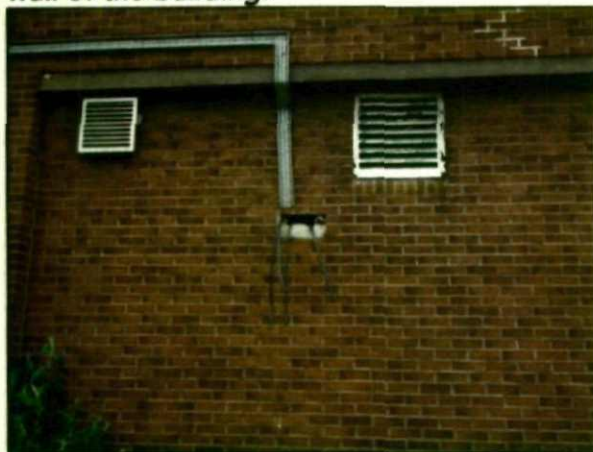
There are several holes in the external structure of the east wall of the building, where pipework or wires used to be present (see Figure 11). However, no evidence of bats was found to be associated with these holes.

Several of the holes in the east wall of the building, where pipework or wires used to be present, may be suitable for nesting birds. However, no evidence that birds were or ever have nested in these features was present (see Figure 11).

**Figure 11: One of several holes in the east wall of the building.**

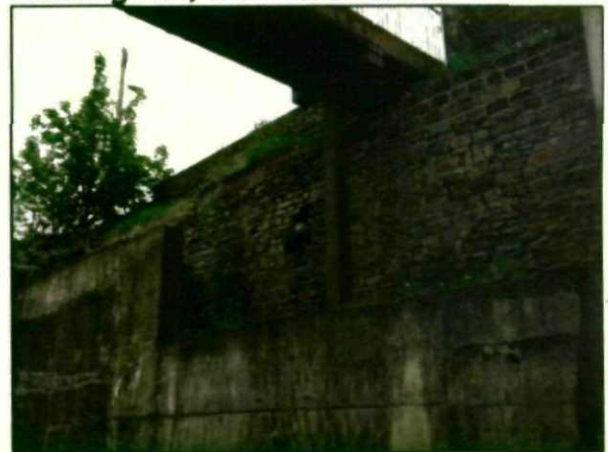
The retaining wall, which forms the boundary with Pitt Street, is constructed largely in concrete, although a stone-built section is present beneath the footbridge. This stonework and pointing is largely intact, although there are some stones missing in the centre. It is not considered that these areas are suitable for roosting bats as they are relatively exposed and superficial (see Figure 12).

The holes in the stonework of the retaining wall below Pitt Street may be suitable for nesting birds, although none were found to be present during the survey (see Figure 12).

**Figure 12: The stone-built section of the retaining wall, with Pitt Street above.**
