# **ARBORICULTURAL REPORT**

## **& Impact Assessment**

*Land at*  
***Halifax Road,***  
***Thurgoland,***  
***Barnsley,***  
***South Yorkshire***  
***S35 7ED***

Reference: AWA2059

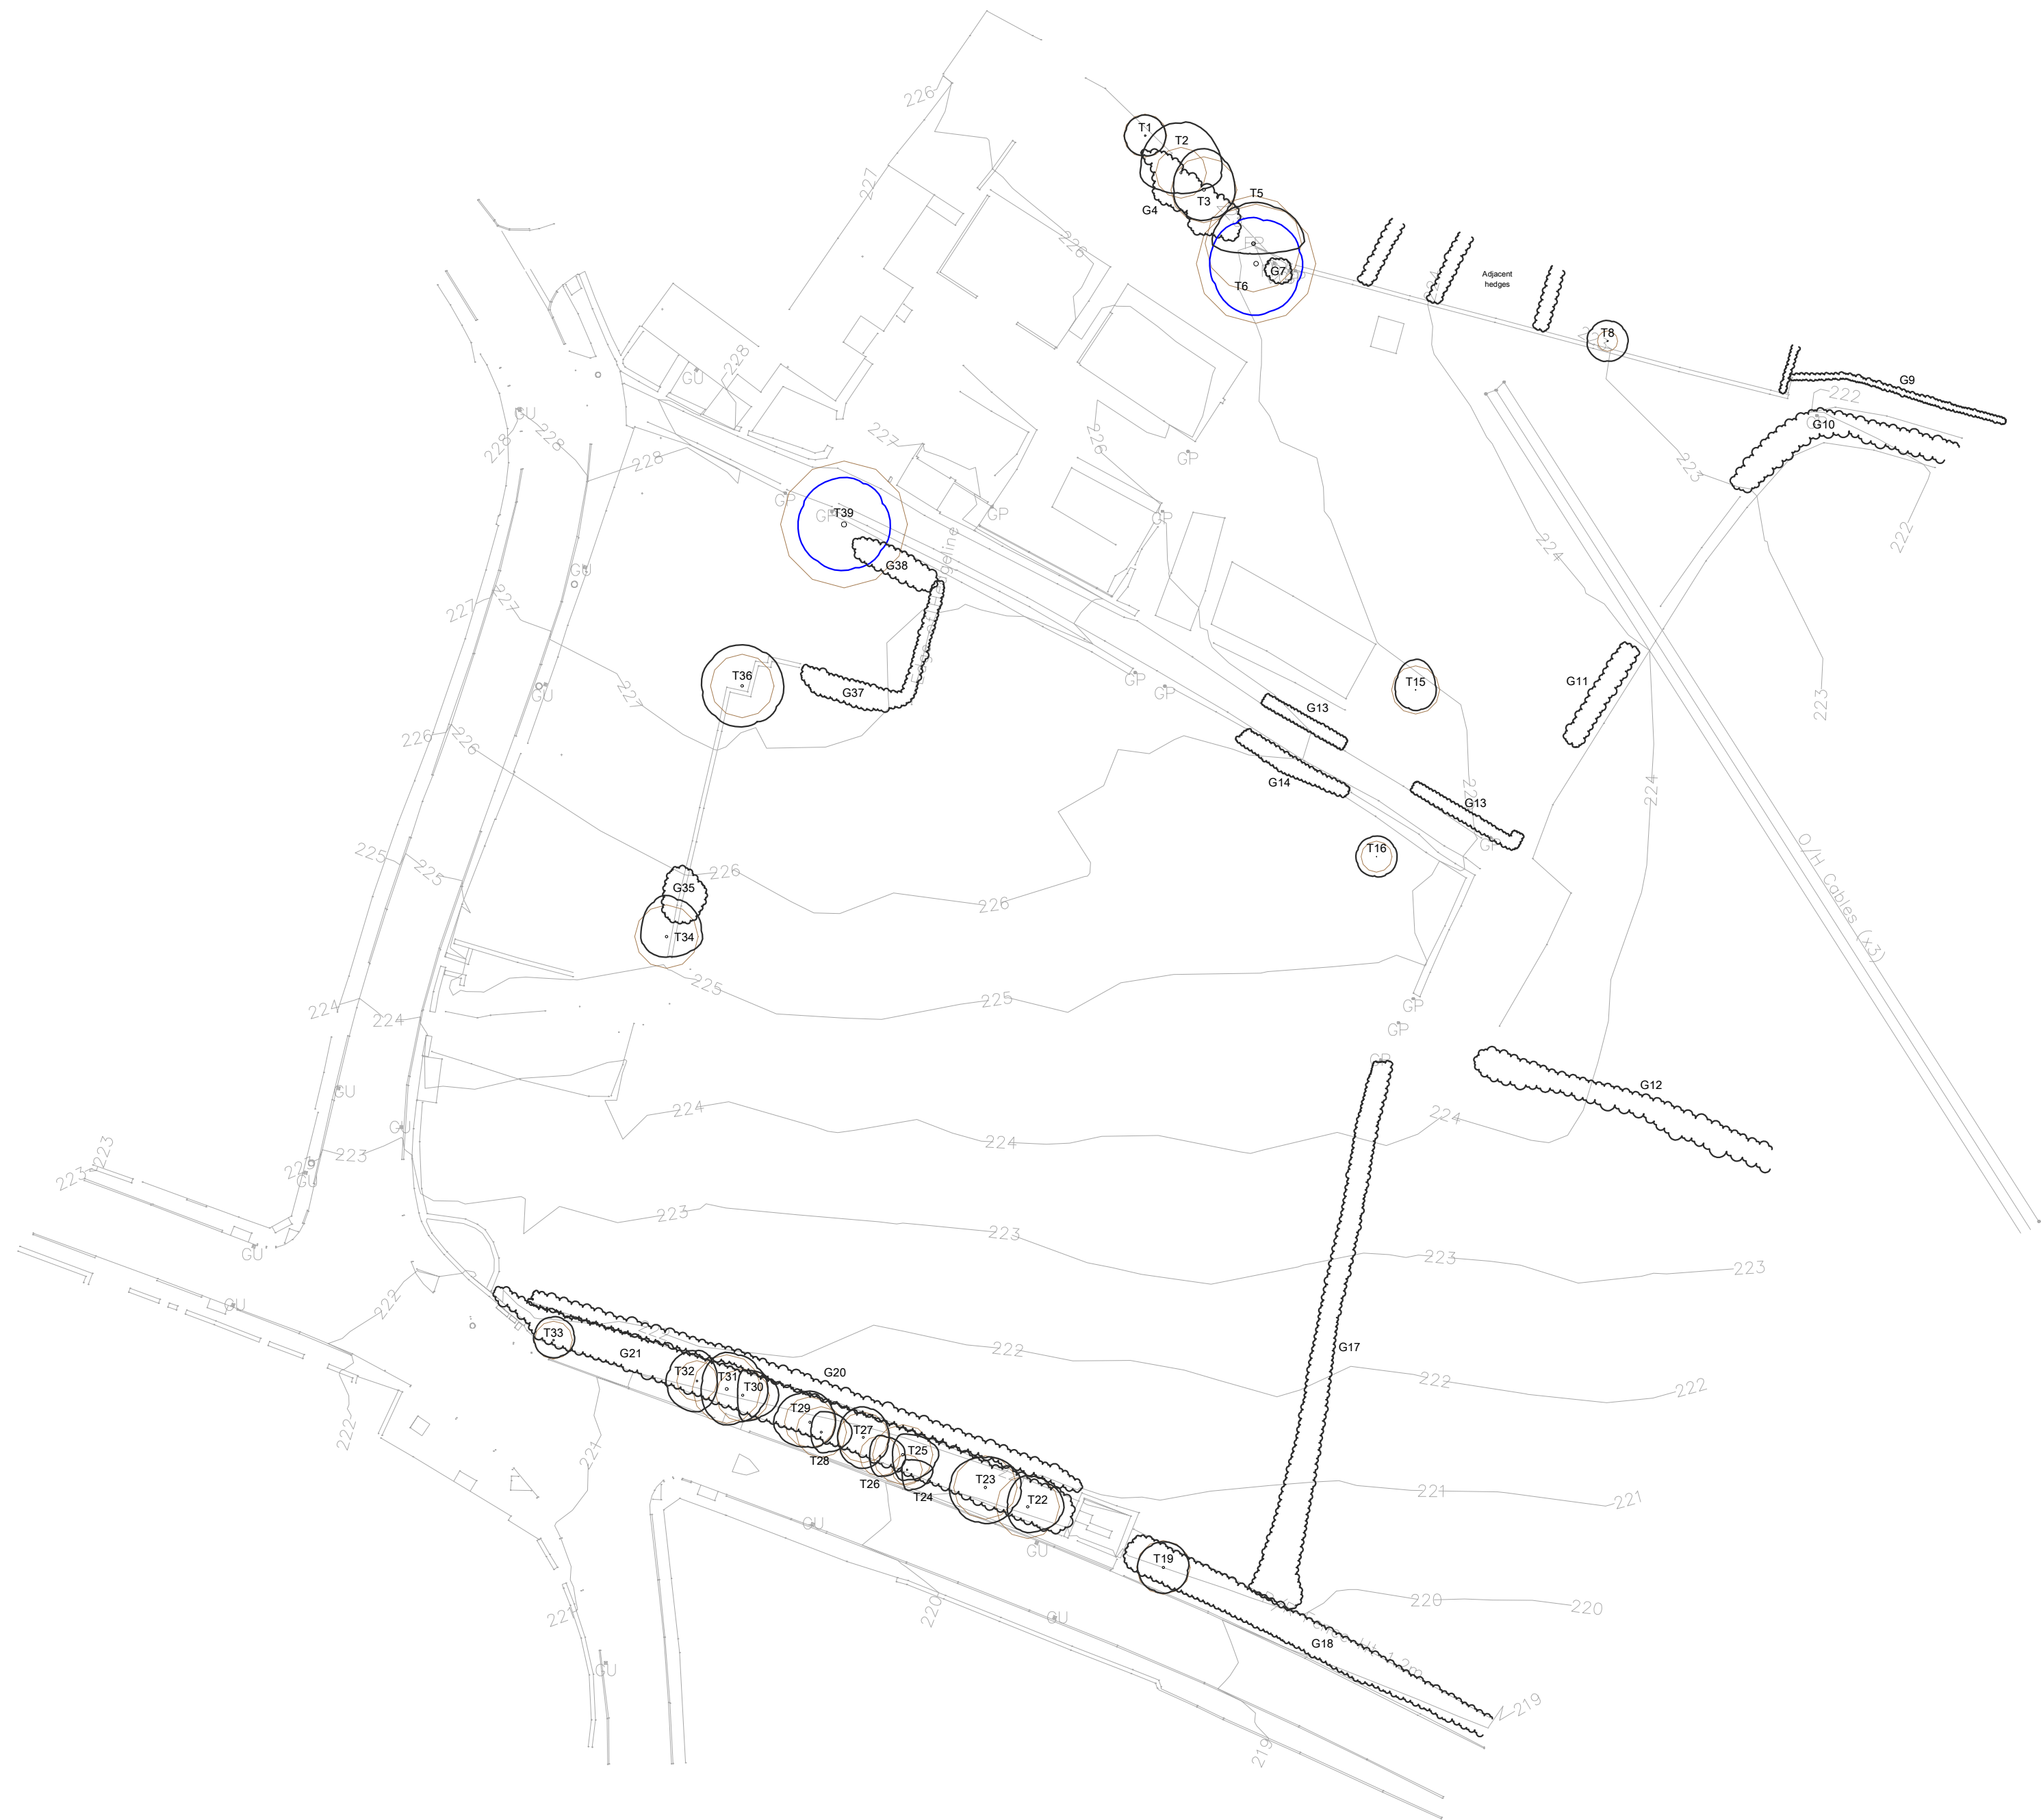
**Appendix 5:**  
**Tree Constraints Plan**

- 3.2.8 The tree Root Protection Area (RPA) detailed on the Tree Constraints Plan at Appendix 5, has been used as a layout design tool, to inform on the area around a tree where the protection of the roots and soil structure is treated as a priority.

- 3.2.10 The RPA for each tree has been plotted as a polygon centred on the base of the stem. Due to the presence of roads, structures, topography (and past tree management) the RPA is likely to be a simplified representation of the tree roots actual morphology and disposition. However, detailed modifications to the shape of the RPA would largely be based on conjecture and so have been avoided.

**C (marked in grey on Appendix 5) = trees which could be retained.** These trees are of low or average quality and value, and are in adequate condition to remain until new planting could be established.

**U (marked in red on Appendix 5) = trees for removal.** These trees are in such a condition that any existing value would be lost within 10 years.

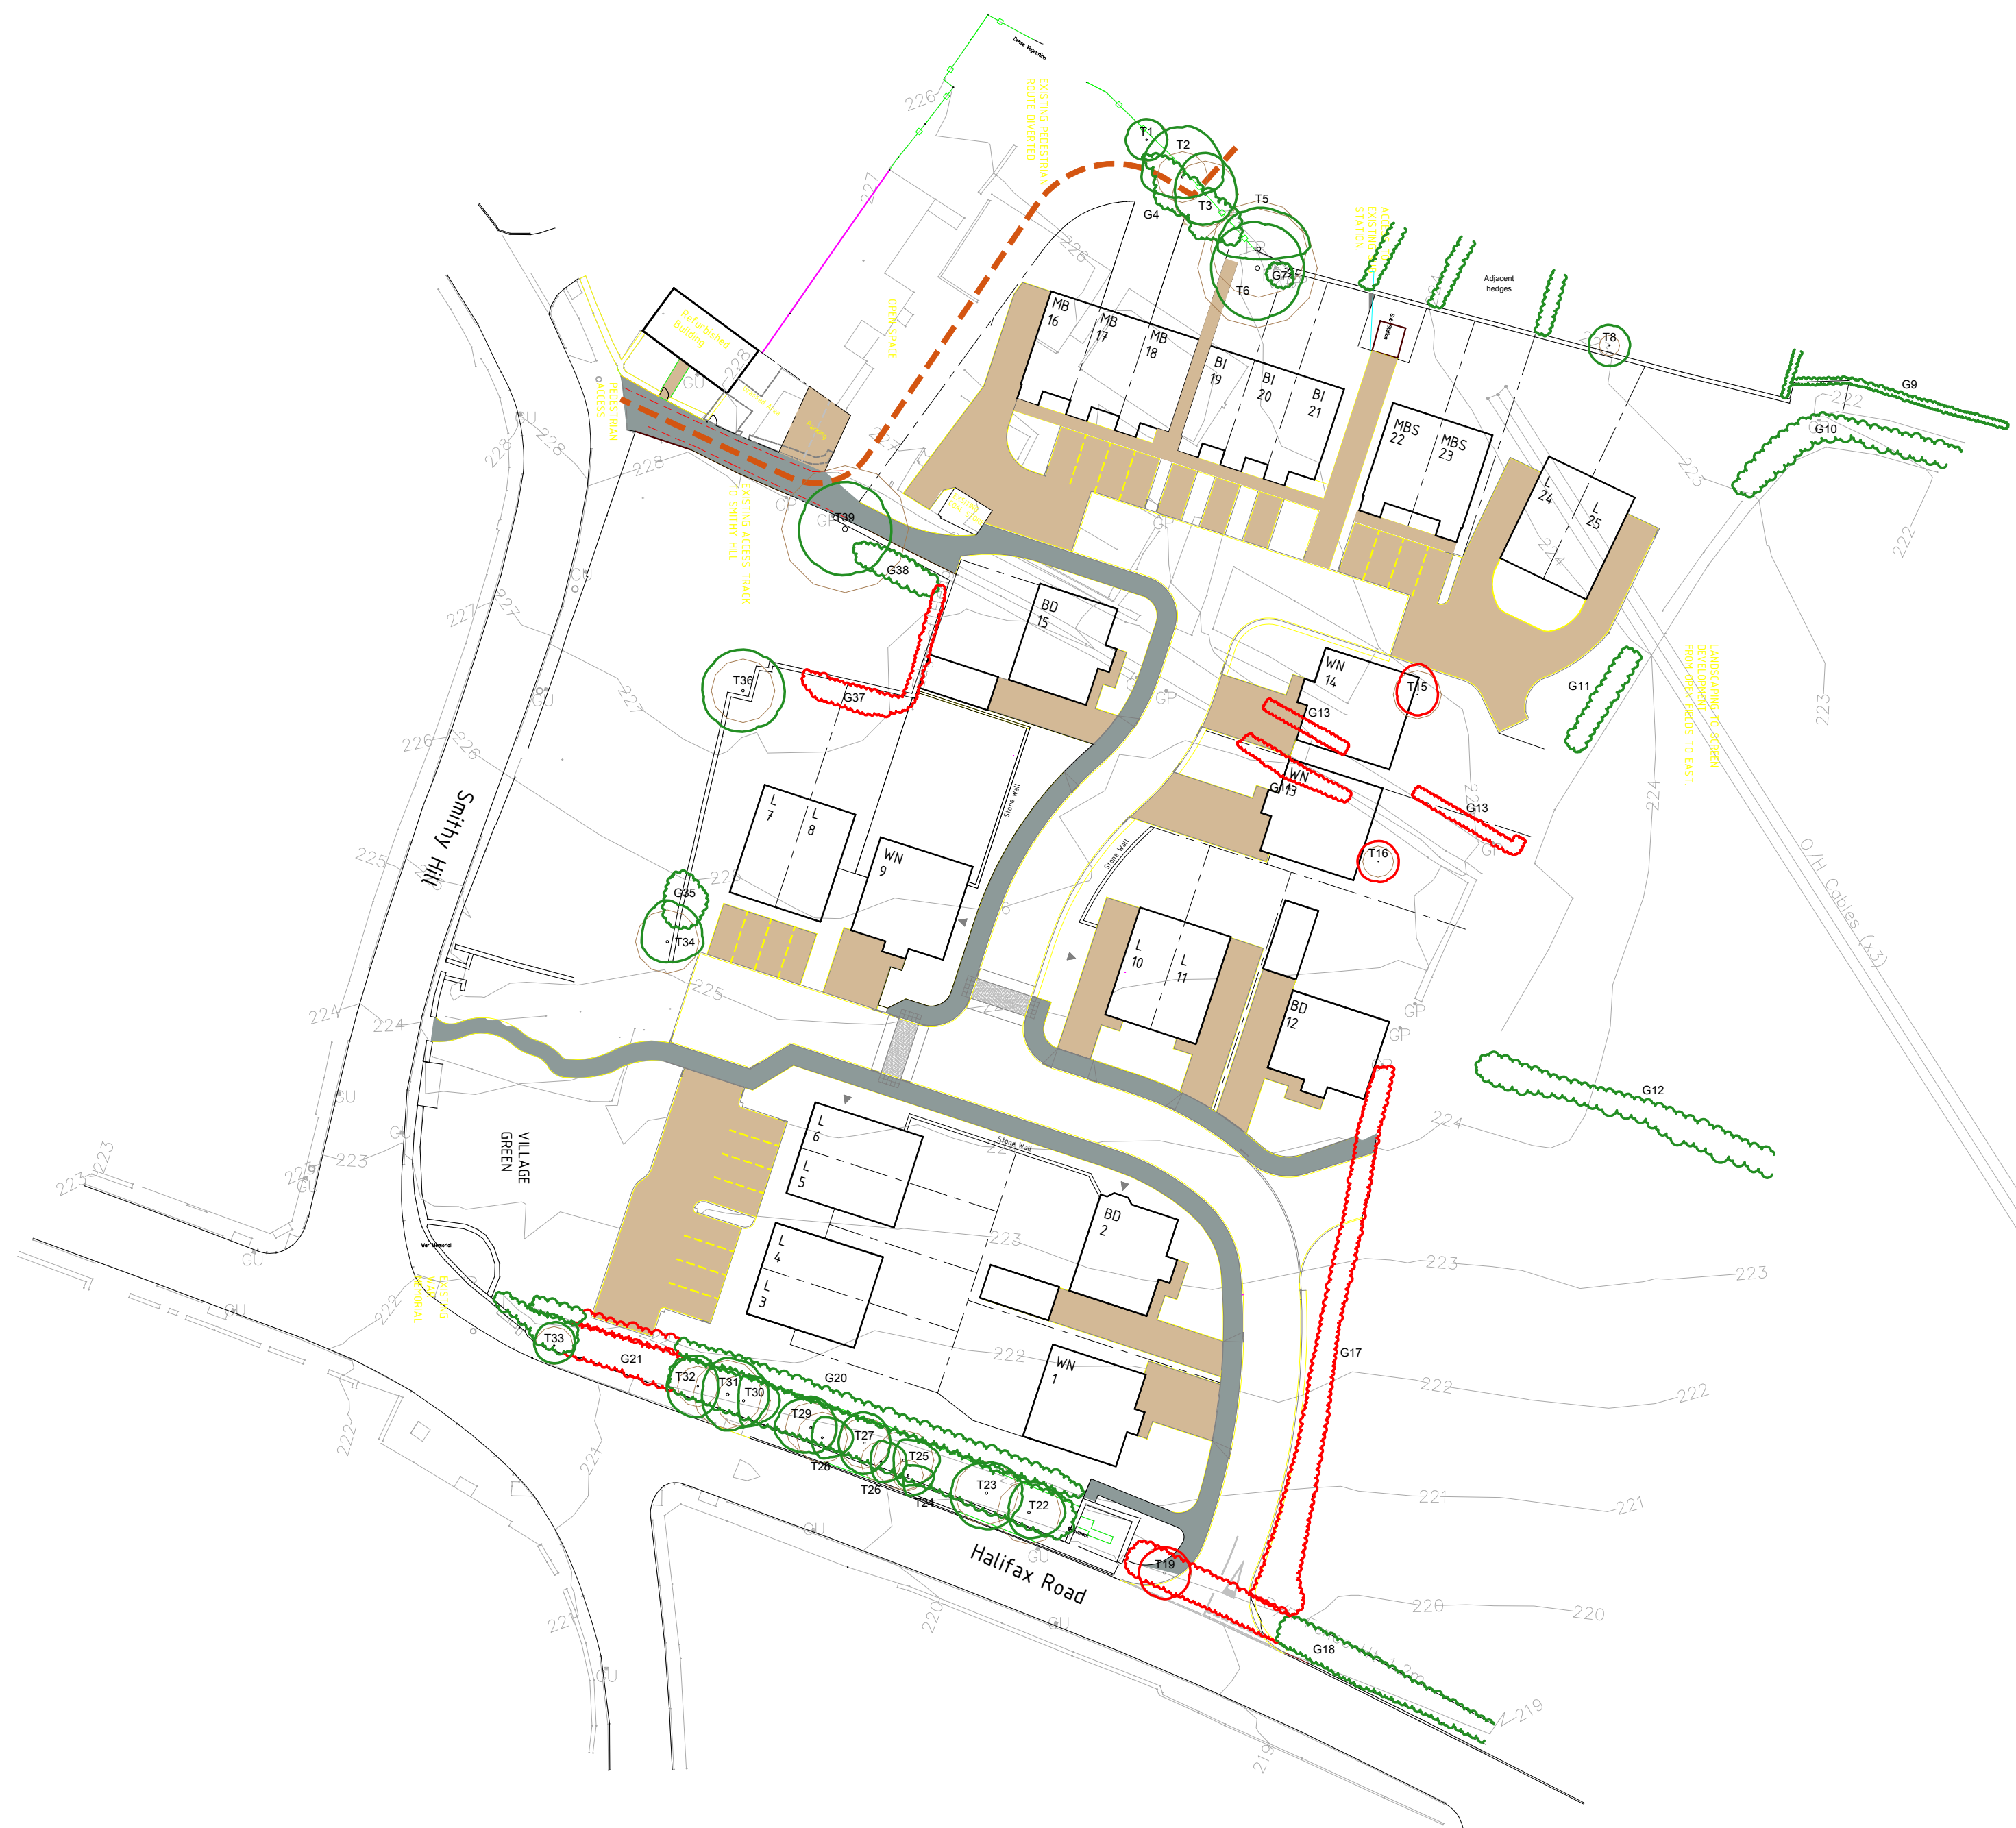
- 4.1.1 It is proposed to build a new residential development with associated access, landscaping and facilities. The development proposals have been provided by my client and inform this arboricultural impact assessment and the Tree Impacts Plan at Appendix 6.

- 4.2.1 From assessing the new development proposals, the removal or partial removal of 10 trees, tree groups or hedges is required as they are situated in the footprint of the development or their retention and protection throughout the development is not suitable.
- 4.2.2 The trees, tree groups and hedges that require removal are G13, G14, T15, T16, G17, T19, G37 and sections of G18, G20 and G21.
- 4.2.3 The trees, tree groups or hedges requiring removal are all of relatively low value and their removal or partial removal will have little negative impact at the site. The screening provided by the boundary tree groups or hedges can be easily replaced with new boundary landscape plantings if required.

- 4.3.2 Potentially damaging activities are proposed in the vicinity of retained trees. A proposed new access road is situated within the RPA of the adjacent Sycamore T39. The construction of hard surfaces within the RPA can have negative impacts on tree roots. However, the existing hardstanding and considerable ground compaction in this area and the wall situated between the tree and the site has likely limited root extension to the north. The tree has also recently undergone heavy crown reduction works. As such, the retained tree should remain largely unaffected by the works, provided care is taken during construction. Potential negative impacts of new hard surfacing on tree roots can often be overcome or minimised by employing a 'no-dig' type construction methods with a porous final surface.

- 4.3.3 A proposed new footpath is situated within the RPA of the retained Sycamore T6. Employing a 'no-dig' type construction method with a porous final surface would overcome the potential negative impacts of the new hard surfacing on tree roots.

- 4.3.4 New boundary fencing is proposed within the RPA of trees T5 and T6. The encroachment into the trees' RPAs should not significantly adversely impact on the health or future condition of the trees, provided posts and panels type footings are used as opposed to strip footings within the RPAs, with the holes for the posts dug by hand, and care is taken during the construction to avoid root damage.

- 4.4.1 The retained trees will require protection by fencing in accordance with BS 5837: 2012, during the development phase.
- 4.4.2 An associated Arboricultural Method Statement, detailing protective fencing specifications and construction methods close to the retained trees has been provided.
