## **Arboricultural Impact Assessment**

**The Horse & Groom,  
Barnsley Road**

Report reference: AR-5503-02  
May 2021

## Tree Survey

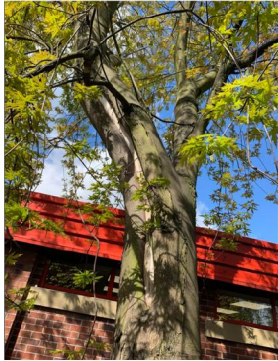
Ref	Species	Life stage	Ht (m)	Can Ht (m)	Stem diam (mm)	Canopy spread (m)	Physiological	Structural condition	Recommendations	Life exp. (yrs)	Ret cat
<b>T1</b>	Silver Maple	M	15	3.5	495	N 6 E 6 S 6 W 6	F	Single vertical stem with a balanced canopy. Large bark wound to SE at 2-3M. Located on far side of a concrete wall/fence along a passageway. Pruning wounds. Bark splitting throughout. Situated on adjacent land. Overhanging footpath, boundary and building.	Monitor	20+	C1
<b>T2</b>	Silver Maple	M	16	4	610	N #6 E 6.2 S 4.6 W #6	F	Single vertical stem with a balanced canopy. Located on far side of a concrete wall/fence along a passageway. Pruning wounds. Bark splitting throughout. Situated on adjacent land. Overhanging footpath, boundary and building.	No action required.	20+	B1
<b>G3</b>	Cherry	Y-M	>12	0+	# >320	See plan	F	Several young to mature trees growing alongside and through a wire mesh fence. Pruning wounds throughout.	No action required.	10+	C2

**Figure 1: A large decaying bark wound on T1.**

Tree ref.	Species	Retention category	Proposal feature	Impact	Mitigation
T1	Silver Maple	C1	Demolition of existing building. Too close to protect	Removal	Mitigation planting on site required.

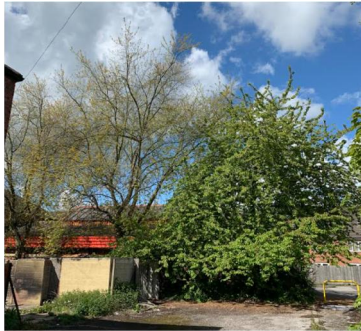
**Figure 3: T2 and G3 located to the west of the site.**

Tree ref.	Species	Retention category	Proposal feature	Impact	Mitigation
<b>T2</b>	Silver Maple	B1	Demolition of existing building. Too close to protect	Removal	Mitigation planting on site required.
<b>G3</b>	Cherry	C2	Demolition of existing building. Too close to protect	Removal	Mitigation planting on site required.
<b>G4</b>	Sycamore	C2	Demolition of existing building. Too close to protect	Removal	Mitigation planting on site required.
<b>T5</b>	Goat Willow	C1	The retainment and protection of existing tarmac hardstanding. In sections repair/make good works are required	Hand tools only	Tree protection fencing in accordance with BS 5837:2012 Hand tools only. No heavy machinery.
<b>T6</b>	Hornbeam	B1	The retainment and protection of existing tarmac hardstanding. In sections repair/make good works are required	Hand tools only	Tree protection fencing in accordance with BS 5837:2012 Hand tools only. No heavy machinery. Care must be taken when removing grass /hard standing within the vicinity of any retained tree.

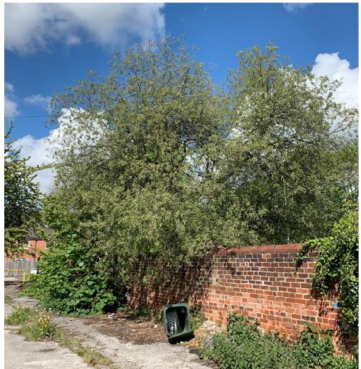
<b>G4</b>	Sycamore	Y	>5	0+	# >90	See plan	F	Self-set group of young trees growing along brick wall.	No action required.	10+	C2
<b>T5</b>	Goat Willow	EM	7	2	315 260	N 5.6 E 6.1 S 4.5 W 3.6	F	Twin stemmed at base with a balanced canopy. Slight lean to east. Pruning wounds throughout, crown lifted over footpath. Dense vegetation growing at base limiting inspection.	No action required.	10+	C1

**Figure 4: G4 and T5 growing either side of a brick wall to the north of the site.**

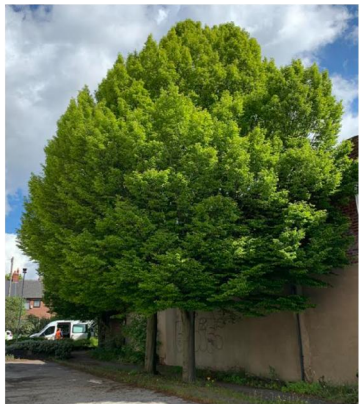
Ref	Species	Life stage	Ht (m)	Can Ht (m)	Stem diam (mm)	Canopy spread (m)	Physiological	Structural condition	Recommendations	Life exp. (yrs)	Ret cat
<b>T6</b>	Hornbeam	M	18	2.5	490	N #6 E #7 S 5.76 W 4.46	G	Single vertical stem with a balanced canopy. Multi-stemmed at 2.2M. Growing at the edge of the car park against timber building. Overhanging boundary and building. No major visible defects.	No action required.	20+	B1
<b>T7</b>	Hornbeam	M	18	2.5	375	N 4.6 E #5 S 2.5 W 5	G	Single vertical stem with a balanced canopy. Multi-stemmed at 2.2M. Growing at the edge of the car park against neighbouring building. Overhanging boundary and building. No major visible defects.	No action required.	20+	B1
<b>T8</b>	Hornbeam	M	18	2.5	400	N 2.1 E #5 S 4.4 W 5.1	G	Single vertical stem with a balanced canopy. Multi-stemmed at 2.2M. Growing at the edge of the car park against neighbouring building. Overhanging boundary and building. No major visible defects.	No action required.	20+	B1

**Figure 5: T6,7 and 8, healthy Hornbeam trees growing along the eastern edge of the site.**

<b>T7</b>	Hornbeam	B1	The retainment and protection of existing tarmac hardstanding. In sections repair/make good works are required	Hand tools only	Tree protection fencing in accordance with BS 5837:2012 Hand tools only. No heavy machinery. Care must be taken when removing grass /hard standing

Tree ref.	Species	Retention category	Proposal feature	Impact	Mitigation
					within the vicinity of any retained tree.
<b>T8</b>	Hornbeam	B1	The retainment and protection of existing tarmac hardstanding. In sections repair/make good works are required	Hand tools only	Tree protection fencing in accordance with BS 5837:2012  Hand tools only. No heavy machinery.  Care must be taken when removing grass /hard standing within the vicinity of any retained tree.

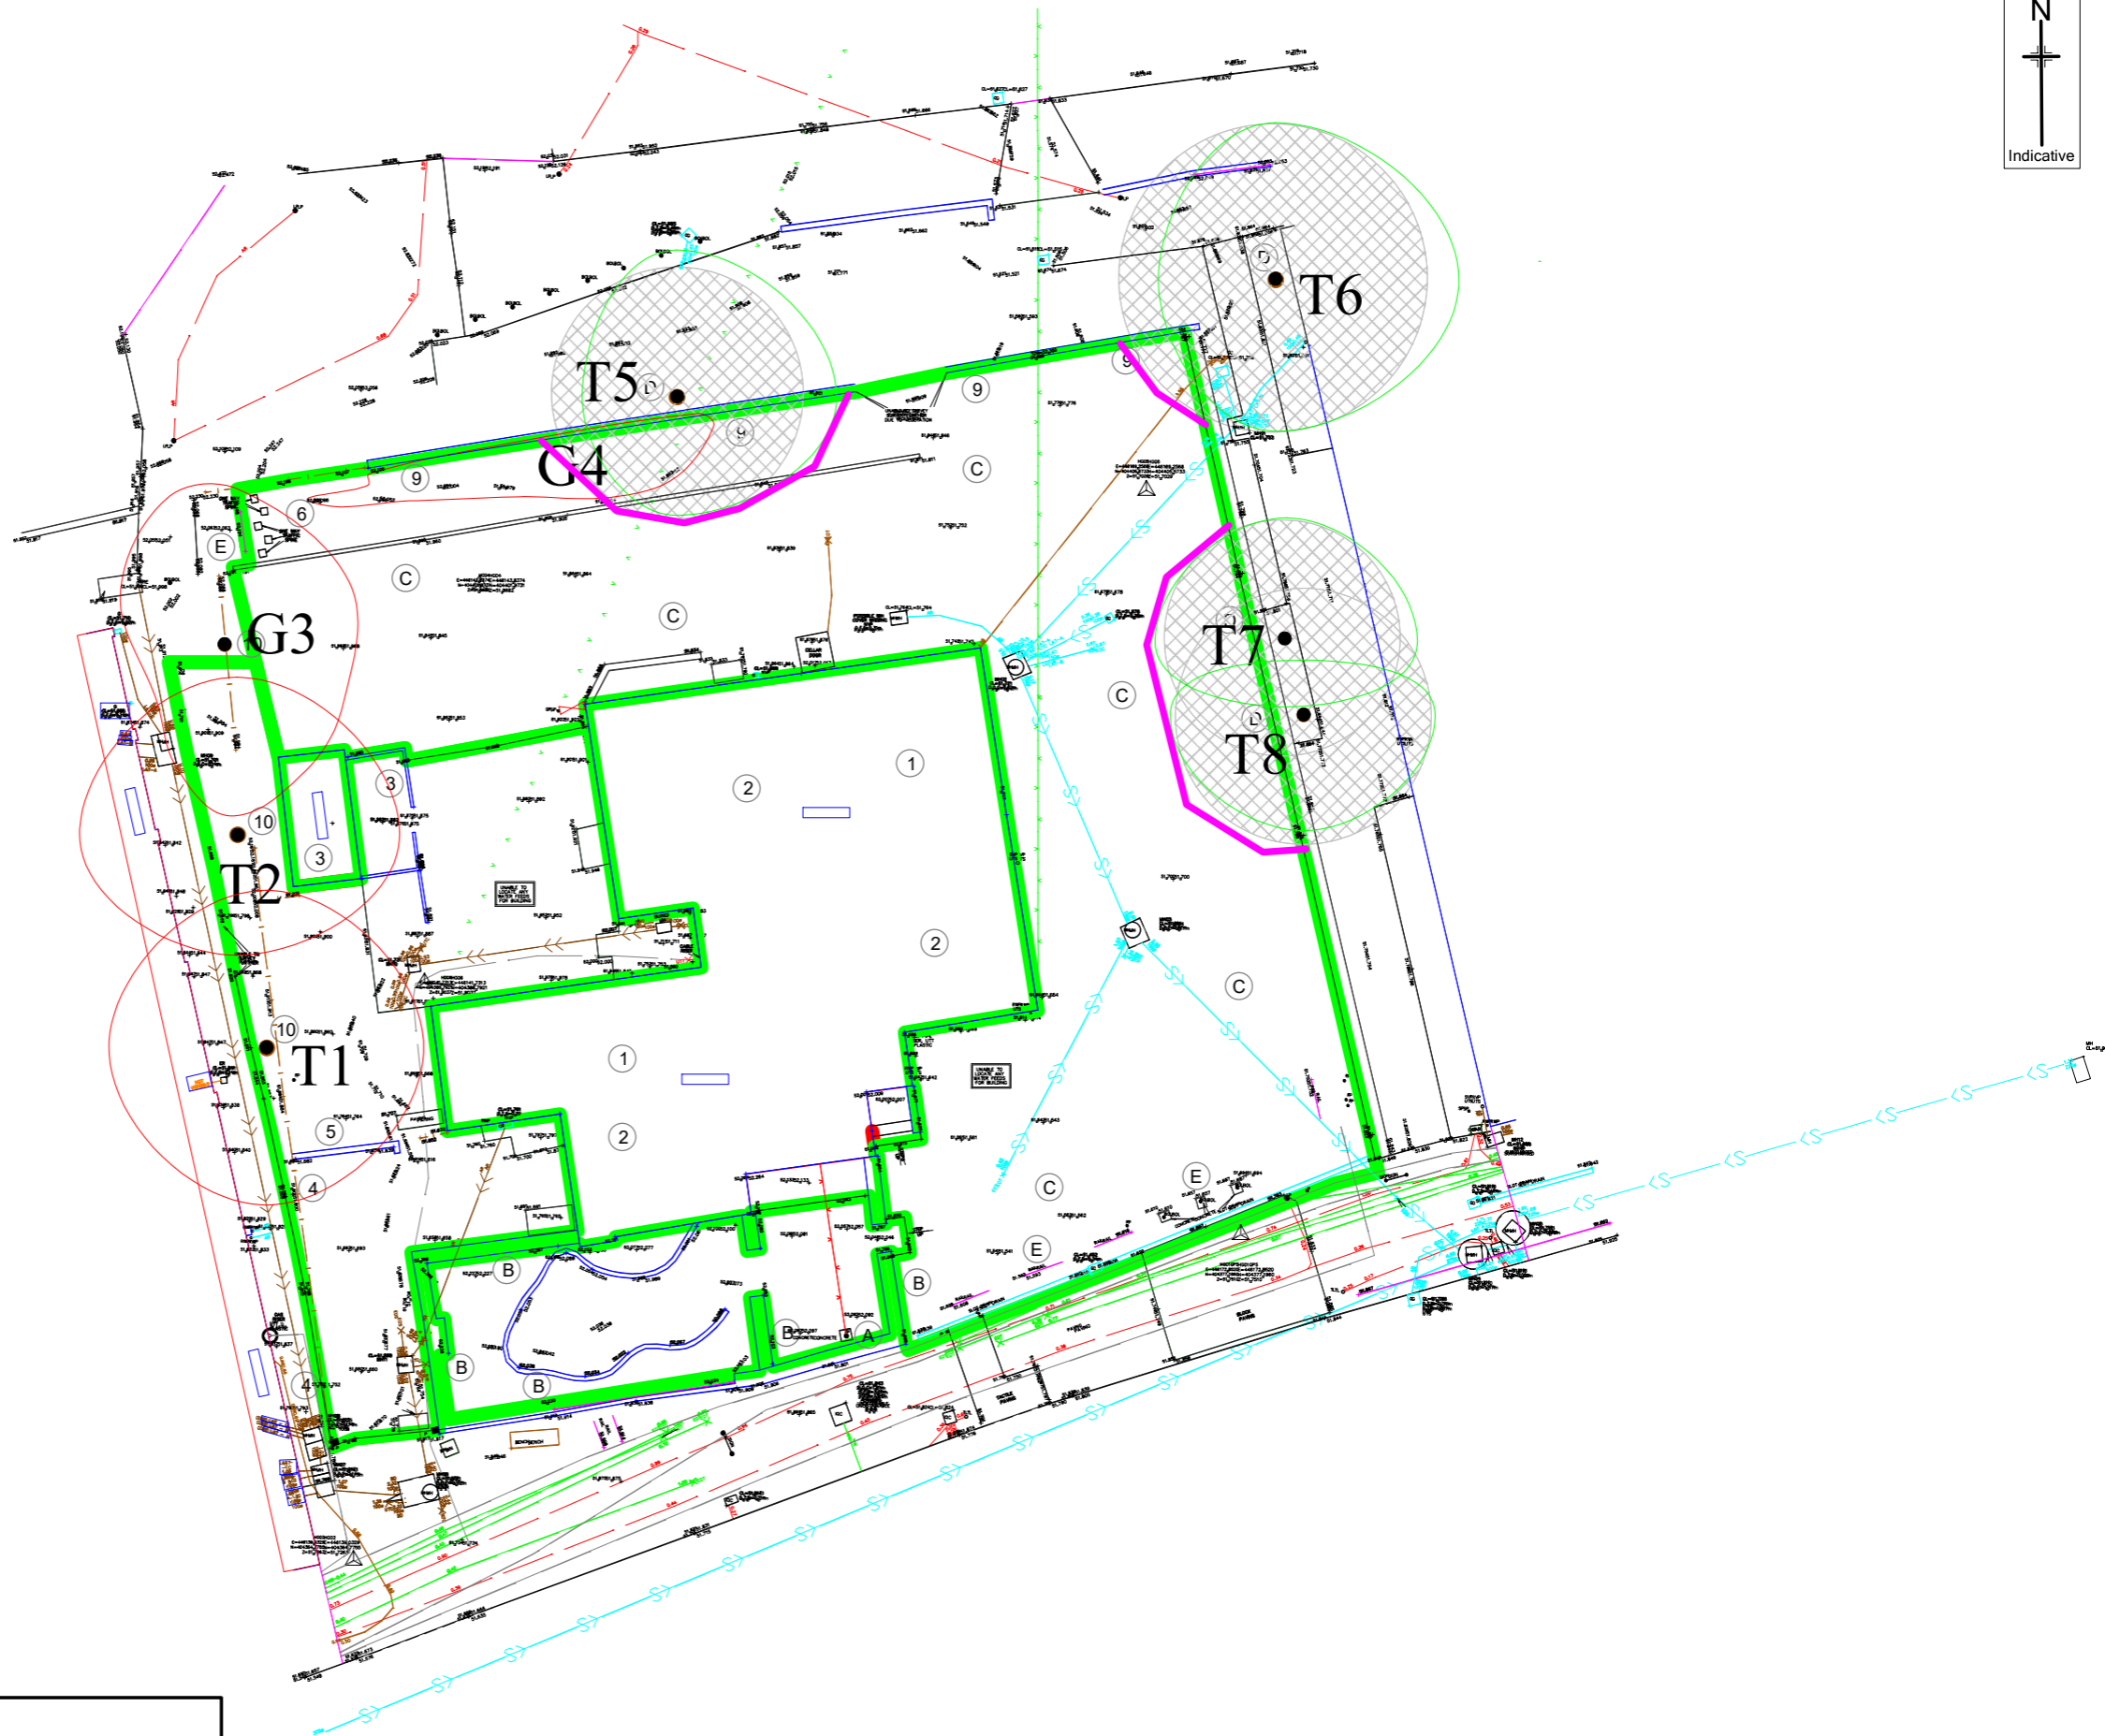
**DR-5503-02 TREE PROTECTION PLAN**

Site: Horse & Groom, Barnsley Road.

Paper Size: A2 Scale: 1:200

3. Trees and tree groups should be protected from unwanted damage during construction works with temporary tree protection barriers. The barriers should be erected to the outer edge of the tree canopy or the edge of the RPA, whichever is the furthest away from the tree, unless otherwise indicated on the Tree Protection Plan.

4. Tree protection barriers should be the default specification for protective barrier, Figure 2, BS 5837: 2012 Trees in relation to design, demolition and constructions – Recommendations. Where Site circumstances prevent the use of the default barrier, an alternative specification would be recommended by the project arboriculturist with agreement of the local planning authority. The recommended locations for tree protective barriers are shown in Tree Protection Plan.
