Heritage Statement

Bank House Farm consists of the main 250 year old Grade II listed farm house facing and set back from Barnsley Road along with two large two storey barns, barn A approximately 150 years old and barn B 200 years old. The barns form a courtyard behind the farm house. The three main buildings are stone built with stone roofs, each in varying states of repair. The main building, Bank House Farm, caught on fire in November 2014. The building suffered severe damage internally and is currently not habitable. The windows and doors are boarded up but it appears that that stonework and the roof have remained intact thanks to the prompt response of the fire brigade. Barn B has been renovated using local stone to compliment Bank House Farm. Barn A is subject to this current application.

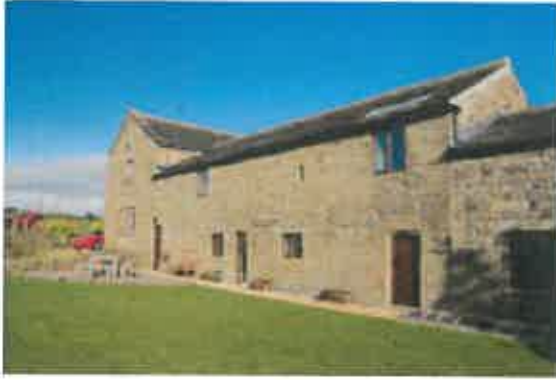
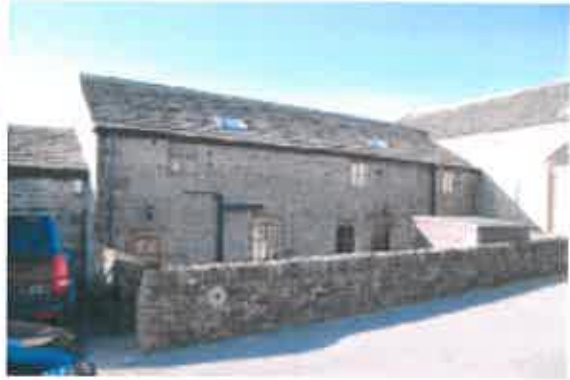
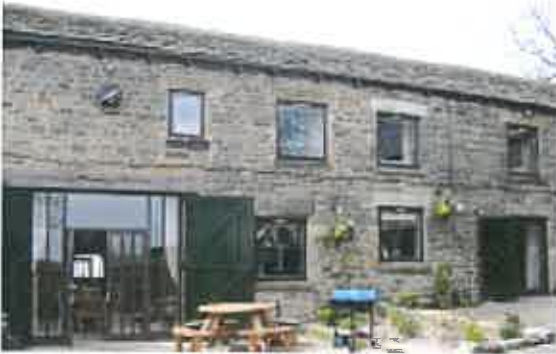
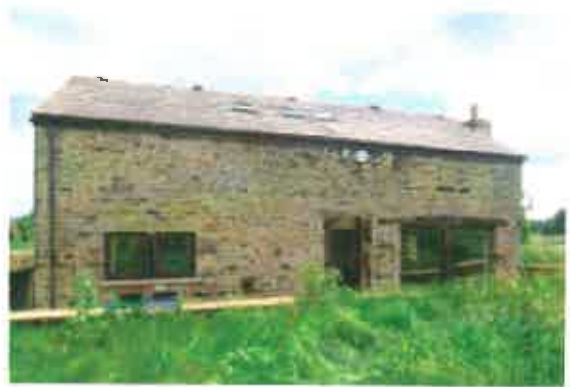
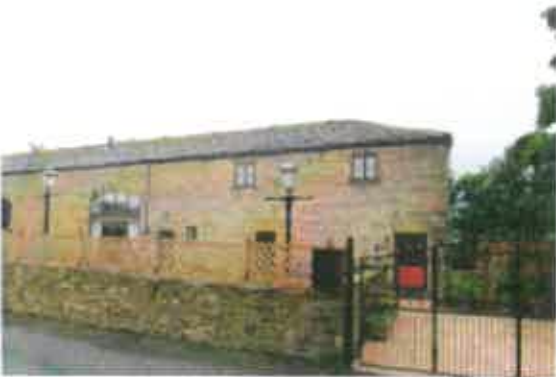
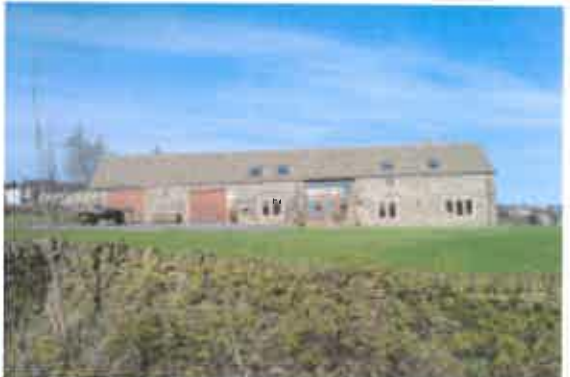
The photos show several sensitive barn conversions around the area.

Barn conversions around the area
