57 High Street, Silkstone

Bat Survey Report

4th July 2024

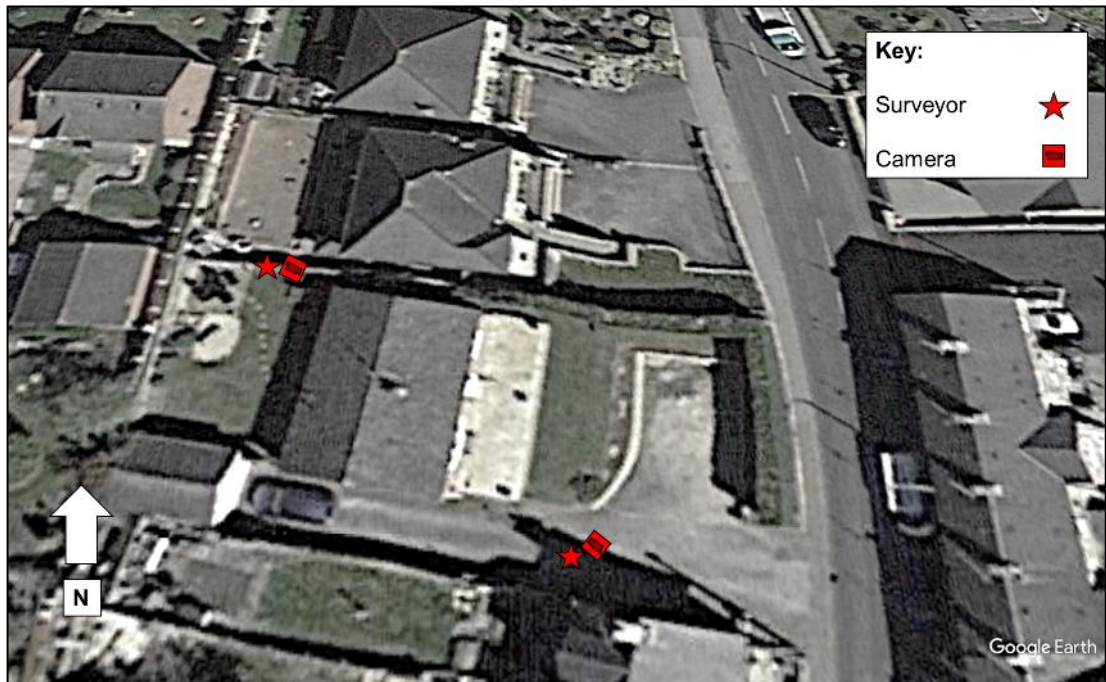
Figure 2. Building numbering and nocturnal survey plan

- 4.2.5 A single dusk emergence survey was undertaken by Amanda Murphy (Bat Survey Class license WML-A34-Level 2, 2020-47913-CLS-CLS) and Carl Dixon on 19th June 2024. This survey commenced 15 minutes prior to sunset and continued until 1.5 hours after this time. Two infra-red lit Canon XA10 cameras with external floodlights were used to aid surveyor observations. Wildlife Acoustics EM Touch bat detectors and accompanying iPod recorders were used to detect and record acoustic bat calls during the survey. The arrangement of surveyors and cameras is shown in Figure 2.

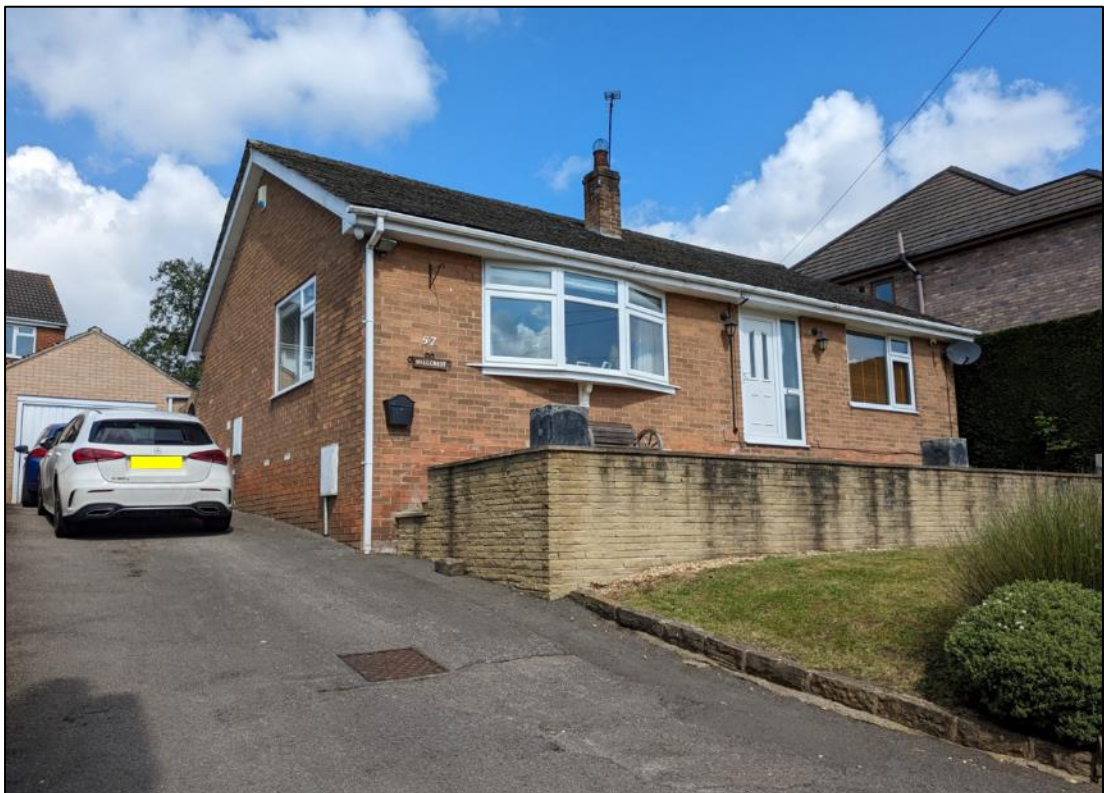
- 5.2.3 The dwelling comprised a c.1980s brick-built bungalow with cavity walls and a dual-pitched concrete tiled roof (Plates 1-3). A single brick chimney was present centrally within the east pitch. The bungalow had wooden soffits, double-glazed uPVC framed windows and plastic gutters.

Plate 1. Southeast corner of bungalow with garage on left of image

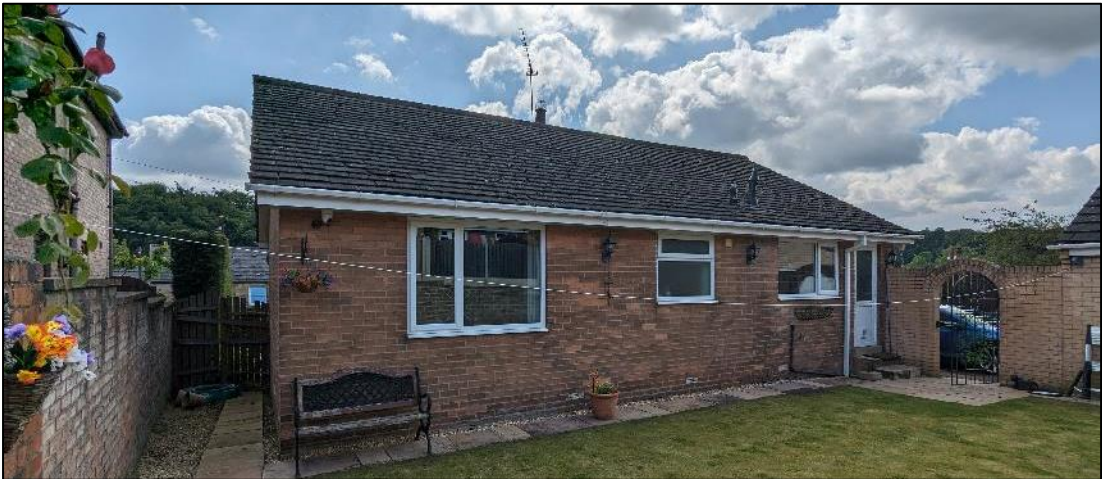
Plate 2. West elevation of bungalow

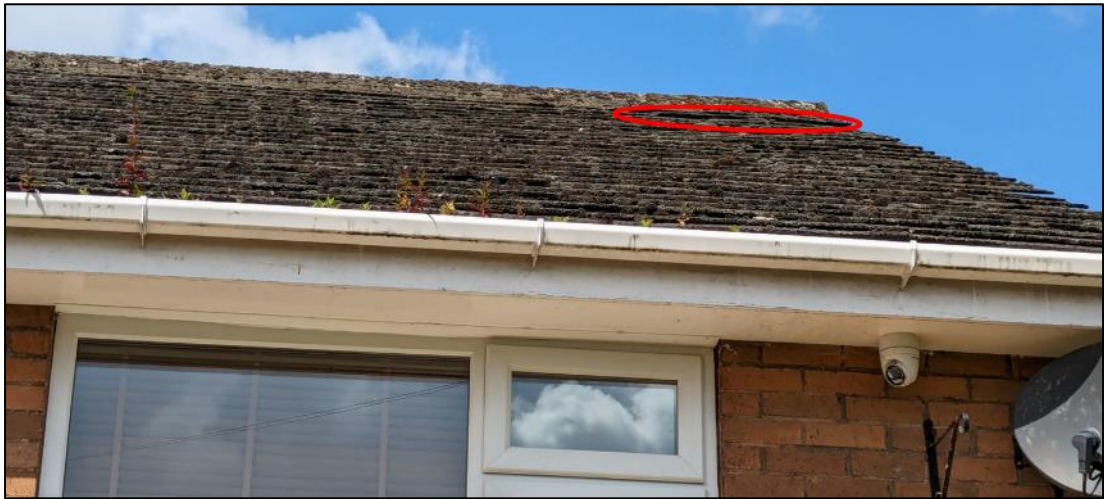
- The verges were un-pointed, potentially allowing bats access to the space between tiles and felt (Plate 4).
- The soffit on the south gable was broken, potentially allowing access between the barge and soffit board (Plate 5).
- Occasional lifted roof tiles were present (Plate 6).

Plate 5. Lifted roof tiles on east pitch

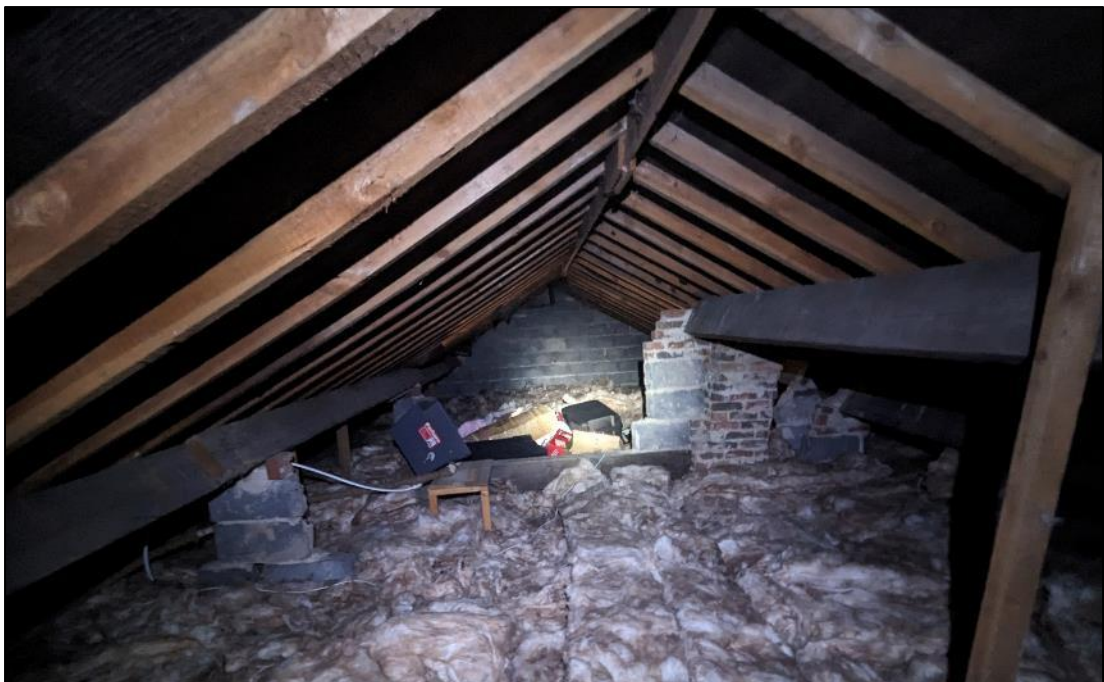
5.2.5 The roof was lined with hessian backed Type 1F bituminous felt and suspended on a ridge beam, purlins, rafters and battens. The roof void was approximately 2 m high with c. 400 mm of glass fibre insulation on the ceiling. No signs of bats were recorded from any location within the roof void or on the exterior of the dwelling. The bungalow's roof void was cobwebby, however, tears in the felt were noted.

Plate 6. Roof void in bungalow

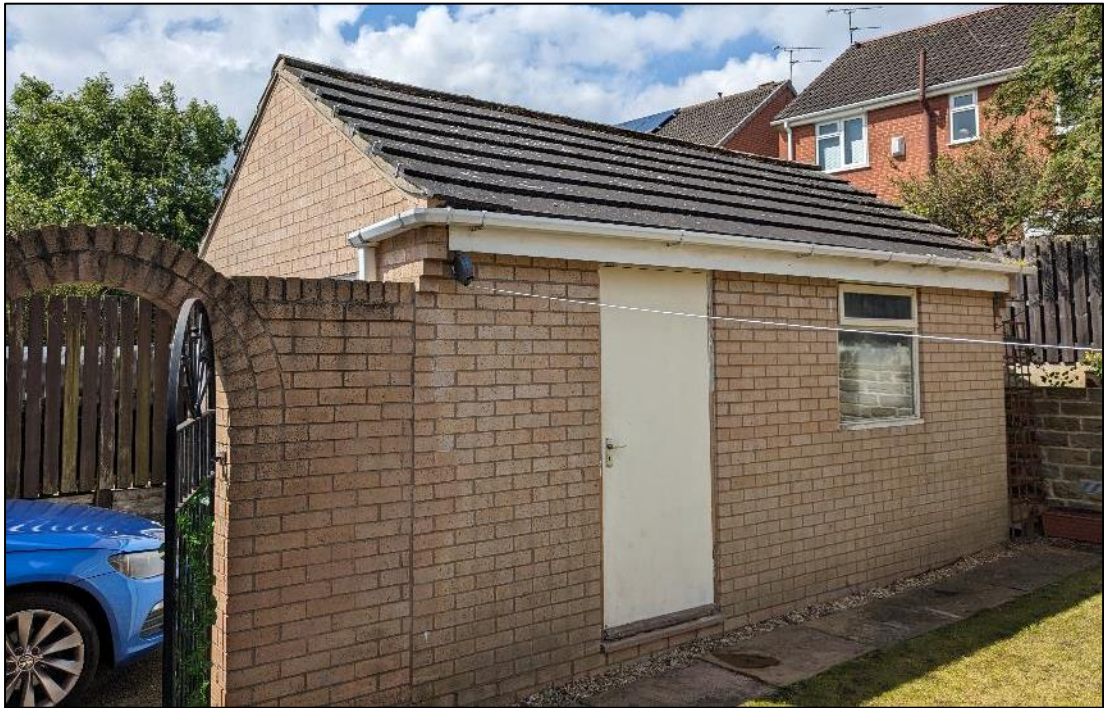
- 5.2.7 A single-storey brick-built garage was located to the southwest of the bungalow (Plates 1 & 7). This structure had a dual-pitch concrete tile covered roof with mortar filled verges. The garage had wooden fascia boards and plastic gutters with an up-and-over door on the east gable and a wooden single door and wood-framed window on the north elevation.

Plate 7. Northeast corner of garage

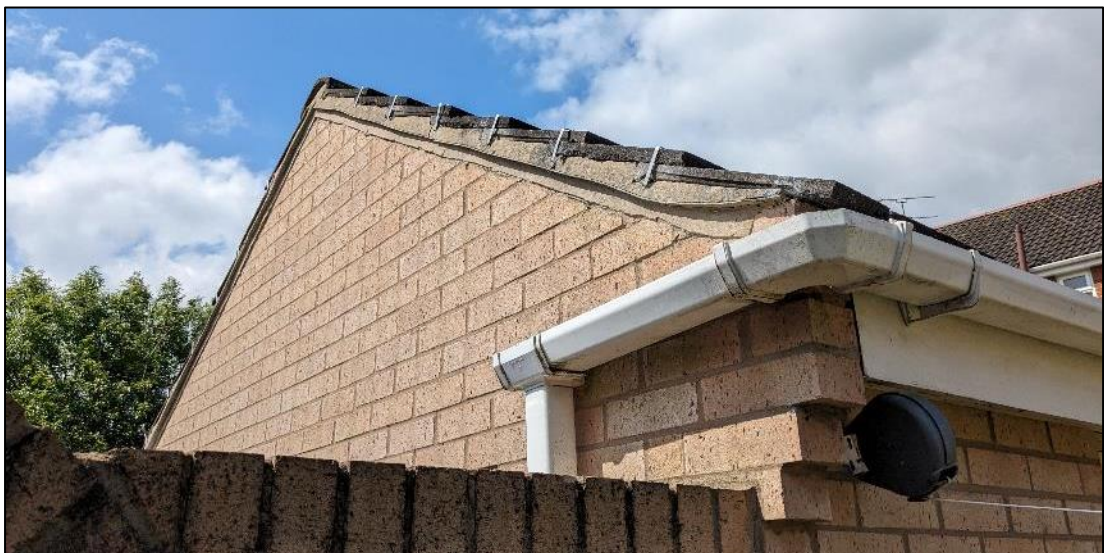
- 5.2.8 No potential roost features were recorded from the exterior of the garage, with the building found to be in a good state of repair (Plate 8).

Plate 8. Well pointed verge on east gable of garage

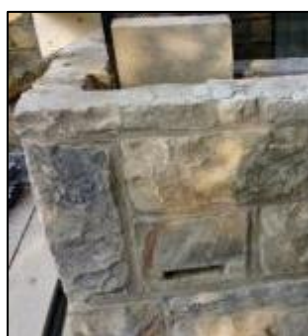
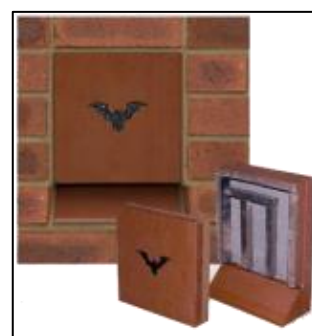
Plates 9-11. Build-in bat roost products

- 6.3.2 Although bats do not appear to be roosting at 57 High Street, in accordance with the aims of the National Planning Policy Framework (2023) and Barnsley Council’s Biodiversity and Geodiversity Supplementary Planning Document, it is recommended that one new bat roosting feature be incorporated within the redeveloped dwelling. It is advised that an enclosed and integrated bat box, of a design such as either the Build-in WoodStone Bat Box or Istock Enclosed Bat Box C (Plates 9-11) be installed, at wall top height on the south gable. The box should be sited away from areas of light spill. For further information on appropriate bat roosting features please contact Middleton Bell Ecology.

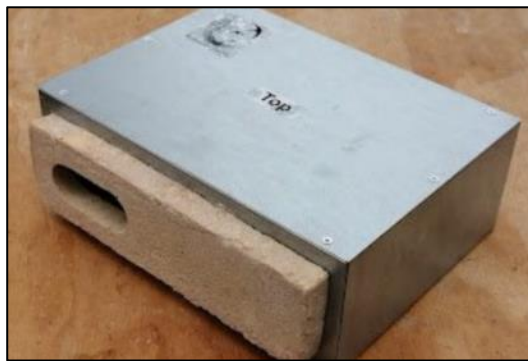
Plate 12. S Brick

- 6.3.5 In accordance with the aims of the National Planning Policy Framework, and to provide an enhancement for nesting birds, it is recommended that one integrated swift *Apus apus* box (i.e. S Brick (Plate 12)) be installed within the new dwelling. This box should be fitted at wall top height and may be installed across any elevation, with the top of the north gable a suitable location. Studies have shown that swift boxes are used by other bird species that utilise buildings and consequently this measure will provide potential nesting space for house sparrows *Passer domesticus* and starlings *Sturnus vulgaris*, in addition to potentially providing future nest space for swift.

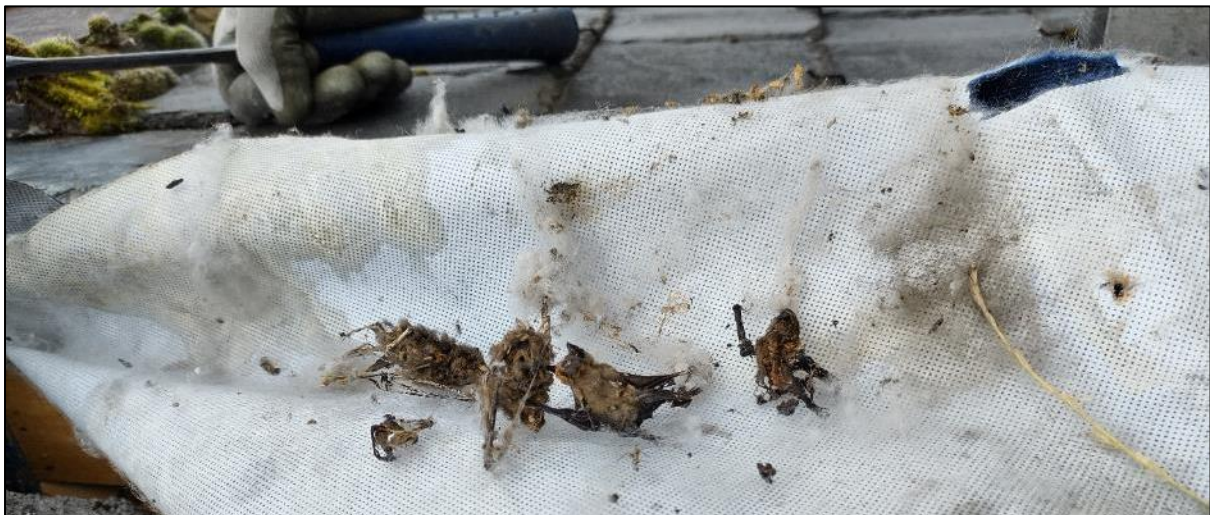
Non-bitumen coated membranes used below roof slates and tiles present a significant problem for bats. Over time, strands are pulled away from the surface of these materials as bats crawl over them. These fuzzy strands are very strong and can tangle and trap bats, sometimes causing the death of bats over multiple years¹.

One example we have encountered comprised a pipistrelle roost which formed in a building extension constructed in 2009. Over the course of just 13 years the roofing felt degraded to the extent that it trapped and killed more than 10 bats. Fortunately, the problem in this roost was identified and remedial work was undertaken to replace the roofing membrane in 2022.

Plate A1.1. Four dead pipistrelles tangled in breathable roofing felt

The best roofing membrane option for areas where bat roosts are expected is traditional Type 1F bitumen coated hessian backed roofing felt. Bitumen coated roofing felts have been widely and safely used as a secondary weather barrier since approximately the 1950s/1960s. Wooden sarking has also been used for many decades and if appropriately treated, is safe for
