**JOWETT HOUSE DOVECOTE.**

**BAT SURVEY REPORT.**

**Ref No: 200901/1.**

**Date: 28<sup>th</sup> September 2020.**

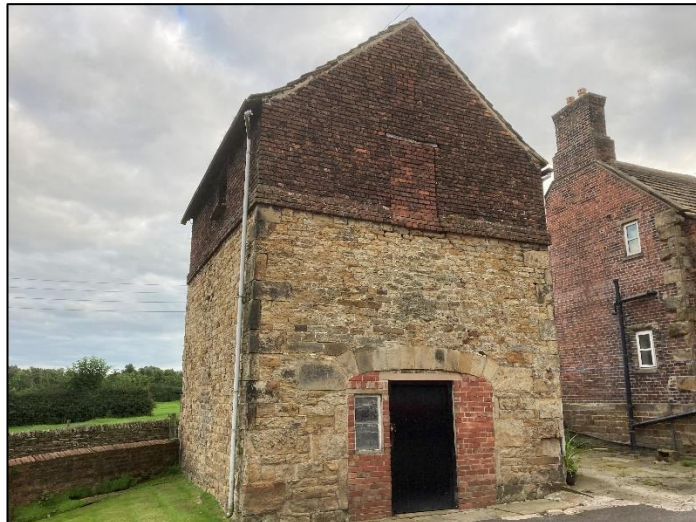
3.3.2. The dovecote building is shown below.

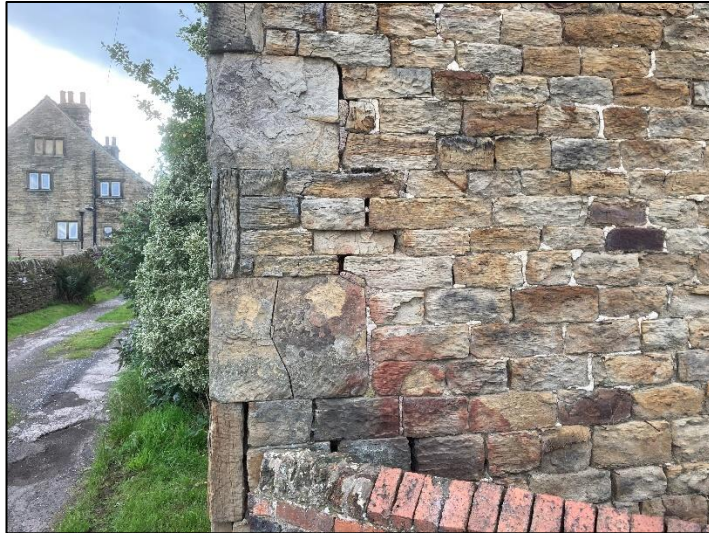
3.3.1. The dovecote is a three-storey building with lower walls of stone and with brick above. There are numerous open joints in both the stonework and the brickwork, as shown below.

6.5. A final check will be carried out by an ecologist prior to works commencing and at that time, a selection of gaps in the pointing of the outer walls will be allocated to remain without additional pointing, to provide continued bat roosting opportunities.

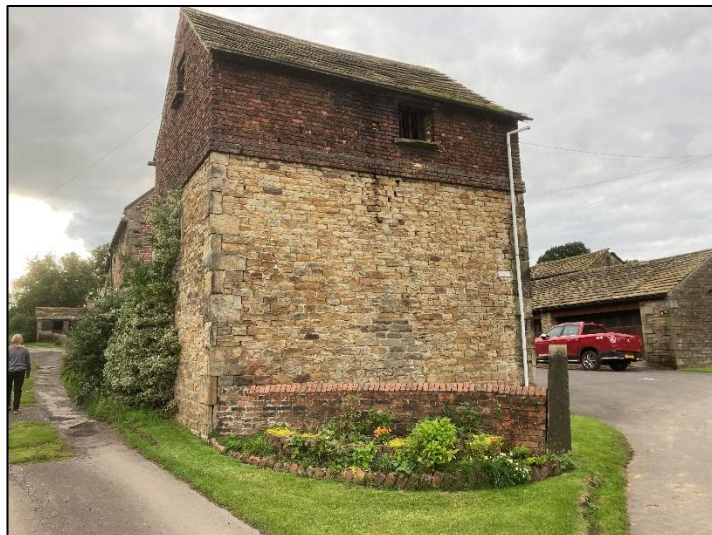
3.3.2. There are also three open windows on the first and second floors, as shown below although the top two windows have a mesh across most of them.

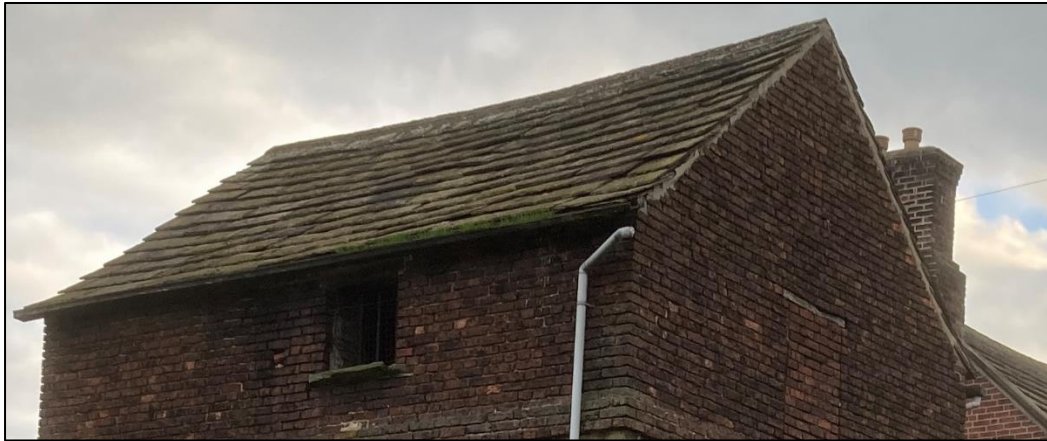
3.3.3. The roof is covered with natural stone tiles. These are all in place, as are the ridge tiles although there are gaps underneath the tiles where they do not sit flat.

6.7. In addition, four bat access tiles will be installed in the replaced roof of the building to provide additional future opportunities for roosting bats. Two bat access tiles will be installed either side of the pitched roof to allow bats to access the space between the tiles and the felt beneath.

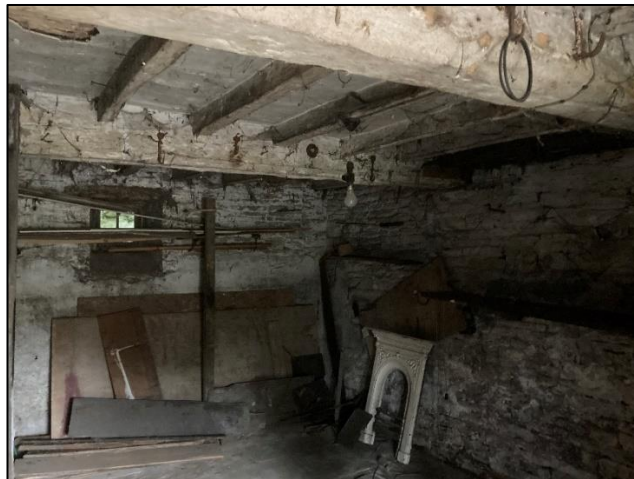
3.3.4. During the first survey there was access into the ground floor of the building only. The photograph below shows inside the ground floor.

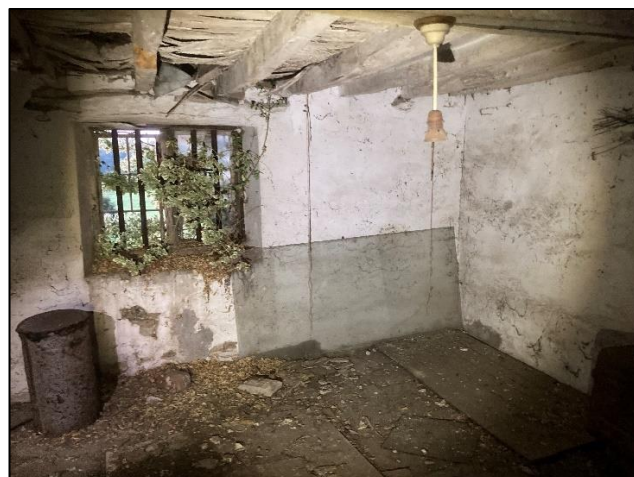
3.3.5. During the second survey access was gained to the middle floor where there is an open window, partly obscured by shrubs. The ceiling and walls are in dilapidated condition.

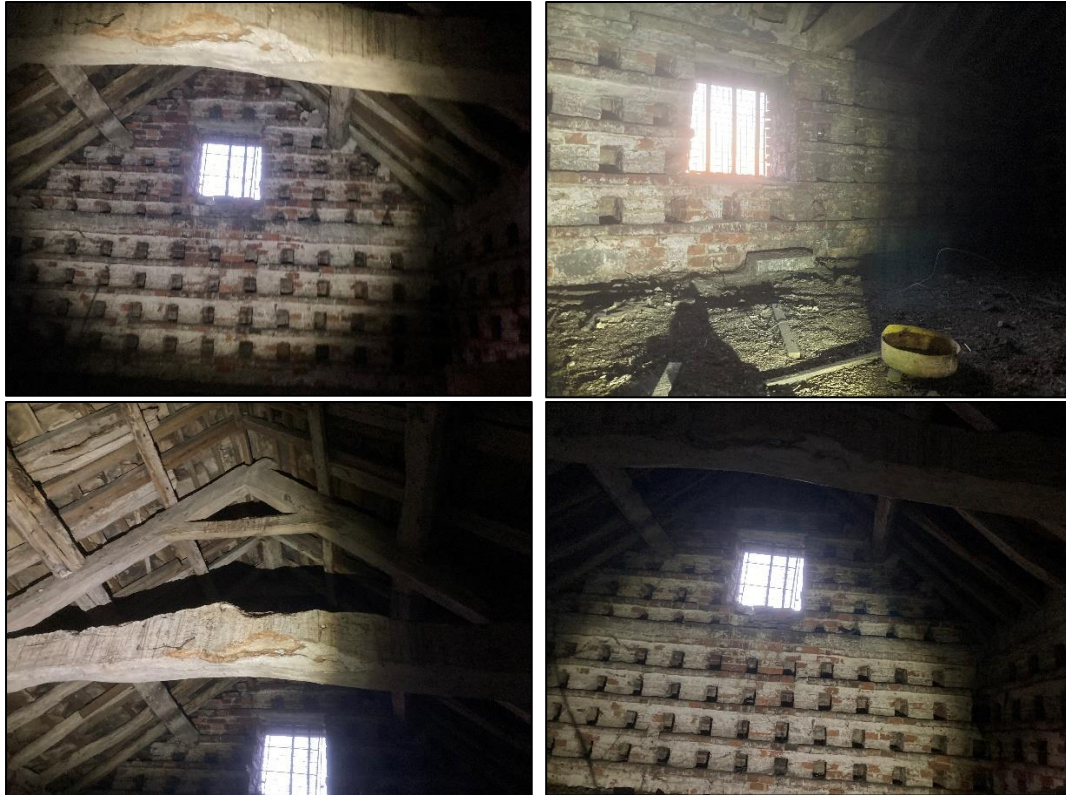
3.3.6. Access was possible through the loft hatch into the top floor although the floor was assessed to be unsafe to walk on. The following photographs were taken from the loft hatch.

3.3.7. The house was assessed to have moderate potential for roosting bats in line with the Bat Conservation Trust Good Practice Guidelines.

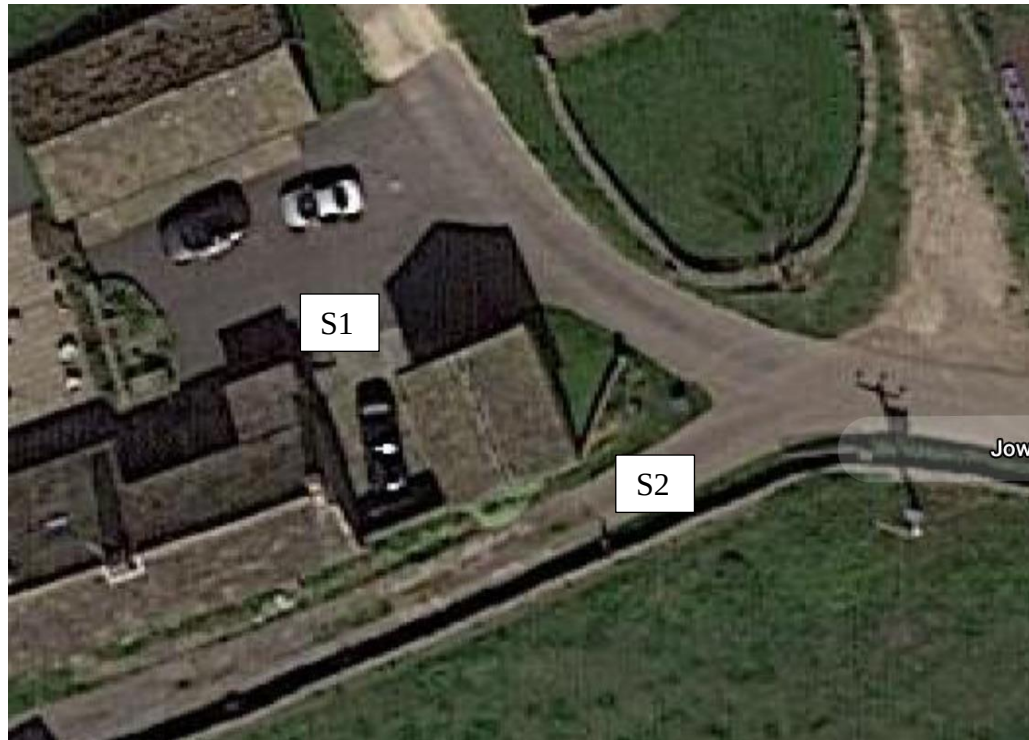
3.4.4. The surveyors were positioned so that they could see all aspects of the building simultaneously. The position of each surveyor was as shown on the aerial photograph below.

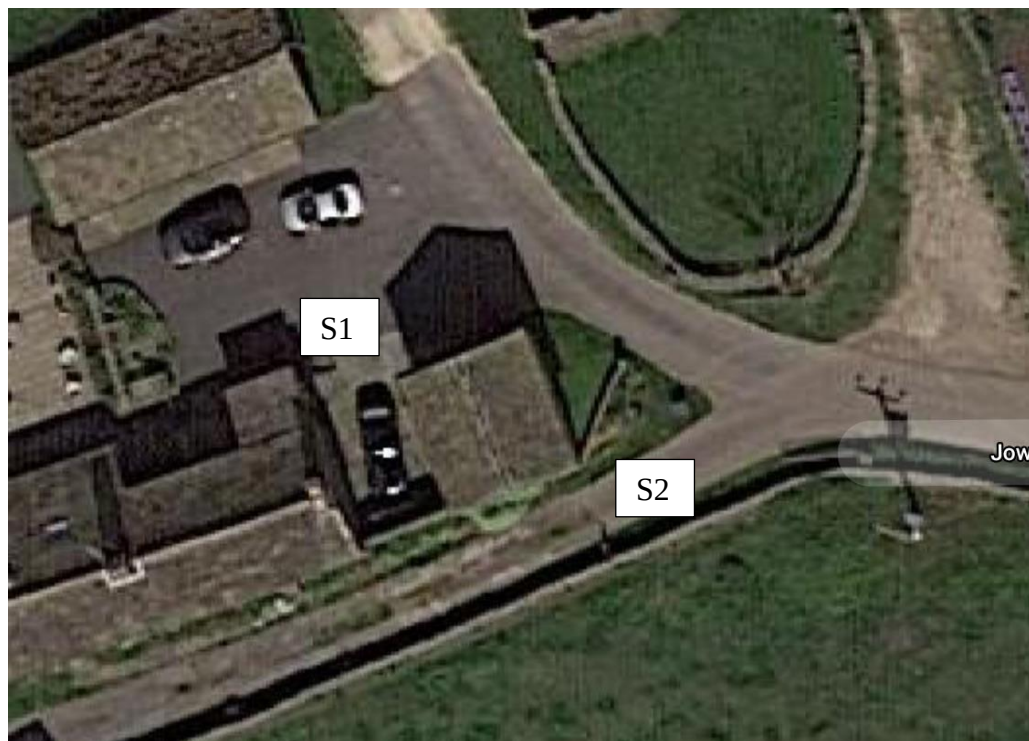
3.5.4. The surveyors were positioned so that they could see all aspects of the building simultaneously. The position of each surveyor was as shown on the aerial photograph below.

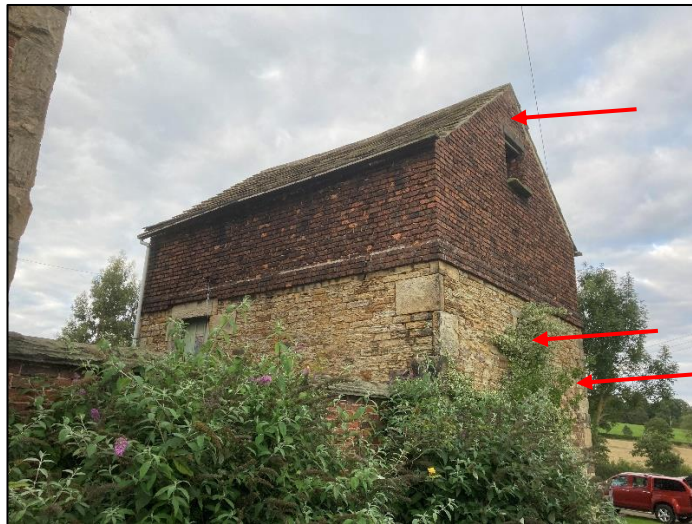
3.5.7.3. In the event, one Common Pipistrelle flew into the building through the window to roost and two flew into gaps in the outer wall to roost, one high up in the brickwork and one low down in the stone wall. The roost locations are shown below.

4.4. The dovecote was assessed to contain a Common Pipistrelle day roost and a Soprano Pipistrelle day roost inside the building plus two Common Pipistrelle day roosts in the outer walls of the building.

5.1. As there are bat roosts in the walls and inside the dovecote, it will be necessary to prepare a mitigation strategy in support of the planning application outlining how the bats will be dealt with in order to maintain their existing conservation status during and after the development.

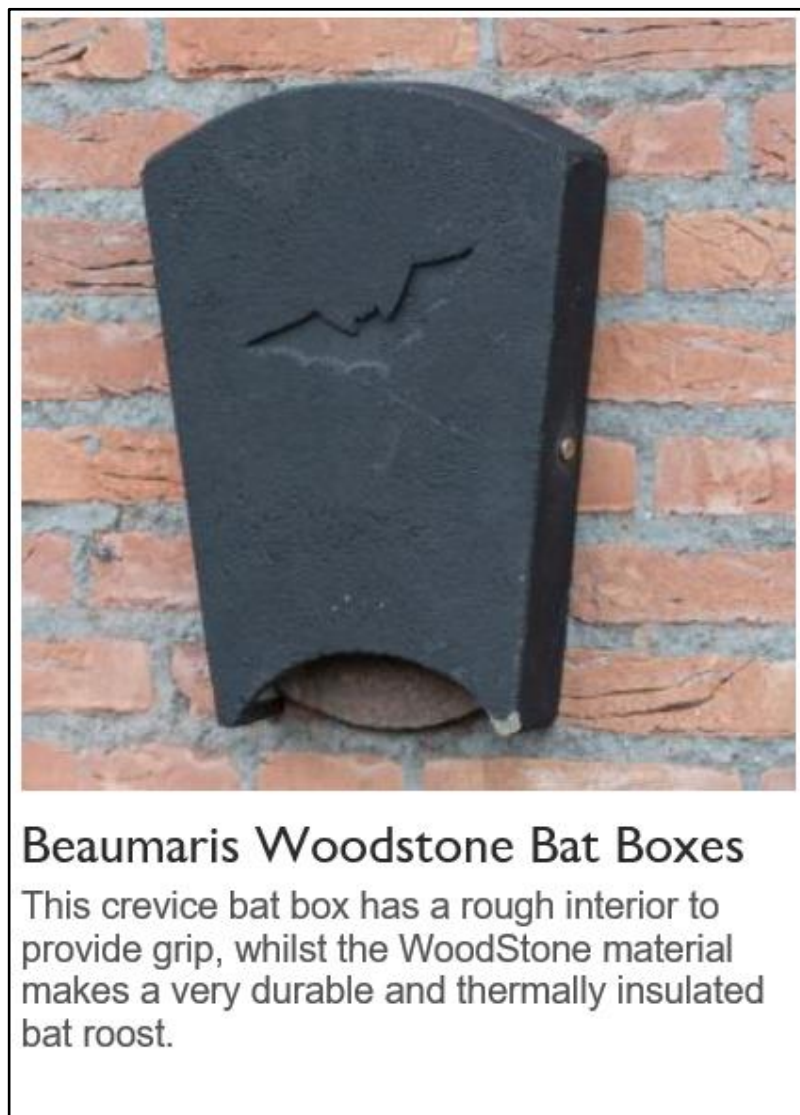
### Beaumaris Woodstone Bat Boxes

6.3. The design of bat box will be a Beaumaris Woodstone box as shown below or equivalent.

This crevice bat box has a rough interior to provide grip, whilst the WoodStone material makes a very durable and thermally insulated bat roost.

6.2. A bat box will be erected on the gable end wall of the garage across the yard from the dovecote. This will be retained for at least five years.

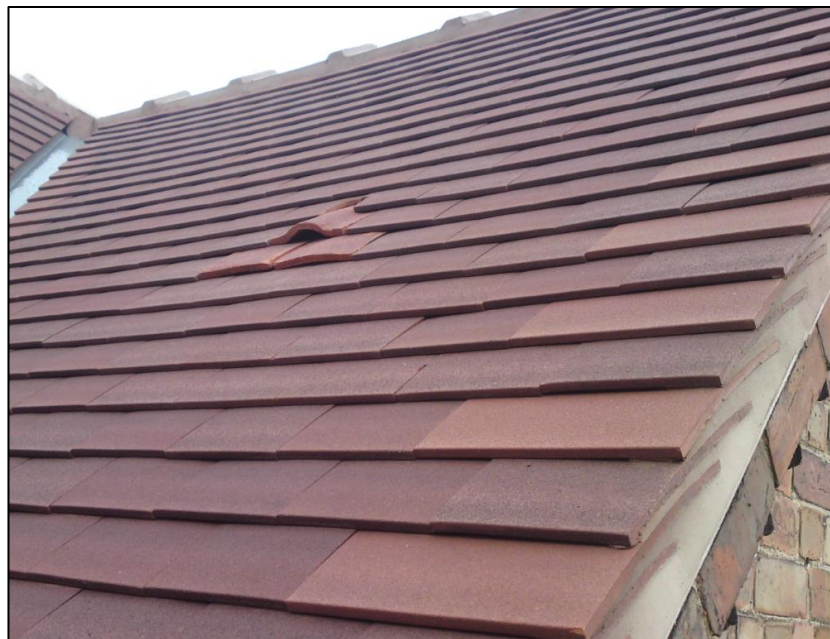
6.8. Bat access tiles will be as shown below or equivalent.
