REMEDIATION STRATEGY  
FORMER MONCKTON COKE WORKS,  
NEAR BARNSELEY  
for  
HARGREAVES (UK) SERVICES Ltd

**Remediation Strategy**  
**Former Monckton Coke Works, near Barnsley**  
**for**  
**Hargreaves (UK) Service Ltd**

| <b>G15009</b> | | <b>Remediation Method Statement</b> | | |

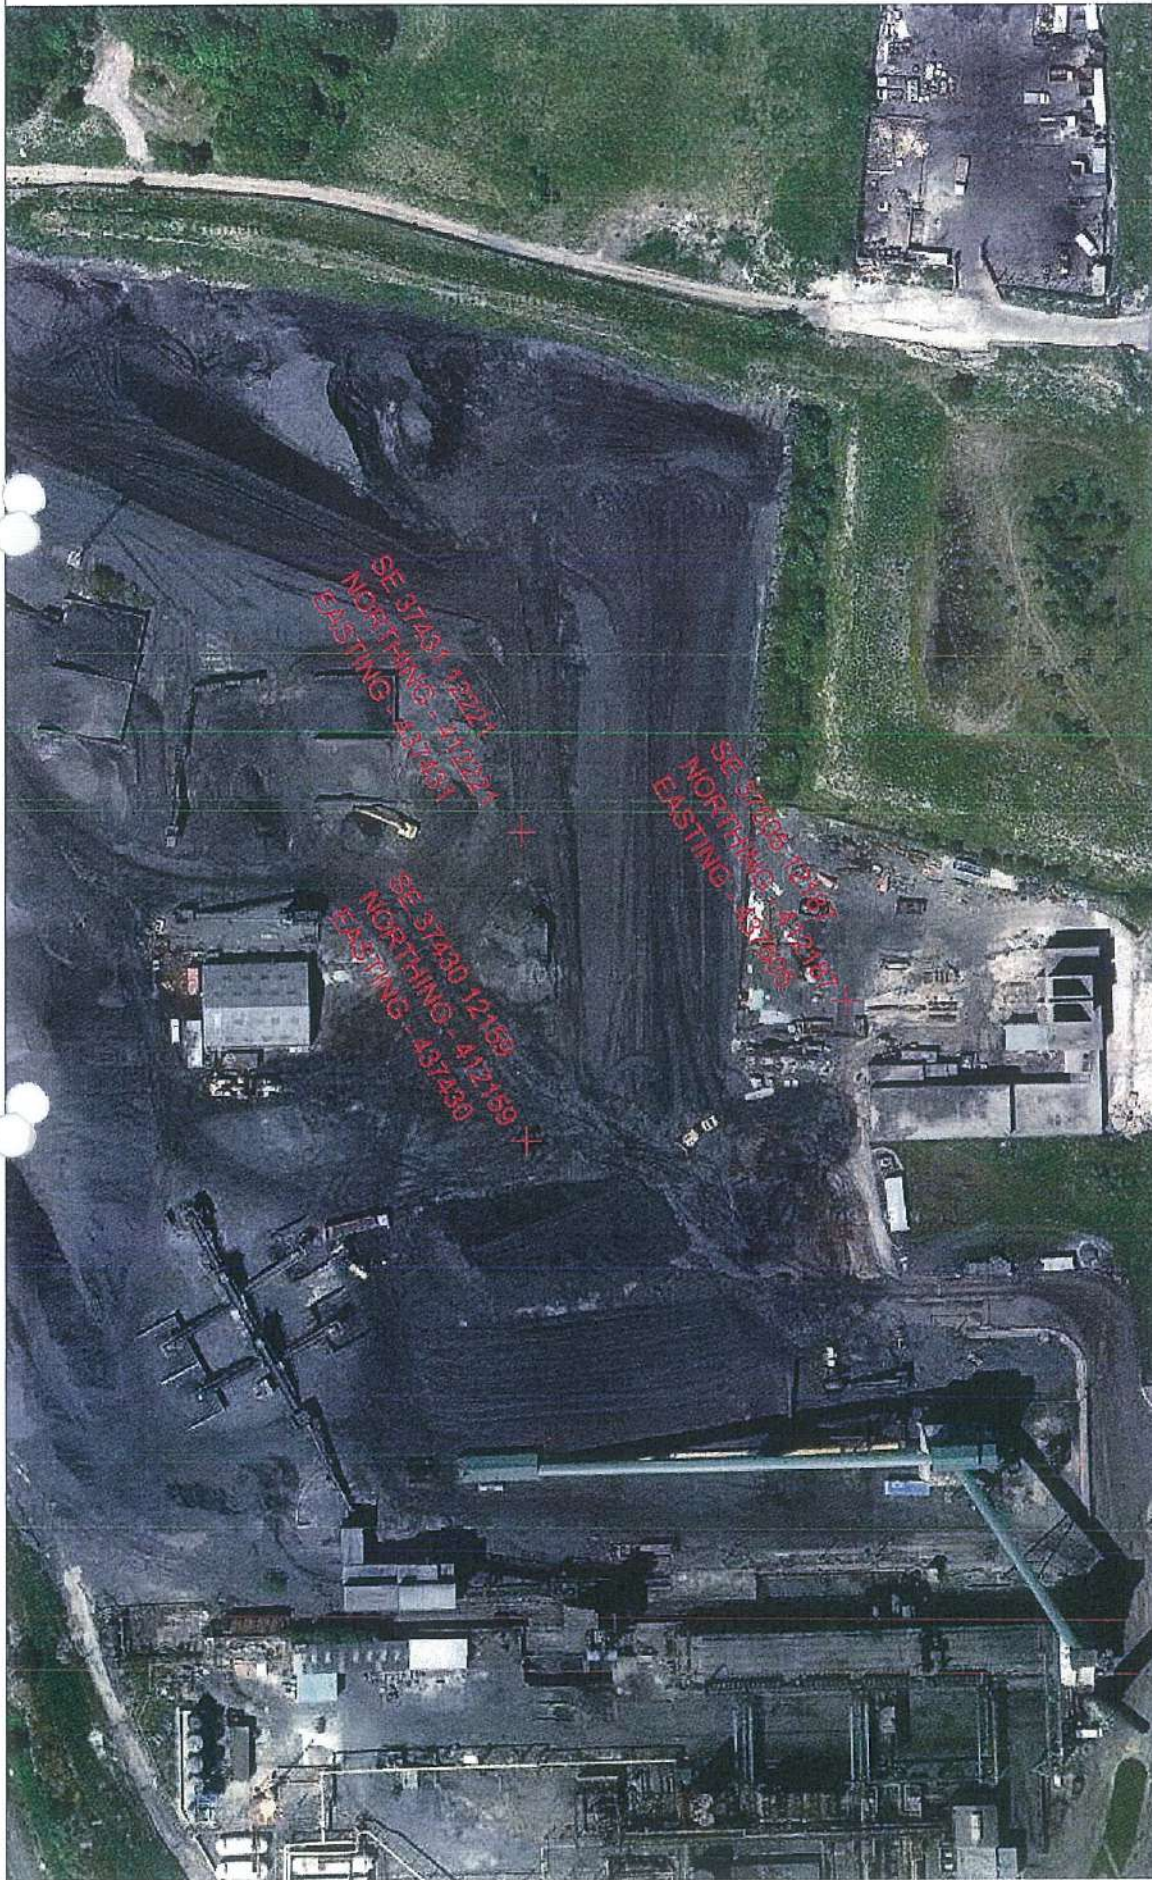
Drawing No. **G15009-700** Rev.

Patrick Parsons Ltd (PPL) has been appointed by Hargreaves (UK) Services Ltd (client) to produce a Remediation Strategy in relation to the proposed mixed land-use development at the site known as Monckton Coke Works. A site features plan is attached in Appendix A.

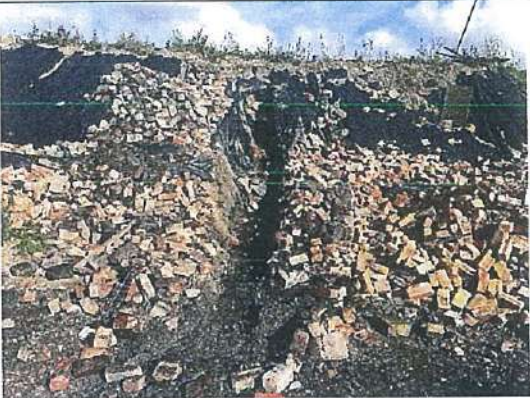
| | Photograph | Description |
|---|---|---|
| TH1 | | Mostly light grey to yellow coloured whole and partially broken bricks, especially in the top two thirds of the exposed stockpile. Occasional red bricks. The bottom third was also made up of the same bricks but with a fine dark brown fill material around the bricks. The odd brick within the stockpile had a black face showing potential signs of contamination. |

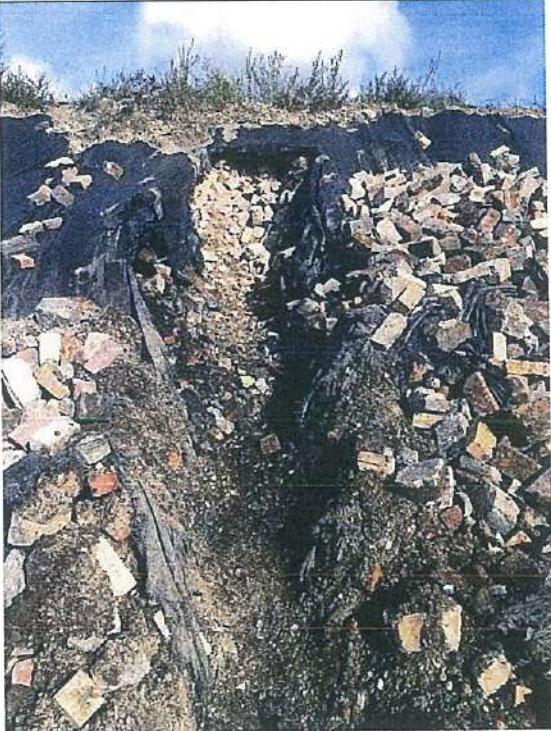
| | Photograph | Description |
|---|---|---|
| TH2 | | Mostly light grey coloured whole and partially broken bricks, especially in the top two thirds of the exposed stockpile. Occasional red bricks. The bottom third was also made up of the same bricks but with a fine dark brown, slightly ashy fill material around the bricks. The odd brick within the stockpile had a black face showing potential signs of contamination. |

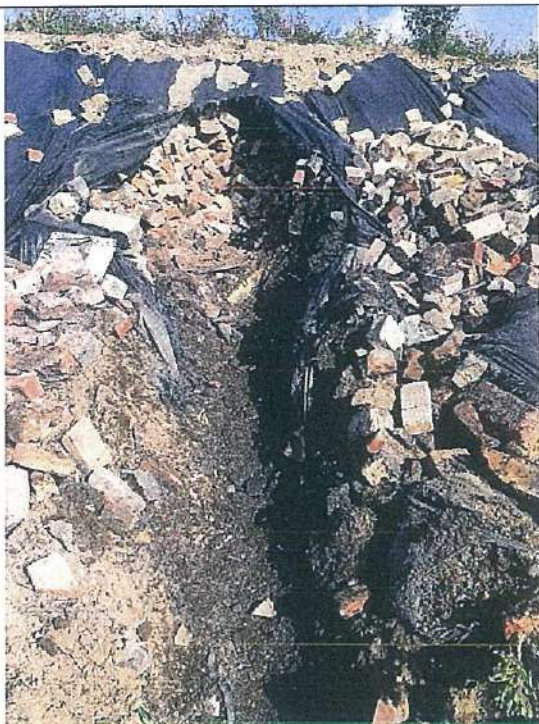
TH3

Mostly light grey and yellow coloured whole and partially broken bricks, especially in the top two thirds of the exposed stockpile. Occasional red bricks. The bottom third was also made up of the same bricks but with a fine dark brown, slightly ashy fill material around the bricks. The odd brick within the stockpile had a black face showing potential signs of contamination.

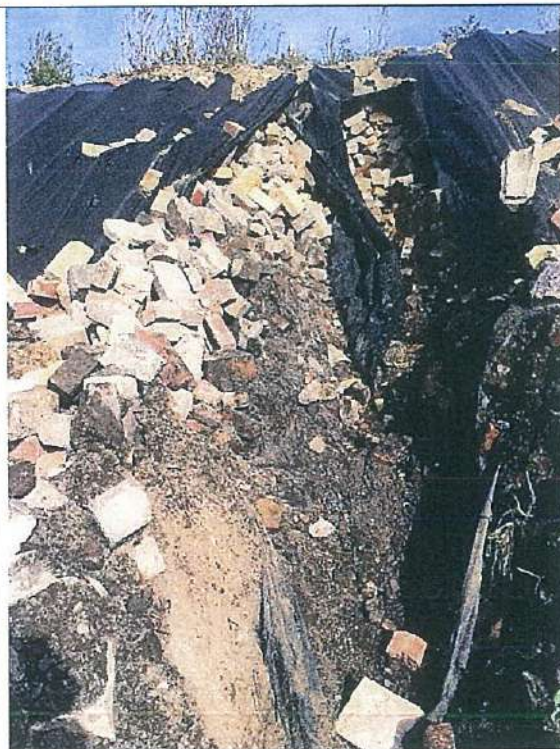
TH4

Mostly light grey and yellow coloured whole and partially broken bricks, especially in the top two thirds of the exposed stockpile. Occasional red bricks. The bottom third was also made up of the same bricks but with a fine dark brown to grey, slightly ashy fill material around the bricks. Some of the bricks looked dirty with dark brown to grey. The odd brick within the stockpile had a black face showing potential signs of contamination. Some metal and wood debris noted within the stockpile material.

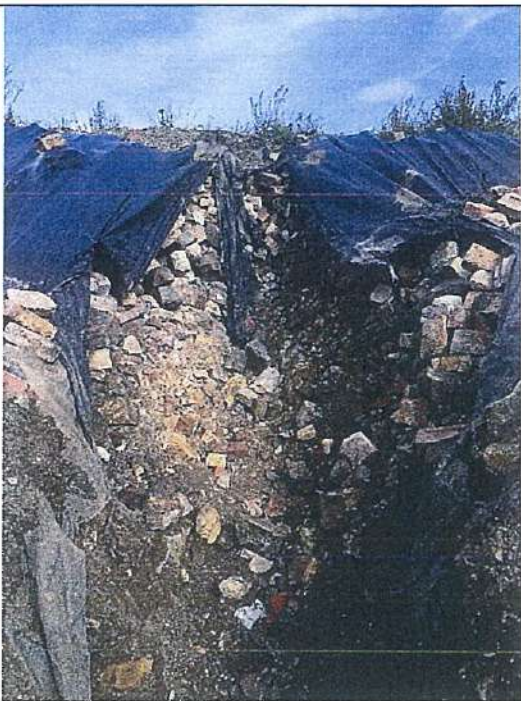
| TH5 | | <p>Mostly light grey coloured whole and partially broken bricks, especially in the top two thirds of the exposed stockpile. Occasional red bricks. The bottom third was also made up of the same bricks but with a fine dark brown, slightly ashy fill material around the bricks. The odd brick within the stockpile had a black face showing potential signs of contamination.</p> <p>While safe to do so this trench was excavated more deeply than the rest to further understand the nature of the brick stockpile..</p> |

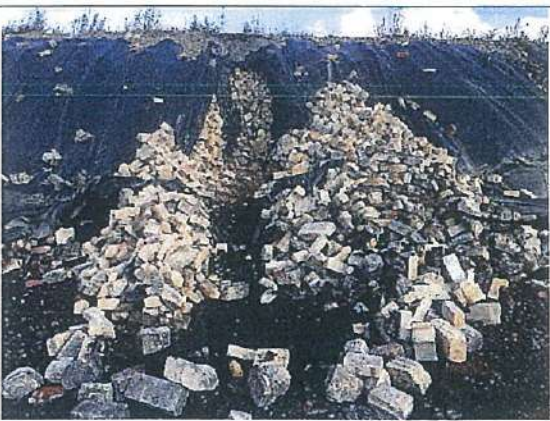
| TH6 | | <p>Mostly light grey and yellow coloured whole and partially broken bricks, especially in the top two thirds of the exposed stockpile. Occasional red bricks. The bottom third was also made up of the same bricks but with a fine dark brown, fill material around the bricks. The odd brick within the stockpile had a black face showing potential signs of contamination. Some metal, wood and plastic debris noted within the stockpile material.</p> |

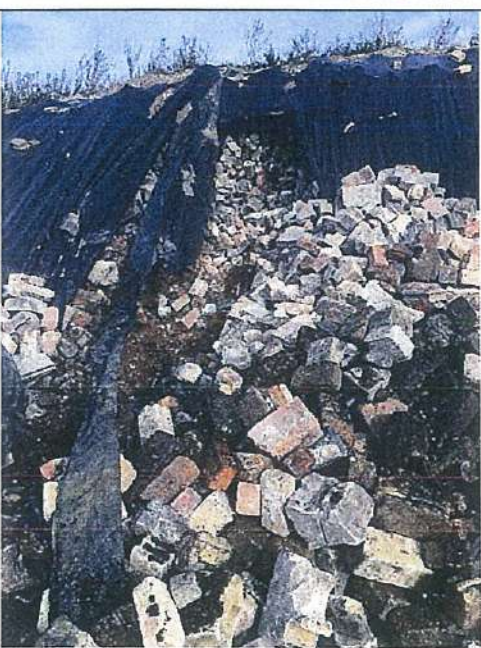
| TH7 | | <p>Mostly light grey and yellow coloured whole and partially broken bricks, especially in the top two thirds of the exposed stockpile. Occasional red bricks. The bottom third was also made up of the same bricks but with a fine dark brown, fill material around the bricks. The odd brick within the stockpile had a black face showing potential signs of contamination.</p> |

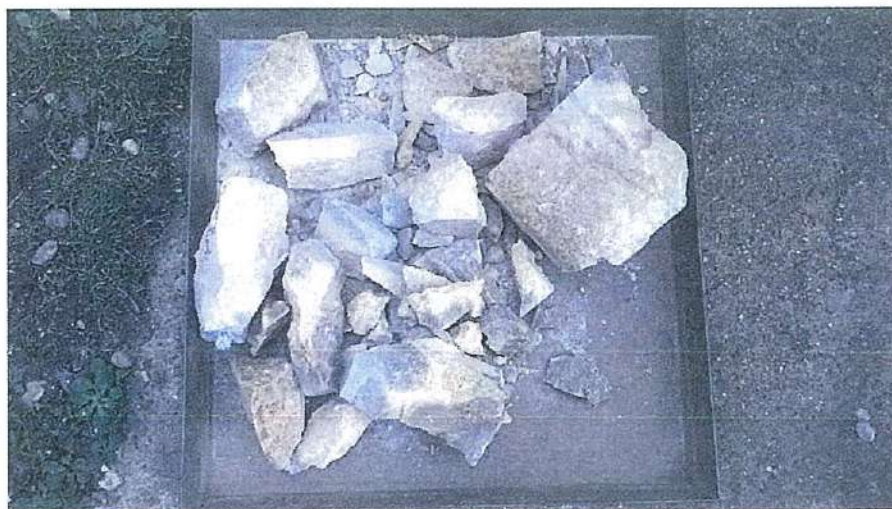
Plate 1 – crushed brick

The crushing tests involved breaking up the bricks using a large metal hammer. The hammering action was used to replicate the hammering of the crushing plates on material within a large scale crushing unit. Two examples of the crushed products can be seen in Plate 1 and Plate 2.

All of the bricks broke down easily with hammering to crush them, which would mean in the full-scale works, there would not be a problem crushing all of the bricks to a reusable size. The lack of detritus and fines within the stockpile means that the stockpile will require little or no screening prior to processing for reuse. On the full scale works as part of the redevelopment, the bricks would be crushed and then potentially graded which would enable use as graded fill. However, further assessment of the risks of grading would be required e.g. requirements for dust suppression and the protection of the health of the operatives.
