**Cannon Hall**  
**Bat Survey Report**  
**21<sup>st</sup> August 2023**

| Document ref: MBE/BAT/2023/077/01 | | | | |

- 1.1.1 A bat survey of Cannon Hall was commissioned by Karen Buttery of Barnsley Council on 19<sup>th</sup> July 2023.
- 1.1.2 The survey was undertaken to inform proposals to re-roof the main Grade II\* listed house at Cannon Hall.

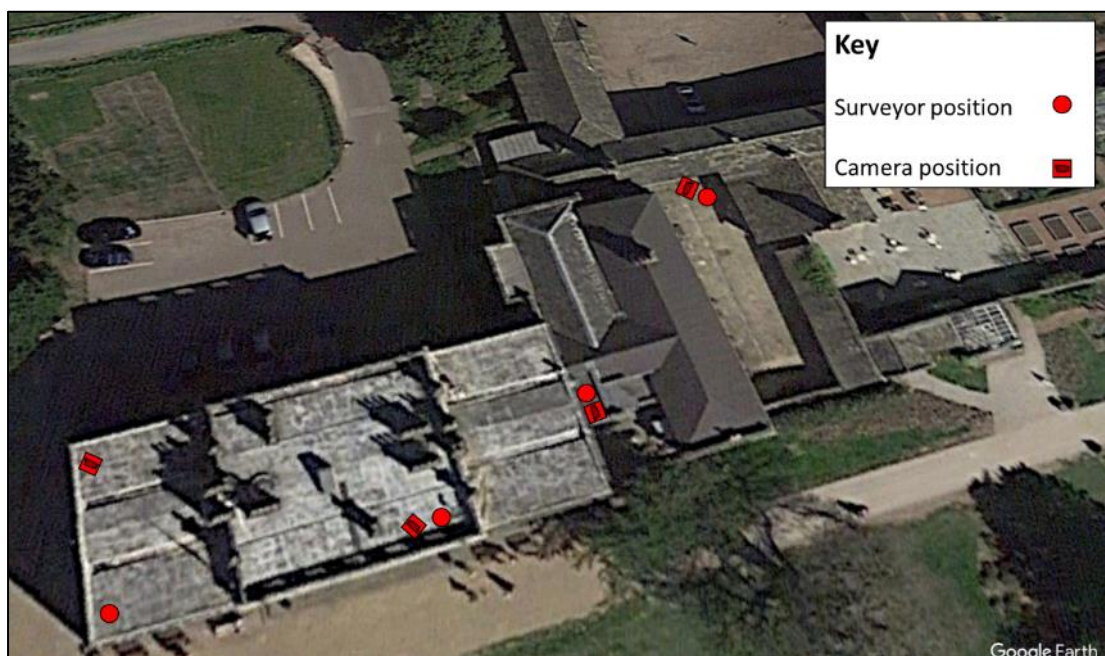
**Figure 2. Nocturnal survey plan**

4.2.7 All surveyors were equipped with Wildlife Acoustics EM Touch bat detectors and iPad/iPod recorders. Three Canon XA10 video cameras and one Panasonic VX980 infra-red video cameras were used during the survey. Camera and surveyor positions are shown in Figure 2.

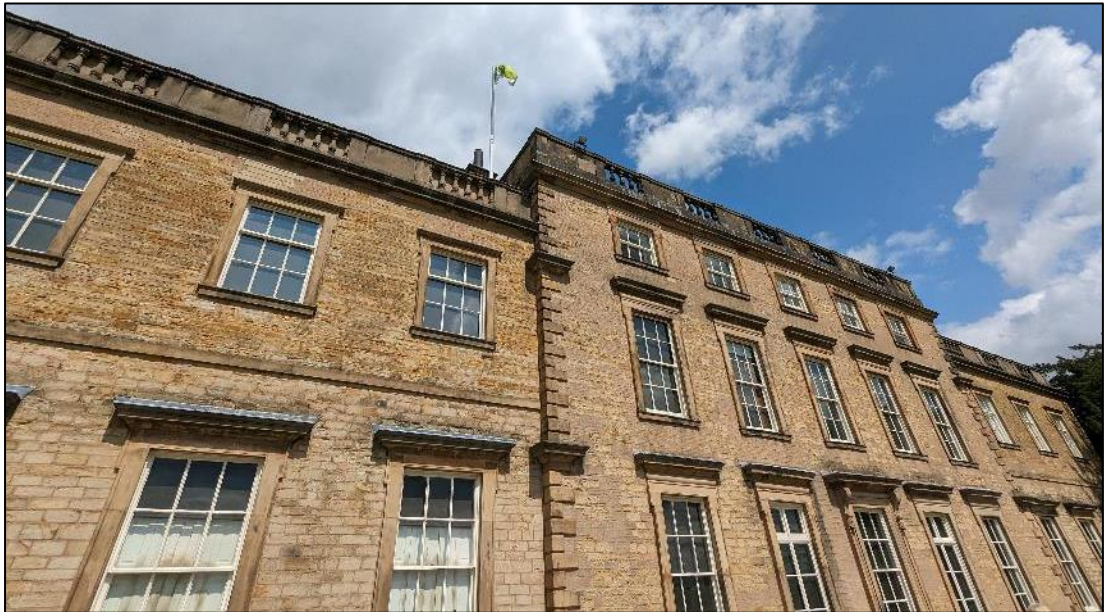
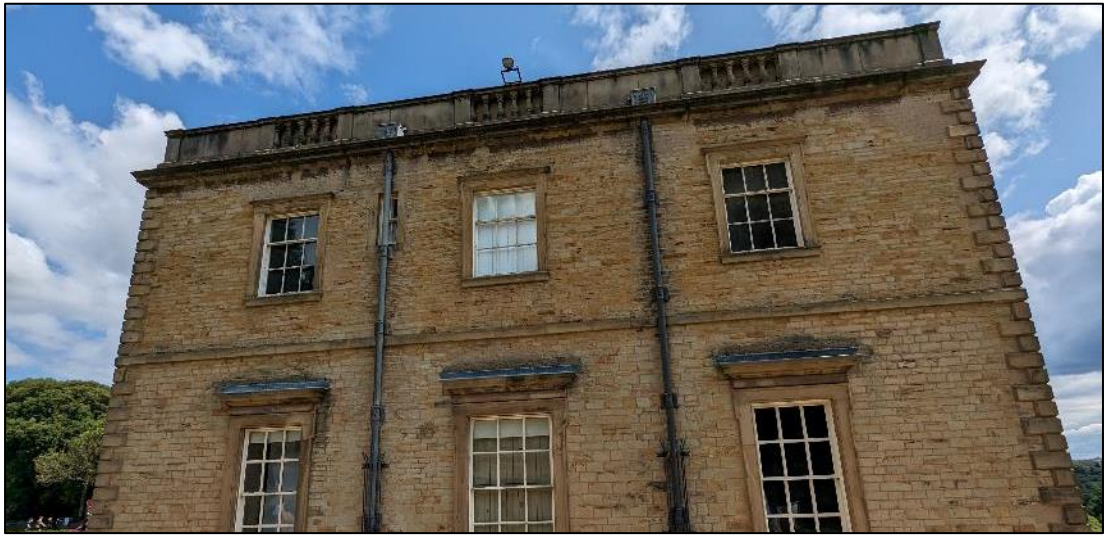
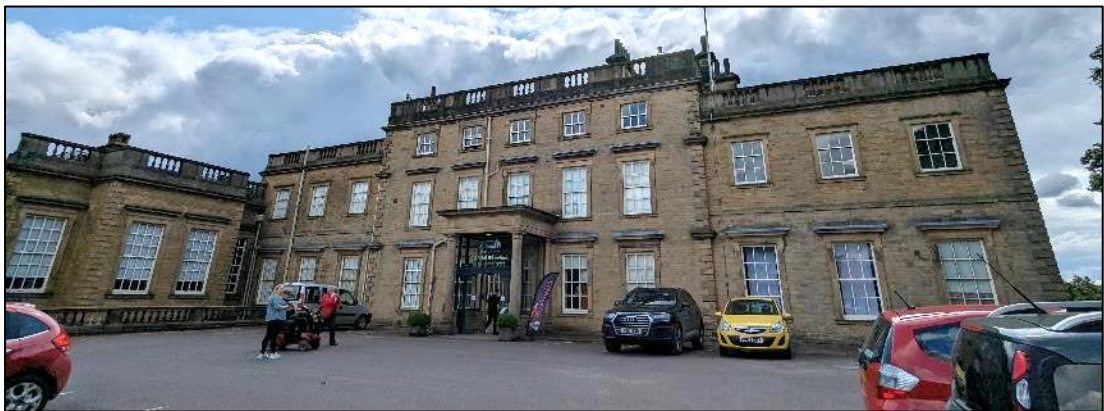
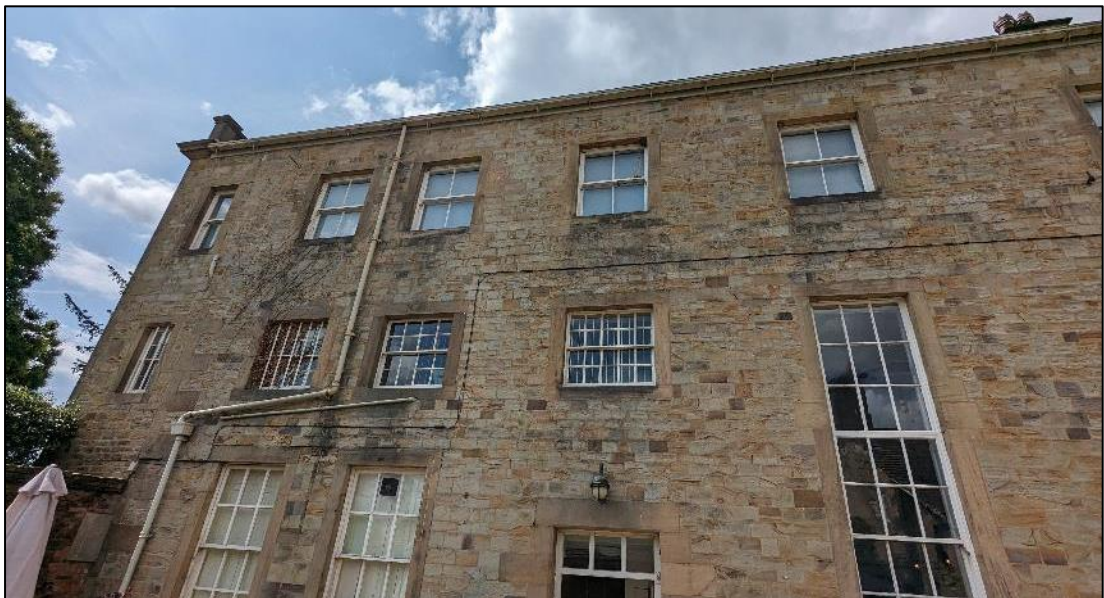
5.2.2 Cannon Hall is a large former country house most likely dating back to the 1700s (Plates 1-4). The house is built of coursed dressed sandstone with a central three storey section and a pair of two storey side wings. A stone built kitchen extends from the northeast elevation. The main house has parapet wall tops, internal rain water goods and single-pane wooden sash windows. The main house has flat bitumen coated roofs with numerous stone chimneys (Plate 5). The kitchen included a dual-pitched and hipped stone slate covered section of roof with a lead ridge, however, the majority of the multi-pitched kitchen roof was covered with bitumen coated felt (Plate 6).

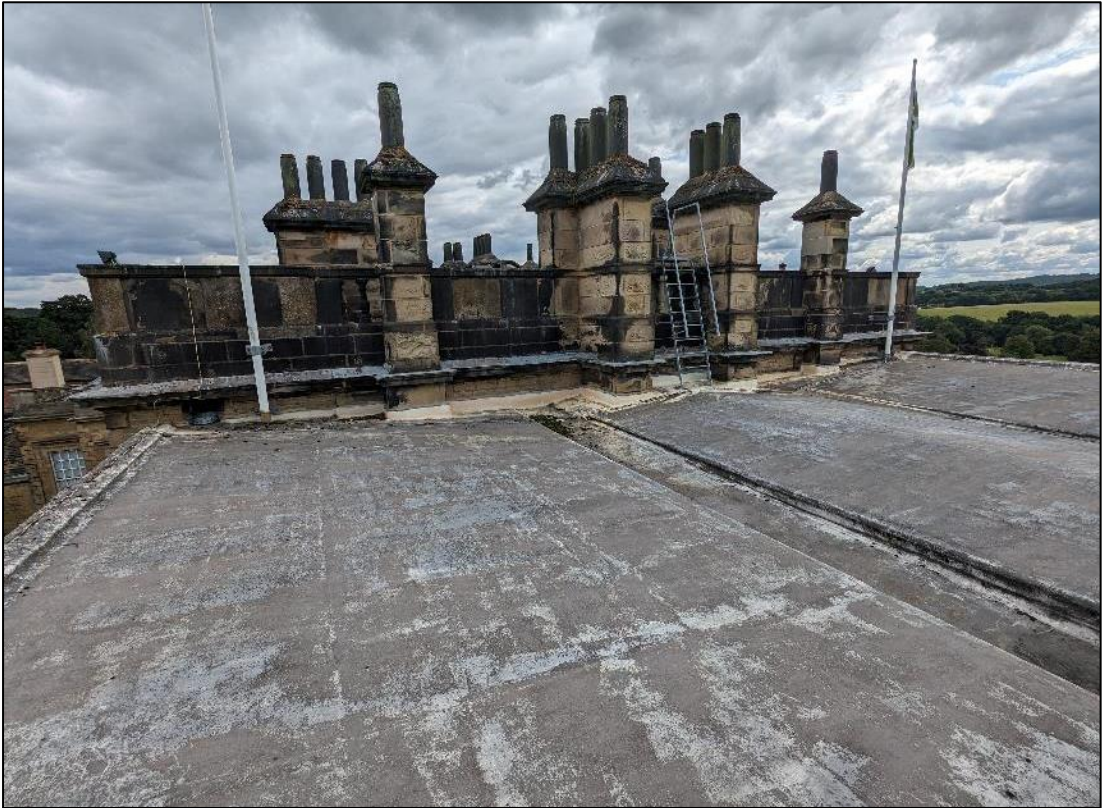
5.2.4 The majority of the roof, being either flat or covered with bituminous felt, lacked potential roost features, the exception comprising the single relatively-small stone slate covered sections of roof (Plate 6). Stone slate covered roofs are associated with use by bats, which may roost in crevice spaces between the stone slates, due to the

**Plate 6. Kitchen roof, including small section of stone slate covered roof**

- 1.1.8 Given that stone-slates are to be used during re-roofing of the kitchen the use of non-bitumen coated roofing membranes (formerly known as breathable roofing membranes) must be completely avoided, with only bituminous Type 1F hessian backed felt to be used. The justification for this recommendation is that bats have been shown to regularly become entangled and die in the component filaments of modern woven roofing membranes. If irregular stone-slates are used, then it will not be possible to prevent future bat access into the roof, whereupon they could come into contact with roofing membranes.

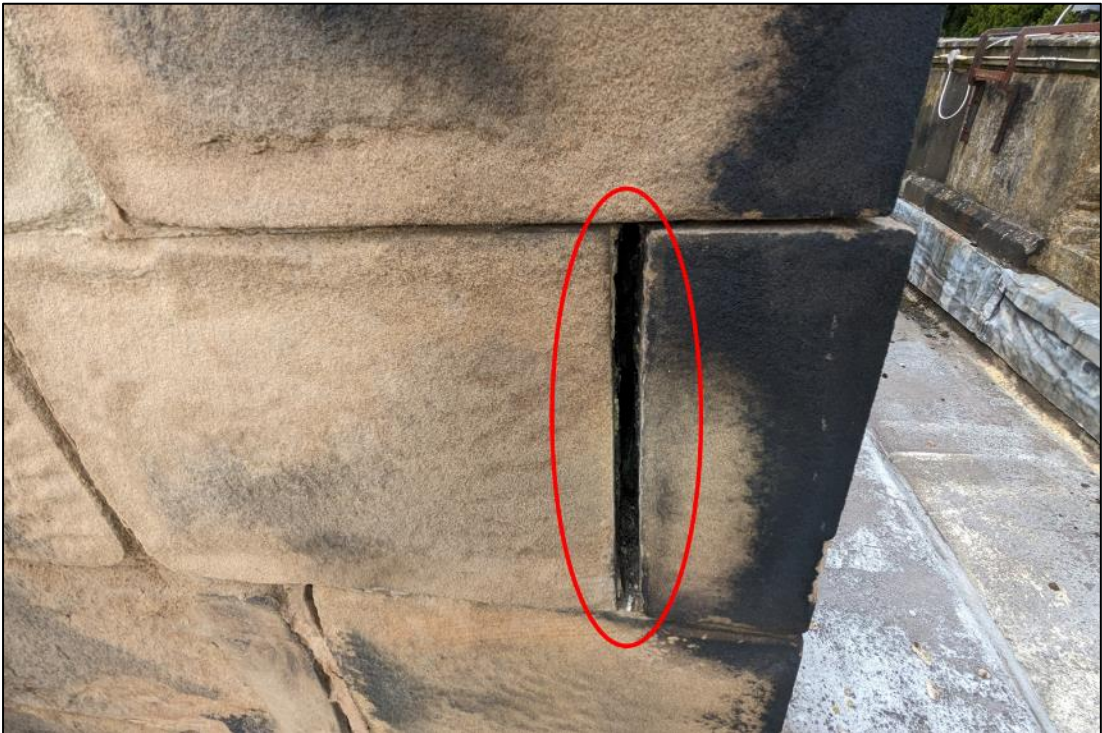
**Plate 7. Open joint on chimney**

uneven width of the stone slates. Other potential roost features on the roof were largely limited to a low number of open joints in the chimneys (Plate 7), with these joints generally open on both the external and internal faces of the chimneys. In addition, flashing fitted below the parapet was slightly lifted in places, however, such openings were generally superficial (Plate 8). A wooden fascia board on the northeast elevation of the kitchen had a number of small (c.15 mm wide) spaces between masonry and the rear of the fascia board, suitable for use by roosting bats.

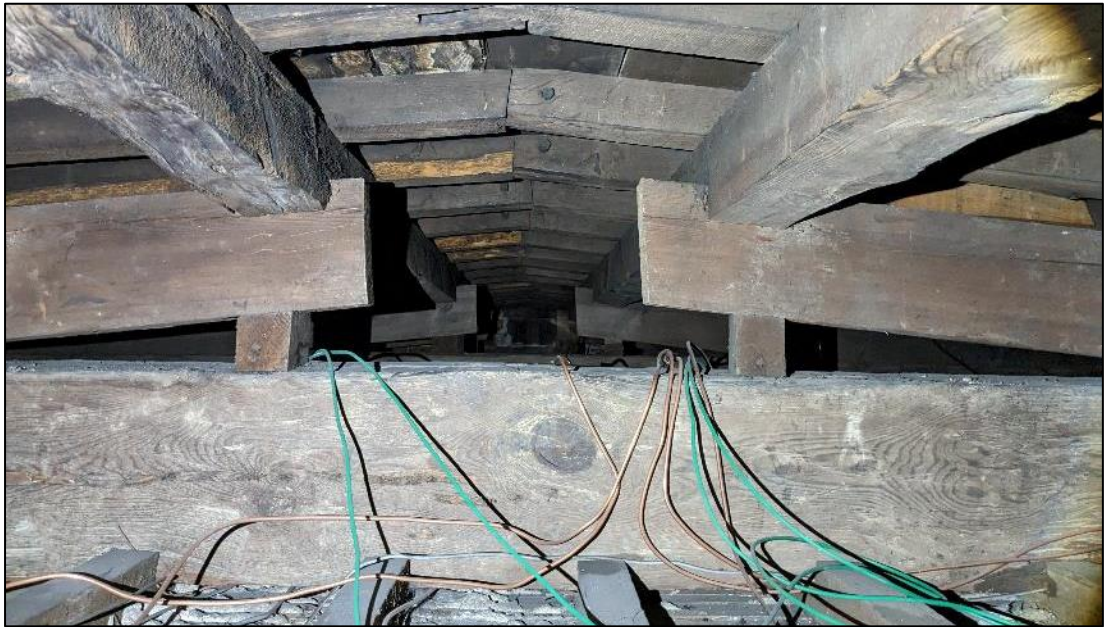
**Plate 9. Void above wing of house**

- 5.2.6 The roof voids associated with the central section of the house and the two wings were only c. 0.5-0.7 m in height (Plate 9) and as a result only a limited inspection of these voids was possible. These voids lacked insulation. No signs of roosting bats were recorded from these areas with no potential access points noted.
- 5.2.7 The roof space above the kitchen comprised a 2 m high void with the felt suspended on a ridge beam, king-post trusses, rafters and battens (Plate 10). The roof void lacked insulation and was dusty, with no potential bat access points or signs of bat presence noted.

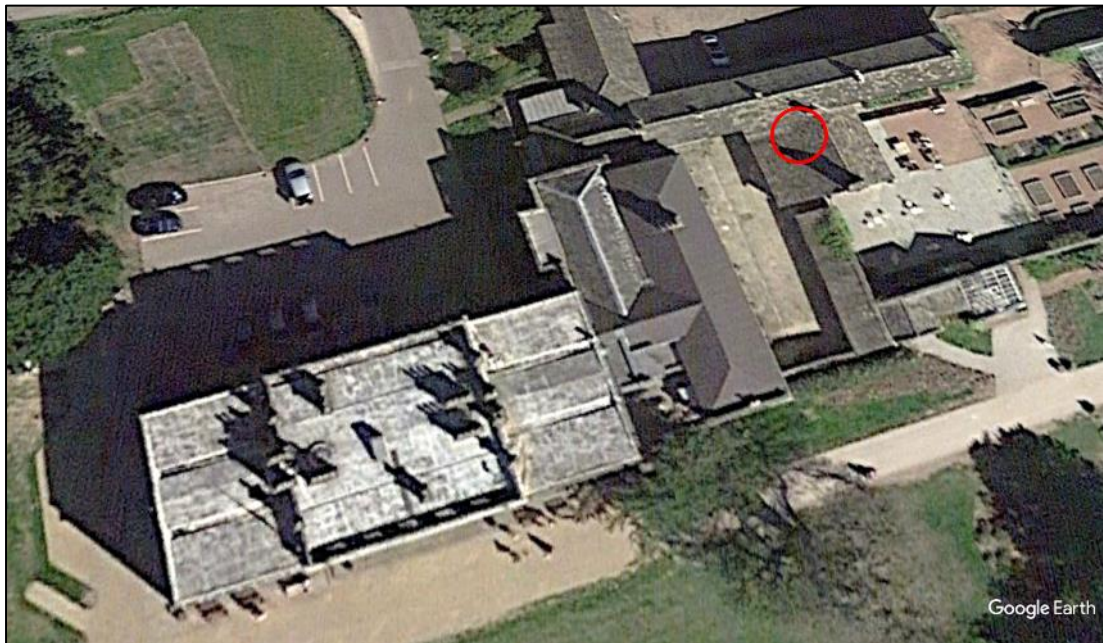
**Figure 2. Location of whiskered or Brandt's bat roost recorded during dawn survey**

- 5.2.9 No bat roosting activity was recorded from Cannon Hall during the survey. A single probable whiskered or Brandt's bat *Myotis brandtii* was however recorded roosting, outside the survey area (Figure 2).
- 5.2.10 The last bat recorded comprised a commuting common pipistrelle, recorded at 04:50 (24 minutes before sunrise). Intermittent common pipistrelle activity was recorded before that time, mainly from the surveyor to the east of the kitchen. In addition, two noctule commuting passes were recorded. Prior to the whiskered or Brandt's bat roosting, a bat of this species group was recorded but following the roosting event no further activity from bats of this species group was noted.
