Supplementary Geoenvironmental Appraisal

Land at Darton Lane, Barnsley For Duchy Homes

Report no: 4386/1

Date: August 2022

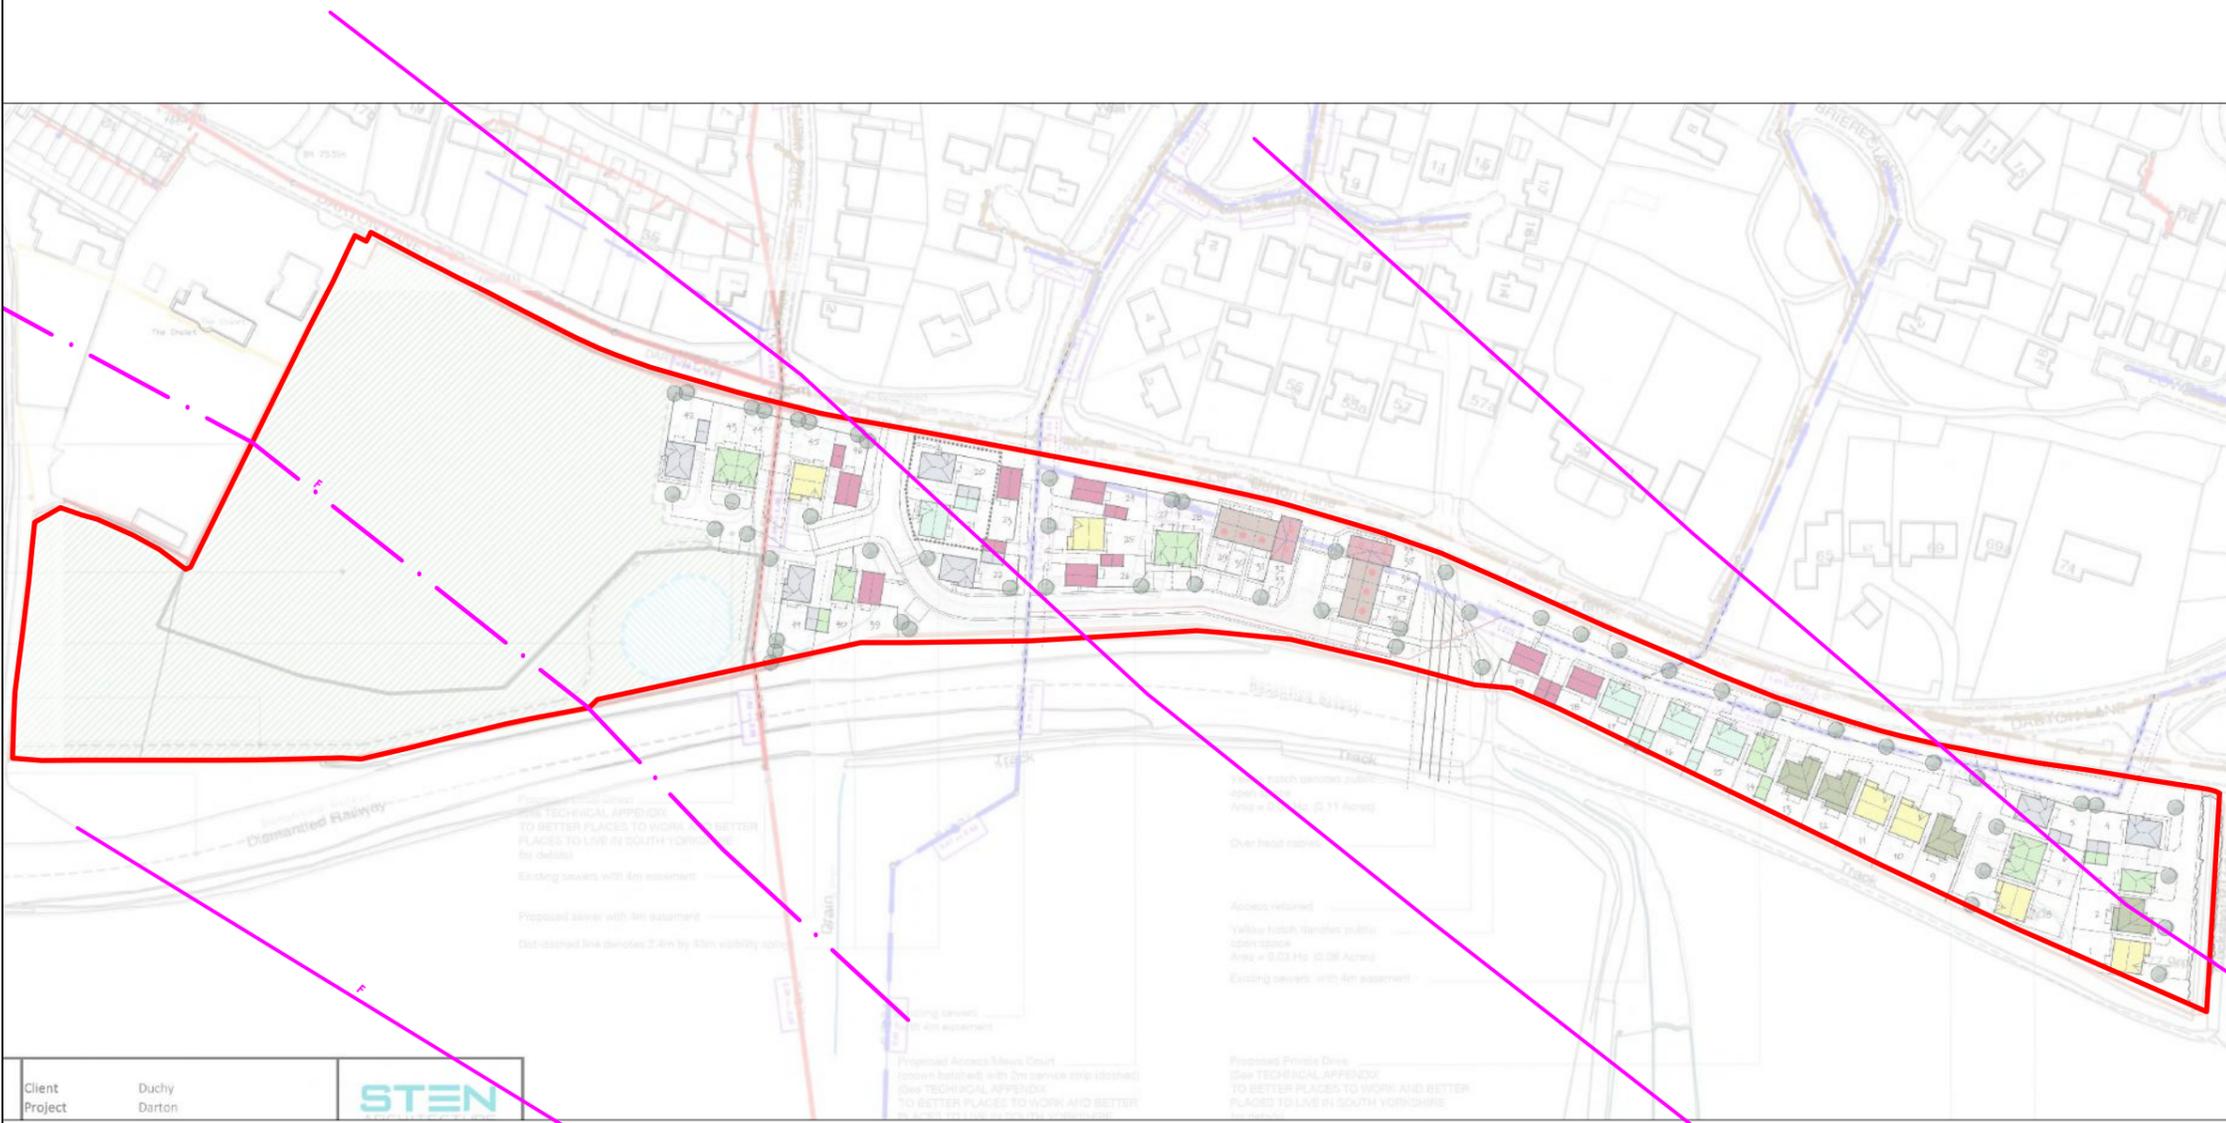
SCALE 1:1250	SHEET A3	DRAWING NO. 4386/ 3a	REVISION
------------------------	--------------------	--------------------------------	----------

DRAWING TITLE
PROPOSED SITE LAYOUT

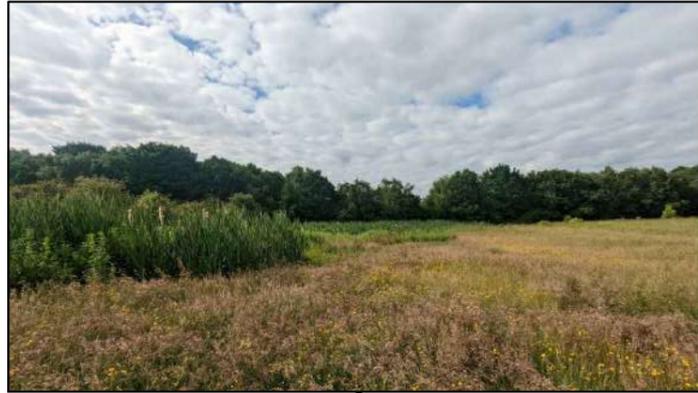
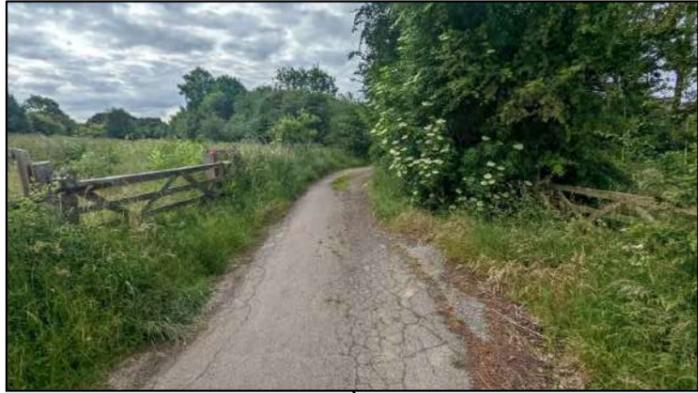
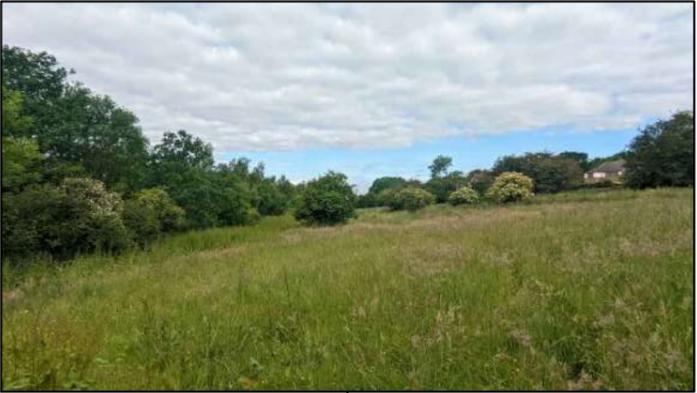
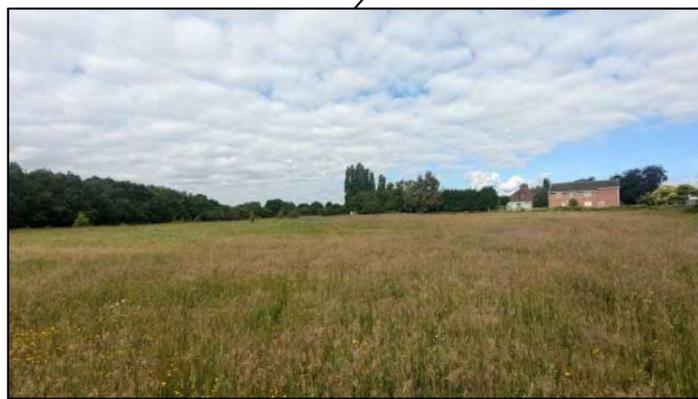
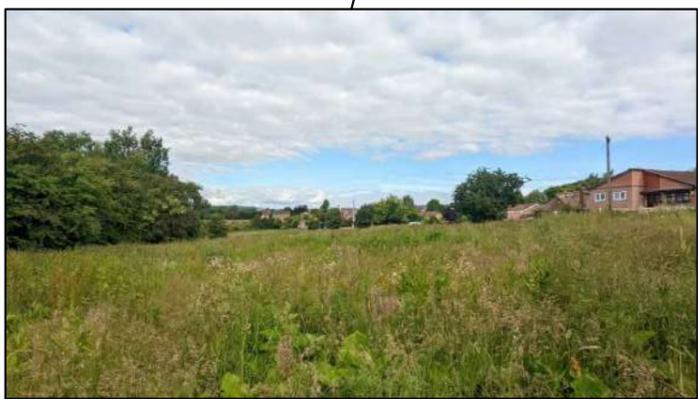
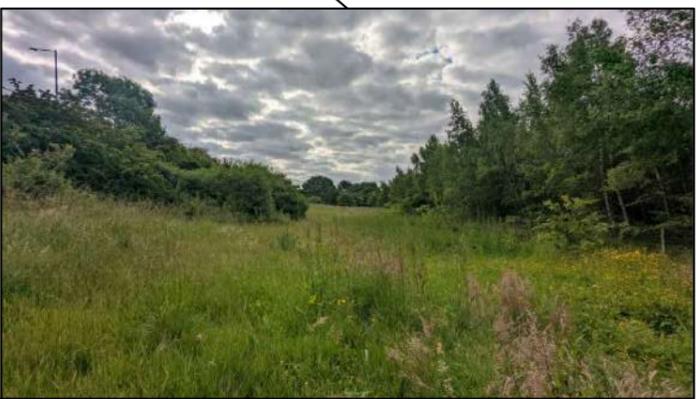
SCALE	1:1250	SHEET	A3	DRAWING NO.	4386/6b
				REVISION

- NOTES
- GRASS & OVERGROWN AREAS
 - GRAVEL HARDCORE SURFACING
 - MARSH & V. DENSE VEGETATION
 - V. DENSE VEGETATION
 - APPROXIMATE SITE BOUNDARY
 - LOCATION & ORIENTATION OF PHOTOGRAPH

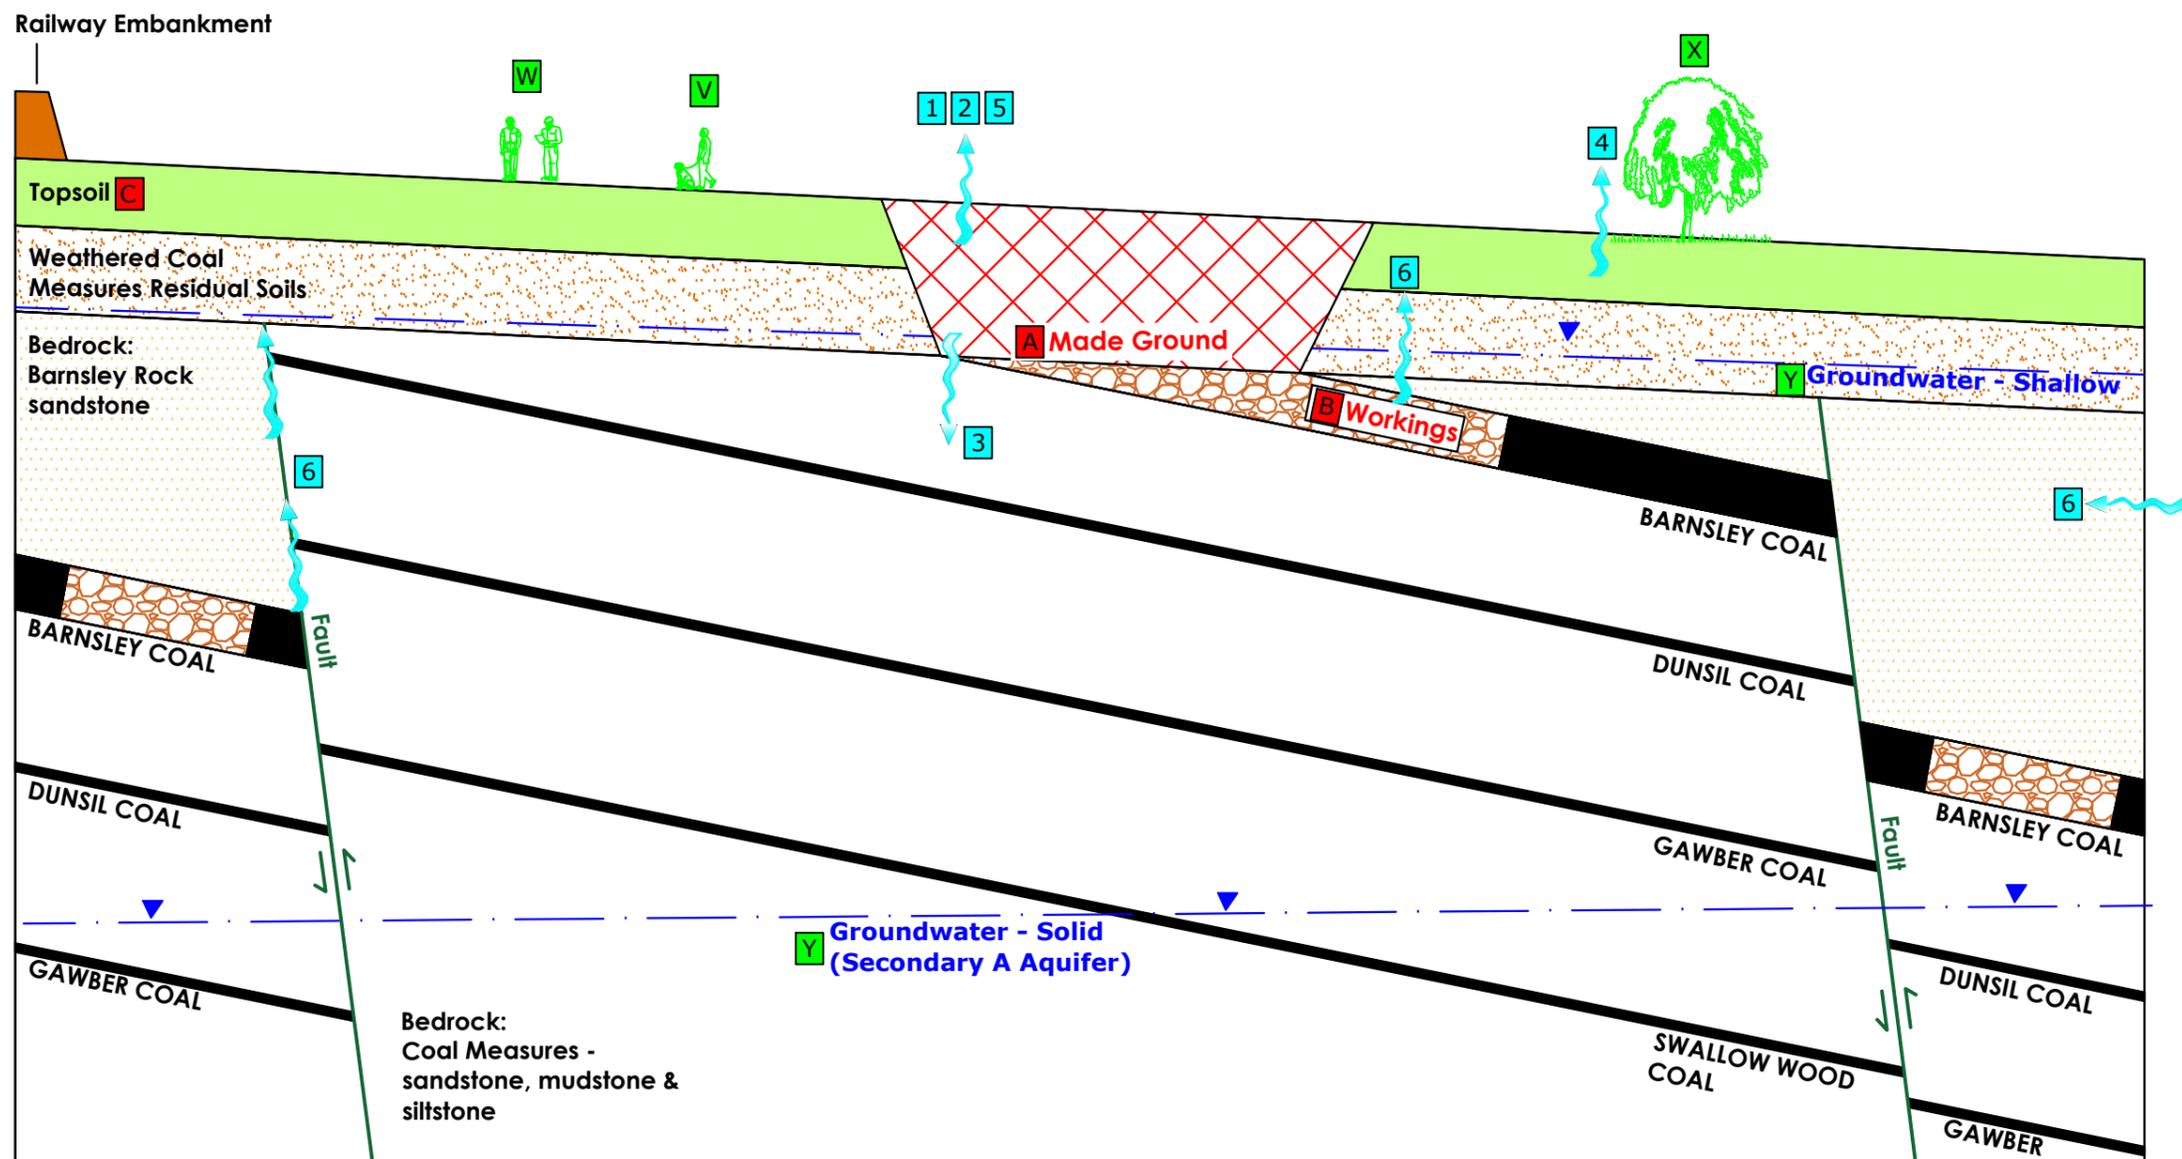
SCALE Not to scale	SHEET A3	DRAWING NO. 4386/5	REVISION
-----------------------	-------------	-----------------------	----------

SOURCES	
A	MADE GROUND (INORGANICS & ORGANICS)
B	COAL & WORKINGS
C	TOPSOIL (ORGANICS & INORGANICS)

PATHWAYS	
1	DERMAL CONTACT
2	INGESTION/INHALATION
3	LEACHING OF CONTAMINANTS
4	UPTAKE BY PLANTS
5	VOLATILISATION
6	MIGRATION OF GAS

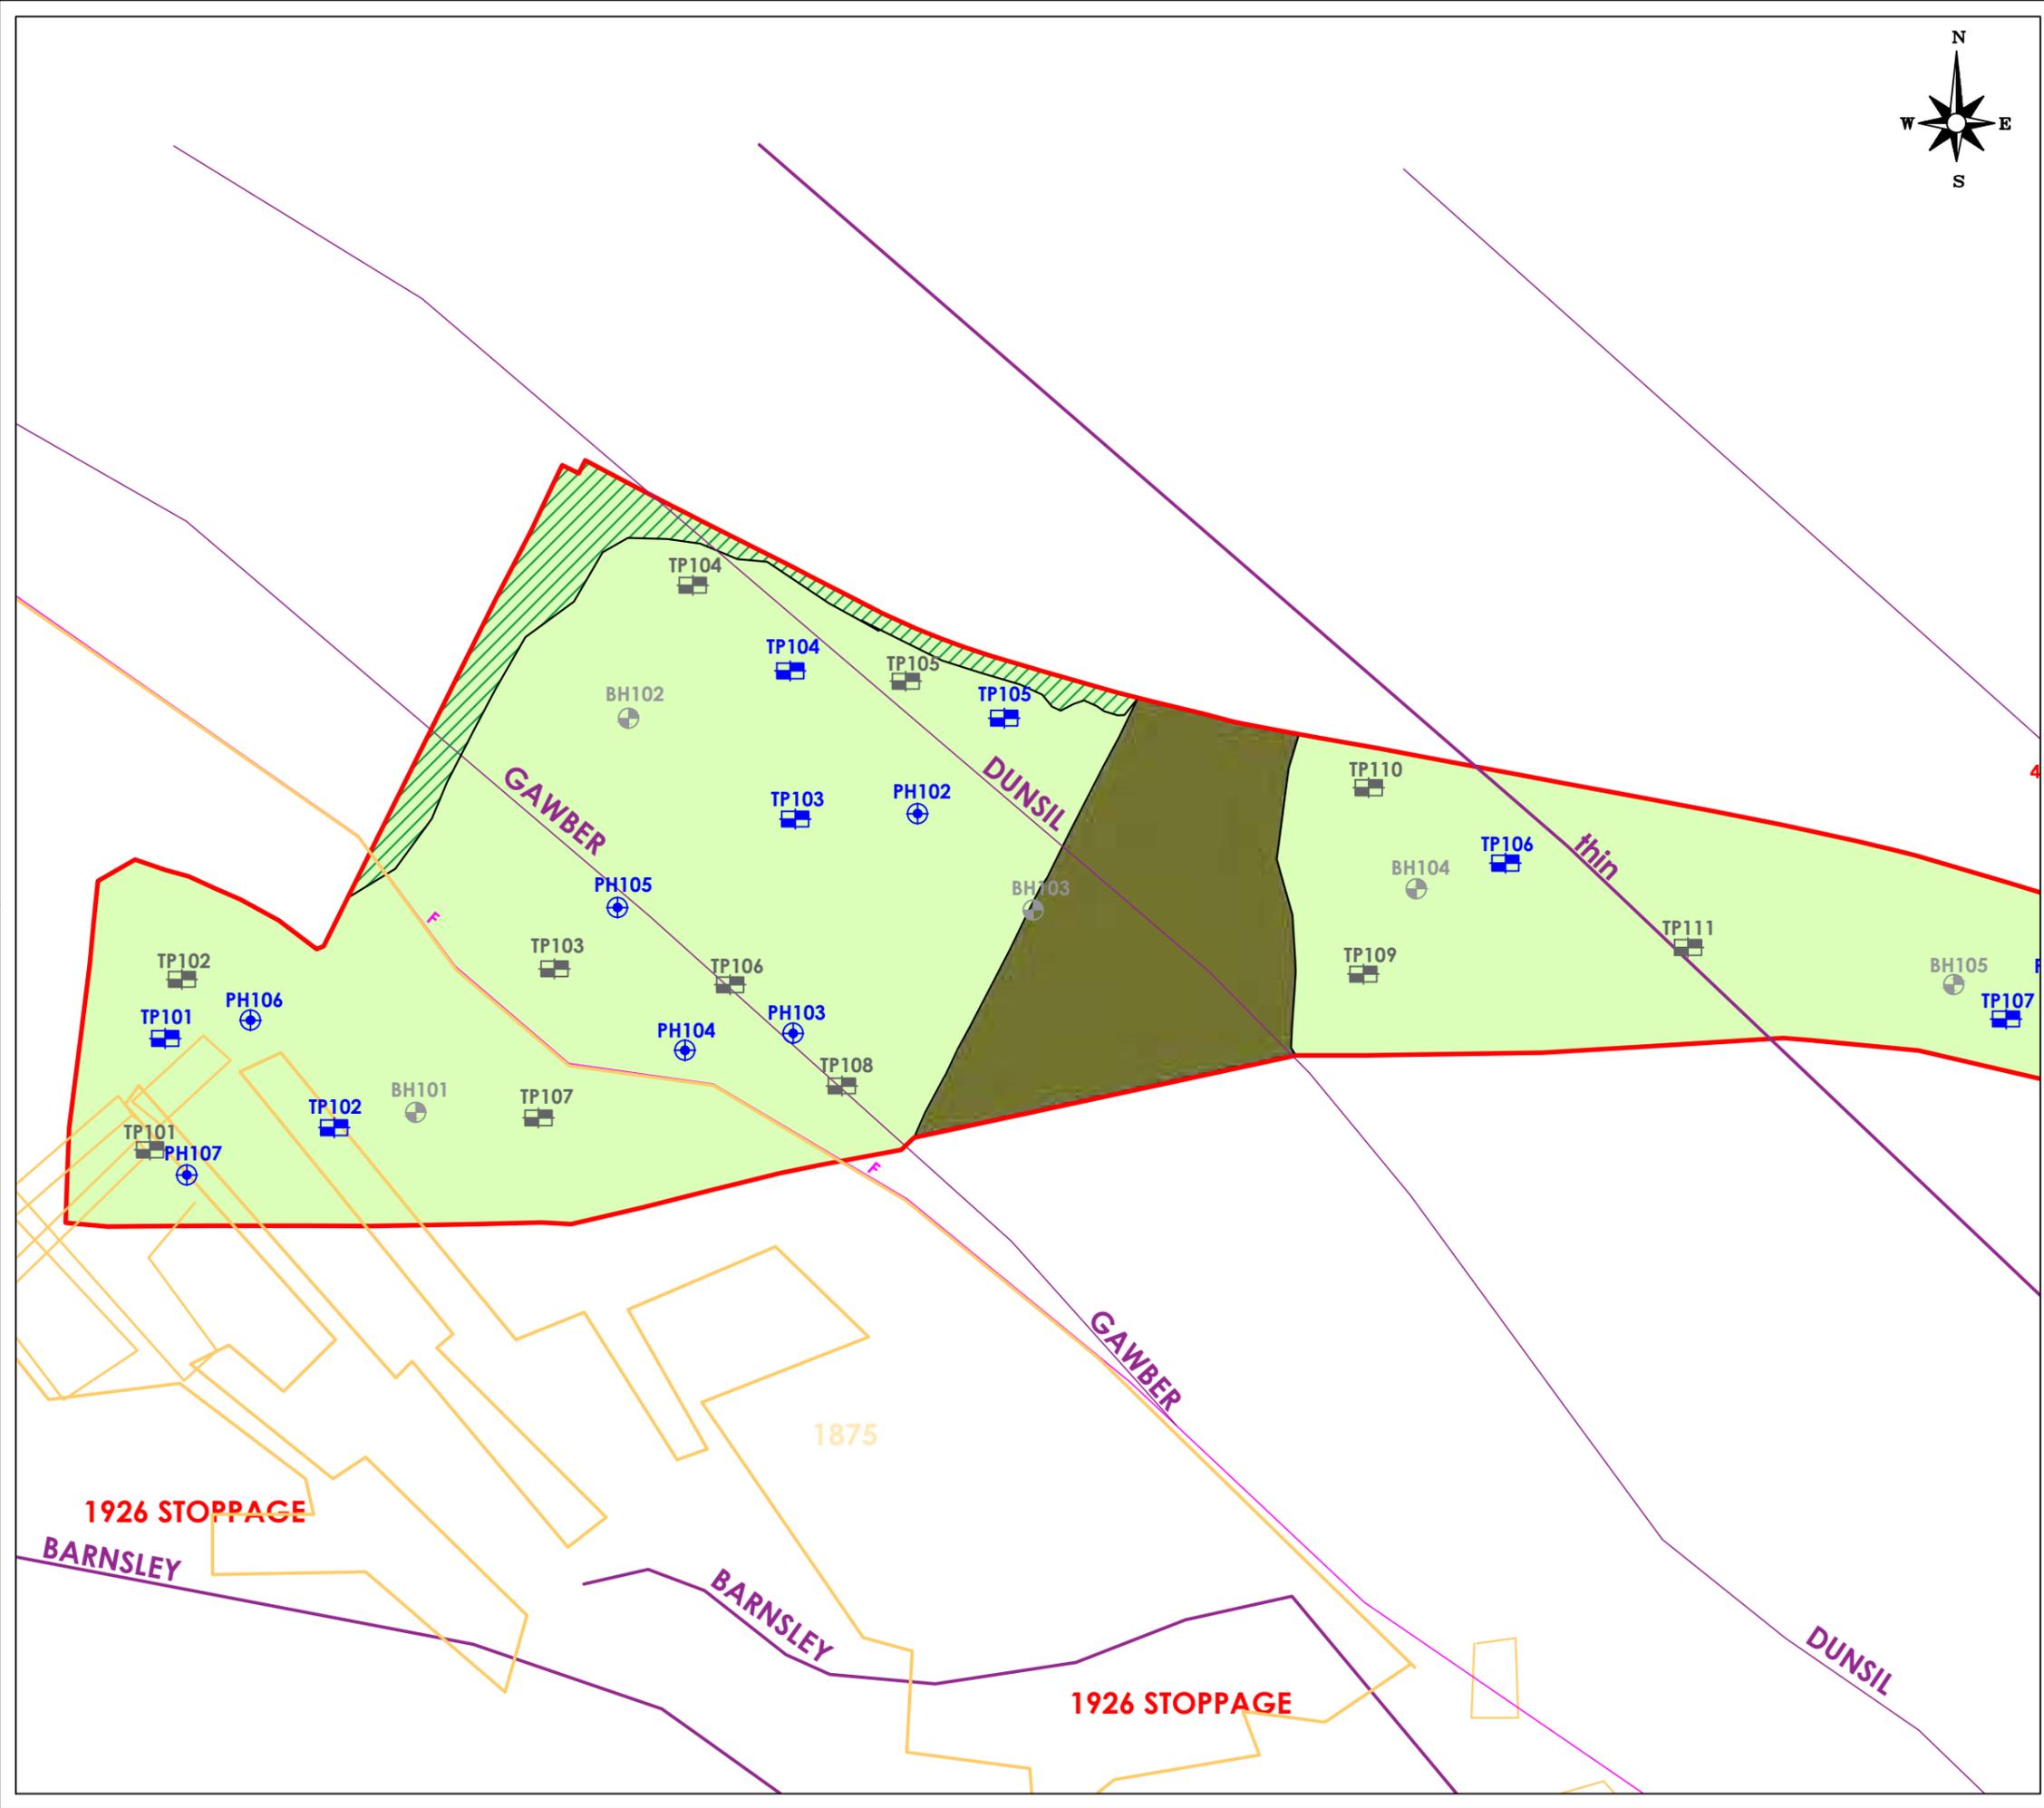
SCALE	1:1250	SHEET	A3	DRAWING NO.	4386/6a	REVISION	
-------	--------	-------	----	-------------	---------	----------	--

- LITHOS TRIAL PIT LOCATION
- LITHOS PROBEHOLE LOCATION
- WA TRIAL PIT LOCATION
- WA PROBEHOLE LOCATION
- GRASS & OVERGROWN AREAS
- GRAVEL HARDCORE SURFACING
- MARSH & V. DENSE VEGETATION
- V. DENSE VEGETATION
- AREA OF COLLIERY SPOIL - REPRODUCED FROM GEOLOGY MAP SE 30 NW
- AREA OF KNOWN OPENCAST WORKINGS - REPRODUCED FROM CA ABANDONMENT PLAN REFERENCE NE.158, DATED 5TH APRIL 1955.
- AREA OF KNOWN UNDERGROUND WORKINGS - REPRODUCED FROM CA ABANDONMENT PLAN REFERENCE NE.863/2, DATED 9TH JULY 1980.
- RECORDED COAL SEAM
- RECORDED FAULT
- APPROXIMATE POSITION OF RAILWAY EMBANKMENT
- APPROXIMATE SITE BOUNDARY

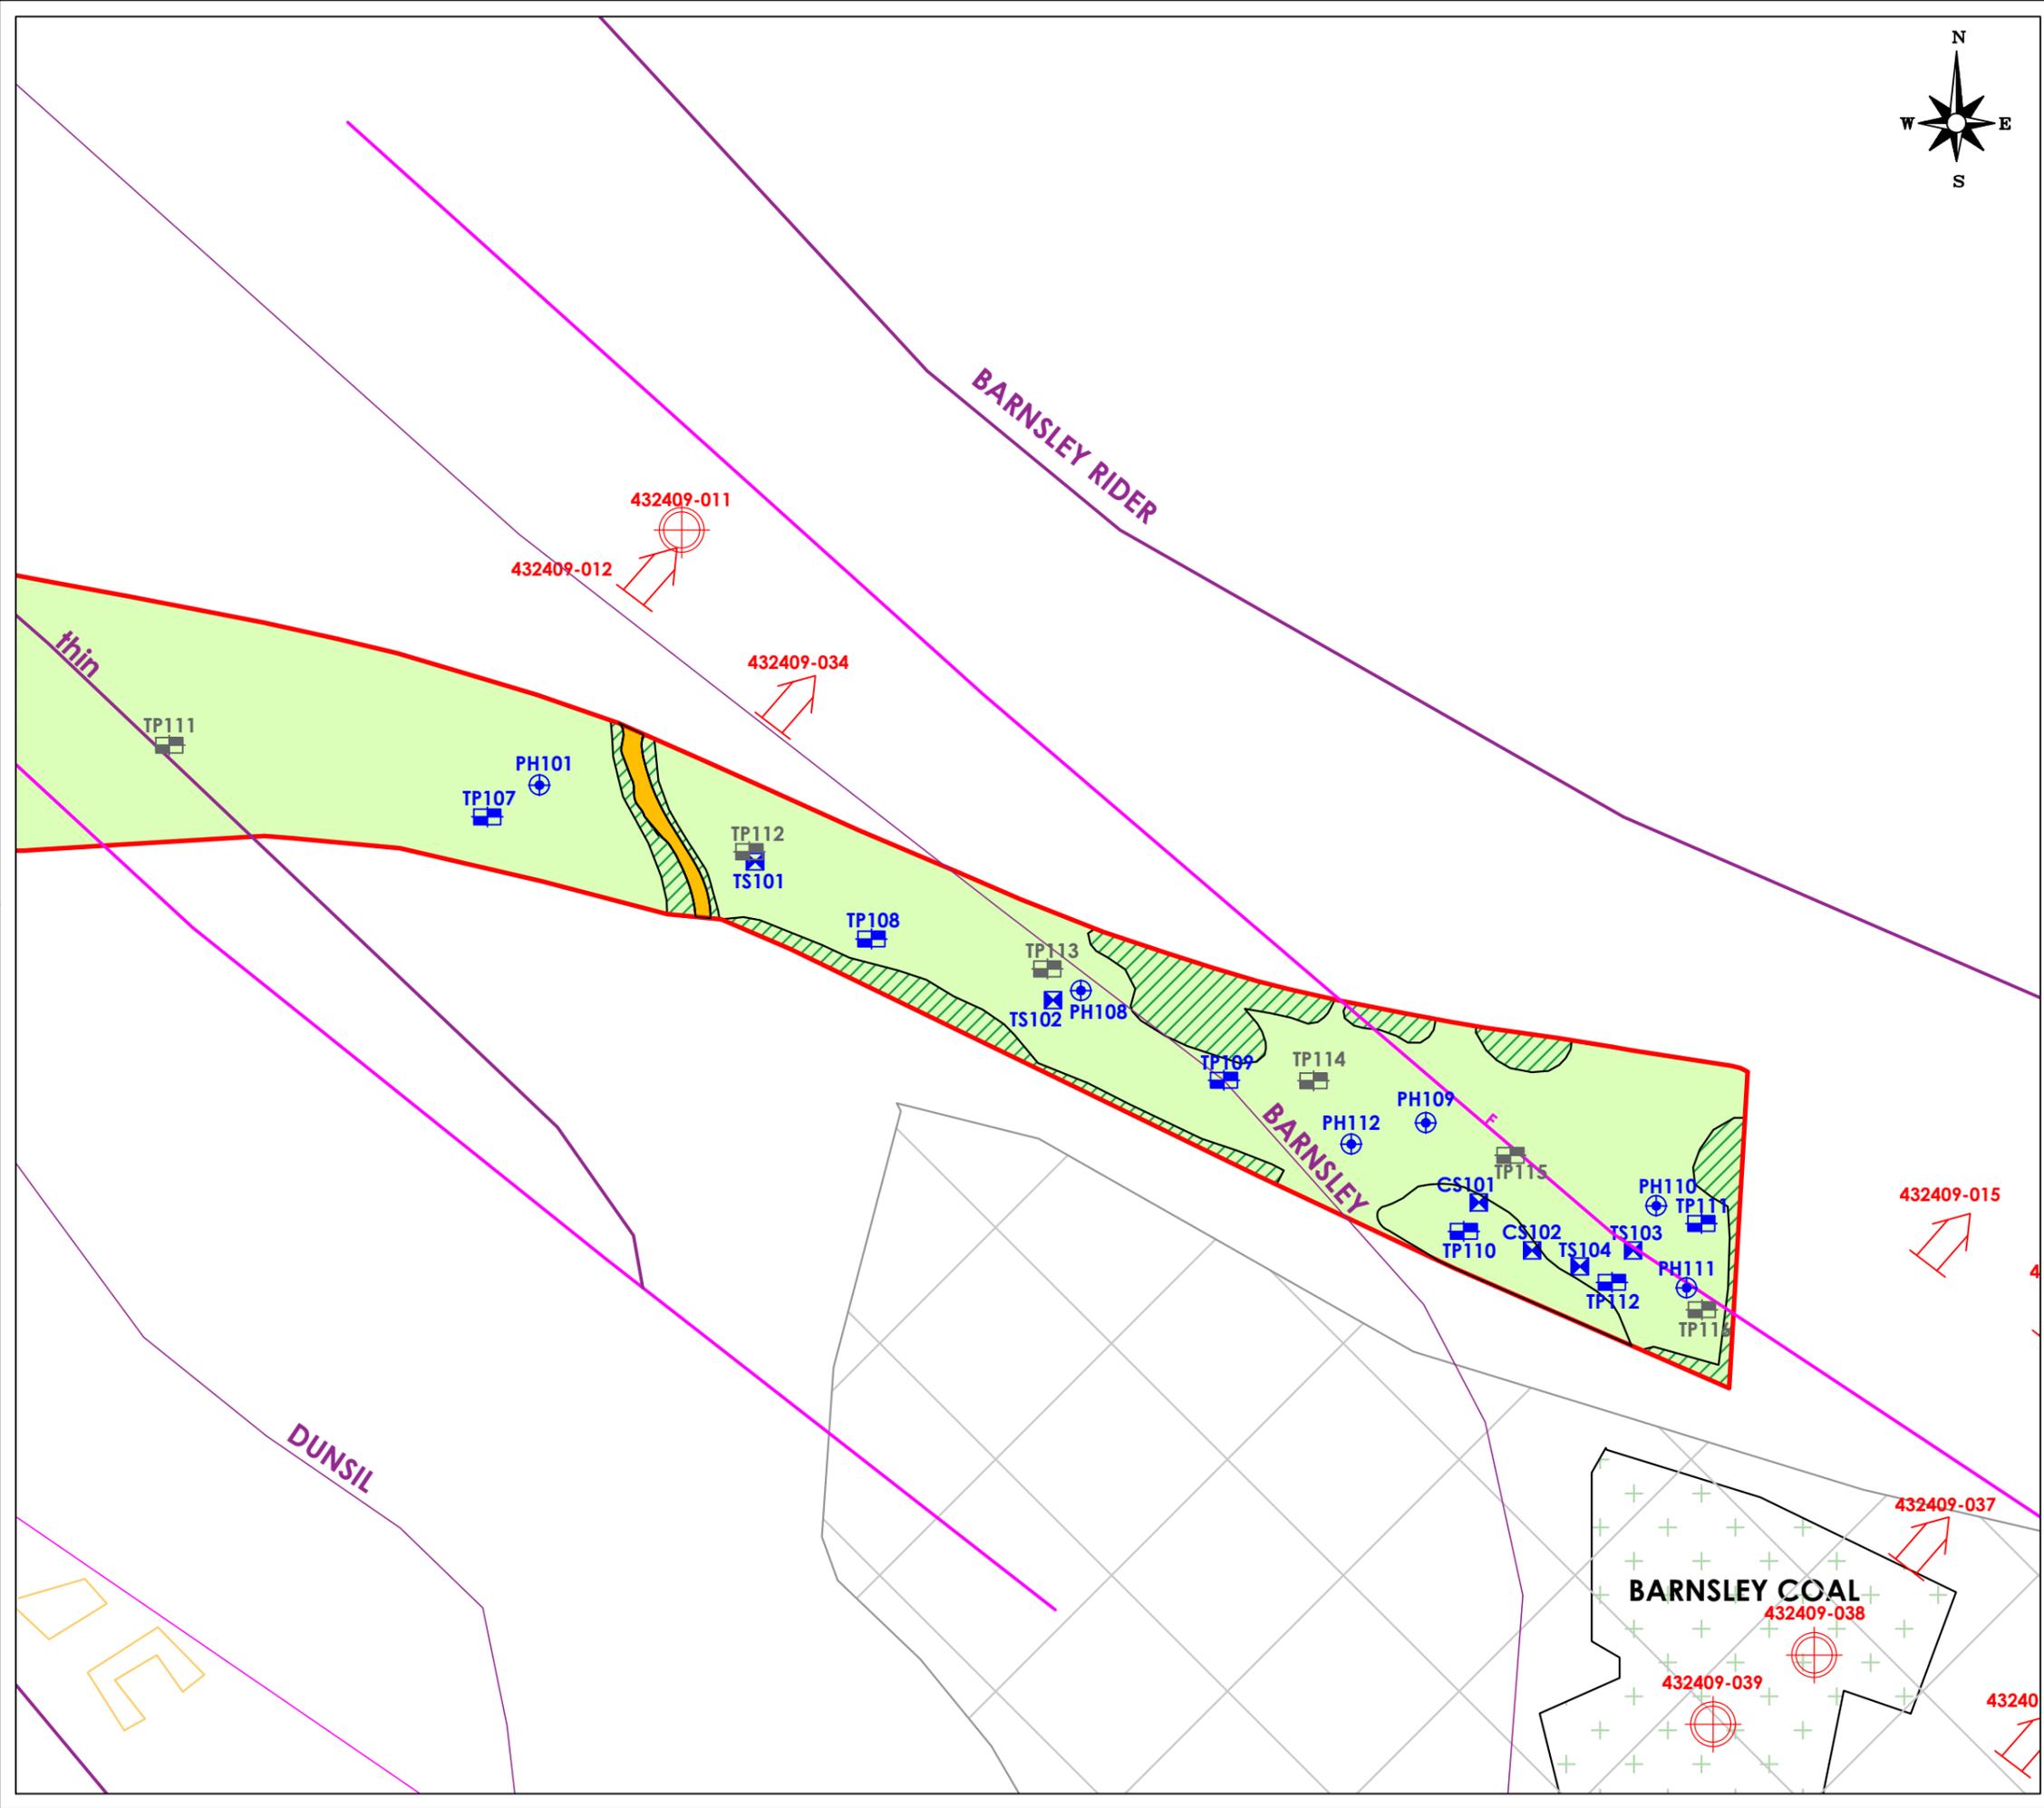
- LITHOS TRIAL PIT LOCATION
- LITHOS PROBEHOLE LOCATION
- WA TRIAL PIT LOCATION
- WA PROBEHOLE LOCATION
- GRASS & OVERGROWN AREAS
- GRAVEL HARDCORE SURFACING
- POSSIBLE OUTCROP WORKINGS
- V. DENSE VEGETATION
- AREA OF COLLIERY SPOIL - REPRODUCED FROM GEOLOGY MAP SE 30 NW
- AREA OF KNOWN OPENCAST WORKINGS - REPRODUCED FROM CA ABANDONMENT PLAN REFERENCE NE.158, DATED 5TH APRIL 1955.
- AREA OF KNOWN UNDERGROUND WORKINGS - REPRODUCED FROM CA ABANDONMENT PLAN REFERENCE NE.863/2, DATED 9TH JULY 1980.
- RECORDED COAL SEAM
- RECORDED FAULT
- APPROXIMATE POSITION OF RAILWAY EMBANKMENT
- APPROXIMATE SITE BOUNDARY

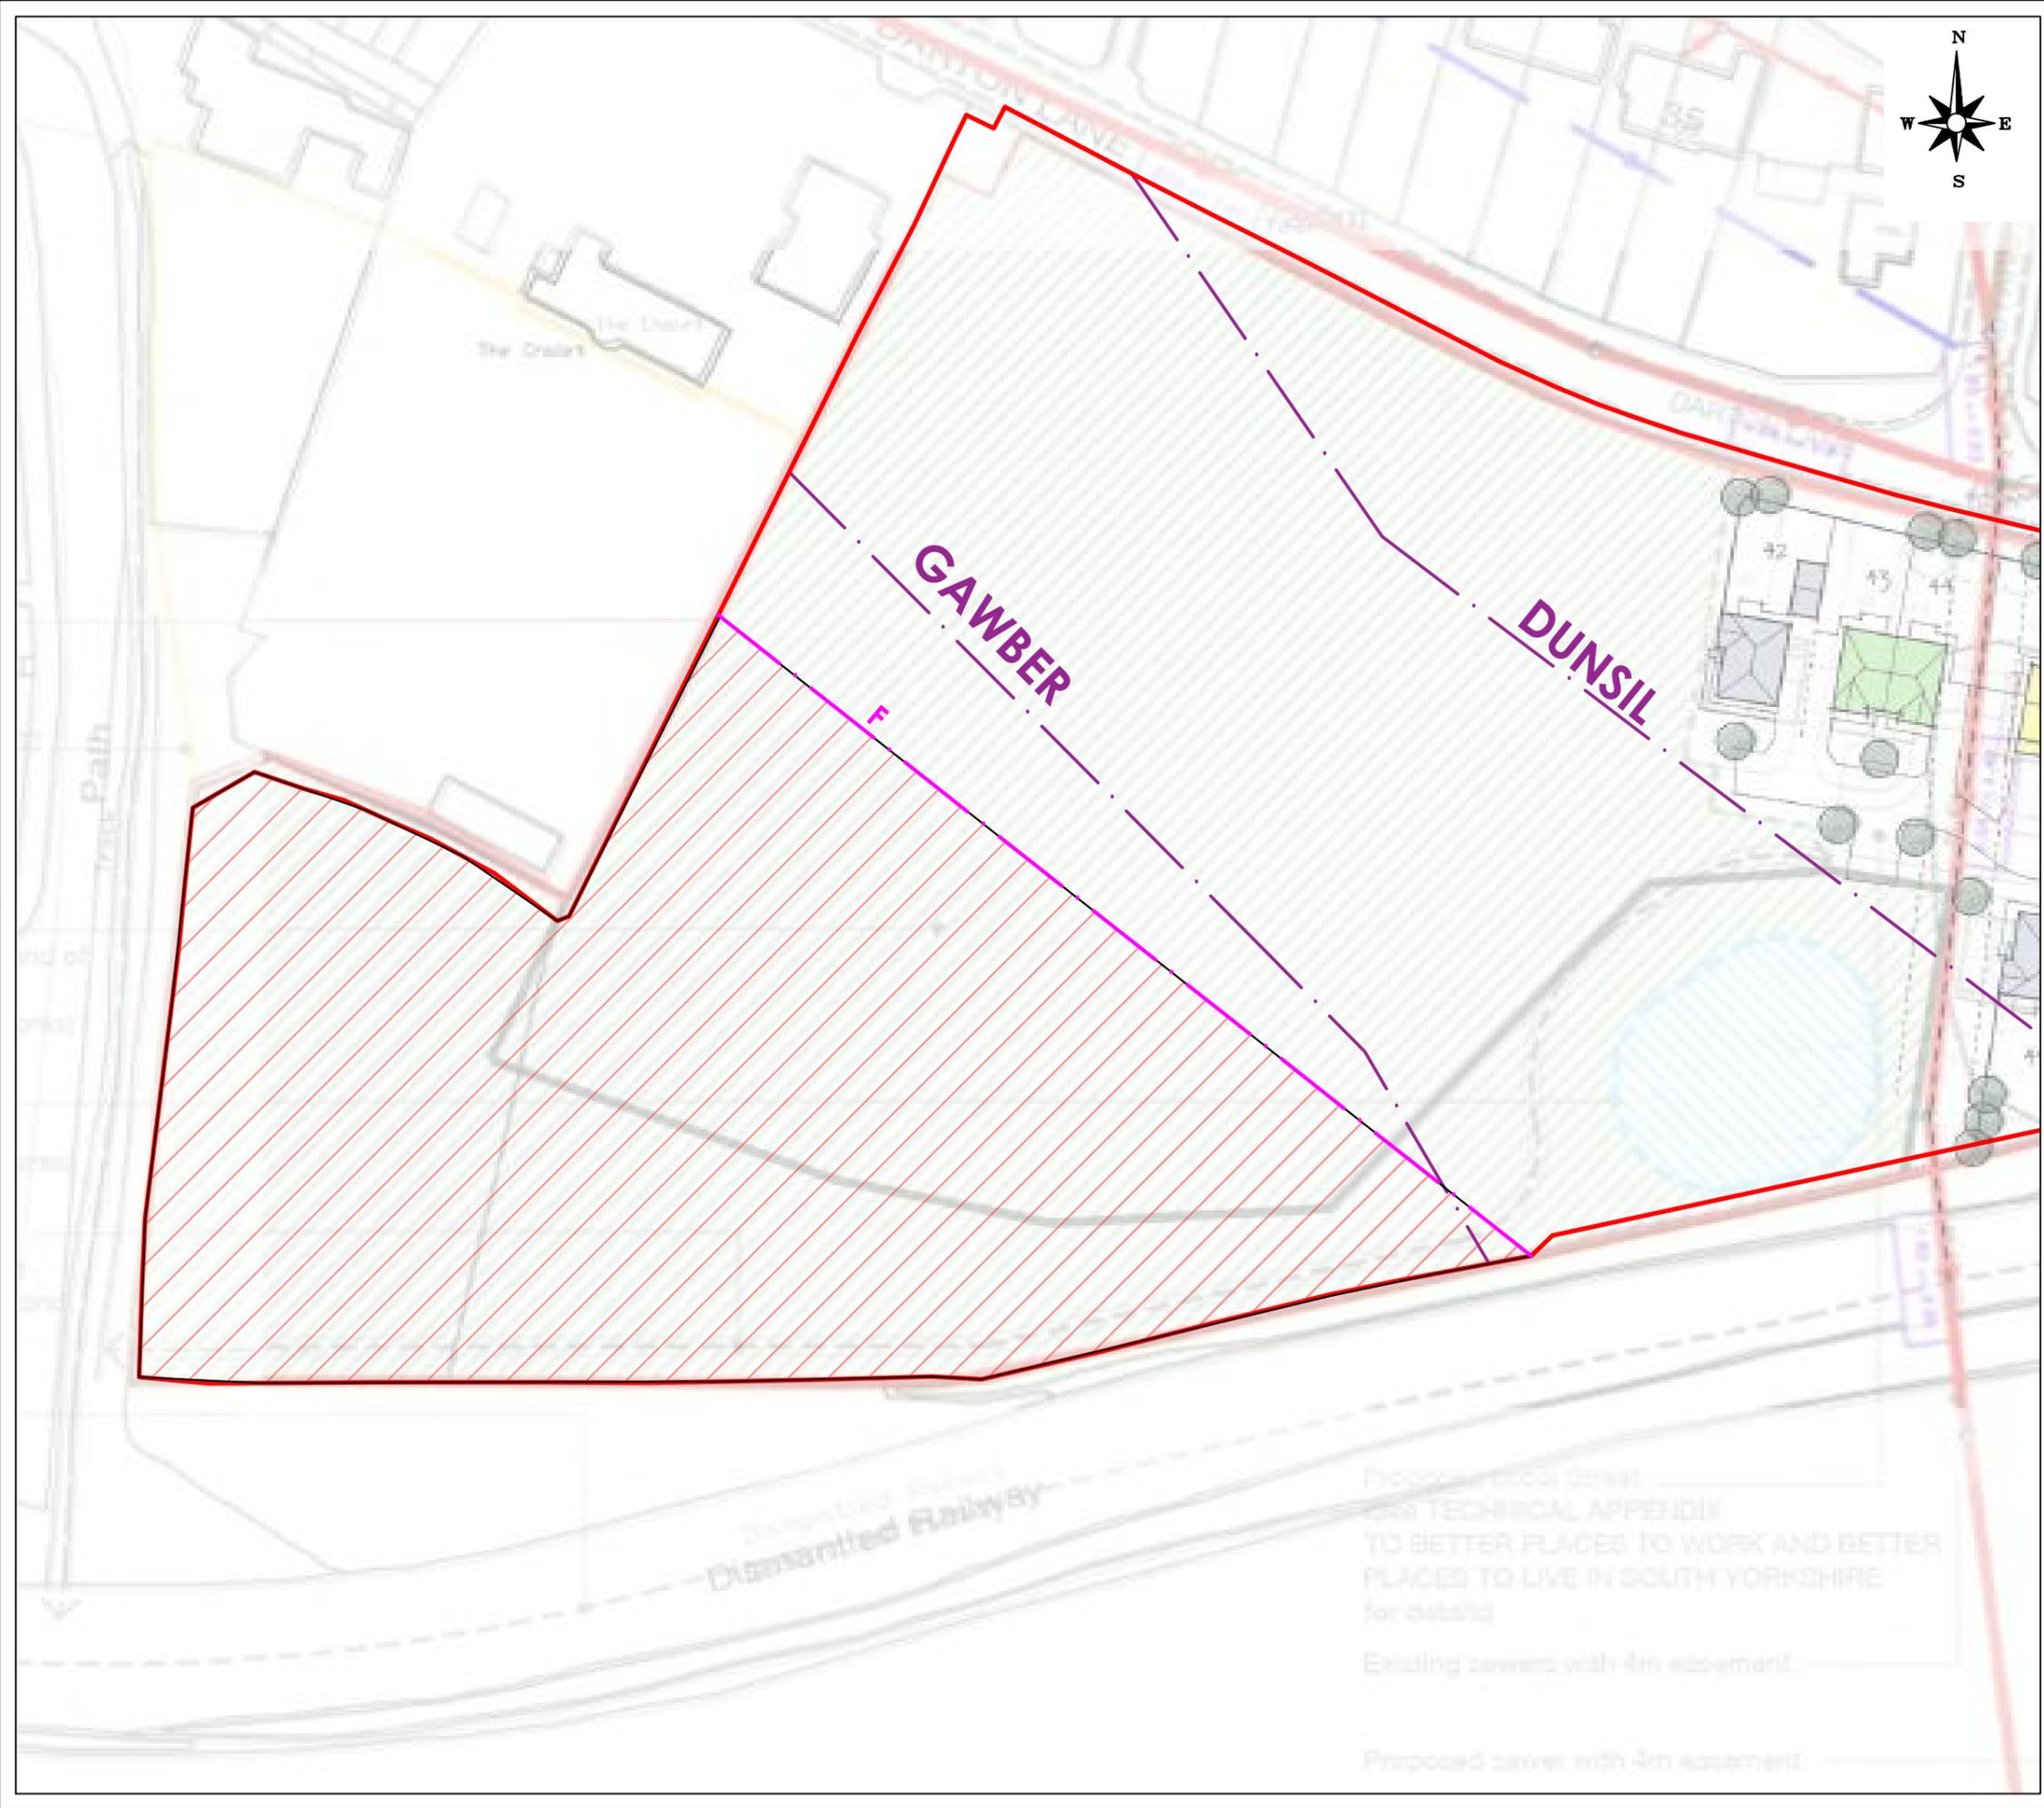
SCALE	1:1250	SHEET	A3	DRAWING NO.	4386/10b	REVISION	
-------	--------	-------	----	-------------	----------	----------	--

- NOTES
- - - ACTUAL COAL SEAM
 - - - F - ACTUAL FAULT
 - ▨ APPROXIMATE DRILL & GROUT AREA REQUIRED - IF DEVELOPED
 - APPROXIMATE SITE BOUNDARY

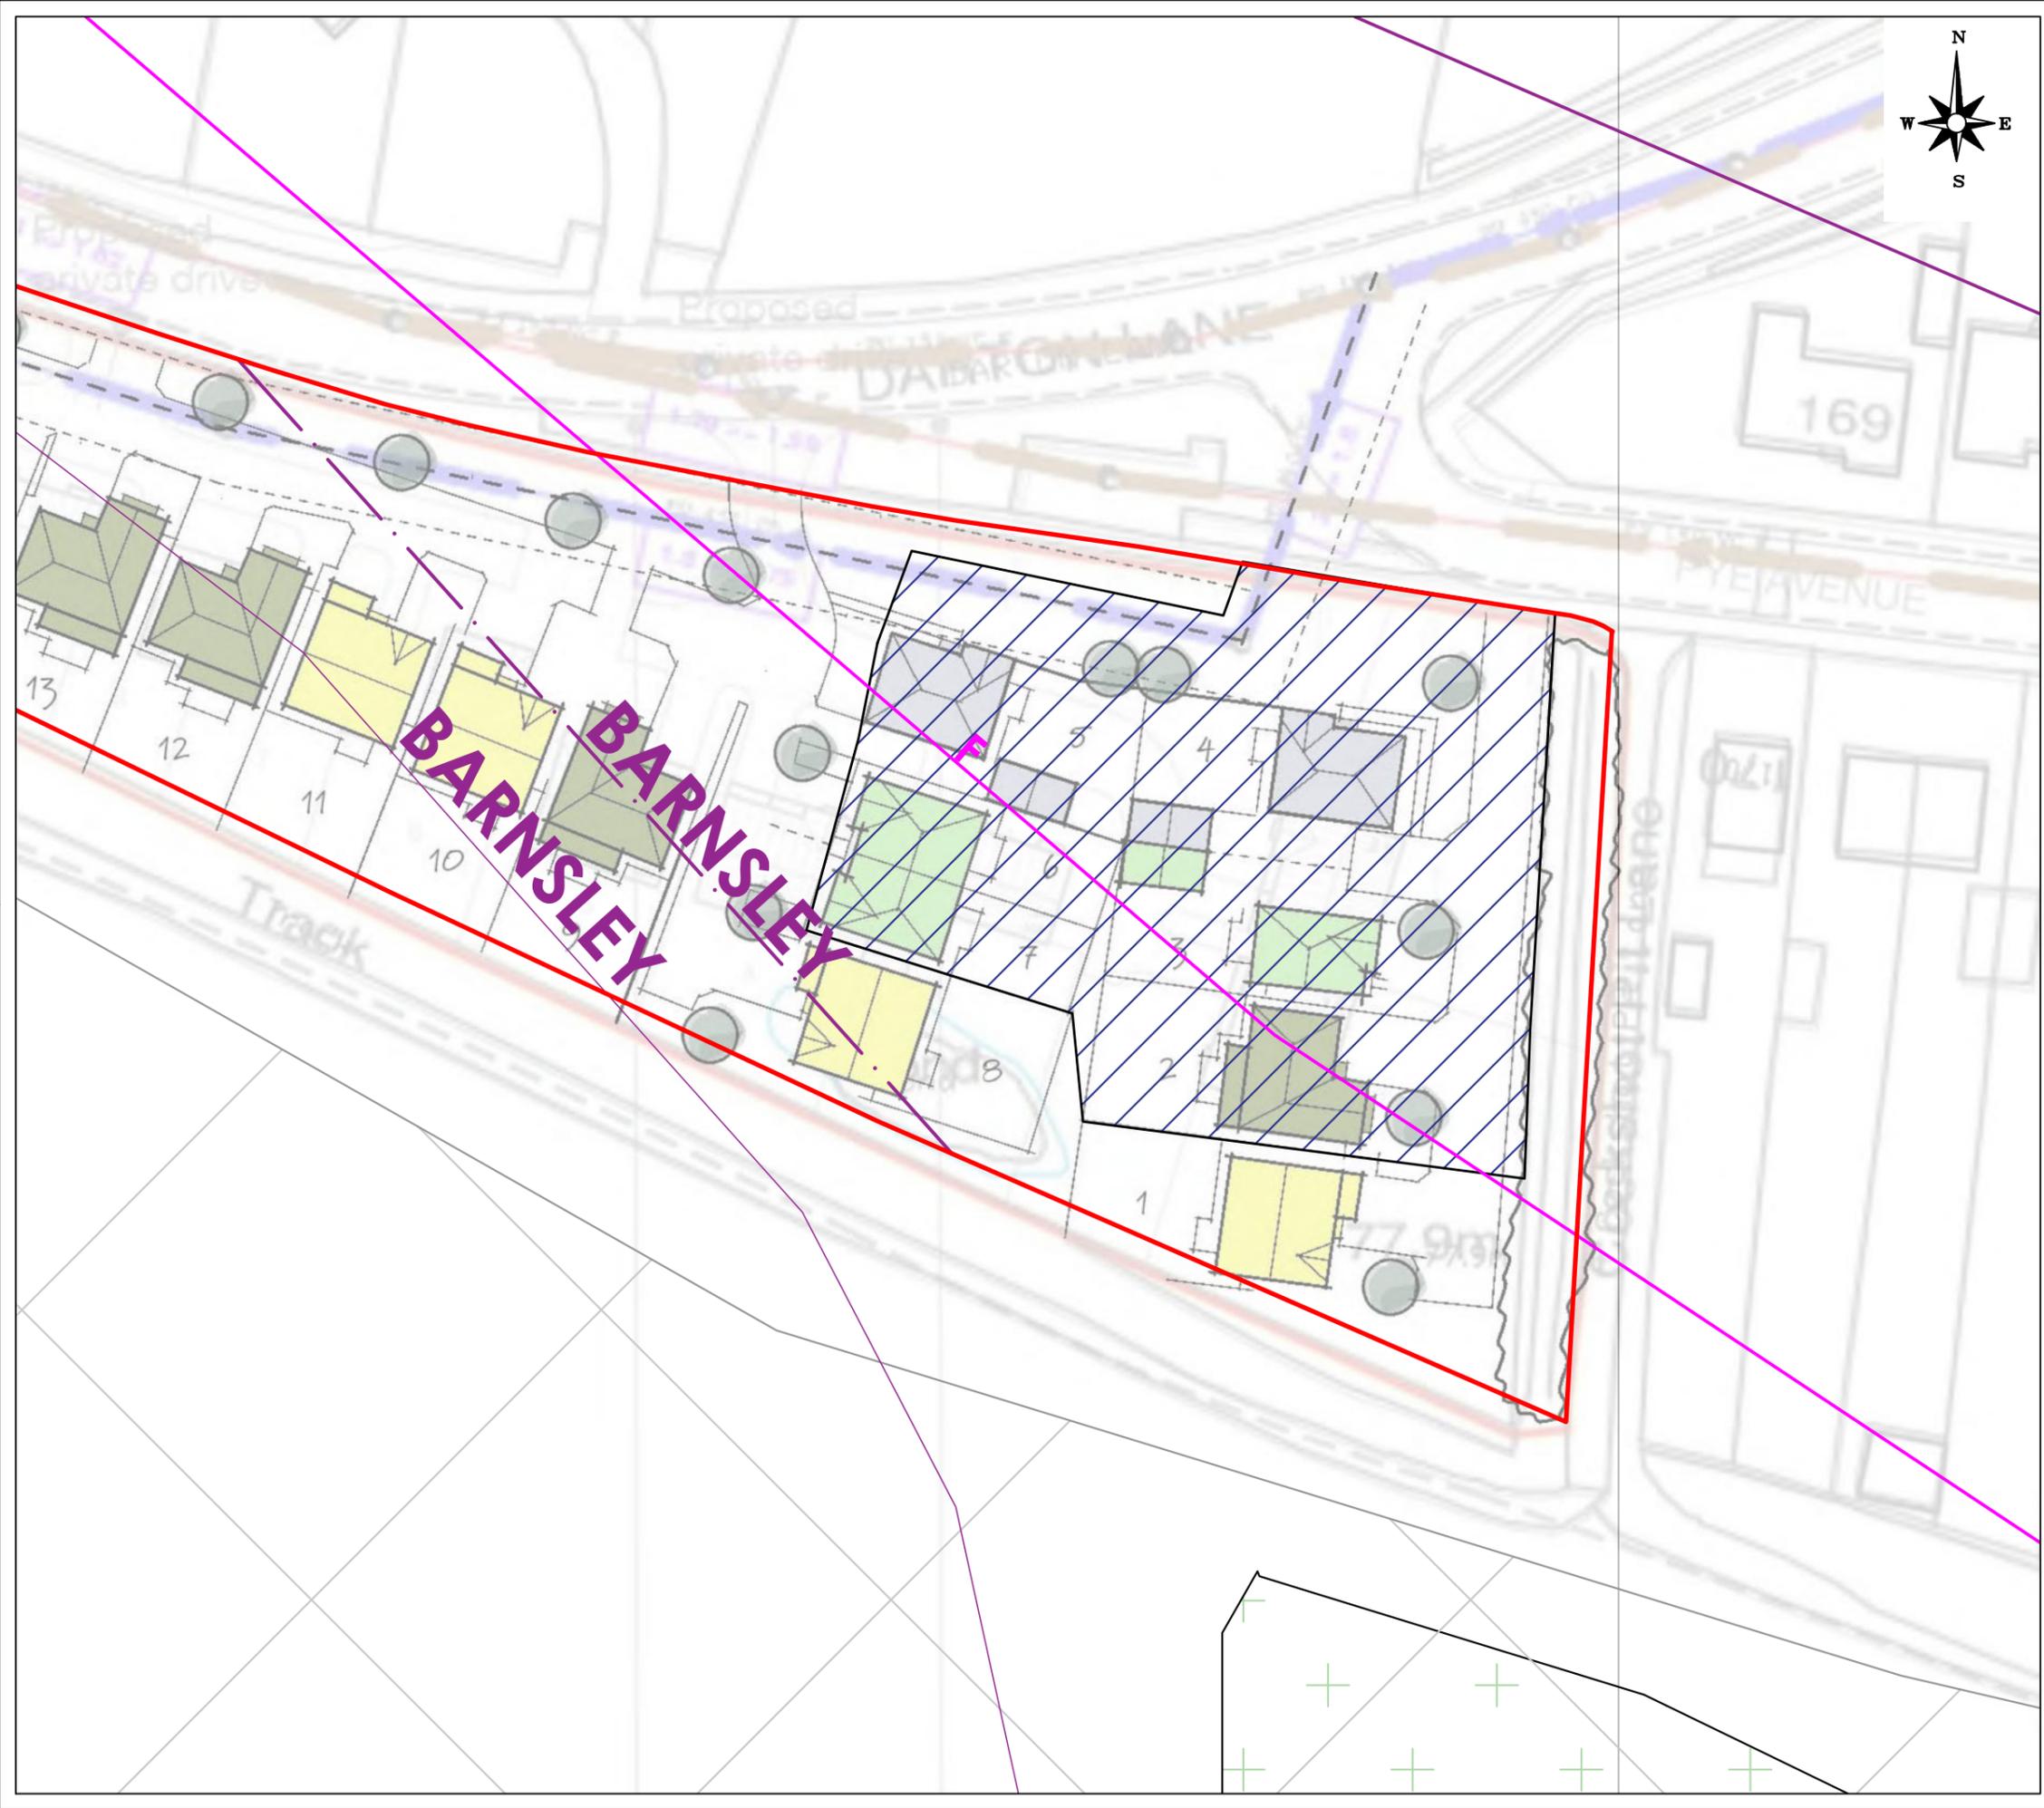
SCALE	SHEET	DRAWING NO.	REVISION
1:1250	A3	4386/ 8a

- NOTES
- - - ACTUAL COAL SEAM
 - - - RECORDED COAL SEAM
 - F FAULT
 - ▨ APPROXIMATE DRILL & GROUT AREA REQUIRED
 - - - APPROXIMATE SITE BOUNDARY

- 3.3.4 Recorded outcrop positions are shown on Drawing 4386/8a and 4386/8b.
- 3.3.5 It should be noted that seam outcrops plotted on geological maps have been known to be inaccurate by distances in excess of 100m.
