Supplementary Geoenvironmental Appraisal

Land at Darton Lane, Barnsley For Duchy Homes

Report no: 4386/1

Date: August 2022

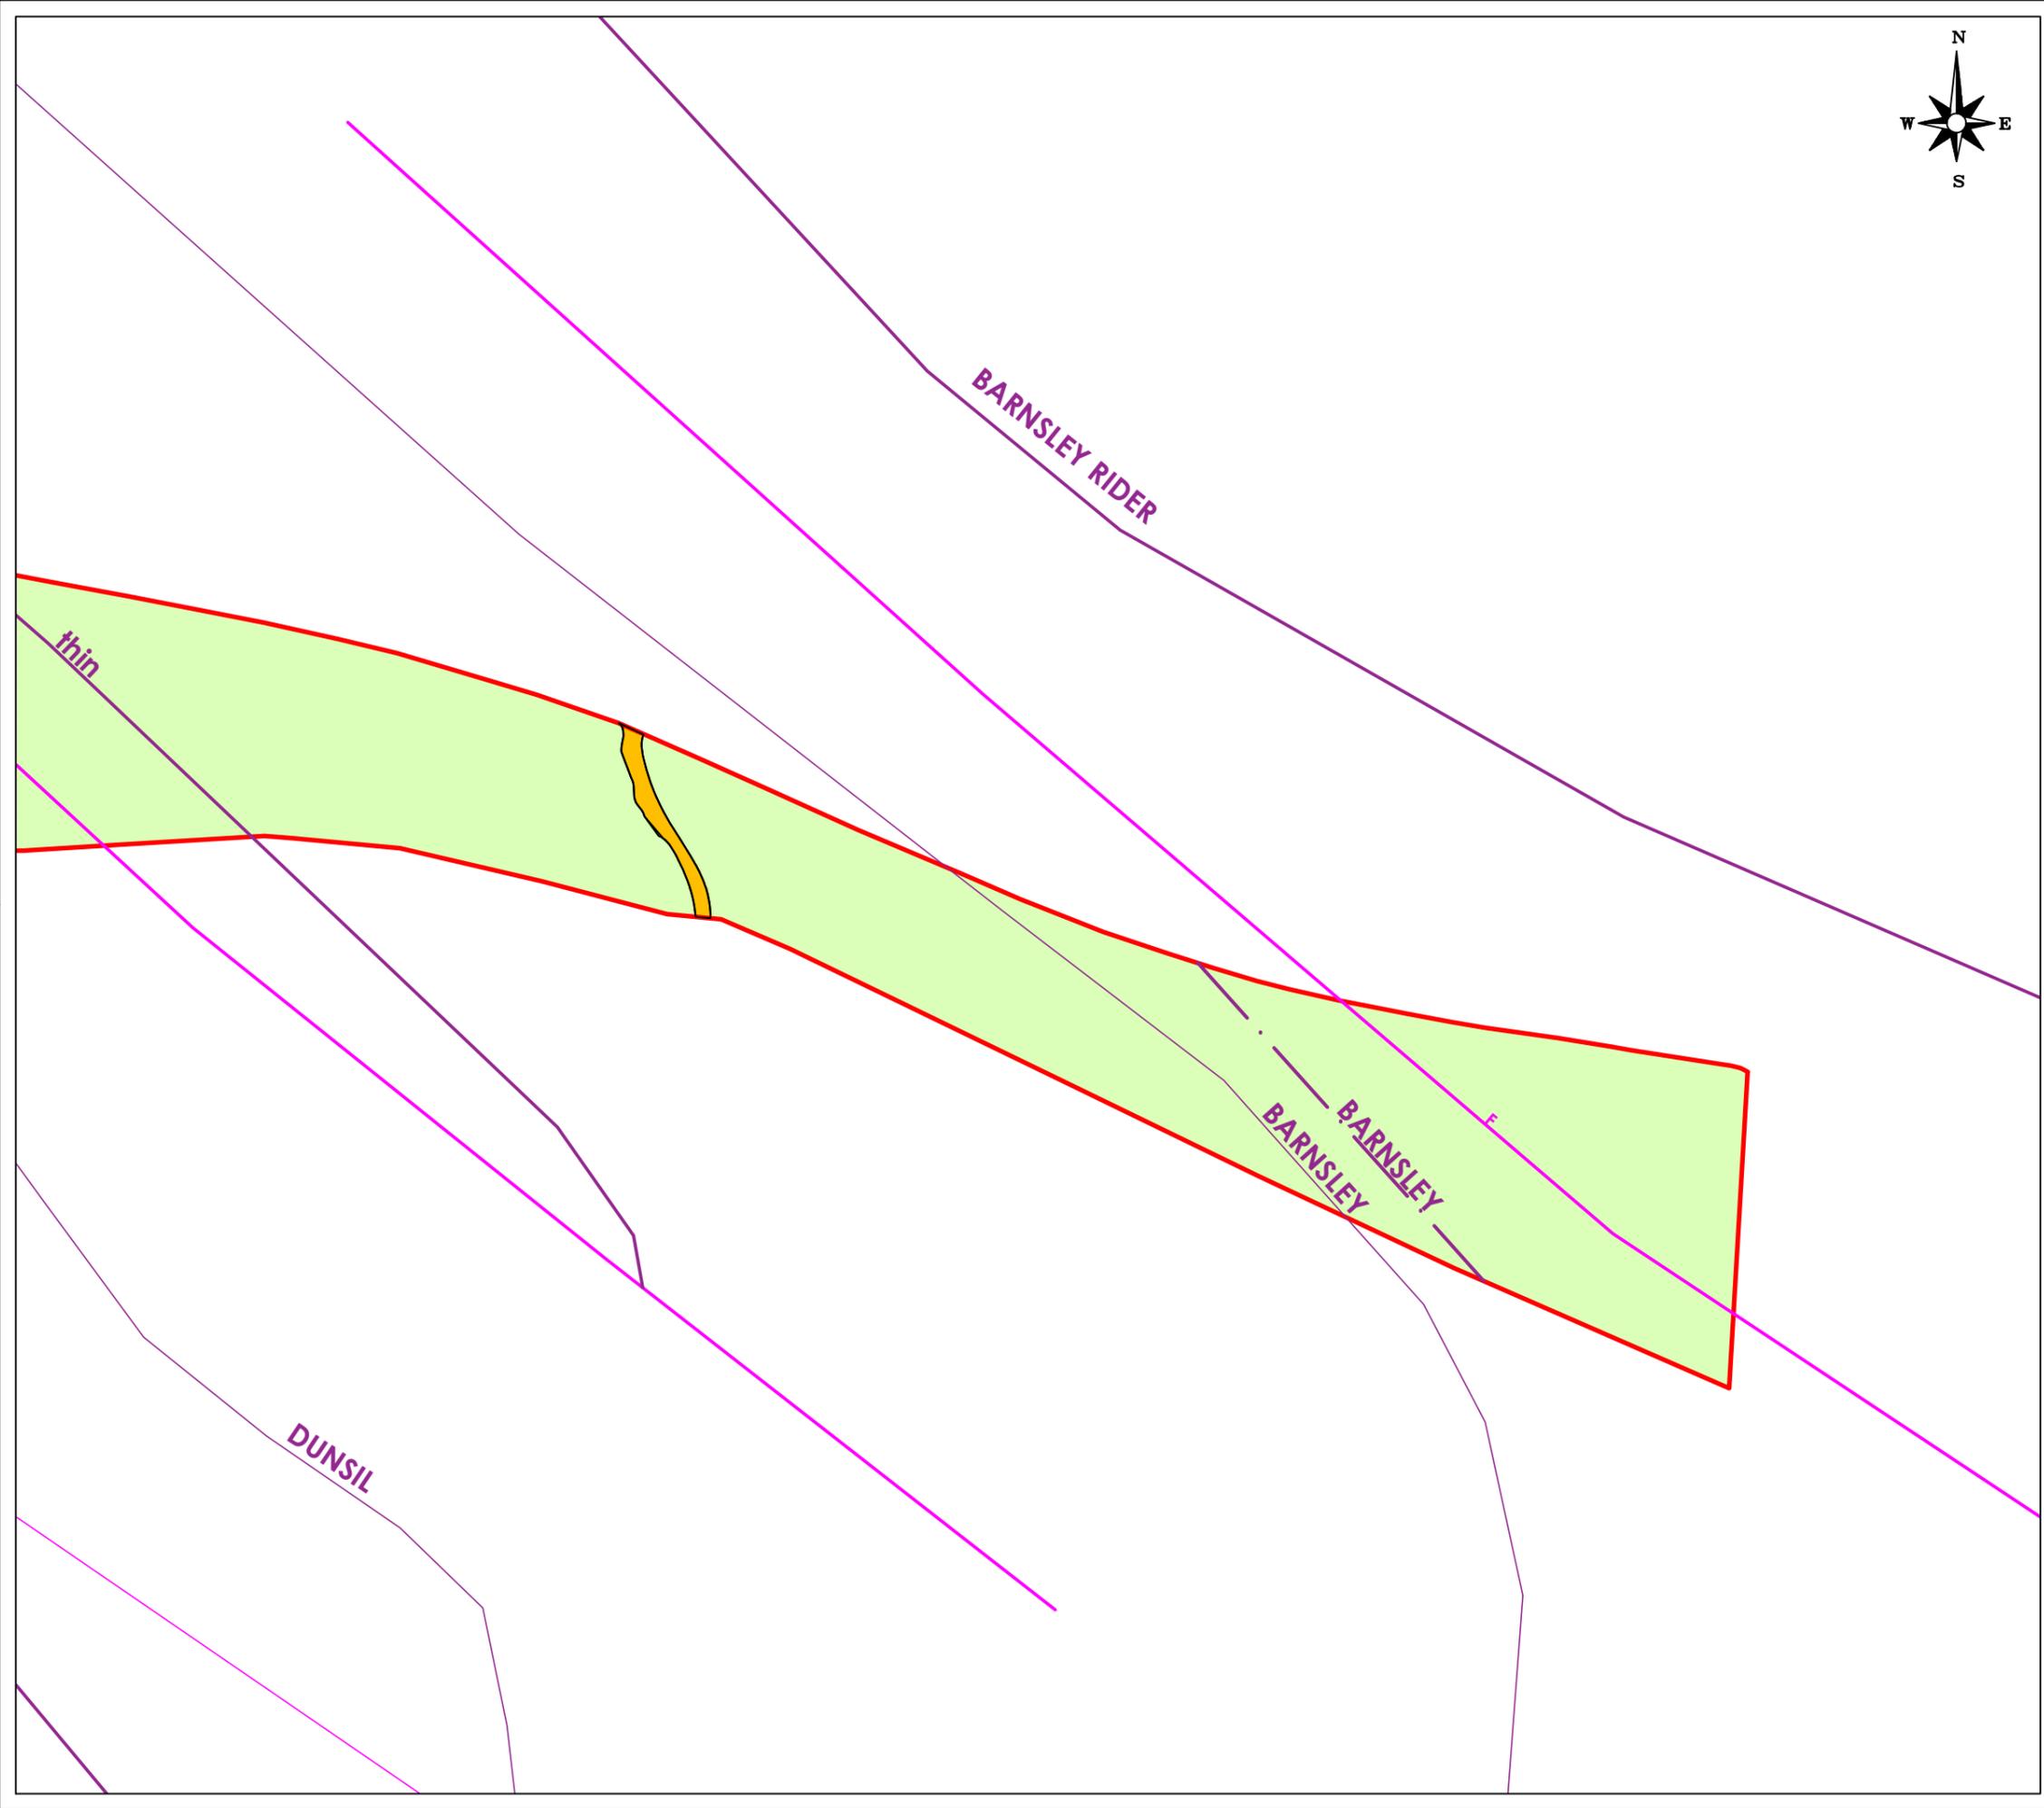
SCALE 1:1250	SHEET A3	DRAWING NO. 4386/8b	REVISION
------------------------	--------------------	-------------------------------	----------

- NOTES
- ACTUAL COAL SEAM
 - RECORDED COAL SEAM
 - F — ACTUAL FAULT
 - F — RECORDED FAULT
 - APPROXIMATE SITE BOUNDARY
 - GRASS & OVERGROWN AREAS
 - GRAVEL HARDCORE SURFACING
 - MARSH & V. DENSE VEGETATION

- 3.3.4 Recorded outcrop positions are shown on Drawing 4386/8a and 4386/8b.
- 3.3.5 It should be noted that seam outcrops plotted on geological maps have been known to be inaccurate by distances in excess of 100m.

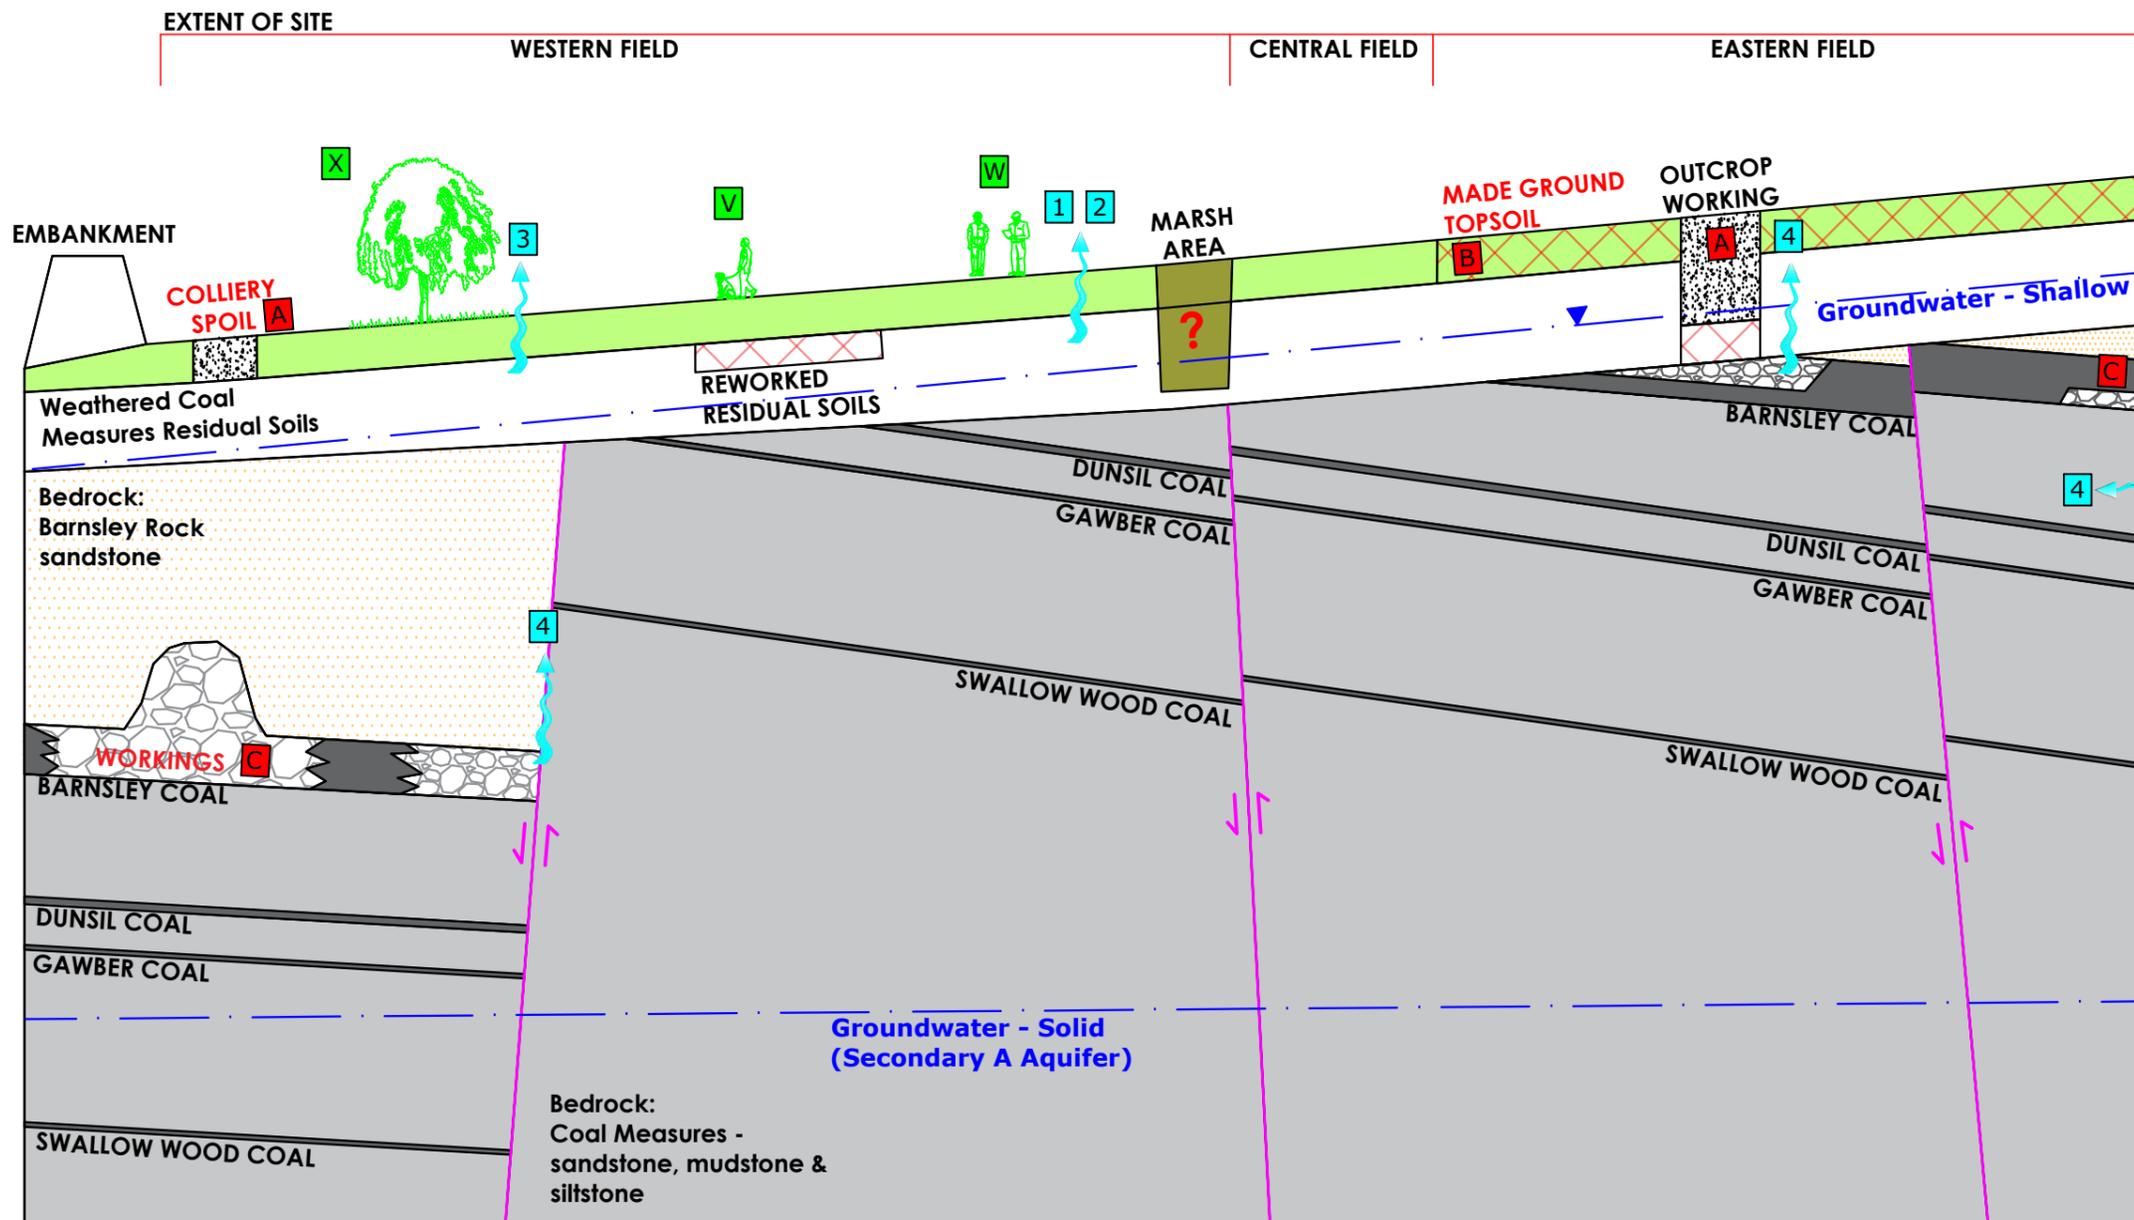
REVISED CONCEPTUAL SITE MODEL

SOURCES	
A	COLLIERY SPOIL (INORGANICS)
B	MADE GROUND TOPSOIL (INORGANICS)
C	WORKINGS/COAL (GAS)

PATHWAYS	
1	DERMAL CONTACT
2	INGESTION/INHALATION
3	UPTAKE BY PLANTS
4	MIGRATION OF GAS

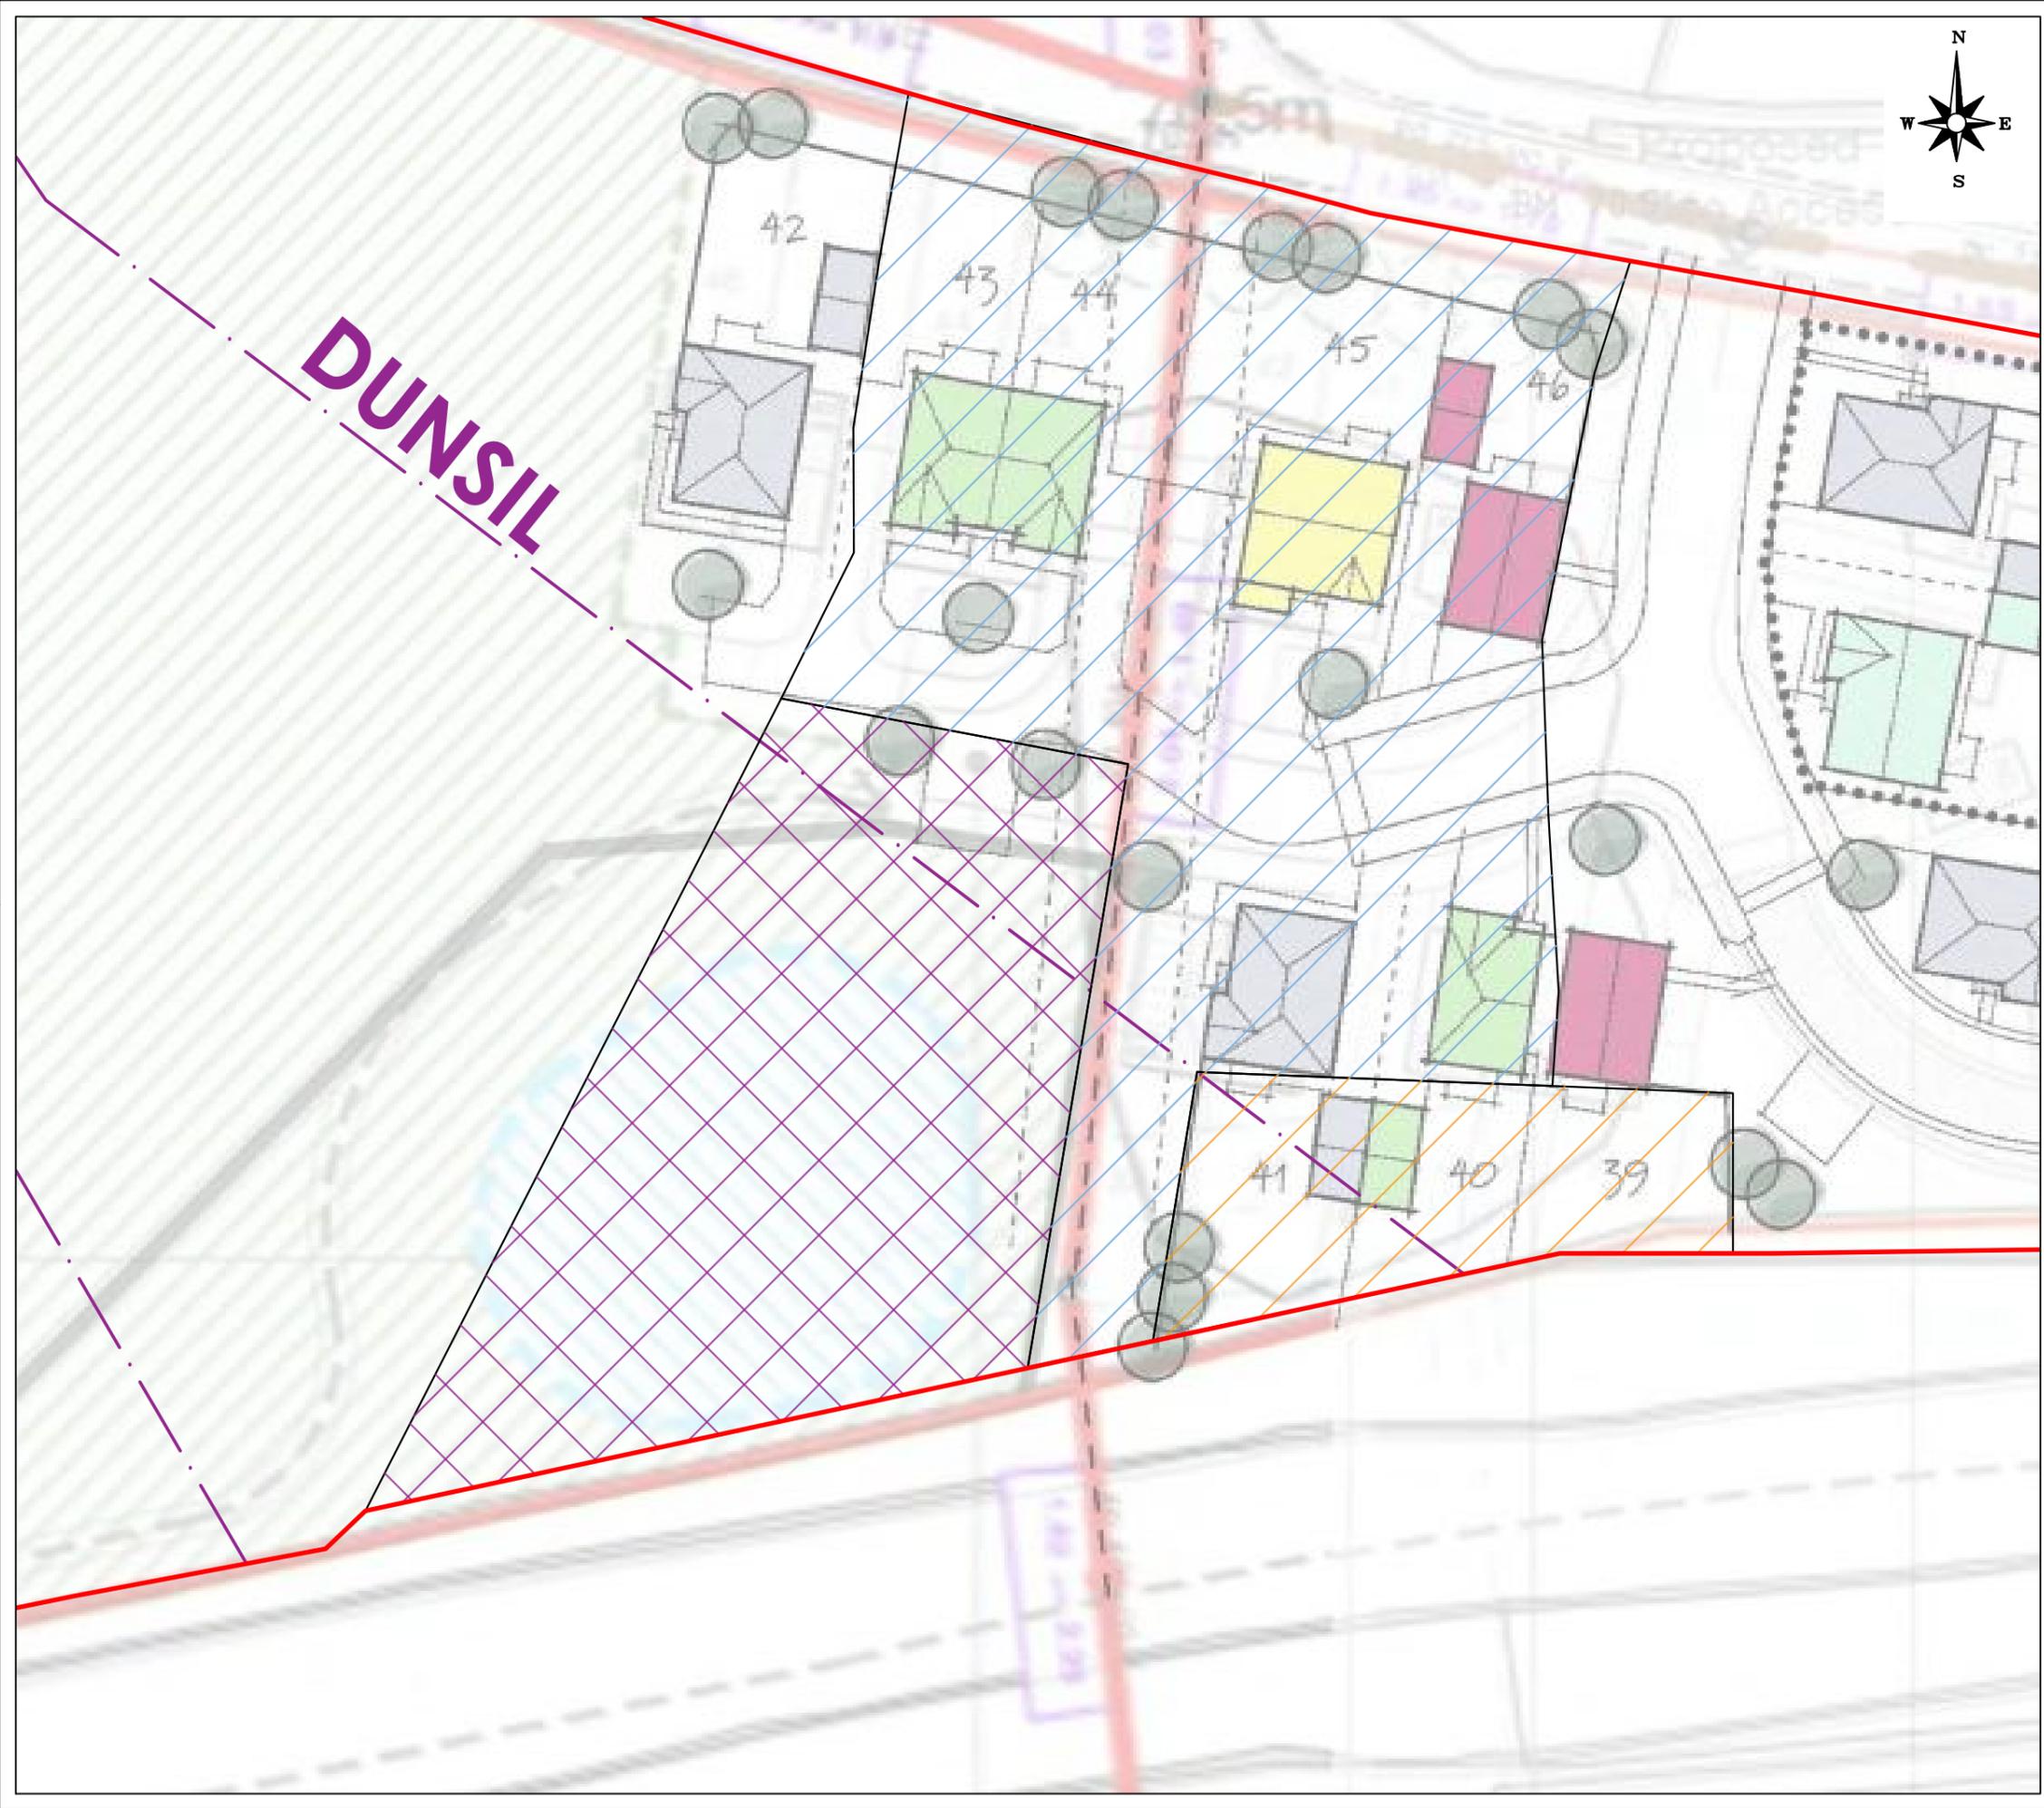
SCALE	1:400	SHEET	A3	DRAWING NO.	4386/10a	REVISION	
-------	-------	-------	----	-------------	----------	----------	--

- NOTES
- ACTUAL COAL SEAM
 - 1000mm COVER NEEDS TO BE MAINTAINED - COMBUSTIBLE SEAM
 - 600mm COVER REQUIRED (GARDENS) - NO DATA
 - 300mm COVER REQUIRED (POS) - NO DATA
 - APPROXIMATE SITE BOUNDARY
- REPRODUCED FROM DUCHY HOMES DRAWING REFERENCE SK04, DATED OCTOBER 2020

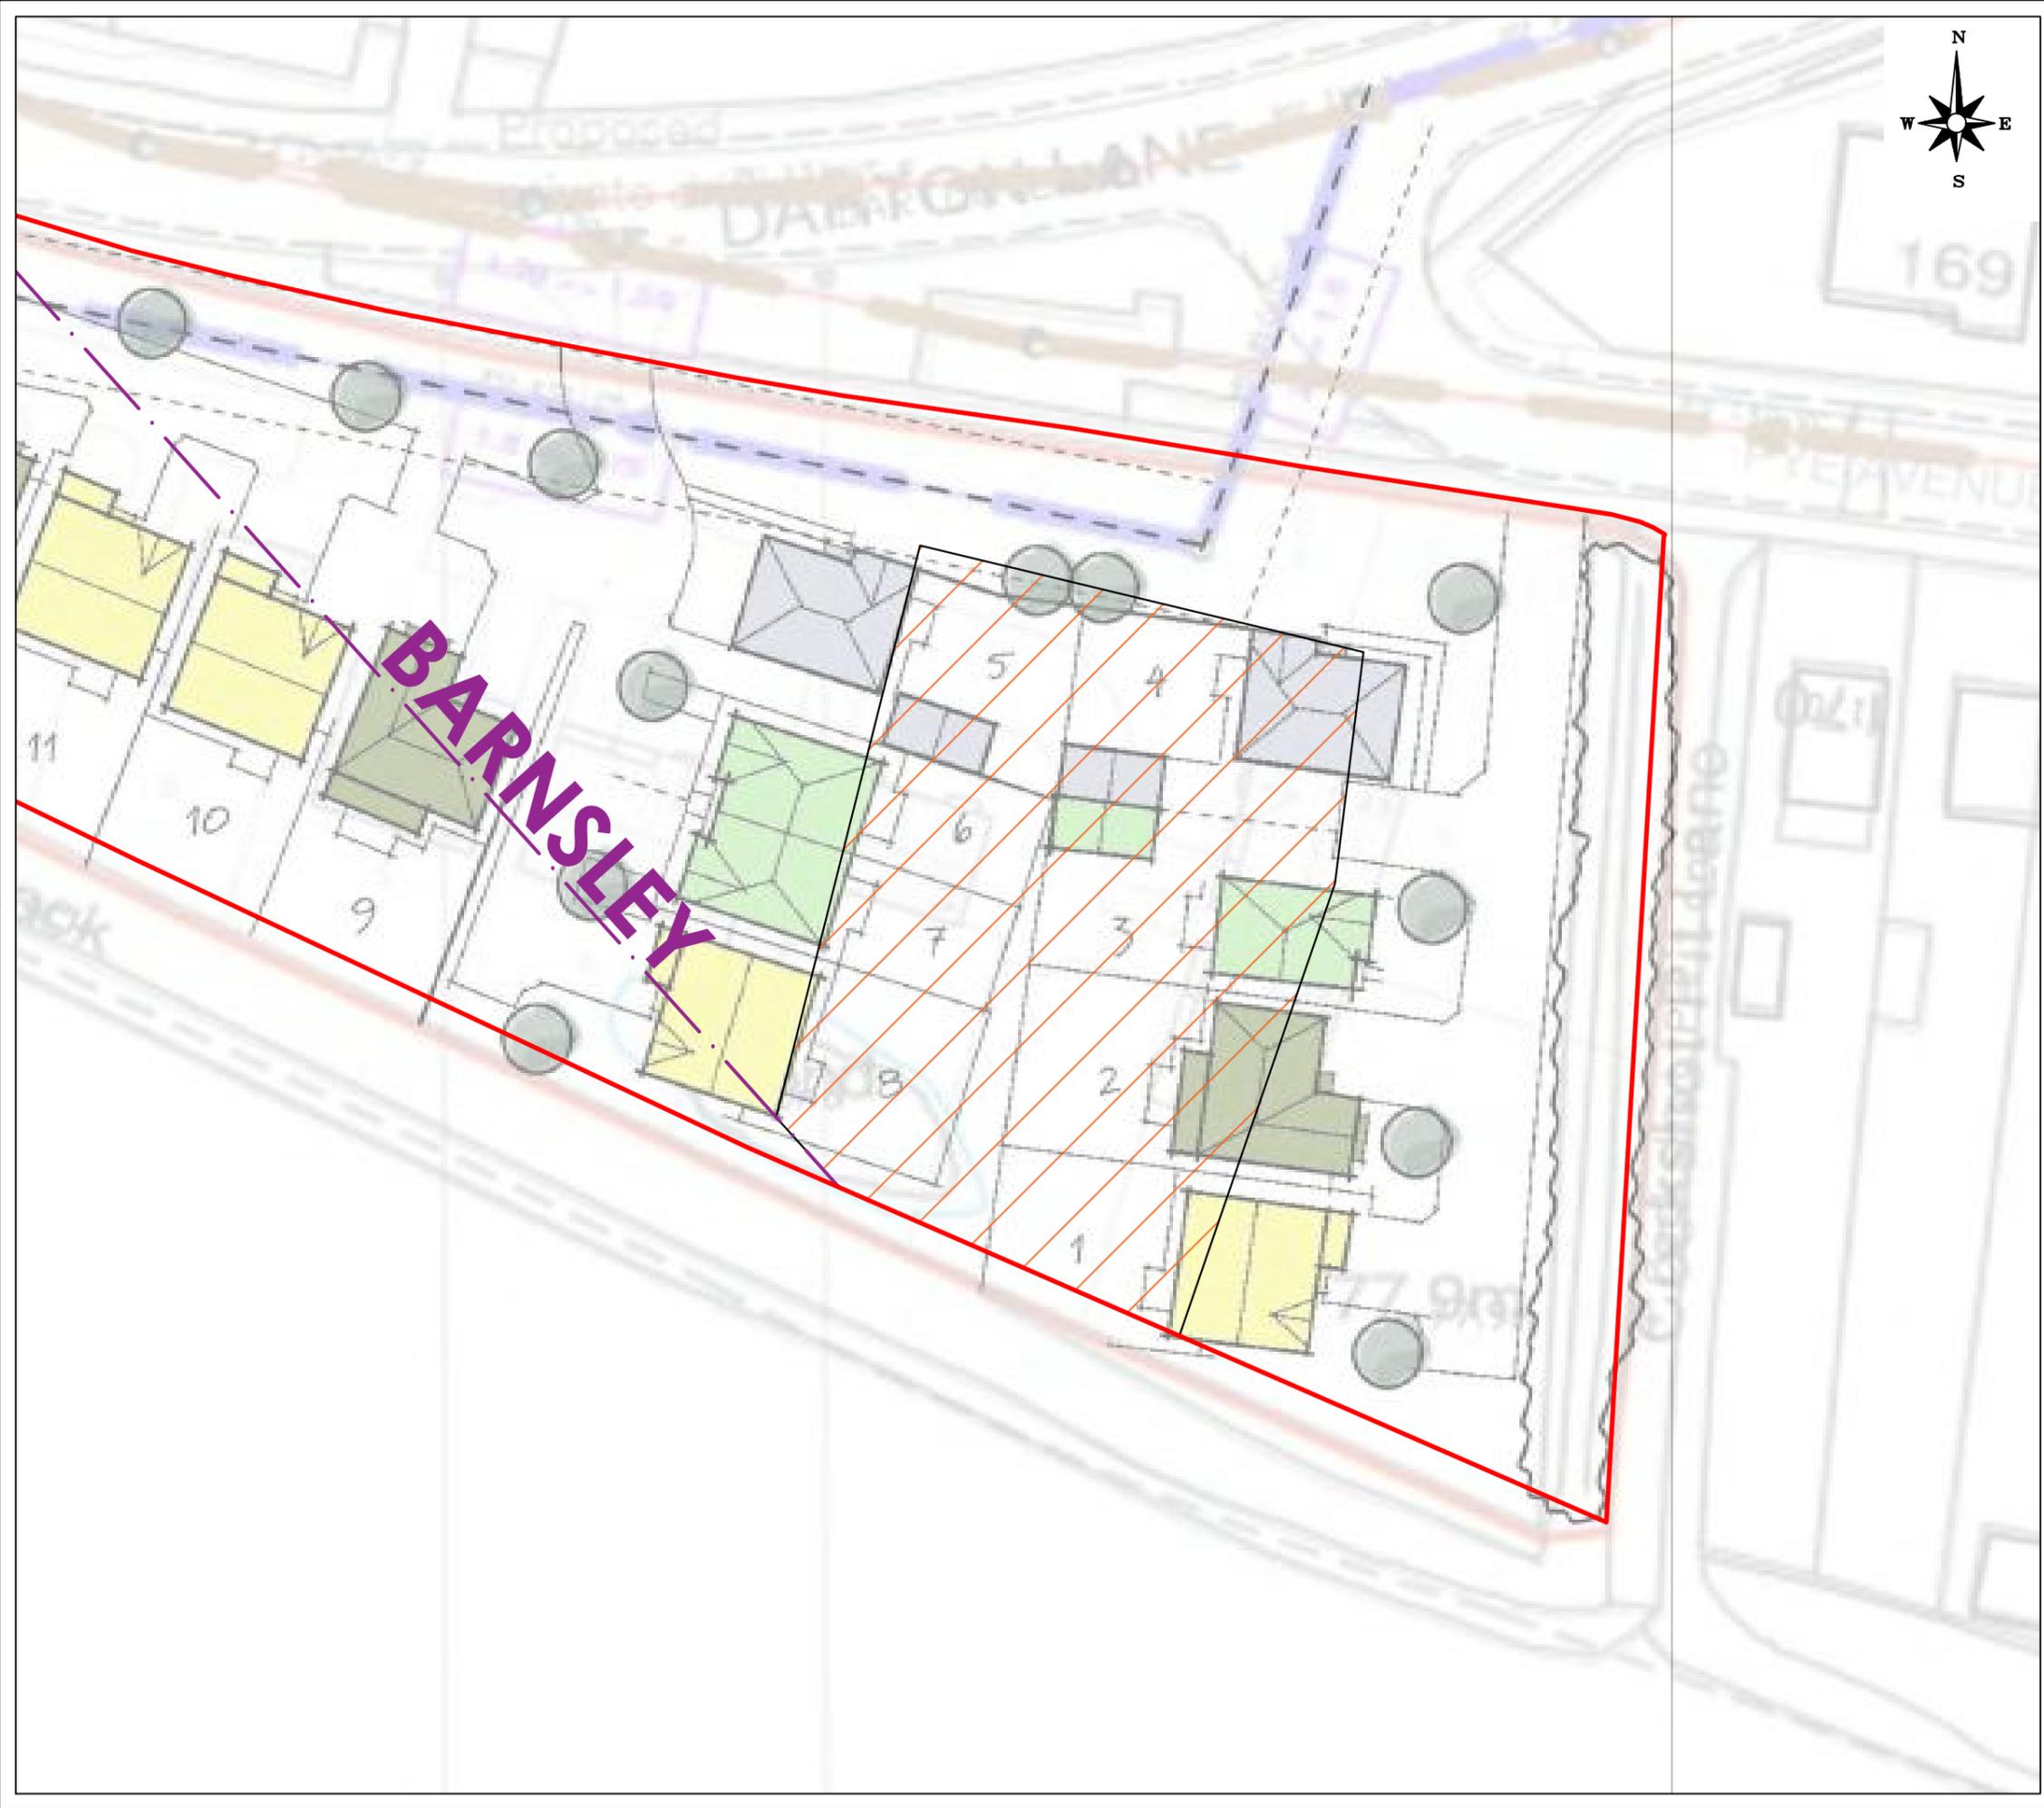
SCALE	1:1250	SHEET	A3	DRAWING NO.	4386/10b	REVISION	
-------	--------	-------	----	-------------	----------	----------	--

- - - ACTUAL COAL SEAM
- ▨ 1000mm COVER NEEDS TO BE MAINTAINED-COMBUSTIBLE SEAM
- APPROXIMATE SITE BOUNDARY

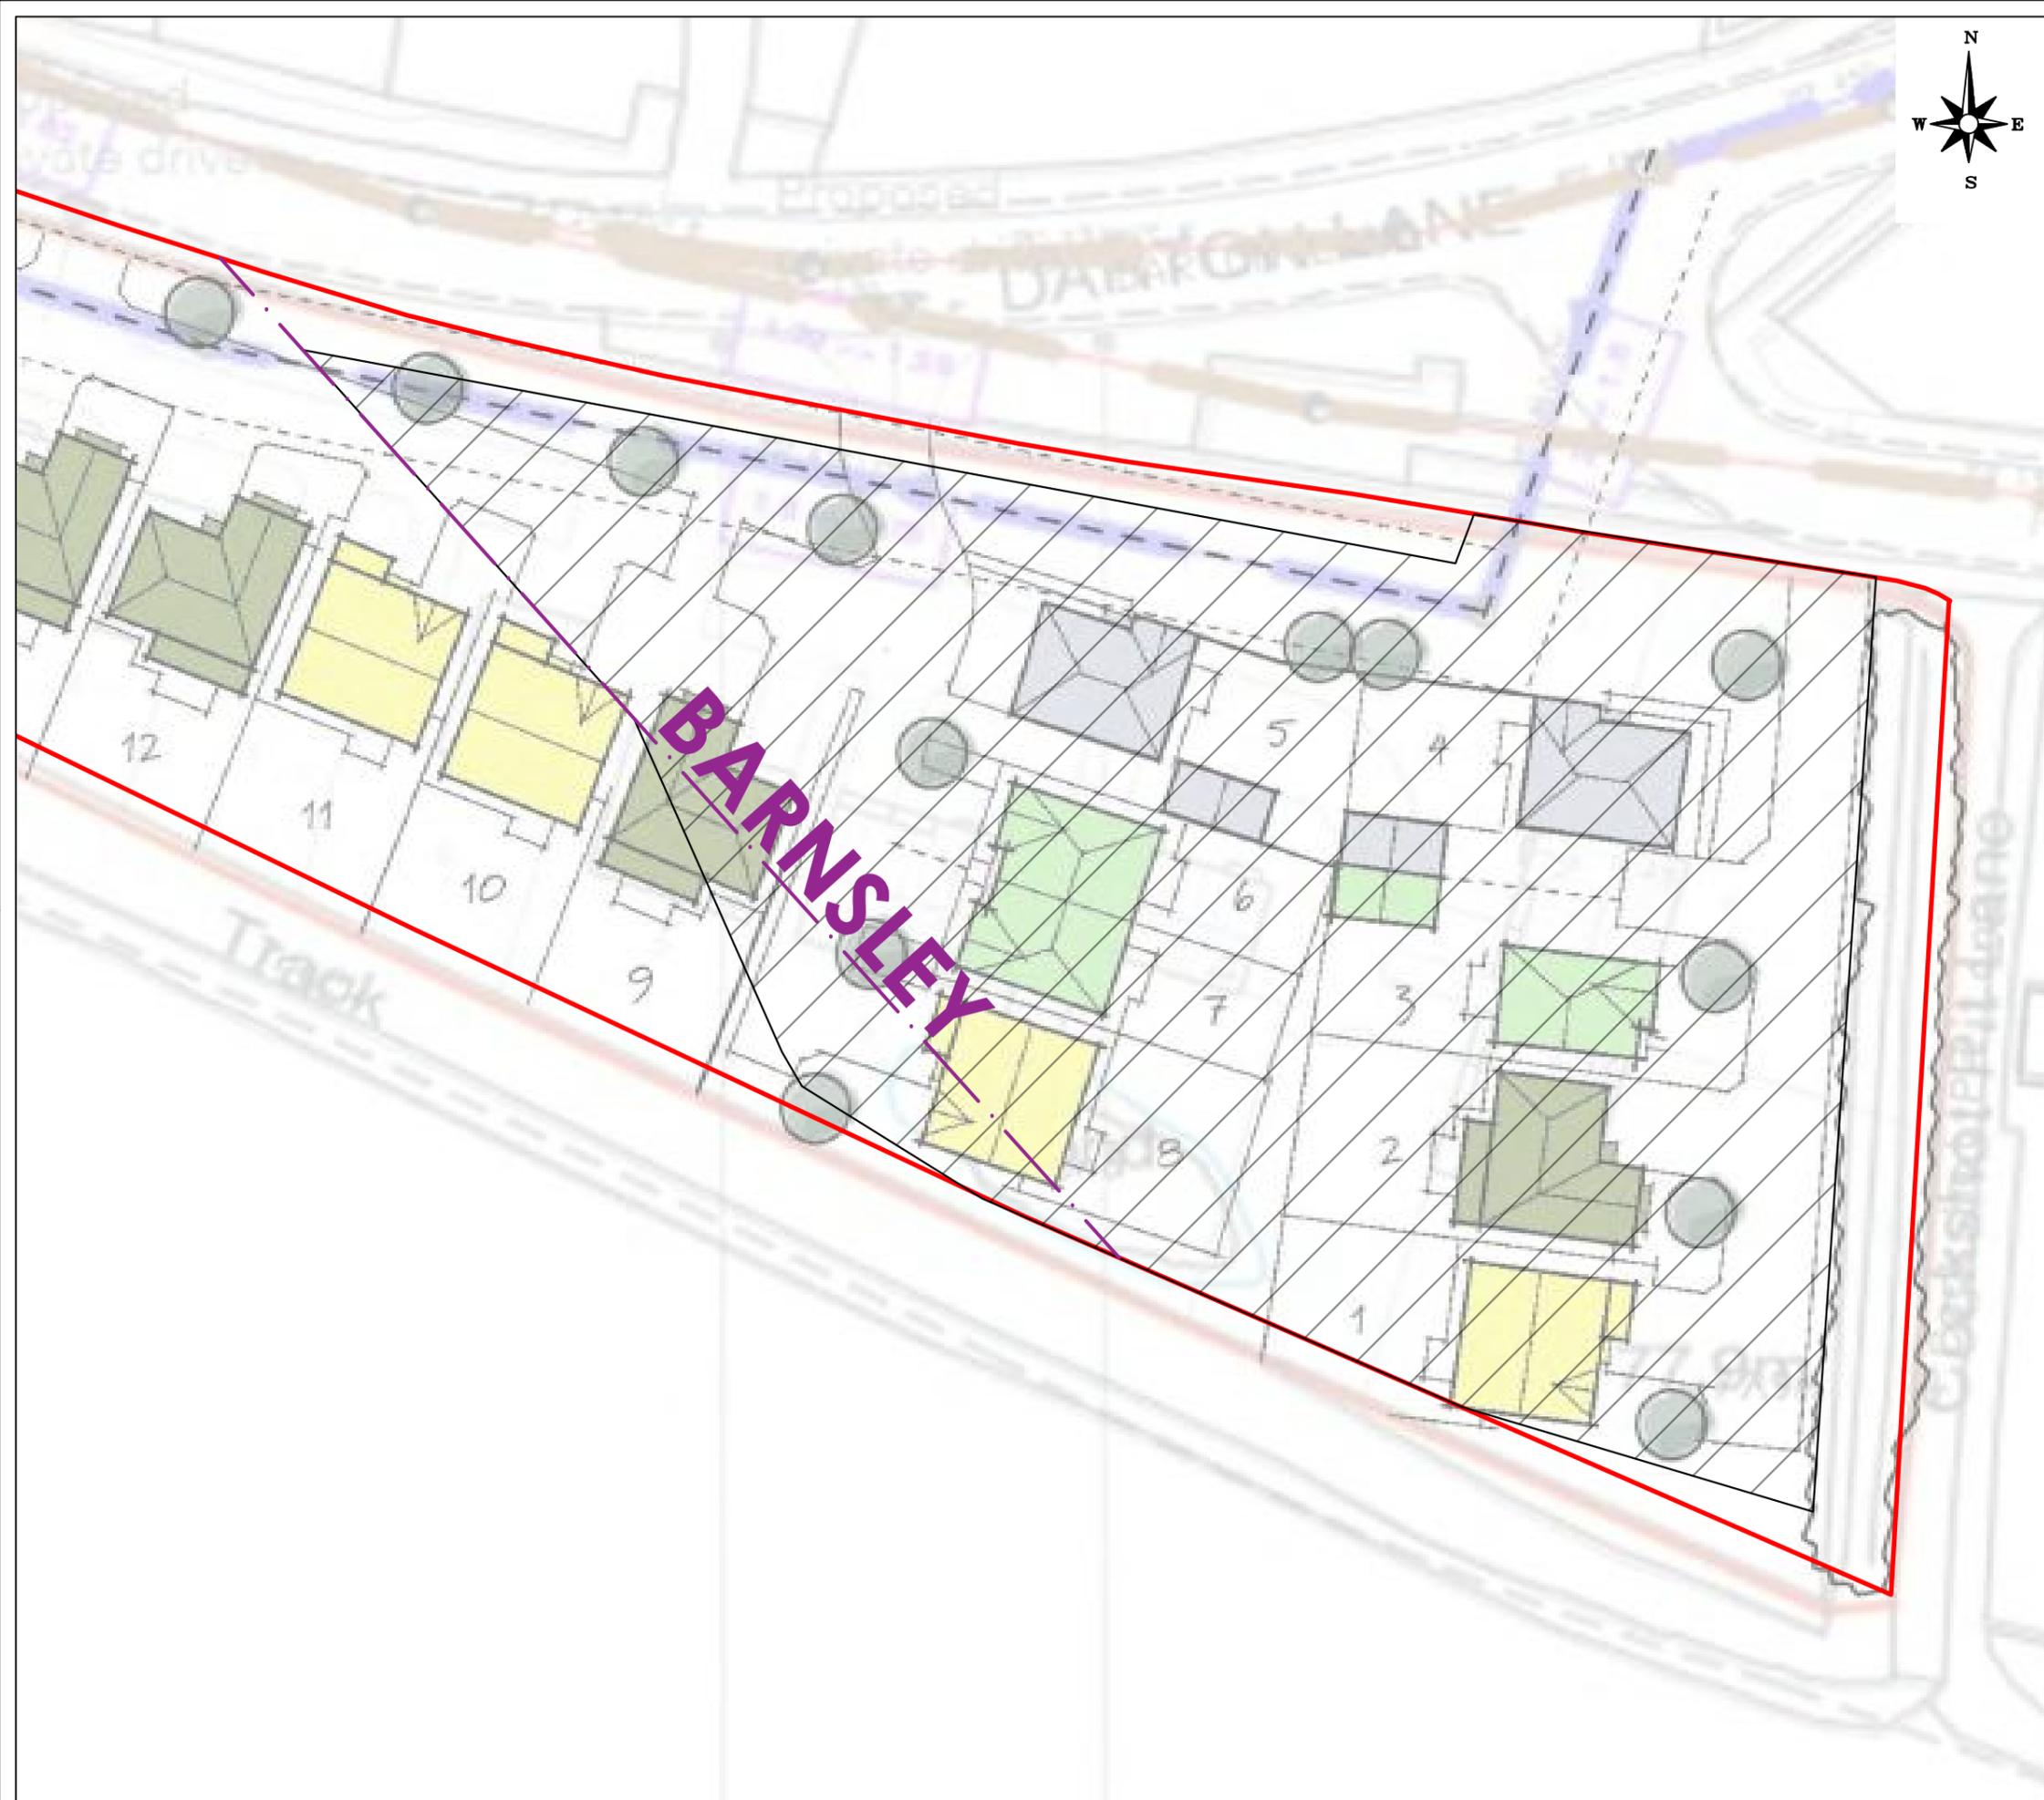
- ACTUAL COAL SEAM
- ▨ TOPSOIL STRIP REQUIRED
- APPROXIMATE SITE BOUNDARY

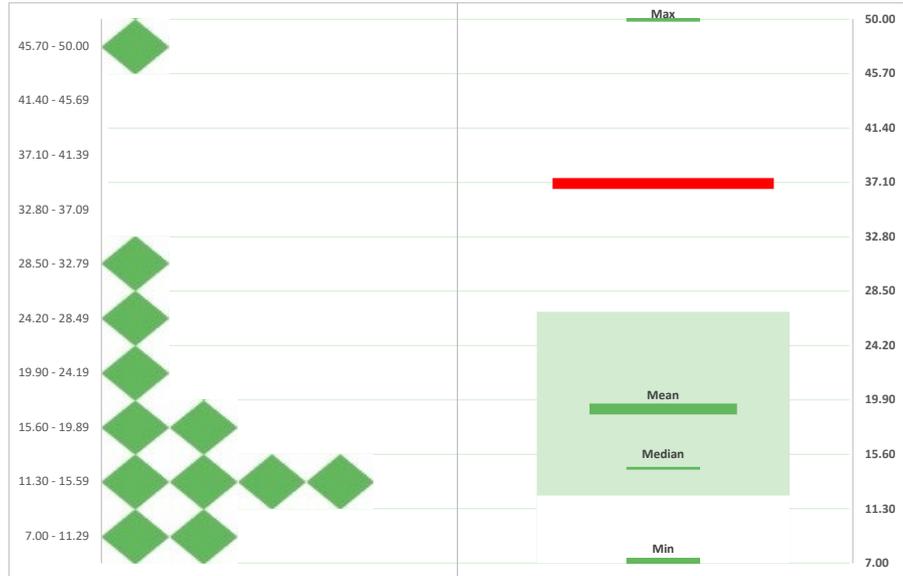
Topsoil: Dataset for As - Dot & Box Plots and Summary Statistics

Determinant	As
Critical concentration	37.00
No. samples	12.00
Max	50.00
Mean	19.18
Min	7.00
Median	14.50
Standard Deviation	12.08
Standard Error	3.49
T value	2.20
Upper Confidence Level (95%)	26.86
Upper Confidence Level (80%)	23.94
Lower Confidence Level (5%)	12.35
Transform data	Normal
Upper Confidence Level for chart	95%

Spatial distribution can show sampling clusters based on ground type it **does not** identify areas of contamination

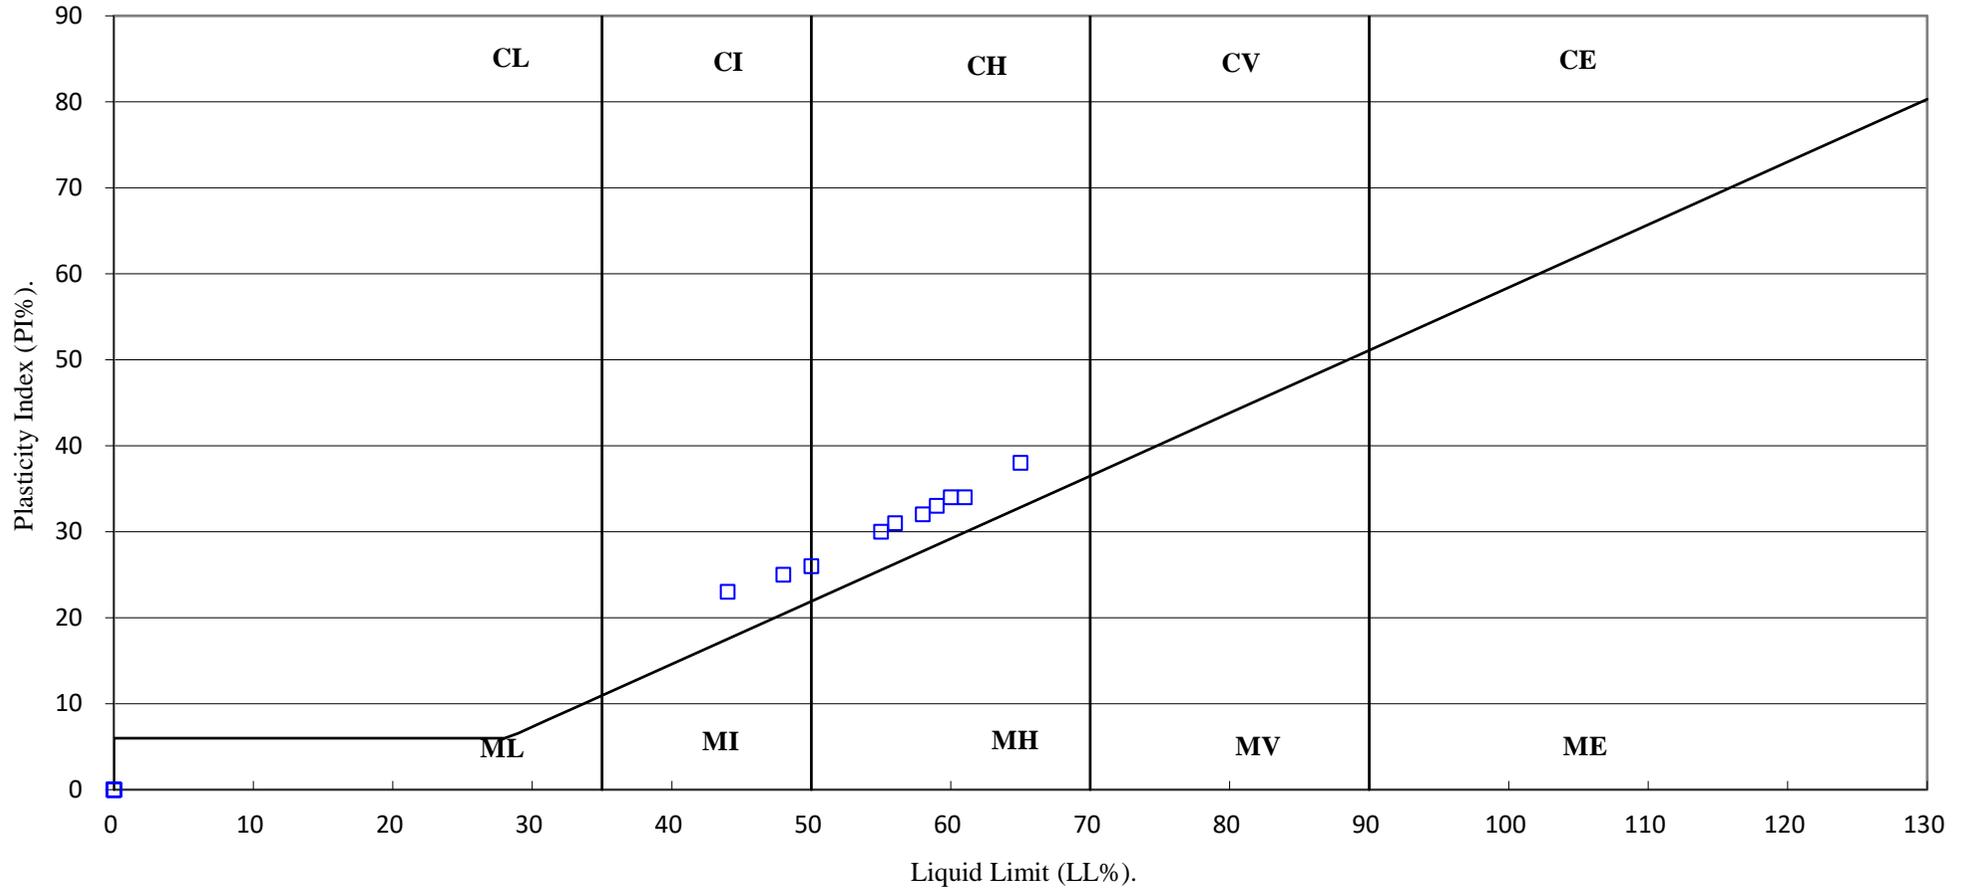
PLASTICITY CHART FOR CASAGRANDE CLASSIFICATION.

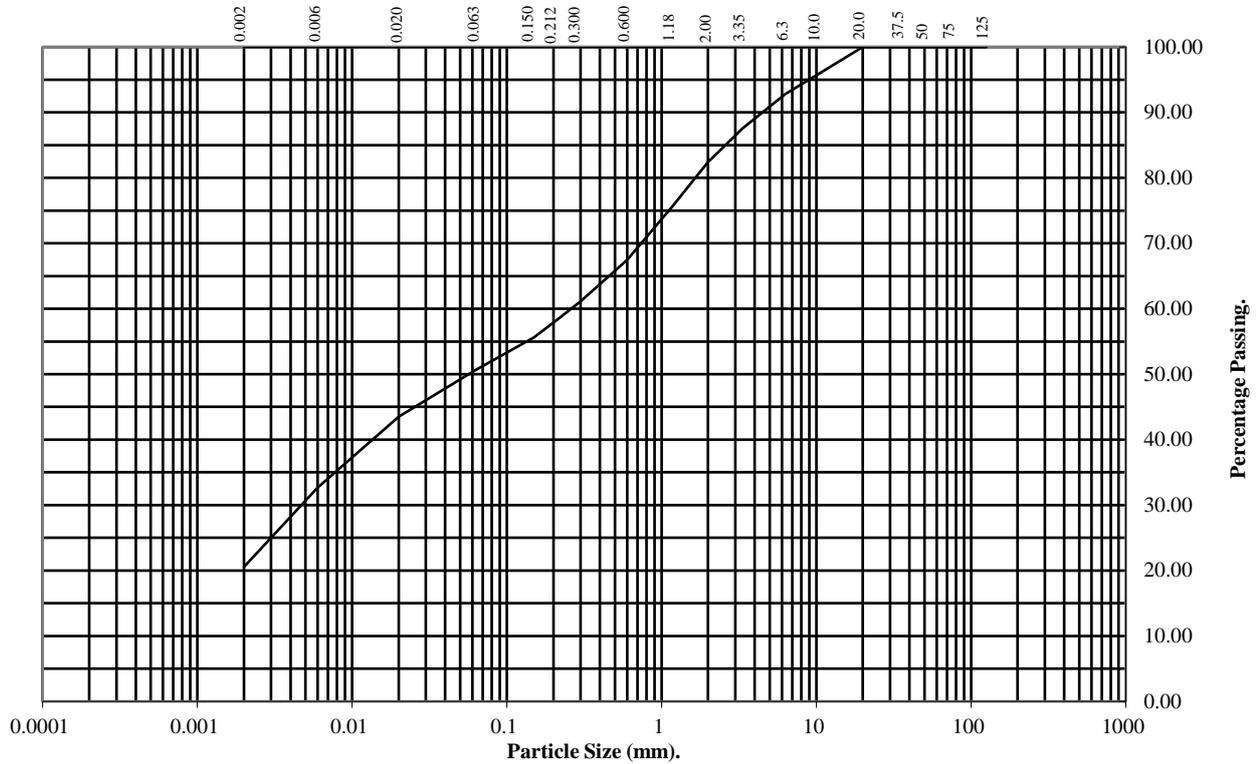
BS Test Sieve (mm)	Percentage Passing
125	100
75	100
50	100
37.5	100
20	100
10	96
6.3	93
3.35	88
2	82
1.18	76
0.6	67
0.3	61
0.212	58
0.15	56
0.063	51

Particle Diameter	Percentage Passing
0.02	44
0.006	33
0.002	21

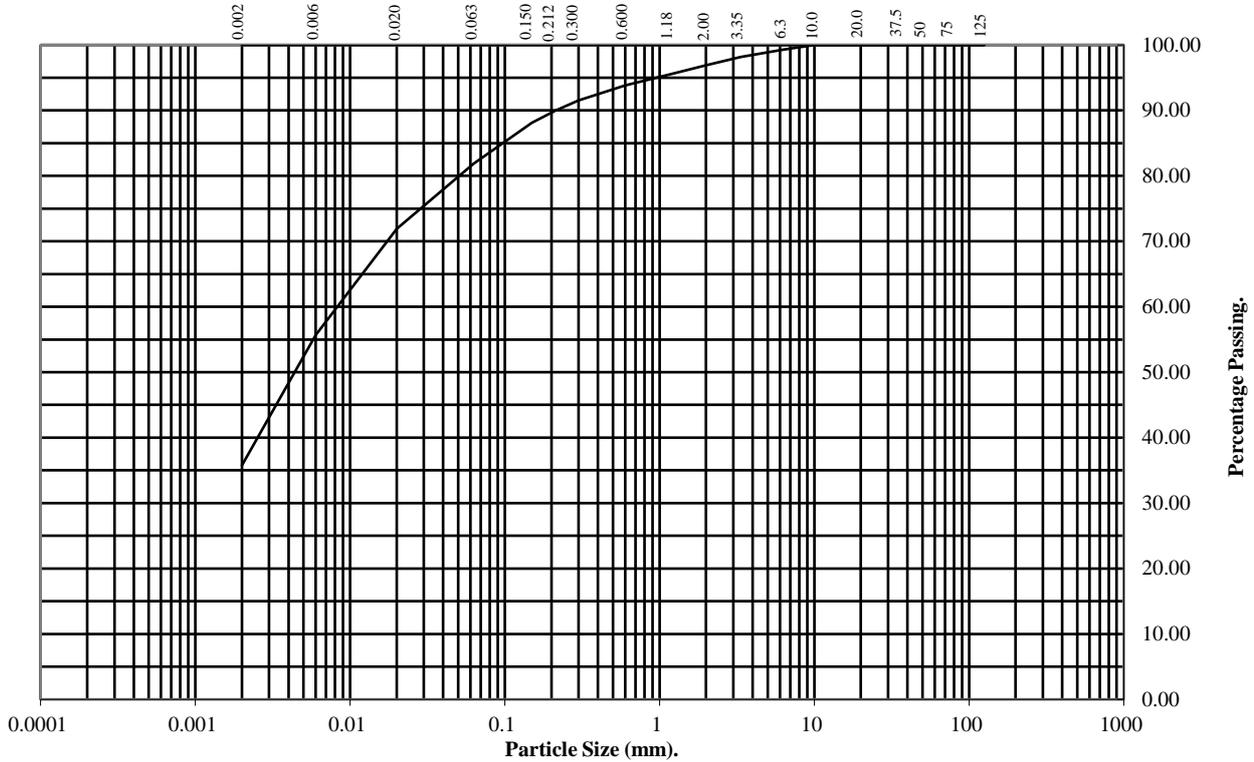
BS Test Sieve (mm)	Percentage Passing
125	100
75	100
50	100
37.5	100
20	100
10	100
6.3	99
3.35	98
2	97
1.18	96
0.6	94
0.3	92
0.212	90
0.15	88
0.063	82

Particle Diameter	Percentage Passing
0.02	72
0.006	56
0.002	36
