Supplementary Geoenvironmental Appraisal

Land at Darton Lane, Barnsley For Duchy Homes

Report no: 4386/1

Date: August 2022

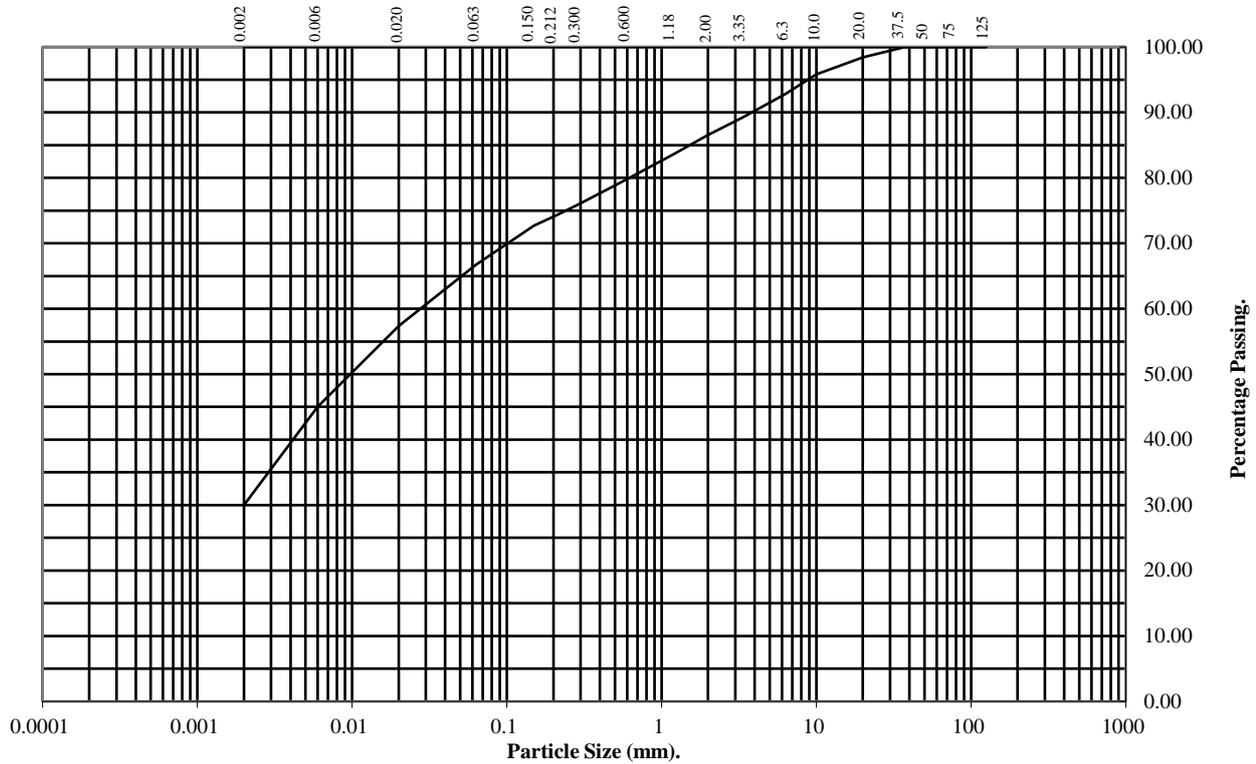
BS Test Sieve (mm)	Percentage Passing
125	100
75	100
50	100
37.5	100
20	98
10	96
6.3	93
3.35	89
2	87
1.18	84
0.6	80
0.3	76
0.212	74
0.15	73
0.063	67

Particle Diameter	Percentage Passing
0.02	57
0.006	45
0.002	30

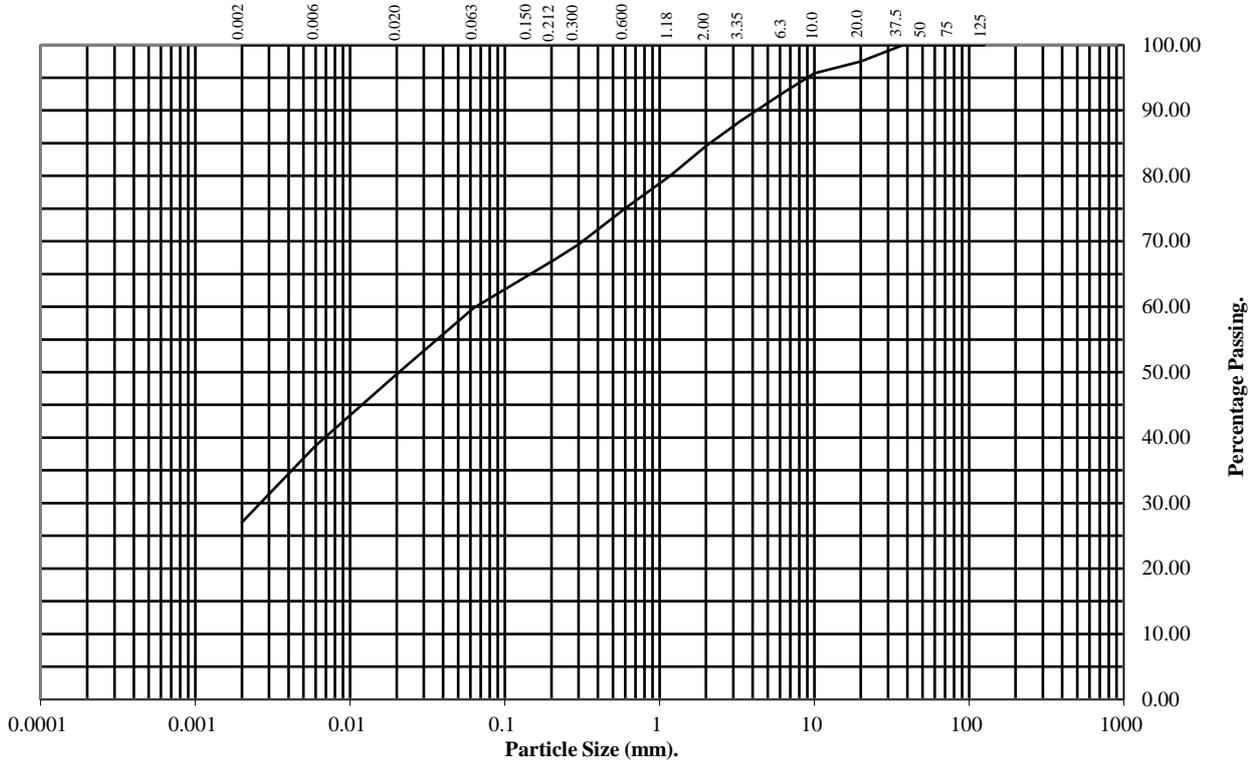
BS Test Sieve (mm)	Percentage Passing
125	100
75	100
50	100
37.5	100
20	97
10	96
6.3	93
3.35	88
2	85
1.18	80
0.6	75
0.3	70
0.212	67
0.15	65
0.063	60

Particle Diameter	Percentage Passing
0.02	50
0.006	39
0.002	27

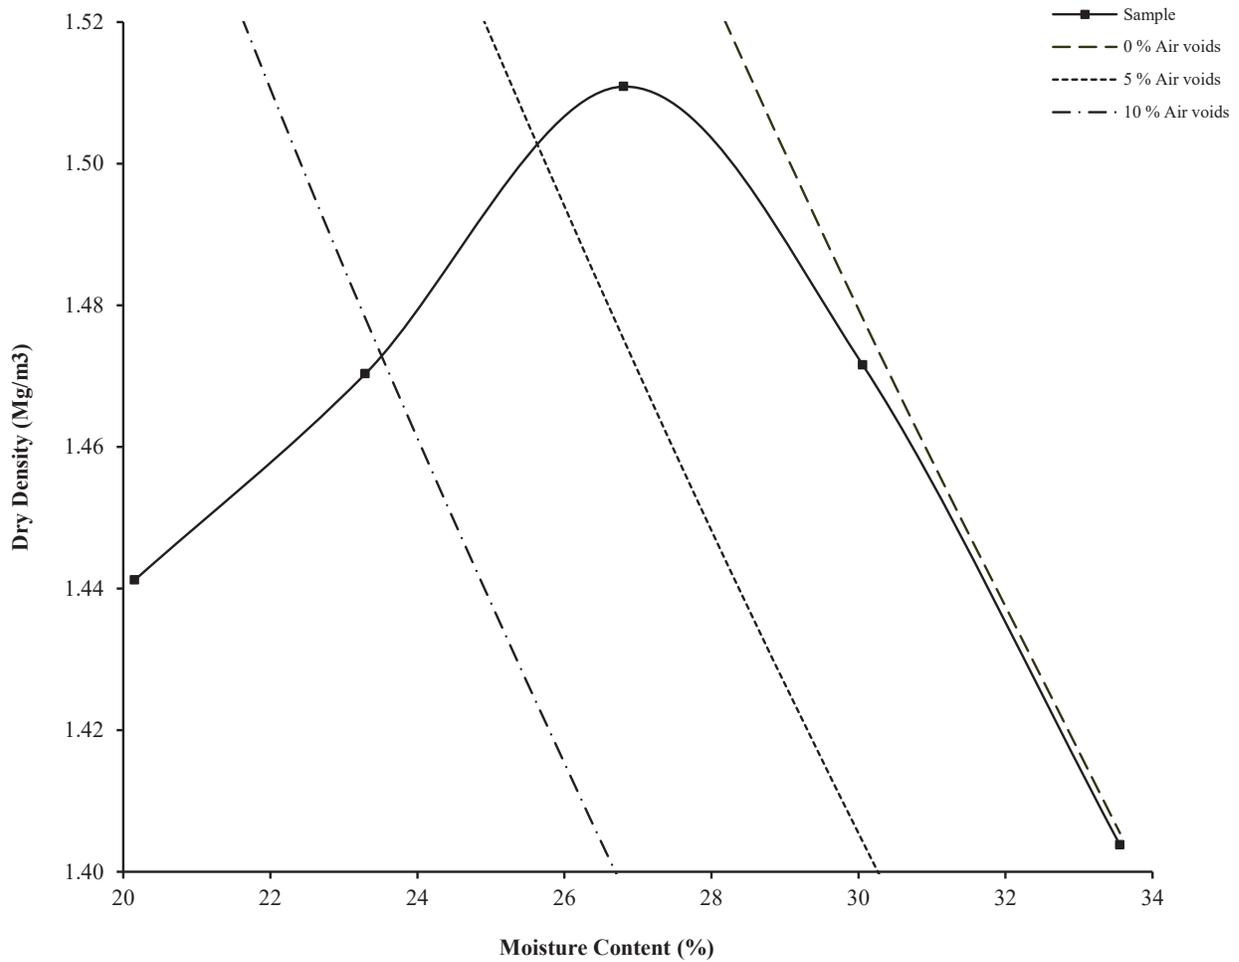
Initial Moisture Content:	34	Method of Compaction:	2.5kg	Separate Samples
Particle Density (Mg/m ³):	2.66	Measured	Material Retained on 37.5 mm Test Sieve (%):	0
Maximum Dry Density (Mg/m ³):	1.51	Material Retained on 20.0 mm Test Sieve (%):	0	
Optimum Moisture Content (%):	27			
Remarks				
See summary of soil descriptions.

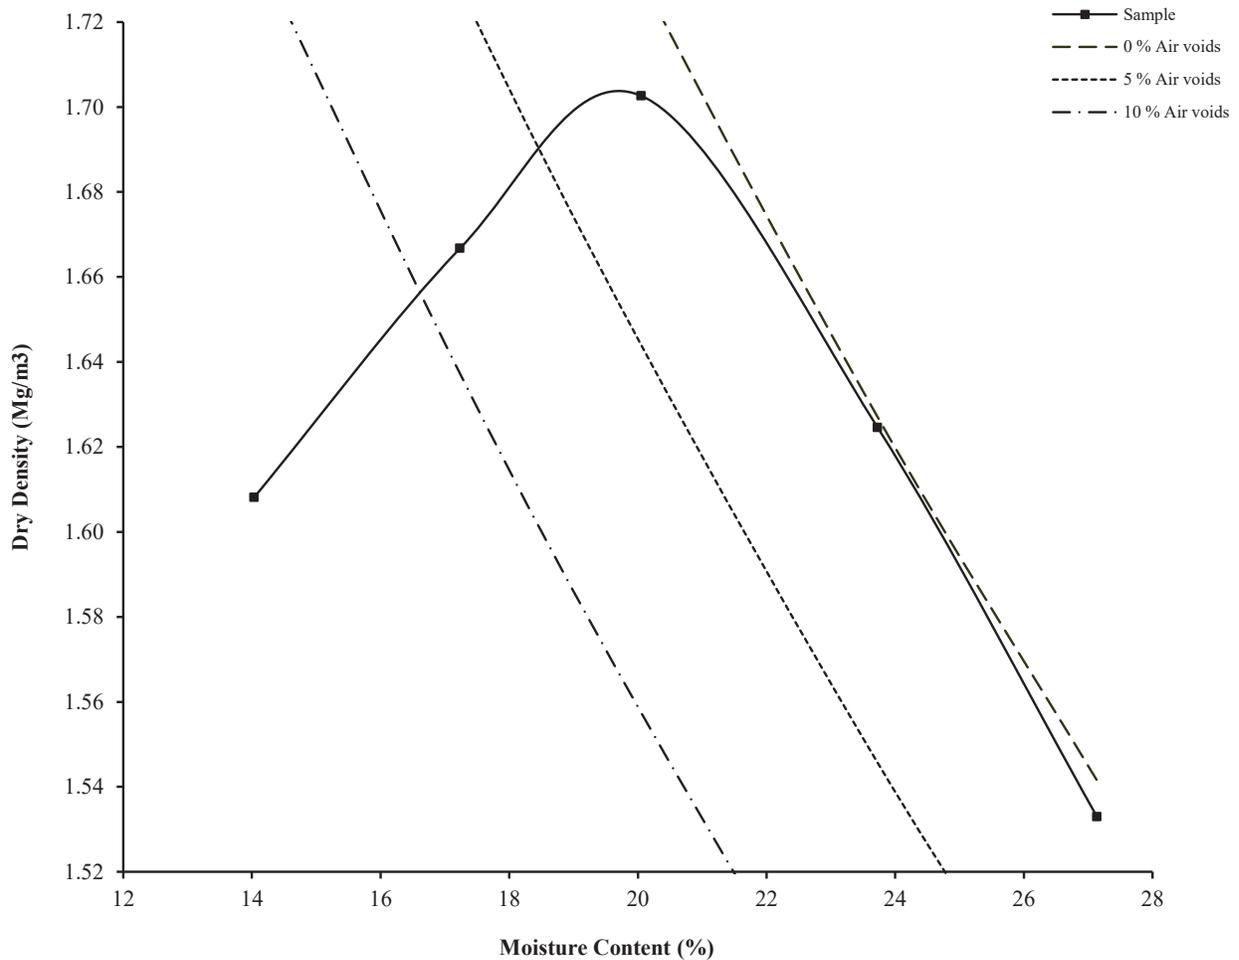
Initial Moisture Content:	20	Method of Compaction:	2.5kg	Separate Samples
Particle Density (Mg/m ³):	2.65	Measured	Material Retained on 37.5 mm Test Sieve (%):	0
Maximum Dry Density (Mg/m ³):	1.70	Material Retained on 20.0 mm Test Sieve (%):	0	
Optimum Moisture Content (%):	20			
Remarks				
See summary of soil descriptions.

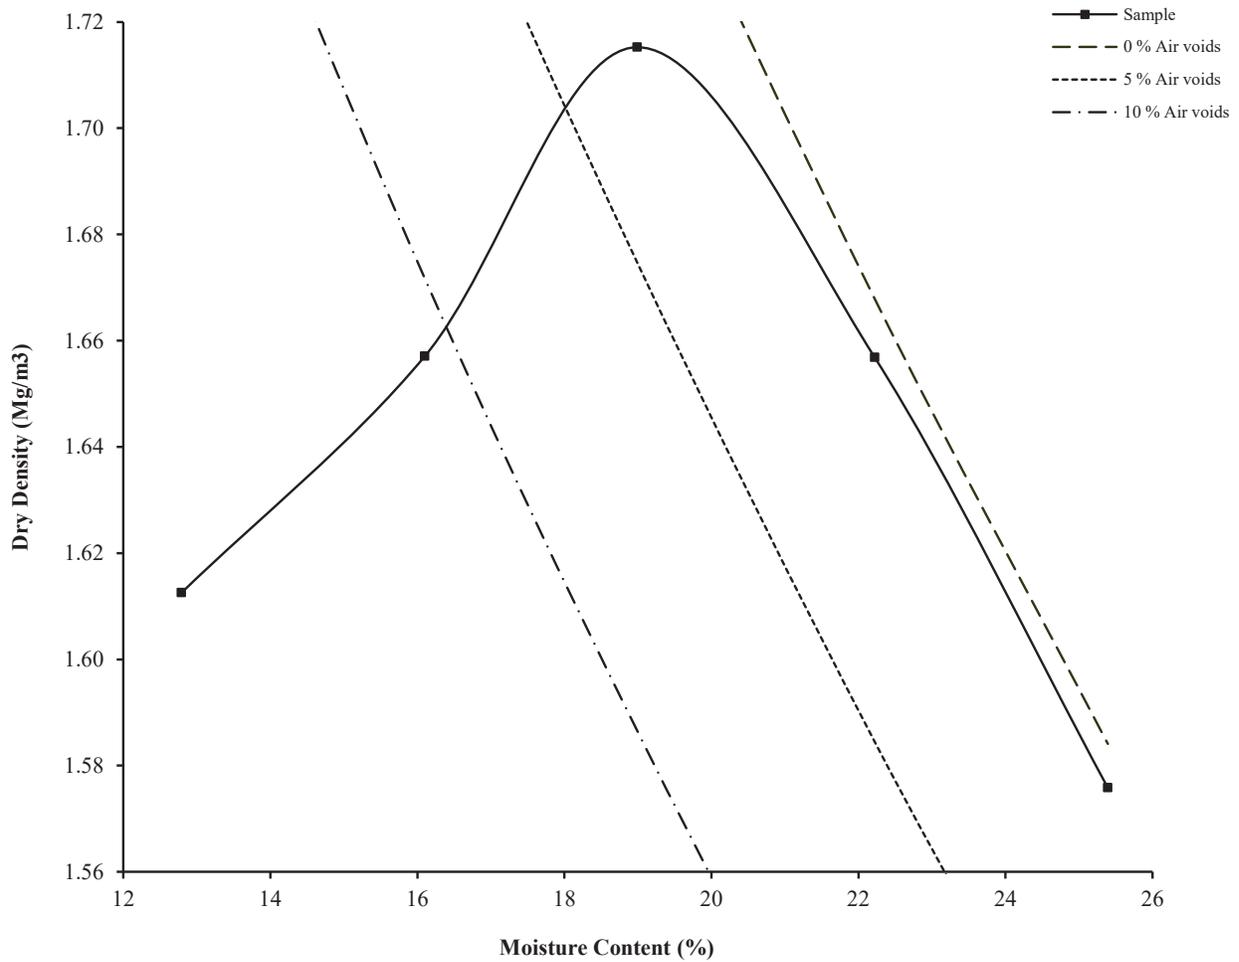
Initial Moisture Content:	22	Method of Compaction:	2.5kg	Separate Samples
Particle Density (Mg/m ³):	2.65	Measured	Material Retained on 37.5 mm Test Sieve (%):	0
Maximum Dry Density (Mg/m ³):	1.72	Material Retained on 20.0 mm Test Sieve (%):	0	
Optimum Moisture Content (%):	19			
Remarks				
See summary of soil descriptions.

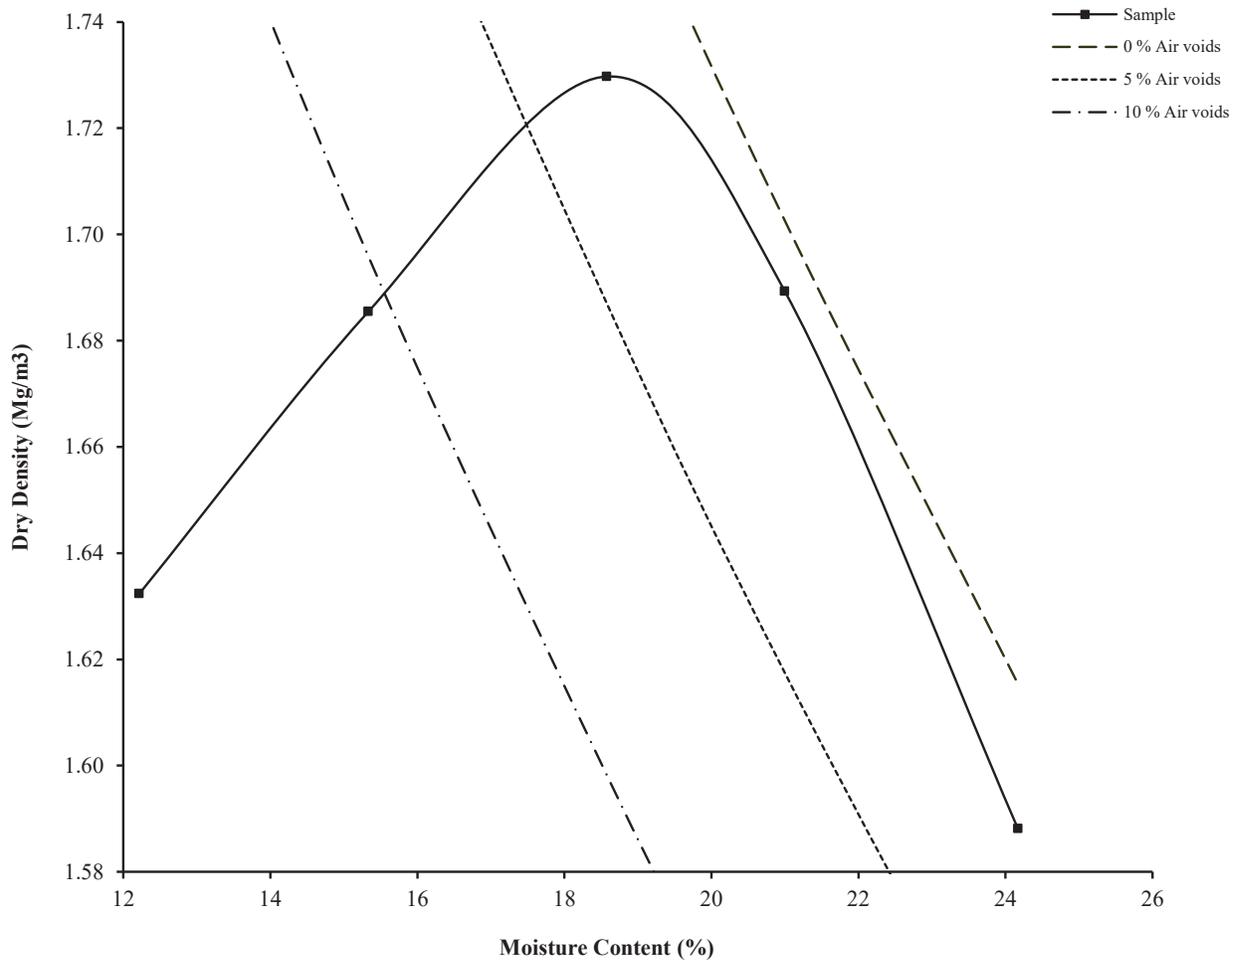
Initial Moisture Content:	21	Method of Compaction:	2.5kg	Separate Samples
Particle Density (Mg/m ³):	2.65	Measured	Material Retained on 37.5 mm Test Sieve (%):	0
Maximum Dry Density (Mg/m ³):	1.73	Material Retained on 20.0 mm Test Sieve (%):	0	
Optimum Moisture Content (%):	19			
Remarks				
See summary of soil descriptions.
