**Barnsley Metropolitan
Borough Council**

P18-01603

**St Michael's Avenue,
Barnsley**

**Phase II
Geo Environmental
Site Assessment**

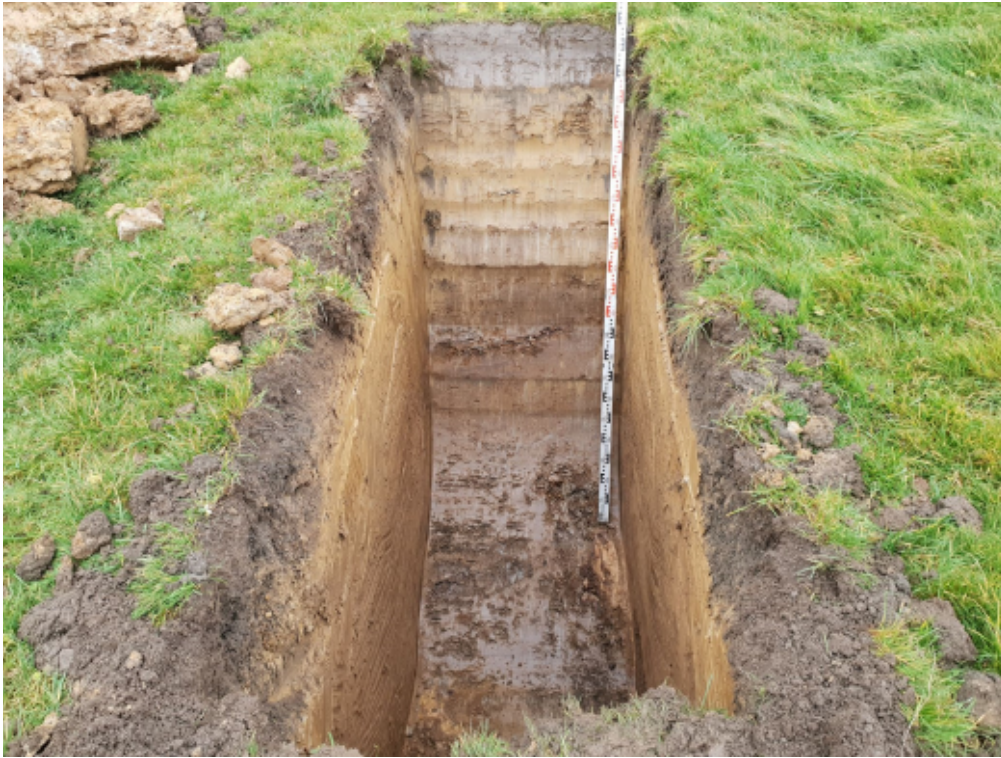
Photograph 05. Trial Pit 03.

Groundwater was infiltrating the sides of trial pits TP03 and TP06 from 2.0mbgl and water strikes were also recorded in WS02 and WS03 at depths of 1.8mbgl and 2.0mbgl respectively.

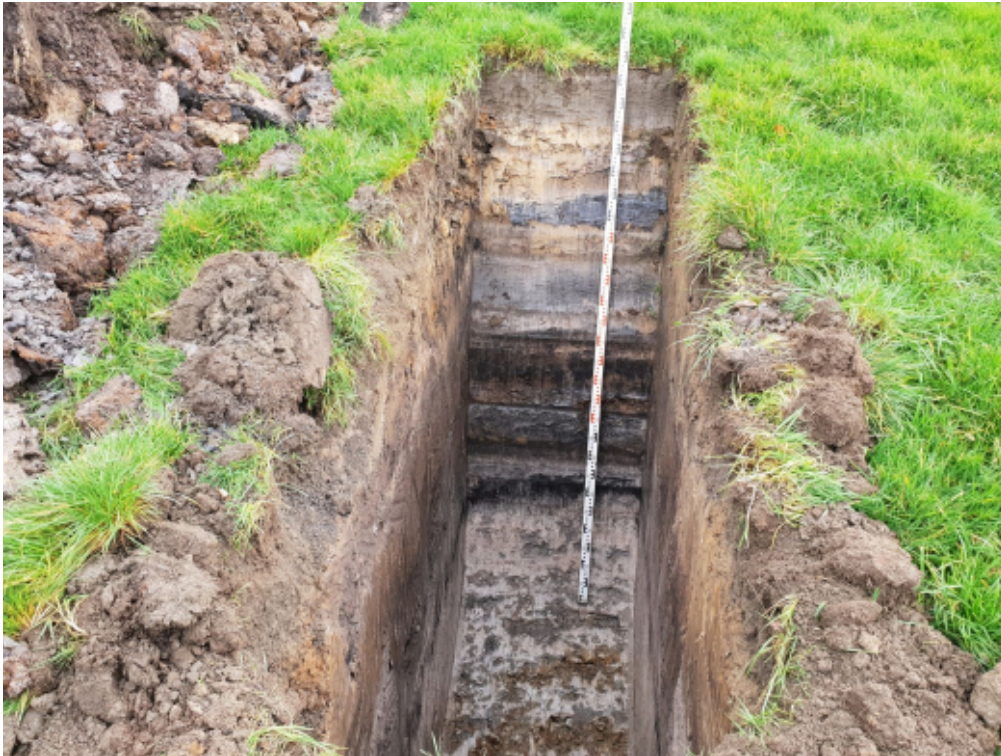
Photograph 09. Trial Pit 05.

Completely weathered mudstone bedrock was identified under the entire site from depths of 0.60mbgl (TP05) and 1.8mbgl (WS01).

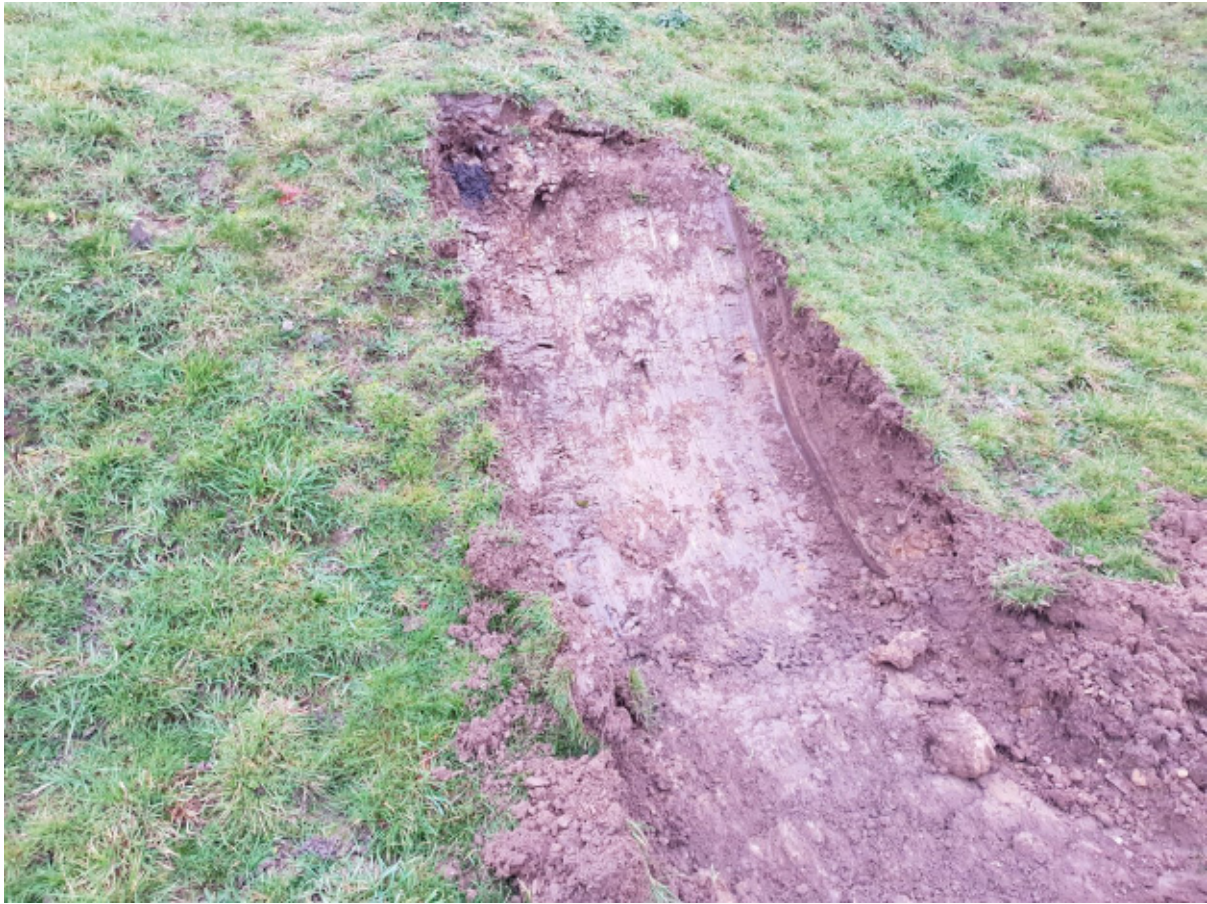
A shallow trial pit was excavated into one of the earth mounds in the north east of the site. This confirmed the mound comprised surface topsoil with occasional fragments and whole bricks underlain by silty CLAY.

Shallow excavation in to earth mound in north east
