**THE BUNGALOW, SHEFFIELD ROAD,
OXSPRING.**

BAT SURVEY REPORT.

Ref No: 230815/1

Date: 1st September 2023.

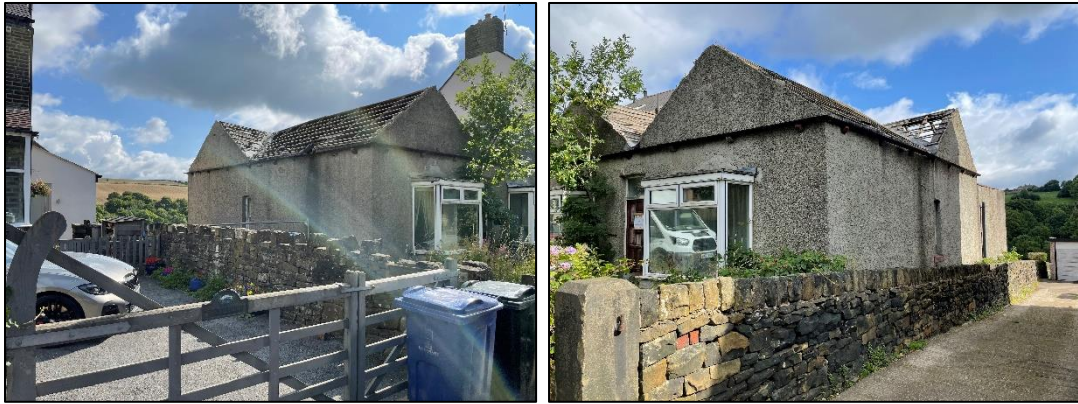
3.2.3. The two photographs below show the bungalow as seen from the main road.

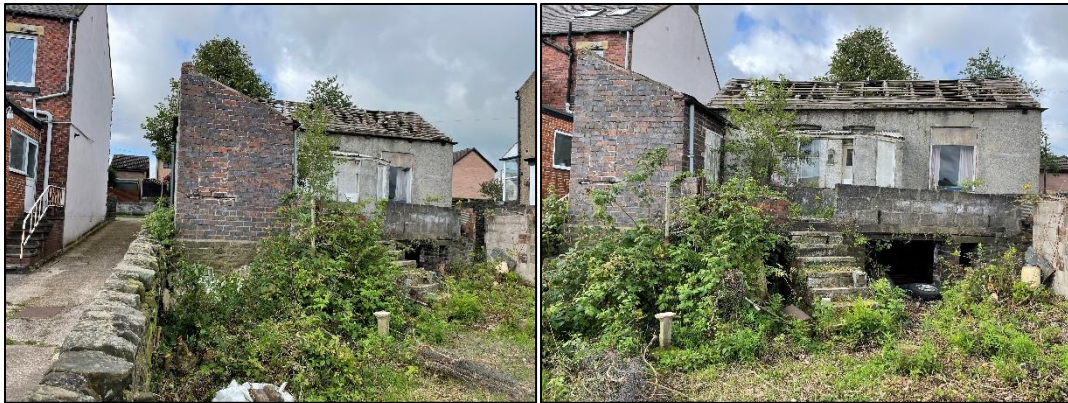
3.2.4. The two photographs below show the rear of the bungalow facing the garden.

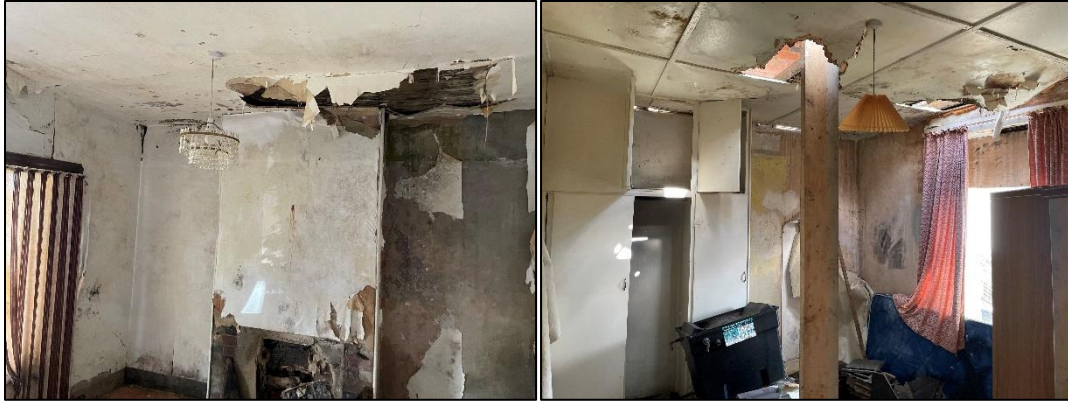
3.3.2. The roof of the bungalow is in a very poor condition with missing slates and torn underfelt. This has allowed water penetration throughout the internal of the bungalow resulting in patches of ceiling fallen in, as shown below. Everything internal is running in water.

3.3.3. Because the property is so badly exposed to the weather, the roof has gone but the walls are remarkably sound, the building is assessed to have negligible potential for roosting bats in line with the Bat Conservation Trust Good Practice Guidelines.

5.1. The existing bungalow is in a very poor condition and is assessed to have negligible potential for roosting bats. Therefore, no further surveys are recommended and there is no requirement for a mitigation strategy or for a Natural England licence in connection with the proposed demolition.

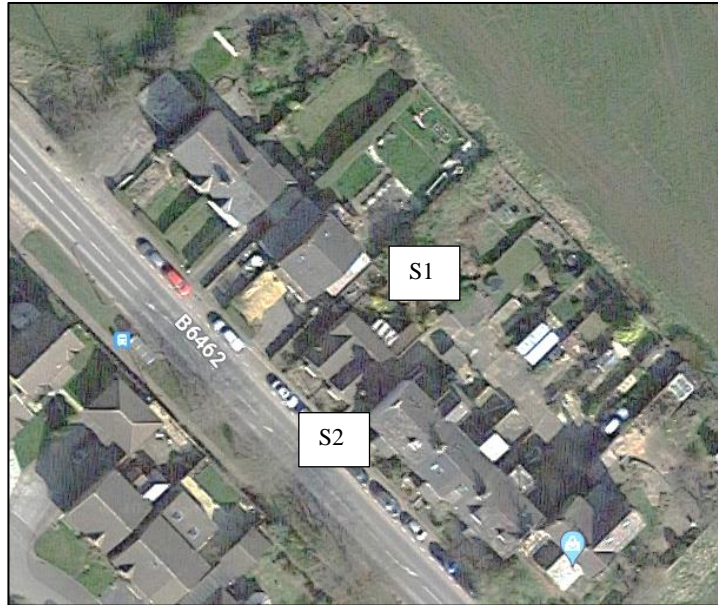
3.4.3. The position of the surveyors and the static Anabats are shown on the aerial photograph below where S is a surveyor.
