Geo-Environmental Investigation Report

**Proposed Foodstore,
Wombwell, Barnsley**

September 2015

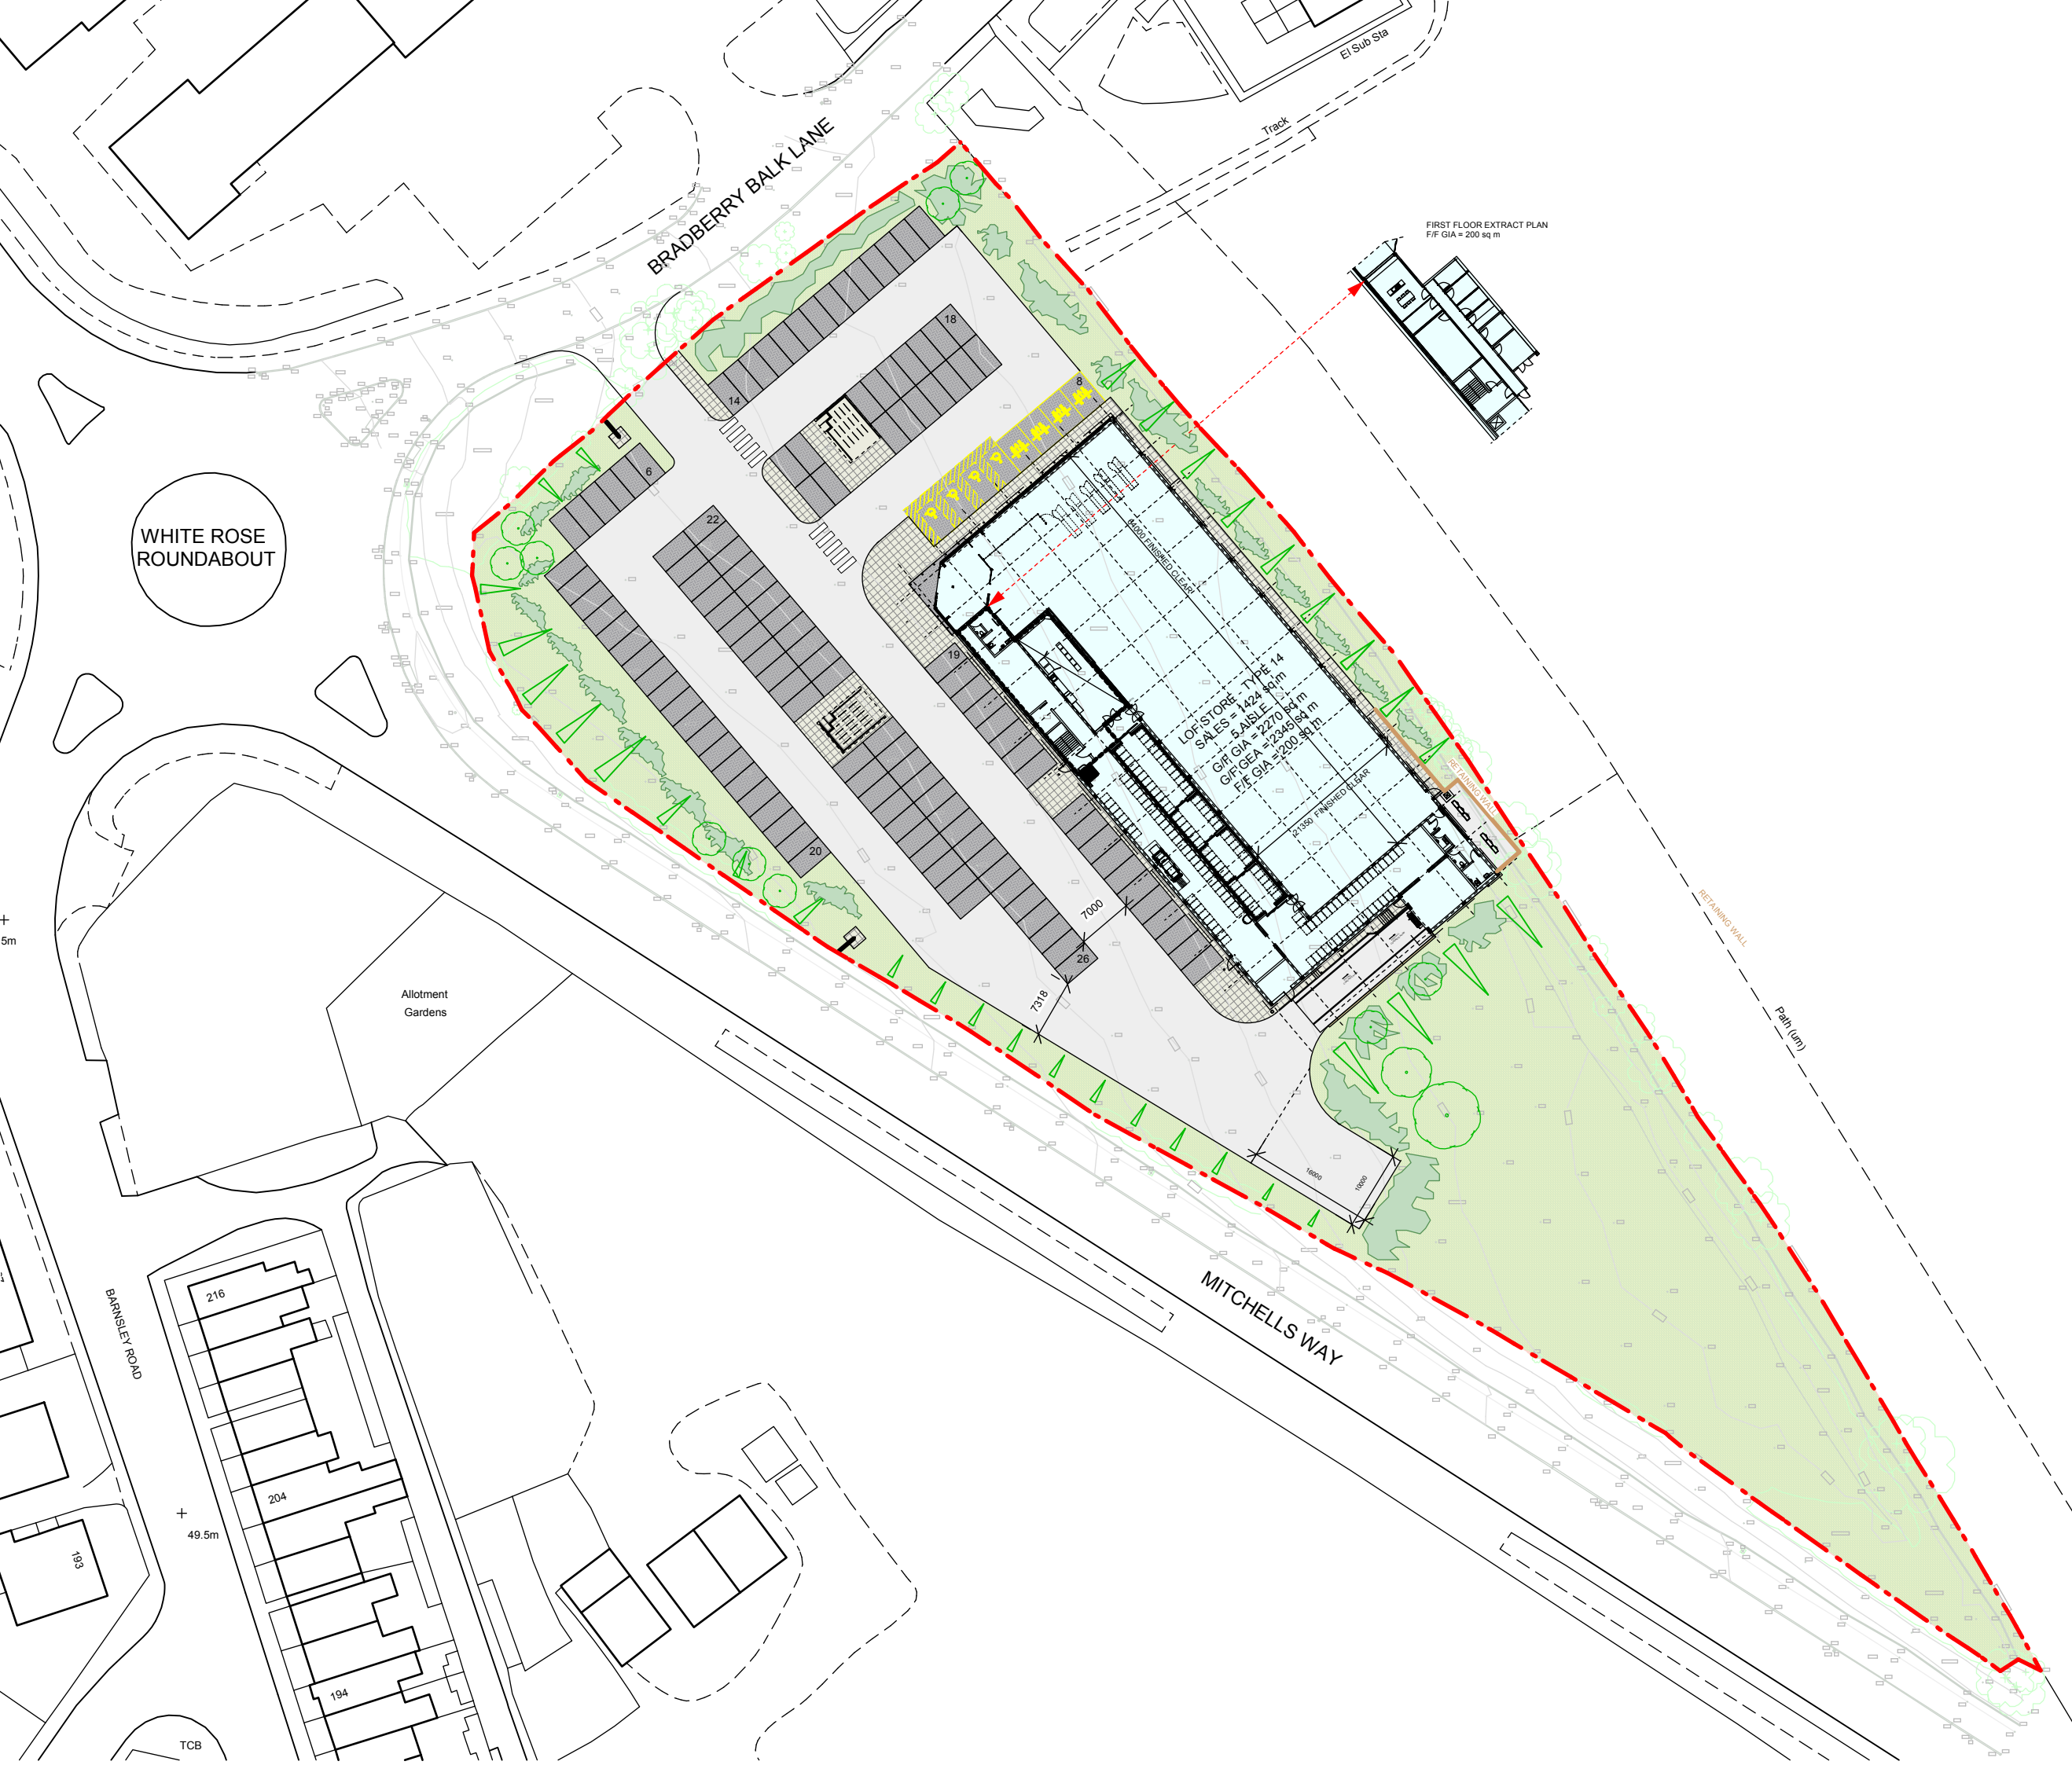
Site Area (sq m)	12,779 sq m
Store Type	LOF Type 14
Reference	(19.03.15)
Sales Areas (sq m)	1,424 sq m
Number of Aisles	5 Aisle
G/F GIA (sq m)	2,270 sq m
G/F GEA (sq m)	2,345 sq m
F/F GIA (sq m)	200 sq m EST
Car Park Spaces	133
