# The Stack Yard, Ingfield Farm, Ingbirchworth

## Bat Survey Report

13<sup>th</sup> August 2019

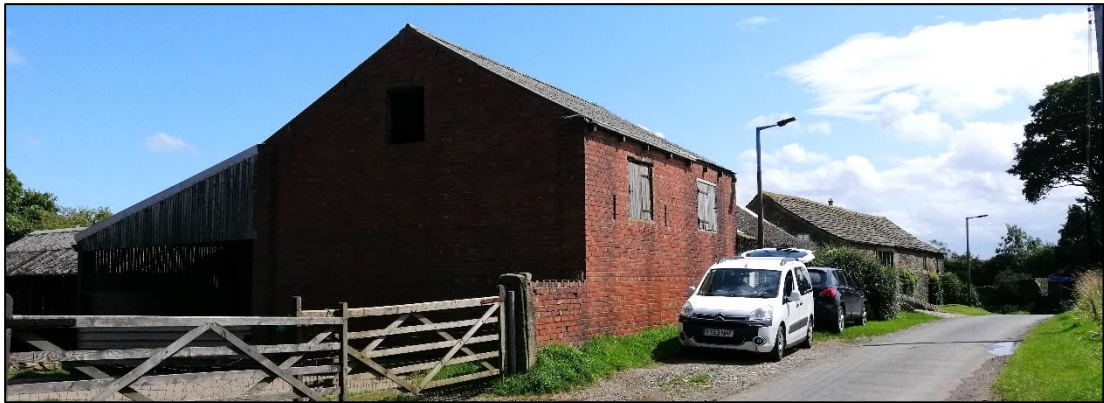
**Plate 1. View from north**

- 5.2.2 The site comprises a brick-built barn with a pitched asbestos cement sheet roof supported by kingpost trusses. The building has brick walls on two elevations (west & north) with an adjacent stone built single storey farm building providing the south wall. The east elevation is open and supported by two brick pillars together with a steel-framed lean-to with a mono-pitched sheet metal roof adjoining this elevation. The two walls are solid 9ins brick with two hay loft openings on the west elevation and a single opening on the north facing gable (see Figure 1 & Plates 1 to 4).

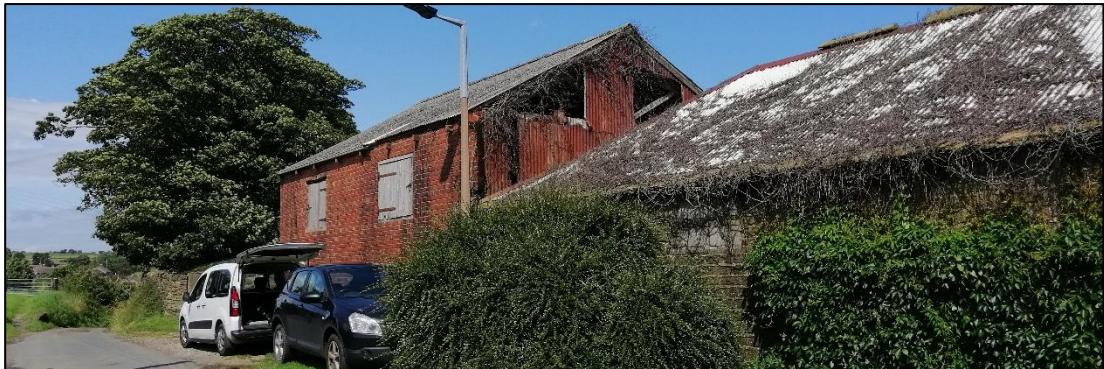
**Plate 2. West elevation and south gable**

- 5.2.3 With the exception of a small section of defective brickwork over a collapsed wood lintel and a section under the eaves on the west elevation, the external brickwork is largely in good condition. These features were inspected with the aid of a ladder and no signs of bats were found but one defunct swallow *Hirundo rustica* nest was located.

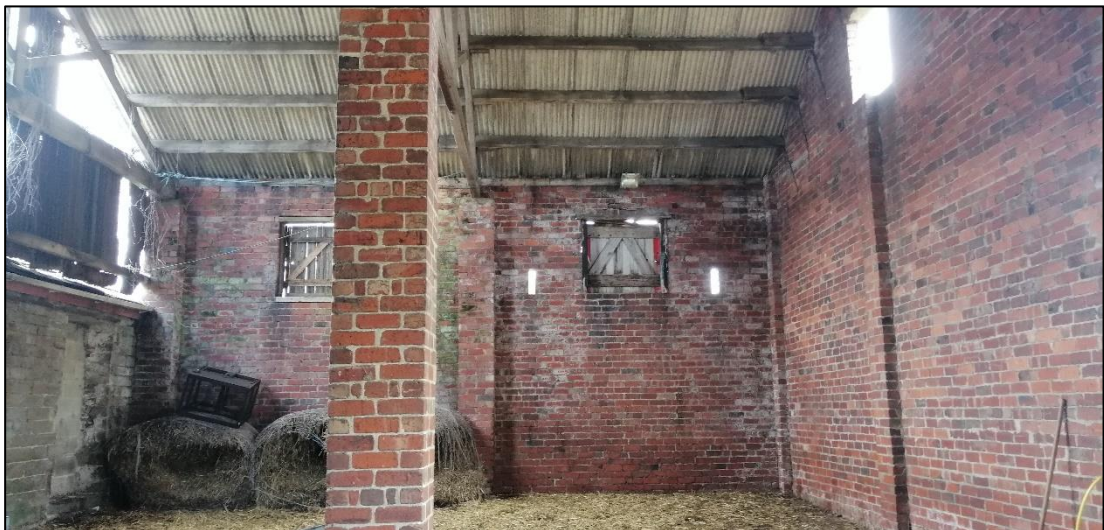
### Plate 4. Inside of barn

- 5.2.4 Holes in mortar joints of the internal brickwork were found to be superficial and crevices in the stone wall of the adjoining building were found to be very dusty and 'cobwebby'. No signs of bats were found. The only features with potential to accommodate bats are the voids between the corrugations of the asbestos sheets and the roof trusses and beneath the asbestos ridge.
