**Derek A Whitcher Ltd.  
Wildlife Consultants.**

**HILLTOP FARM, REDBROOK ROAD,  
BARNSELY.**

**BAT SURVEY.**

**Ref No:- 071104.**

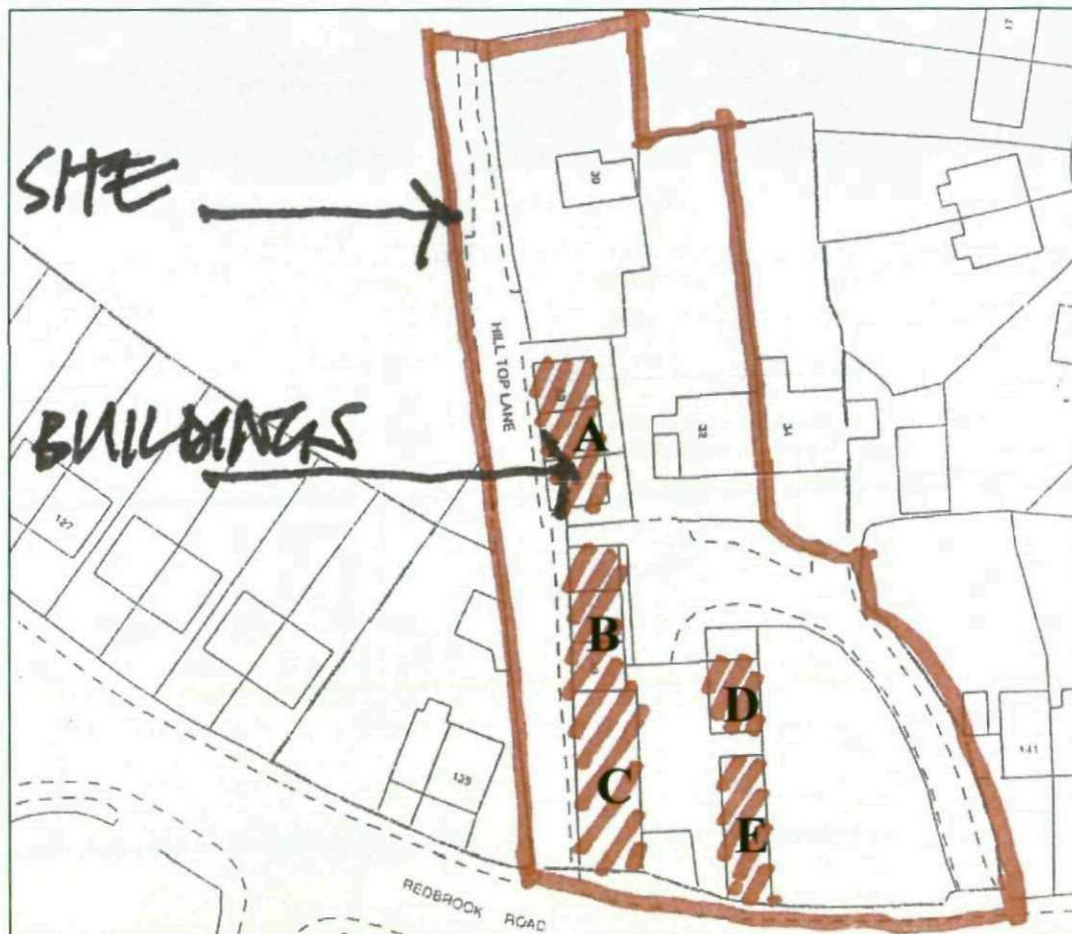
3.2. Below is a plan of Hill Top Farm. The buildings to be affected by the works are highlighted in red and are individually labeled for the purpose of this report. Each building is dealt with individually.

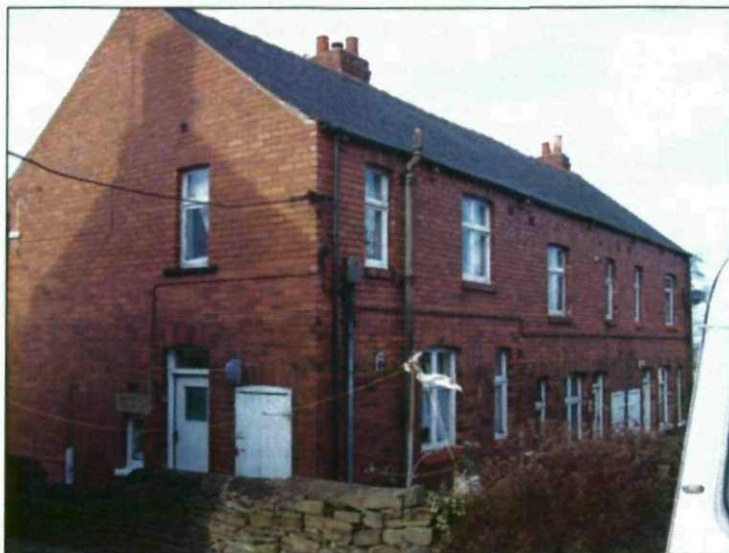
### **3.3. Building A.**

3.3.1. Building A comprises a row of three terraced houses. They have brick walls with occasional missing pointing, sealed windows and doors, and a pitched slate roof that seems to be in good condition and generally well sealed around the eaves.

3.3.2. There are no fascias or soffits and no accesses were identified for bats. No bat field signs were identified around the exterior of the terrace.

3.3.3. There was no available access to the inside of the loft spaces during this survey.

4.2. Although there was no access inside building A during the survey, no suitable access points were identified for roosting bats as the walls and roof are in good condition and there are no obvious gaps around the eaves. Building A is therefore assessed as low potential for roosting bats.

5.2. It is recommended that access is arranged to access the loft spaces of building A to confirm the results of the survey on this building.

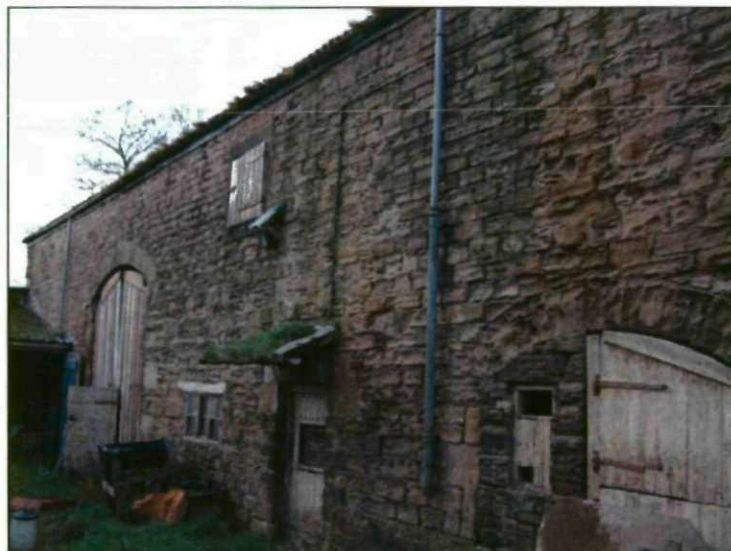
### **3.5. Building C.**

3.5.1. Building C is an old, two storey high, ex slaughter house. It has not been used for a number of years.

3.5.2. The building comprises coursed stone walls with deeply weathered faces and with a number of open joints between, leading into the middle of the walls.

3.5.3. There is an open window on the west side of the building on the first floor and there are gaps above the doors.

3.5.4. The roof comprises a corrugated cement sheet roof with skylights. The roof beams are of a king post structure. There are gaps around the eaves due to the nature of the corrugated roof, but these are just meeting points with the walls and lead directly inside the barn providing no roost opportunities.

3.5.5. The interior of the barn is partitioned into three sections. The south section is completely open to the roof. It is obvious that pigeons regularly use this part of the building as there is a huge amount of bird excrement on the floor.

3.5.6. The middle section of the barn is open to the roof structure with a single storey room built into one end. A large amount of bird excrement was identified across the floor.

3.5.7. The north section comprises two floors and a loft space. The first floor and the loft space are unstable and could not be accessed safely.

3.5.8. There is a double garage extension on the east side of the building. This comprises stone walls with two sets of large double wooden doors and a corrugated single pitch roof.

3.5.8. No bat field signs were identified inside or outside the buildings.

4.4. Building C has a corrugated roof, which is unsuitable for roosting bats. There is potential for bats to roost in the walls as there are a number of accesses that lead into the walls.

5.1. It is recommended that no work is carried out on buildings C and D until a bat dusk emergence survey has been carried out in the spring/summer months.
