Project No: 22131
Project: Roughbitchworth Lodge
Roughbitchworth Lane
Oxspring
Barnsley
S36 8YZ
Subject: Road Condition Report
Date: 2nd December 2022

BDI STRUCTURAL SOLUTIONS LTD

2.0 ROAD CONDITION ASSESSMENT

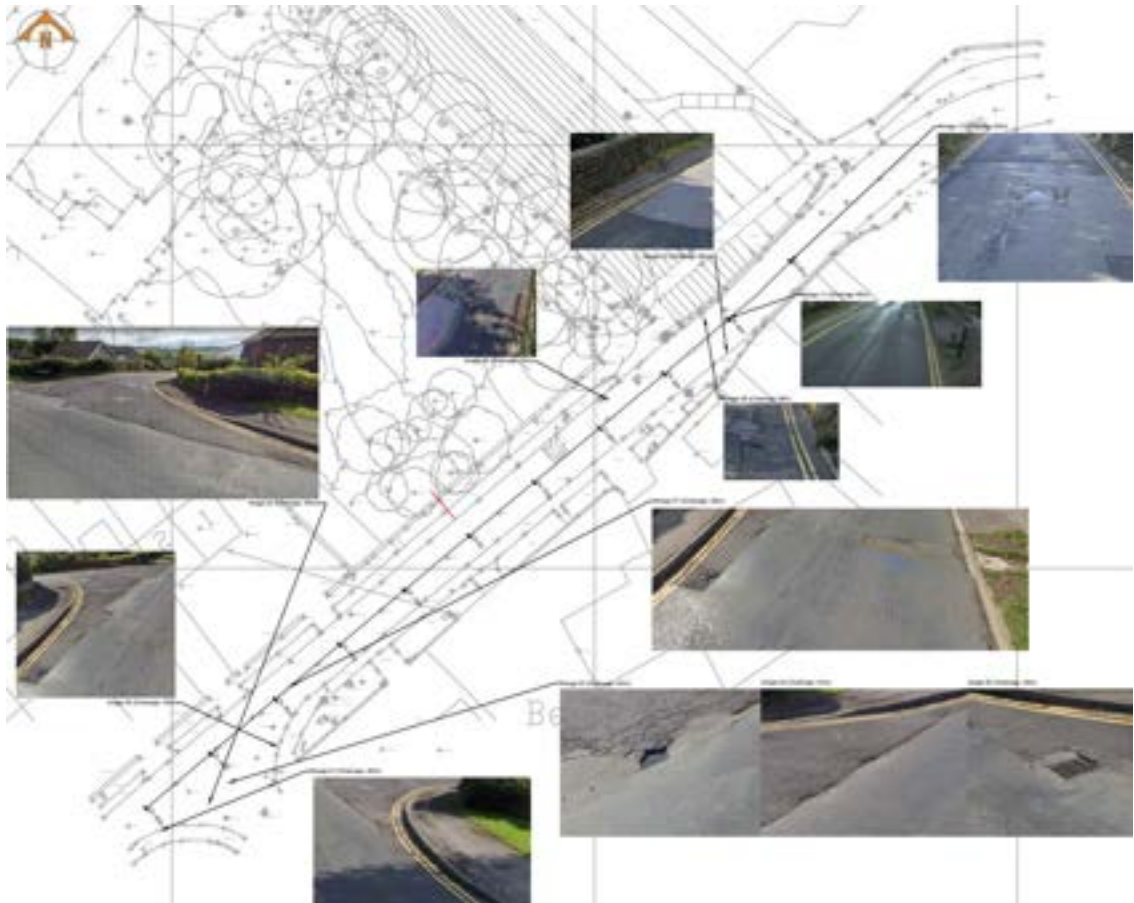
Figure 2.1A – Photograph Location Plan

The road condition has been assessed for 50m prior to the main access of the development. The location of the photographs can be seen below and in Appendix B.

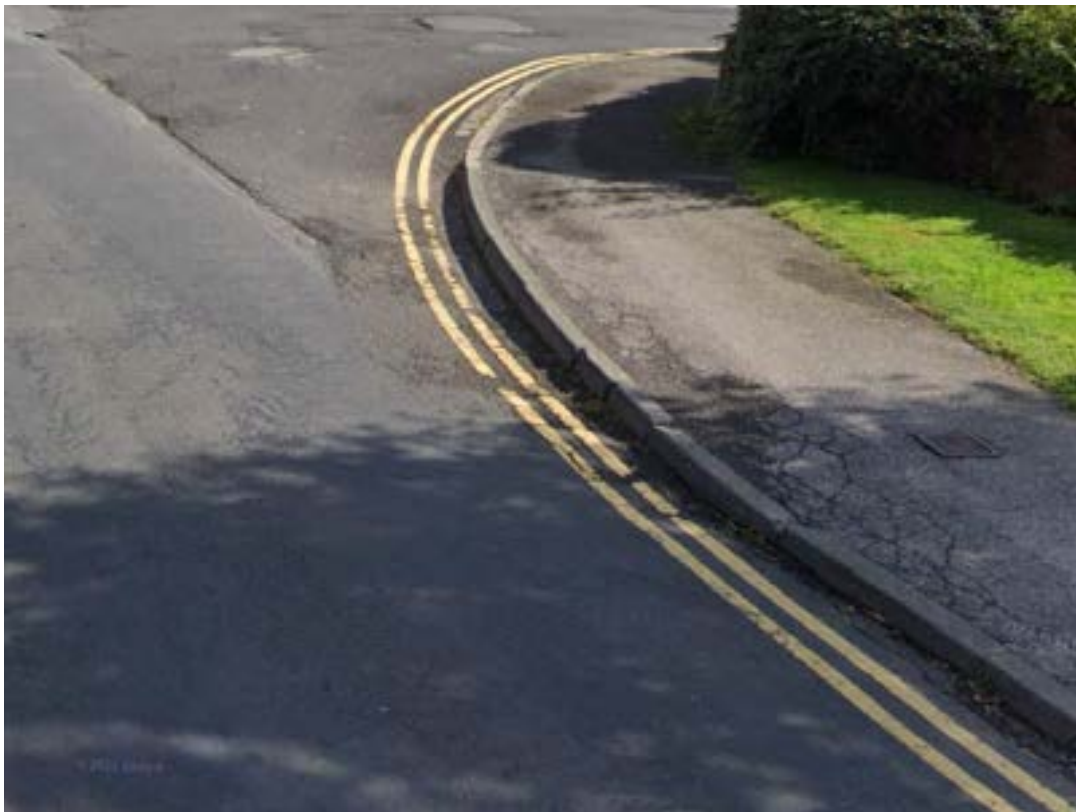
Image 01 – Chainage -50m

This location includes the junction between Roughbirchorth Lane and Tolbar Close. Image 01 clearly shows crazing in the footpath surface layer and in addition, kerbs and road markings are in poor condition. Image 03 & 04 show crazing in the carriageway and potholes forming along the junction tie-in construction joint. Image 05 shows concrete gully surround failure including fretting and crazing of the surface layer.

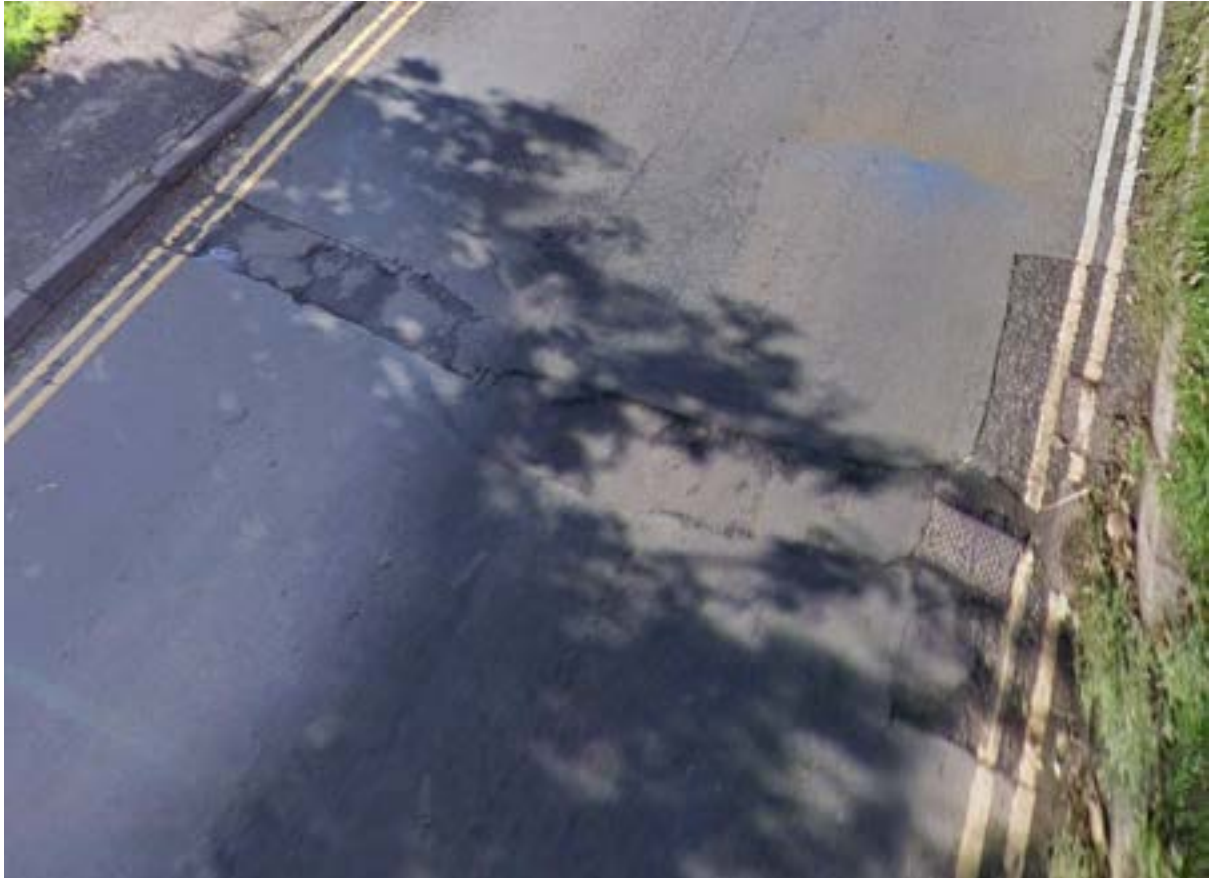
Image 08 – Chainage 23m

Image 08 reveals failing trench infill forming along the construction joint of the trench. The failure is likely due to none application of sealant.

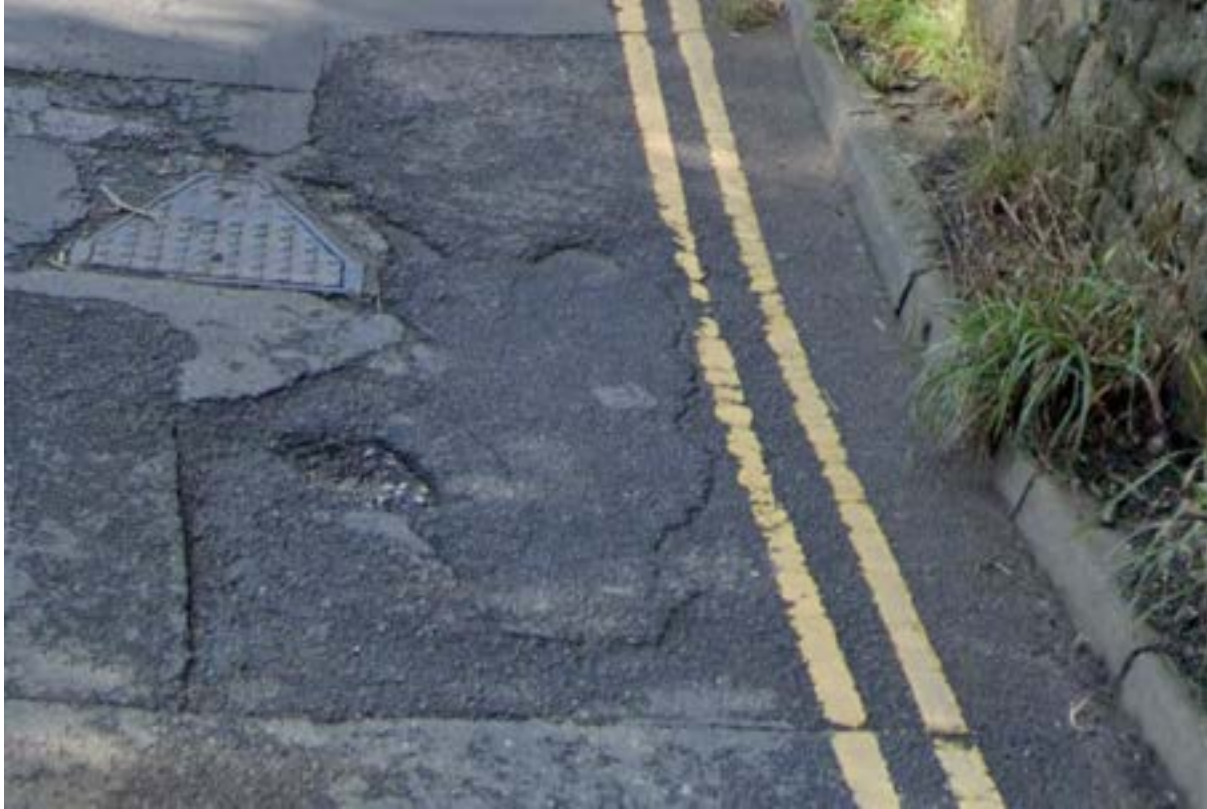
Image 09 – Chainage 38m

Image 09 reveals several patch repairs that are poorly constructed with potholes forming. The use of varying aggregates and no sealant has caused weakness in the surface layer.

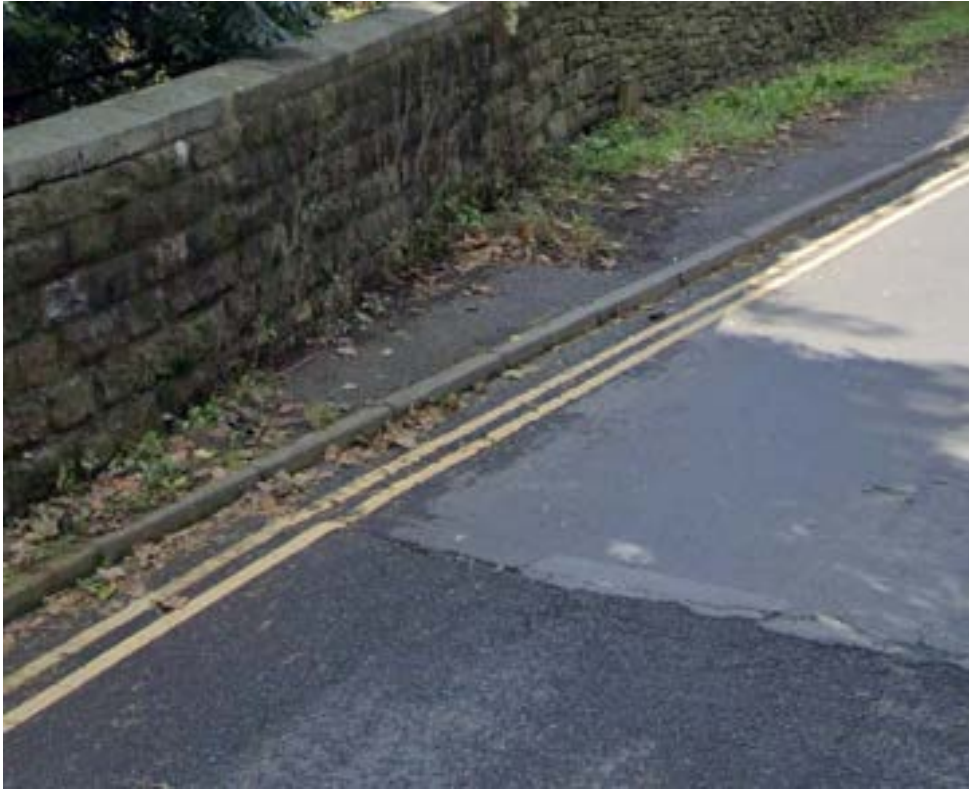
Image 10 – Chainage 38m

Image 10 reveals cracks forming in the joint tie-in and the use of different aggregates is causing weakness in the surface layer.

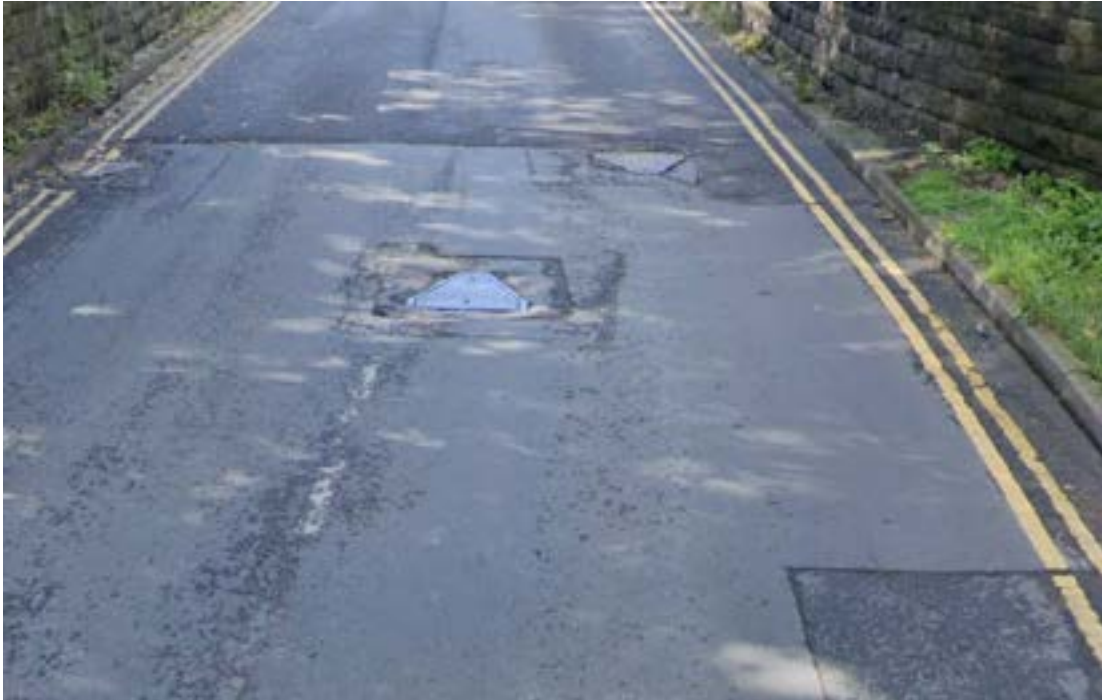
Image 12 – Chainage 50m

Image 12 reveals the failure of manhole surround, which is usually the symptom of partial or total failure of the road surface layer.
