ARBORICULTURAL REPORT

IMPACT ASSESSMENT

**Woodbine Cottage,
Billingley,
Barnsley
S72 0JE**

Reference: *AWA4026*

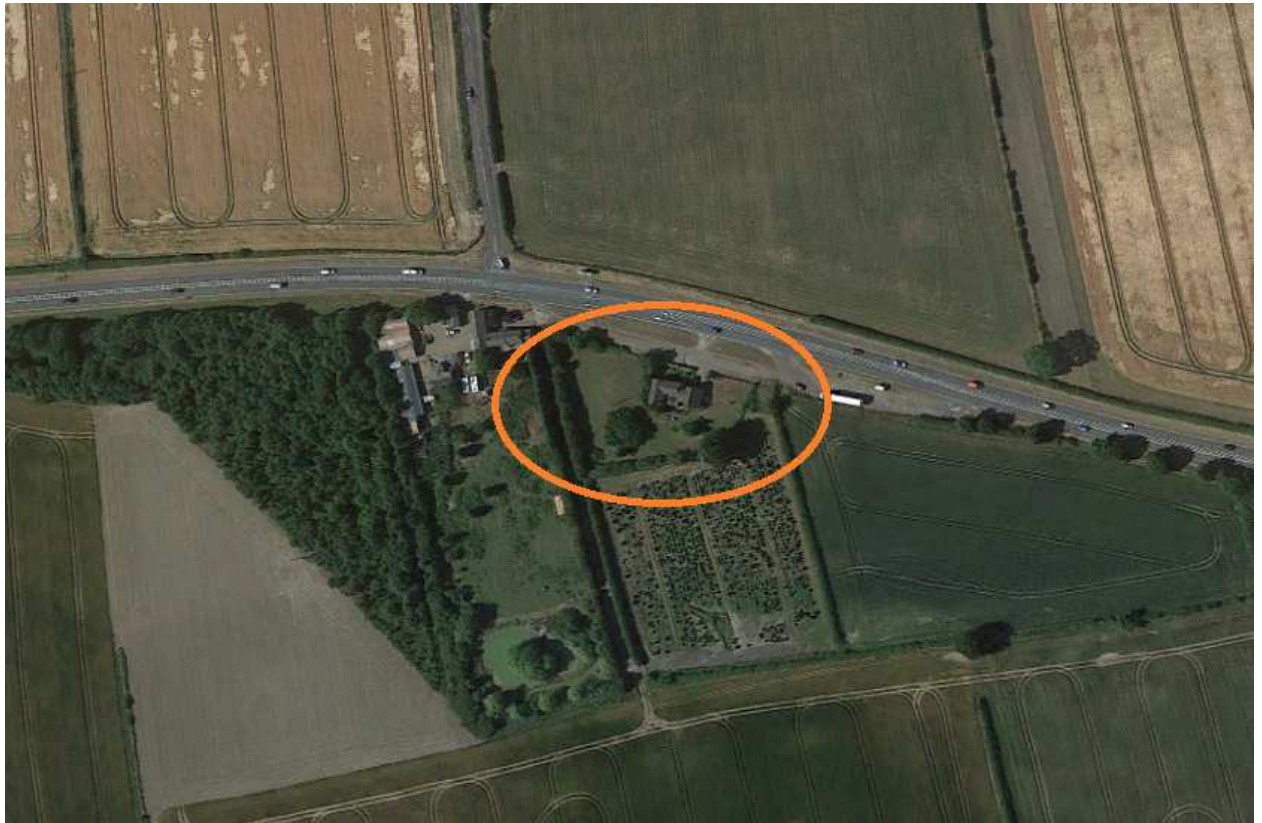
- 2.1.1 The site is located in the village and civil parish of Billingley, approximately 7 miles east of Barnsley Town Centre.
- 2.1.2 The site currently consists of a detached residential dwelling with associated access and gardens.
- 2.1.3 The approximate survey area has been highlighted in the (2018 Google Earth) image below:
