**Phase 1 Geoenvironmental Risk Assessment and
Phase 2 Ground Investigation**

**NAYLOR CONCRETE
WHALEY ROAD
BARNSELY**

Naylor Concrete Products Limited

Report Number 4387

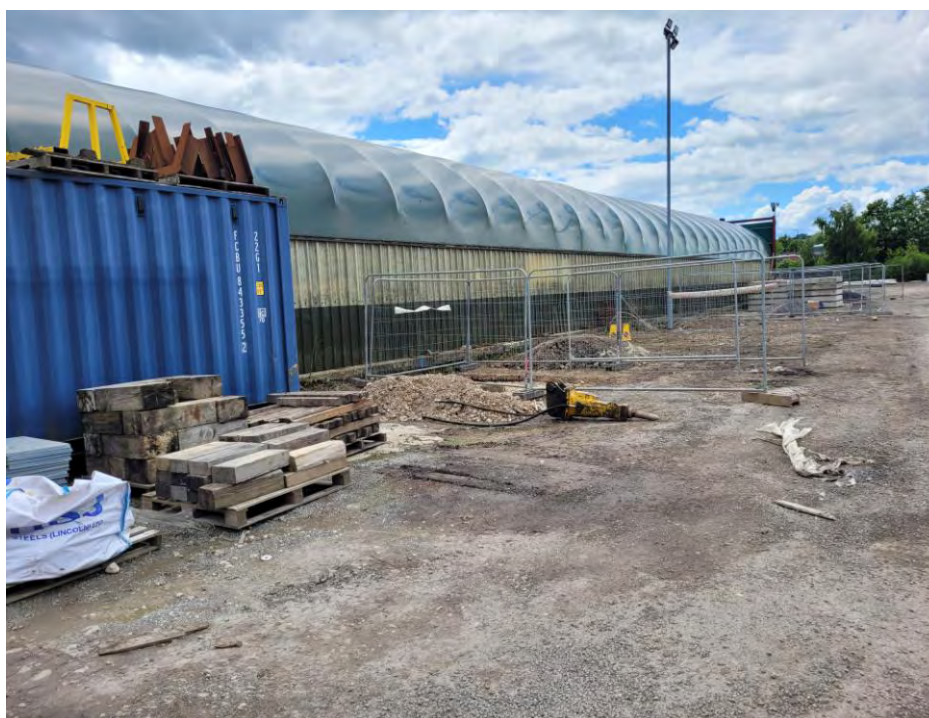
View of northwestern elevation of building

- 3.5 The Made Ground along the northwestern elevation has also been topped by a thin layer (300mm thick) of geotextile matting, overlain by limestone sub-base material.

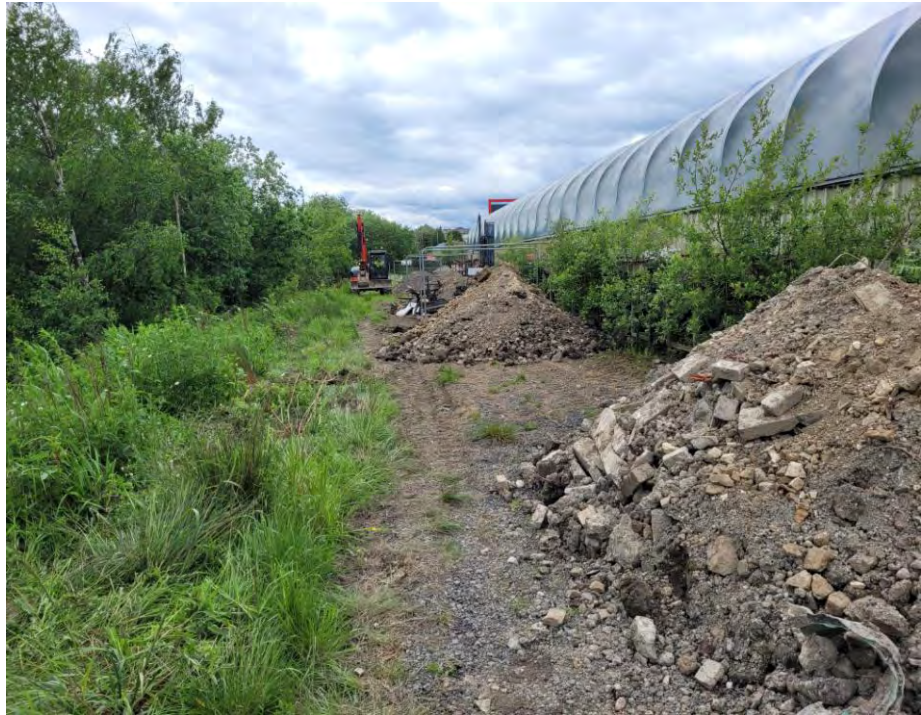
View of southeastern elevation of building

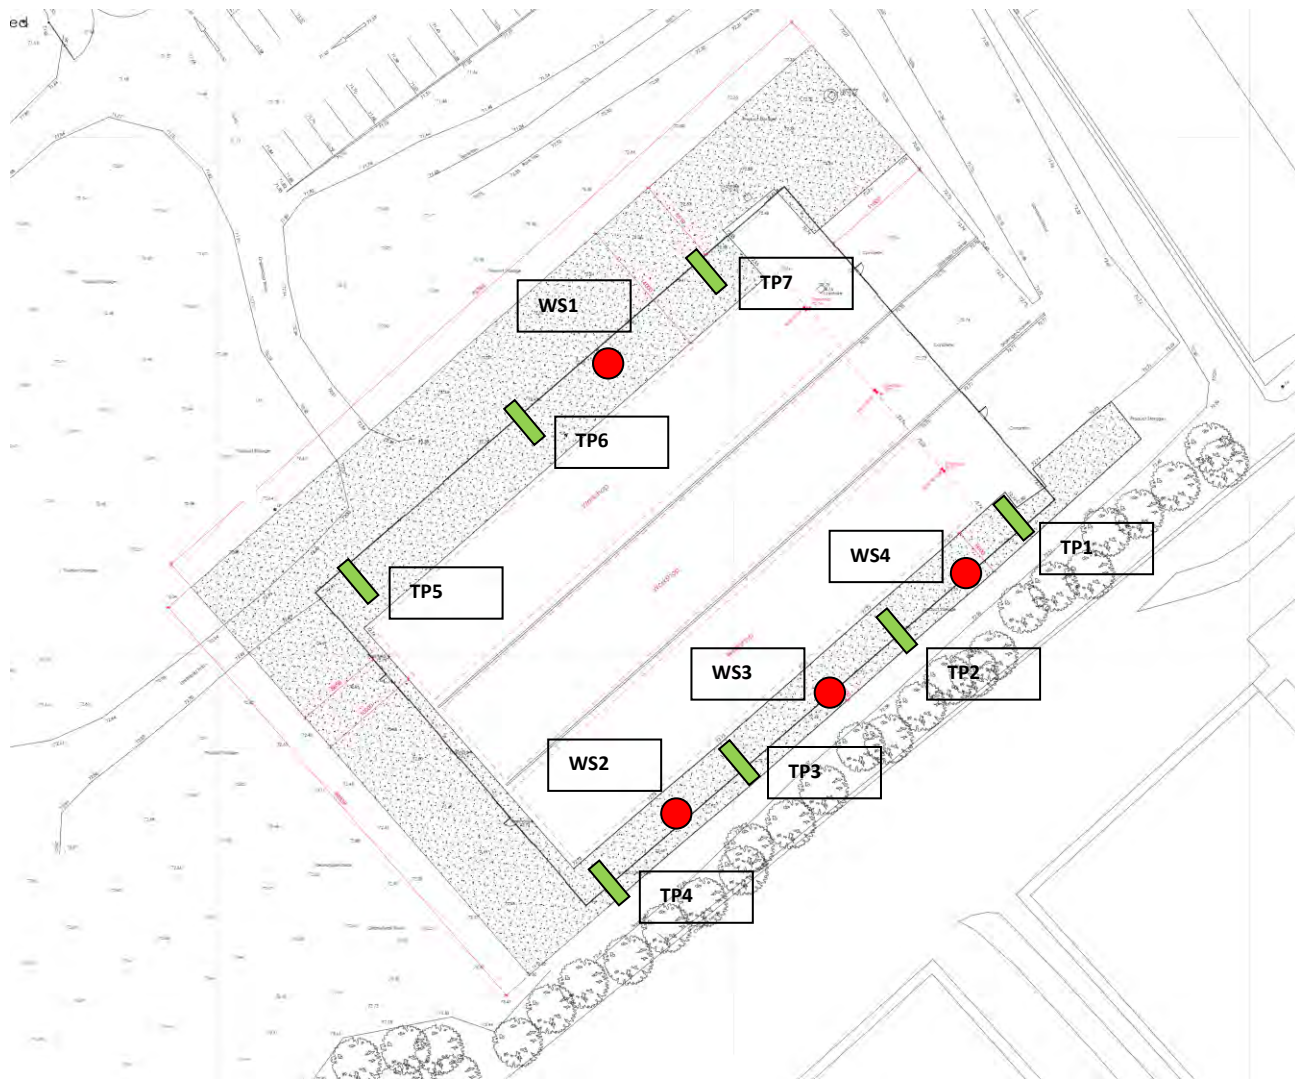
Figure: 2

Whaley Road, Barnsley

Development Proposals (extended slab shaded) with Trial Pit and Borehole Locations

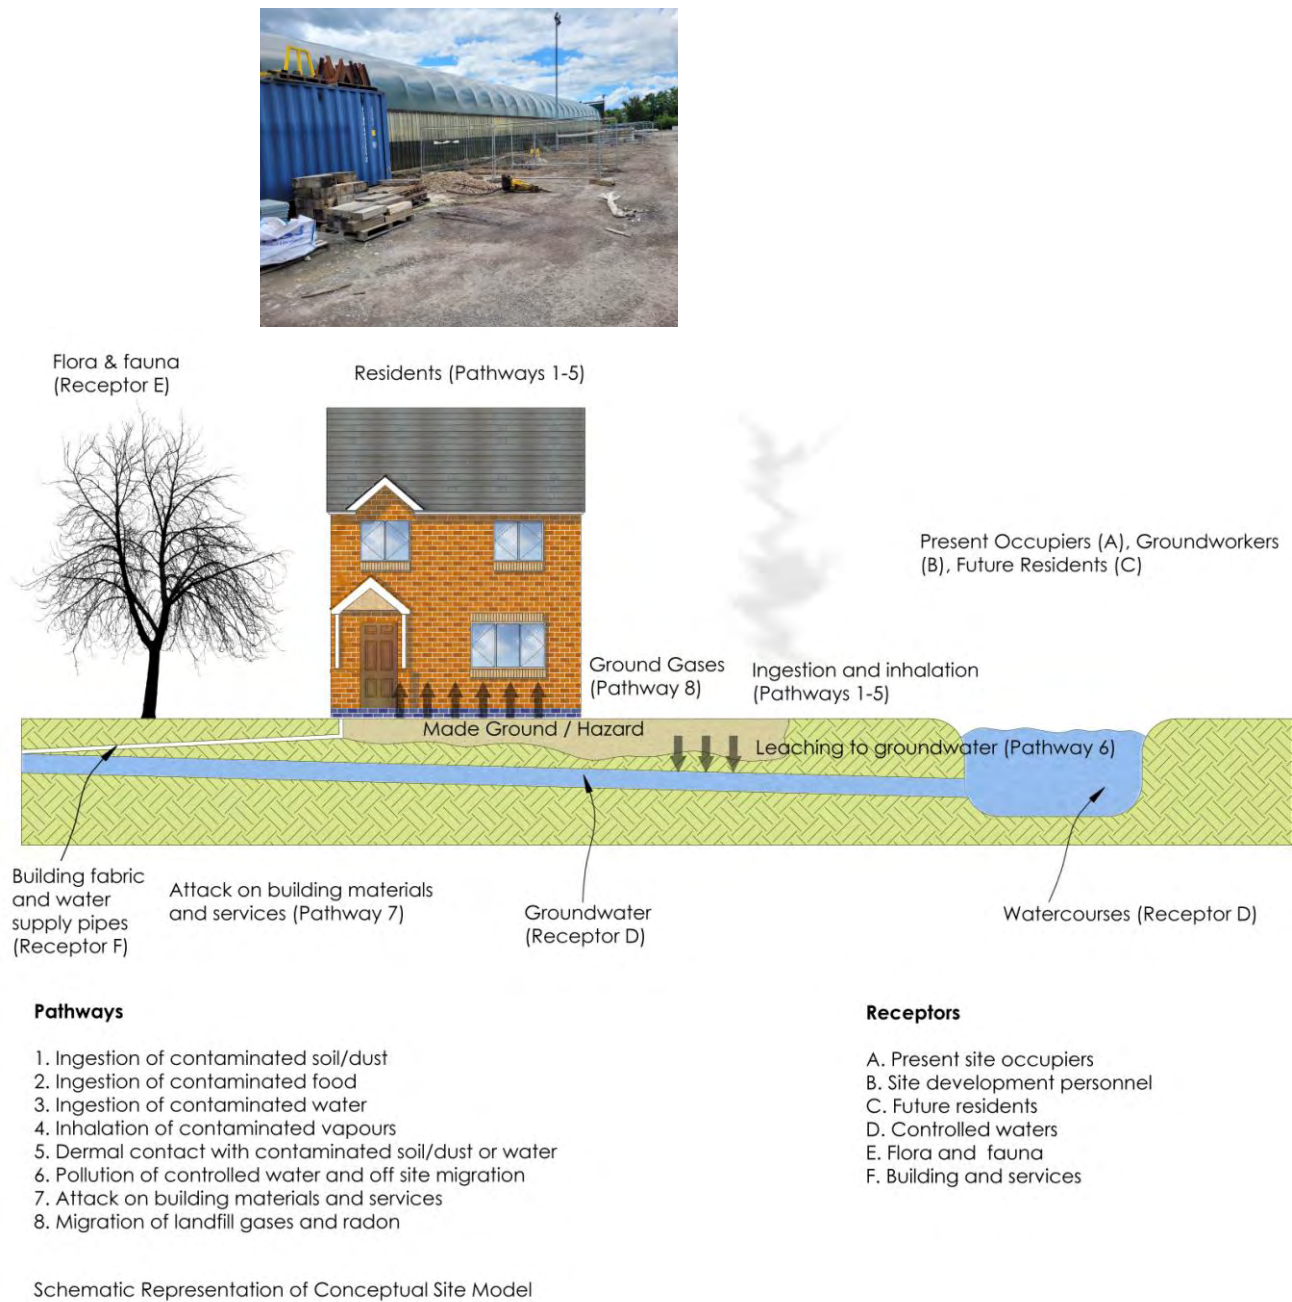
Industrial Units and Offices (Pathways 1 – 5)

Schematic Representation of Conceptual Site Model

- 12.7 For any contaminant source identified, judgement is used regarding the probability of a pollution linkage occurring and the potential consequences of that linkage. Based on the probability and likely consequences, the overall risk (significance) can be established. The definitions that have been used for this purpose are given in Standard Appendix B. The probability of a hazard, combined with its consequences, can be used to assess risk. This forms the so-called Conceptual Site Model.
