## **Needlewood, Keresforth Hill Road Barnsley**

### **Report of Bat Survey**

July 2008.

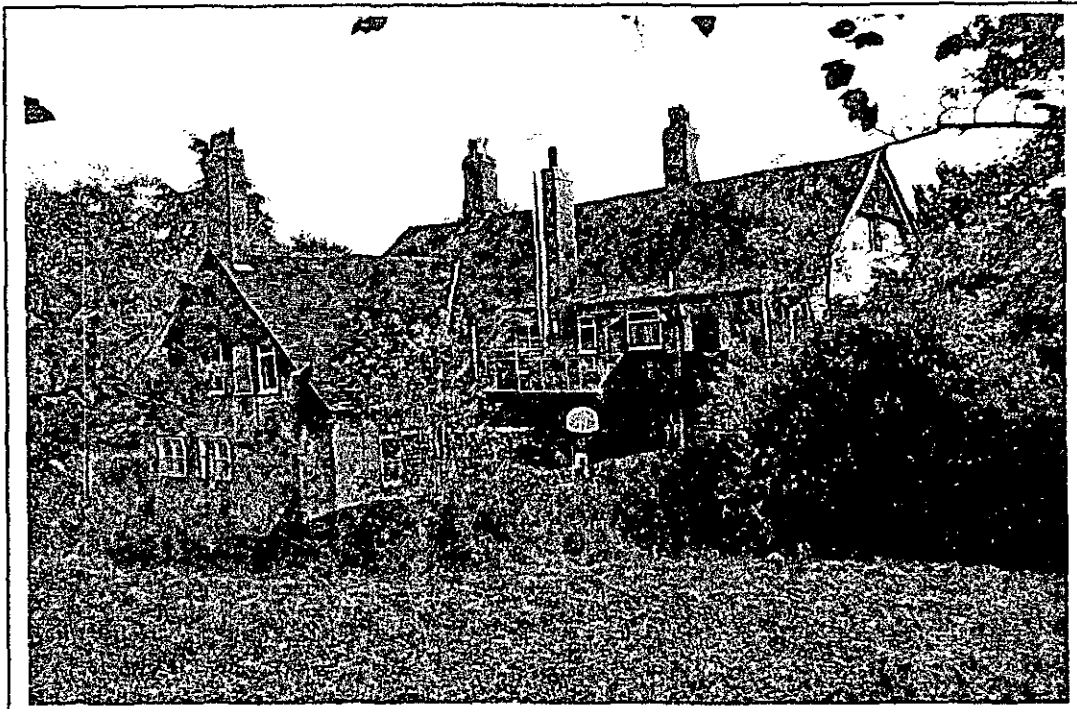
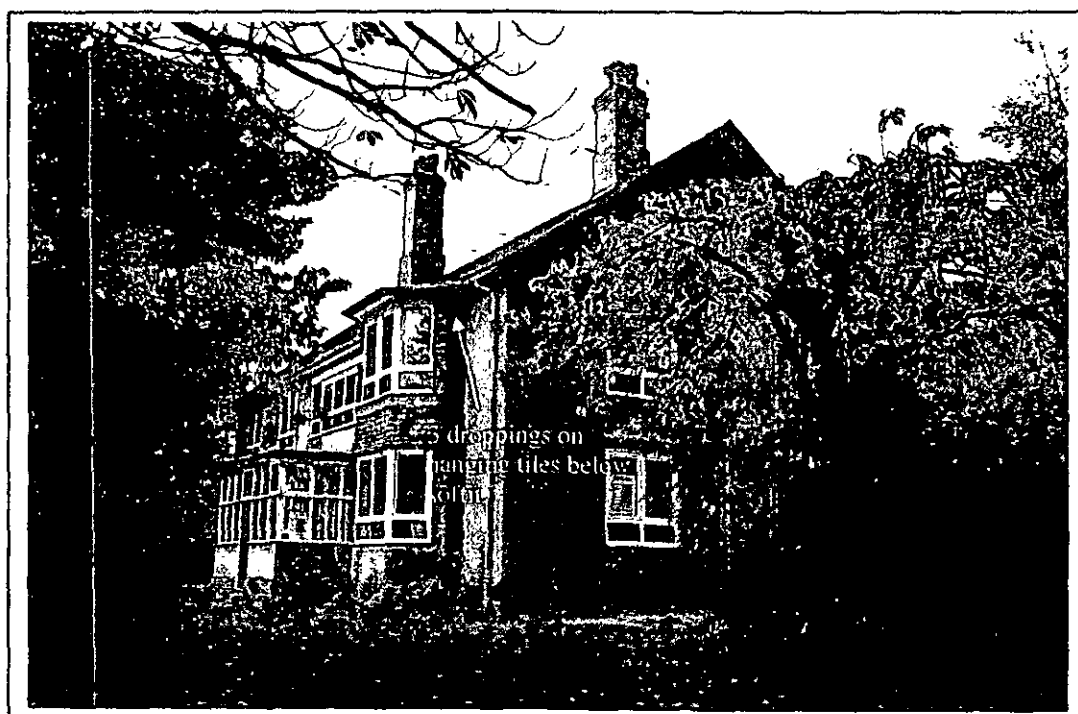
**FIG 1**

- 7.3 The western gable was smooth painted render with hanging tile cladding to the apex. Two patches of bat droppings were found on the wall face each side of the loft window and further droppings were found on the roof of the conservatory close to the wall face. These are shown on Fig 1. The droppings were identified as Pipistrelle bat, probably Common Pipistrelle and indicated the likely presence of a summer breeding roost.

- 7.4 A small number of droppings were also found on hanging tiles below the soffit on a bay window at the south-east corner of the building. These were also Pipistrelle and likely to involve a single bat, probably a male roost. The location is shown on Fig 1.

- 15.3 Since the existing building is to be demolished alternative provision will need to be made. Details of the new building are not known but wherever possible replacement roost sites should be provided as close as possible to existing. For example in the same orientation and height as the existing roosts but with alternative opportunities on other elevations and priority should be given to creating openings in gable apex locations and/or behind hanging tiles.

- 15.4 Provision would be in the form of small access openings in the wall corner at gable apex or eaves level, allowing bats into the wall top area under the slates or tiles, with some access to the wall cavity. Suitable openings need only be approximately 15mm x 75mm. The roost area can be boxed if necessary to limit bat access to the areas provided.
