**Bat Emergence Survey
Mount Vernon Hospital**

Report reference: R-3064-02.1
June 2018

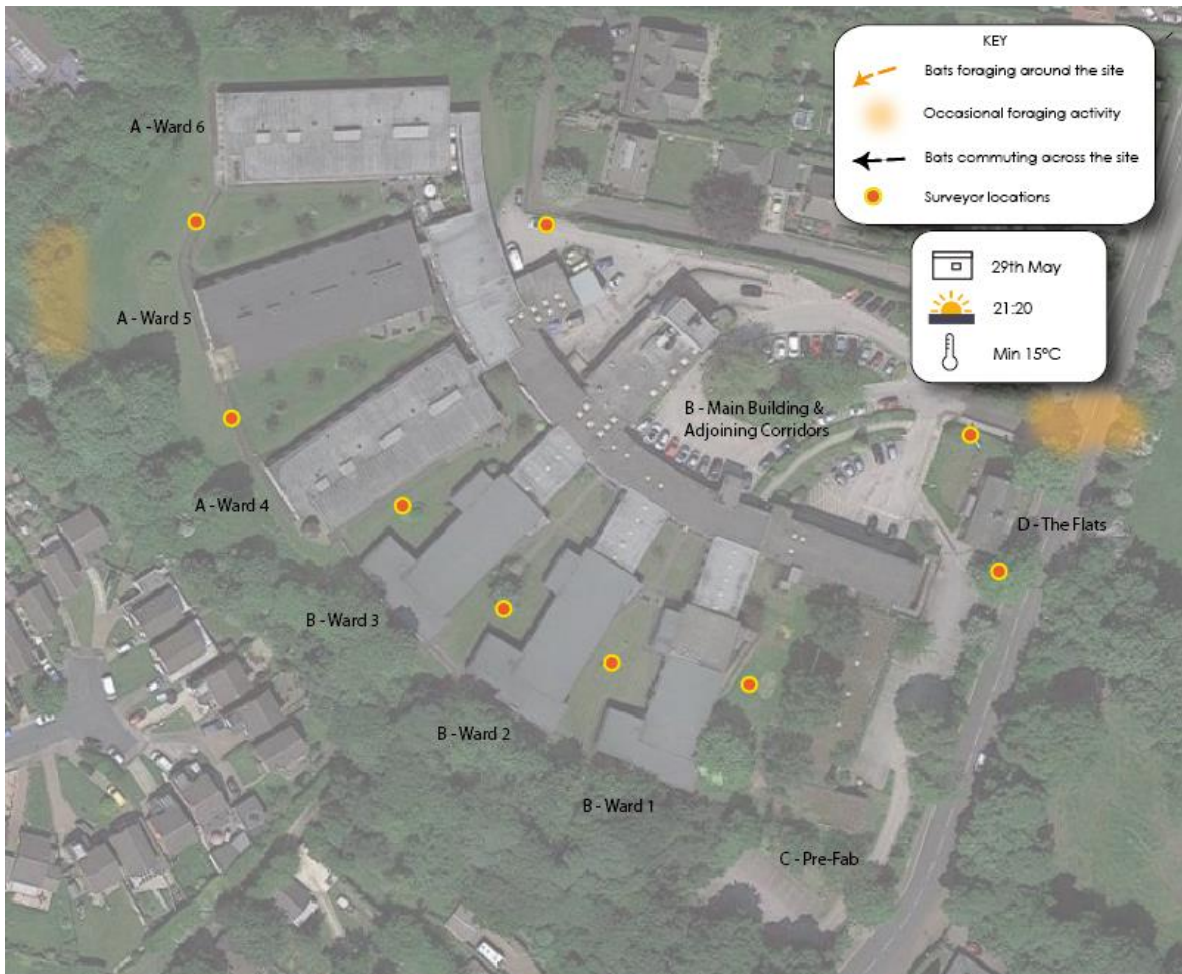
Figure 1 Bat emergence drawing

7. No bats were seen during the survey.
8. The first bat heard was a common pipistrelle, briefly heard to the east of the Site close to the Mount Vernon Road entrance.
9. A second common pipistrelle was briefly heard moving along the tree-line to the north-west of the Site.
10. No bats were seen to emerge from the surveyed building.
11. Bats calls throughout the survey were recorded on an Anabat Express device. This confirmed that activity levels were very low, with just a single pipistrelle call being registered.
