**An Archaeological Desk-Based Assessment
of Brierley Hall, Brierley, Barnsley**

Archaeological Research Services Ltd
Report No. 2010/12
February 2010

**An Archaeological Desk-Based Assessment
of Brierley Hall, Brierley, Barnsley.**

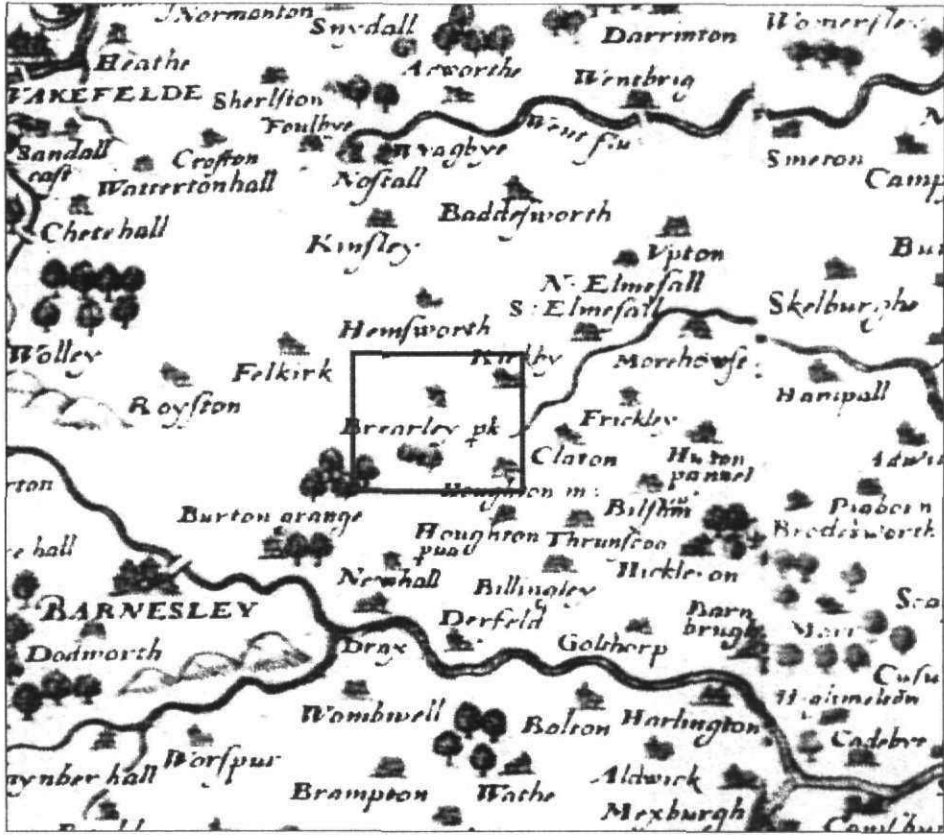
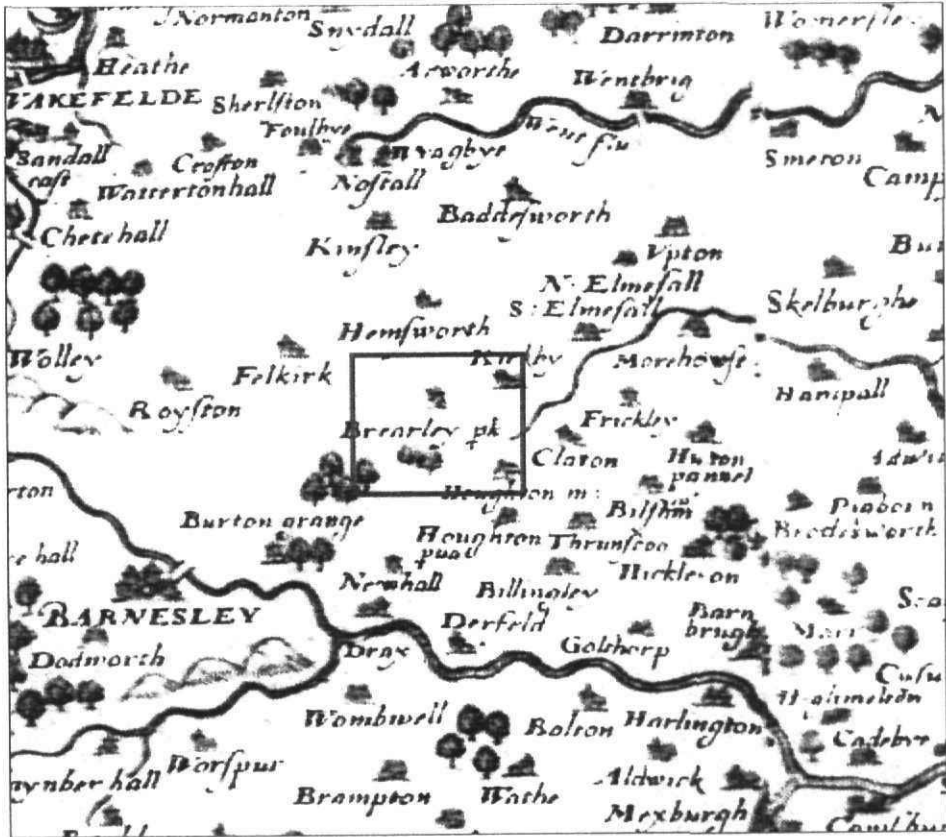
Fig. 3 Saxton's map, 1577

Saxton's map of Derbyshire from 1577 shows a house within the pale of 'Brearley' Park (Fig. 3).

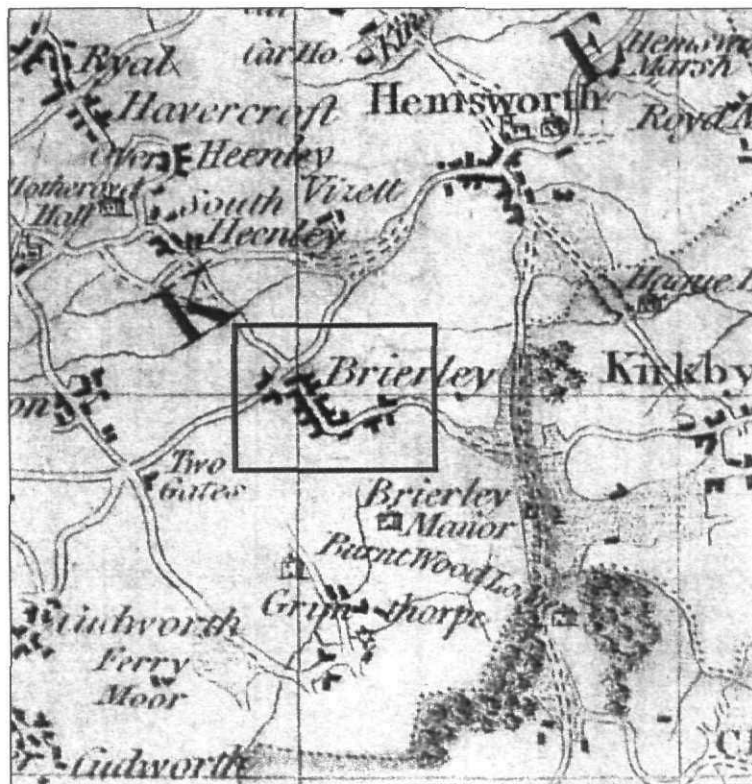
Fig. 6 John Tuke's Map of the County of York, 1798

Tuke's map of Brierley is almost exactly the same as Jeffery's map with the only difference being that Brierley Manor is more clearly marked (Fig. 6).

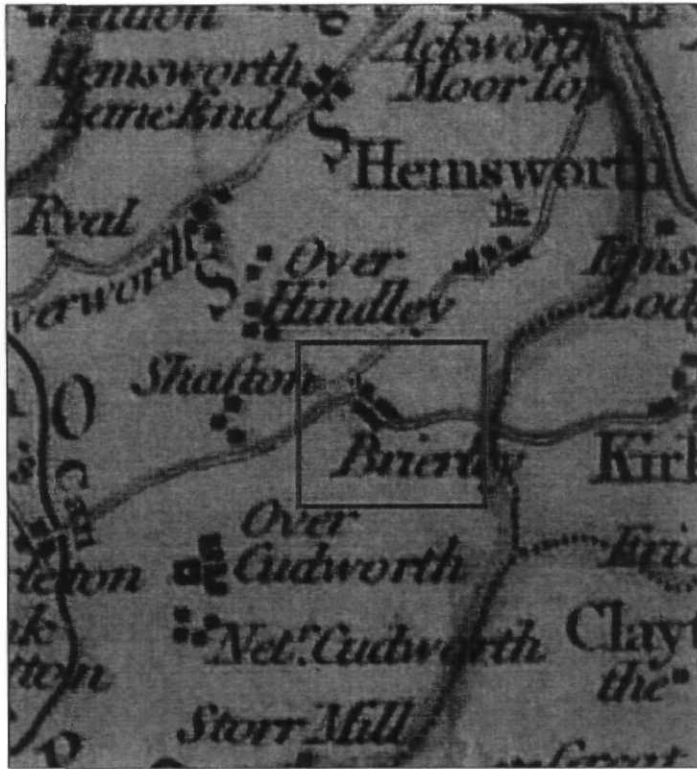
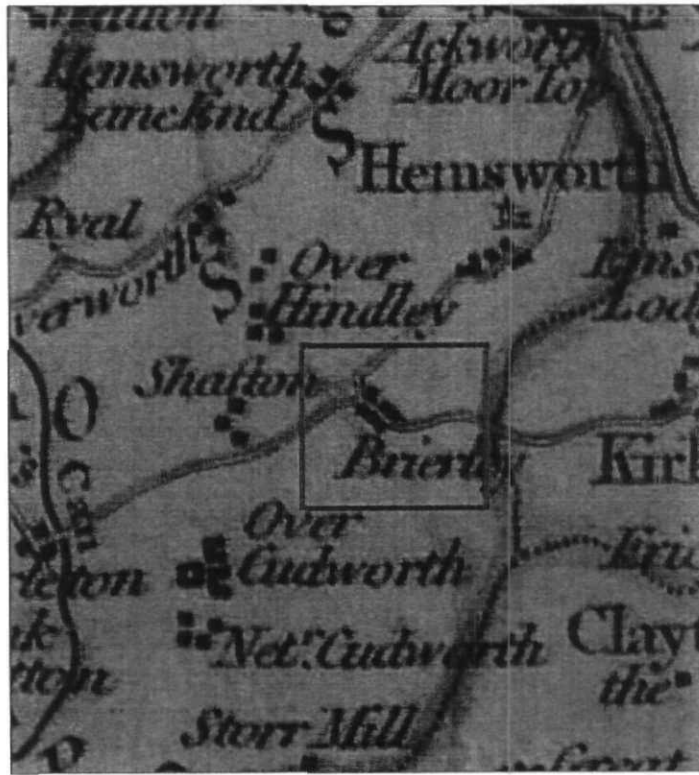
Fig. 7 John Carey's Map of the County of Yorkshire, 1810

Carey's map does not show Brierley in enough detail to determine any buildings around the site of the later hall (Fig. 7).

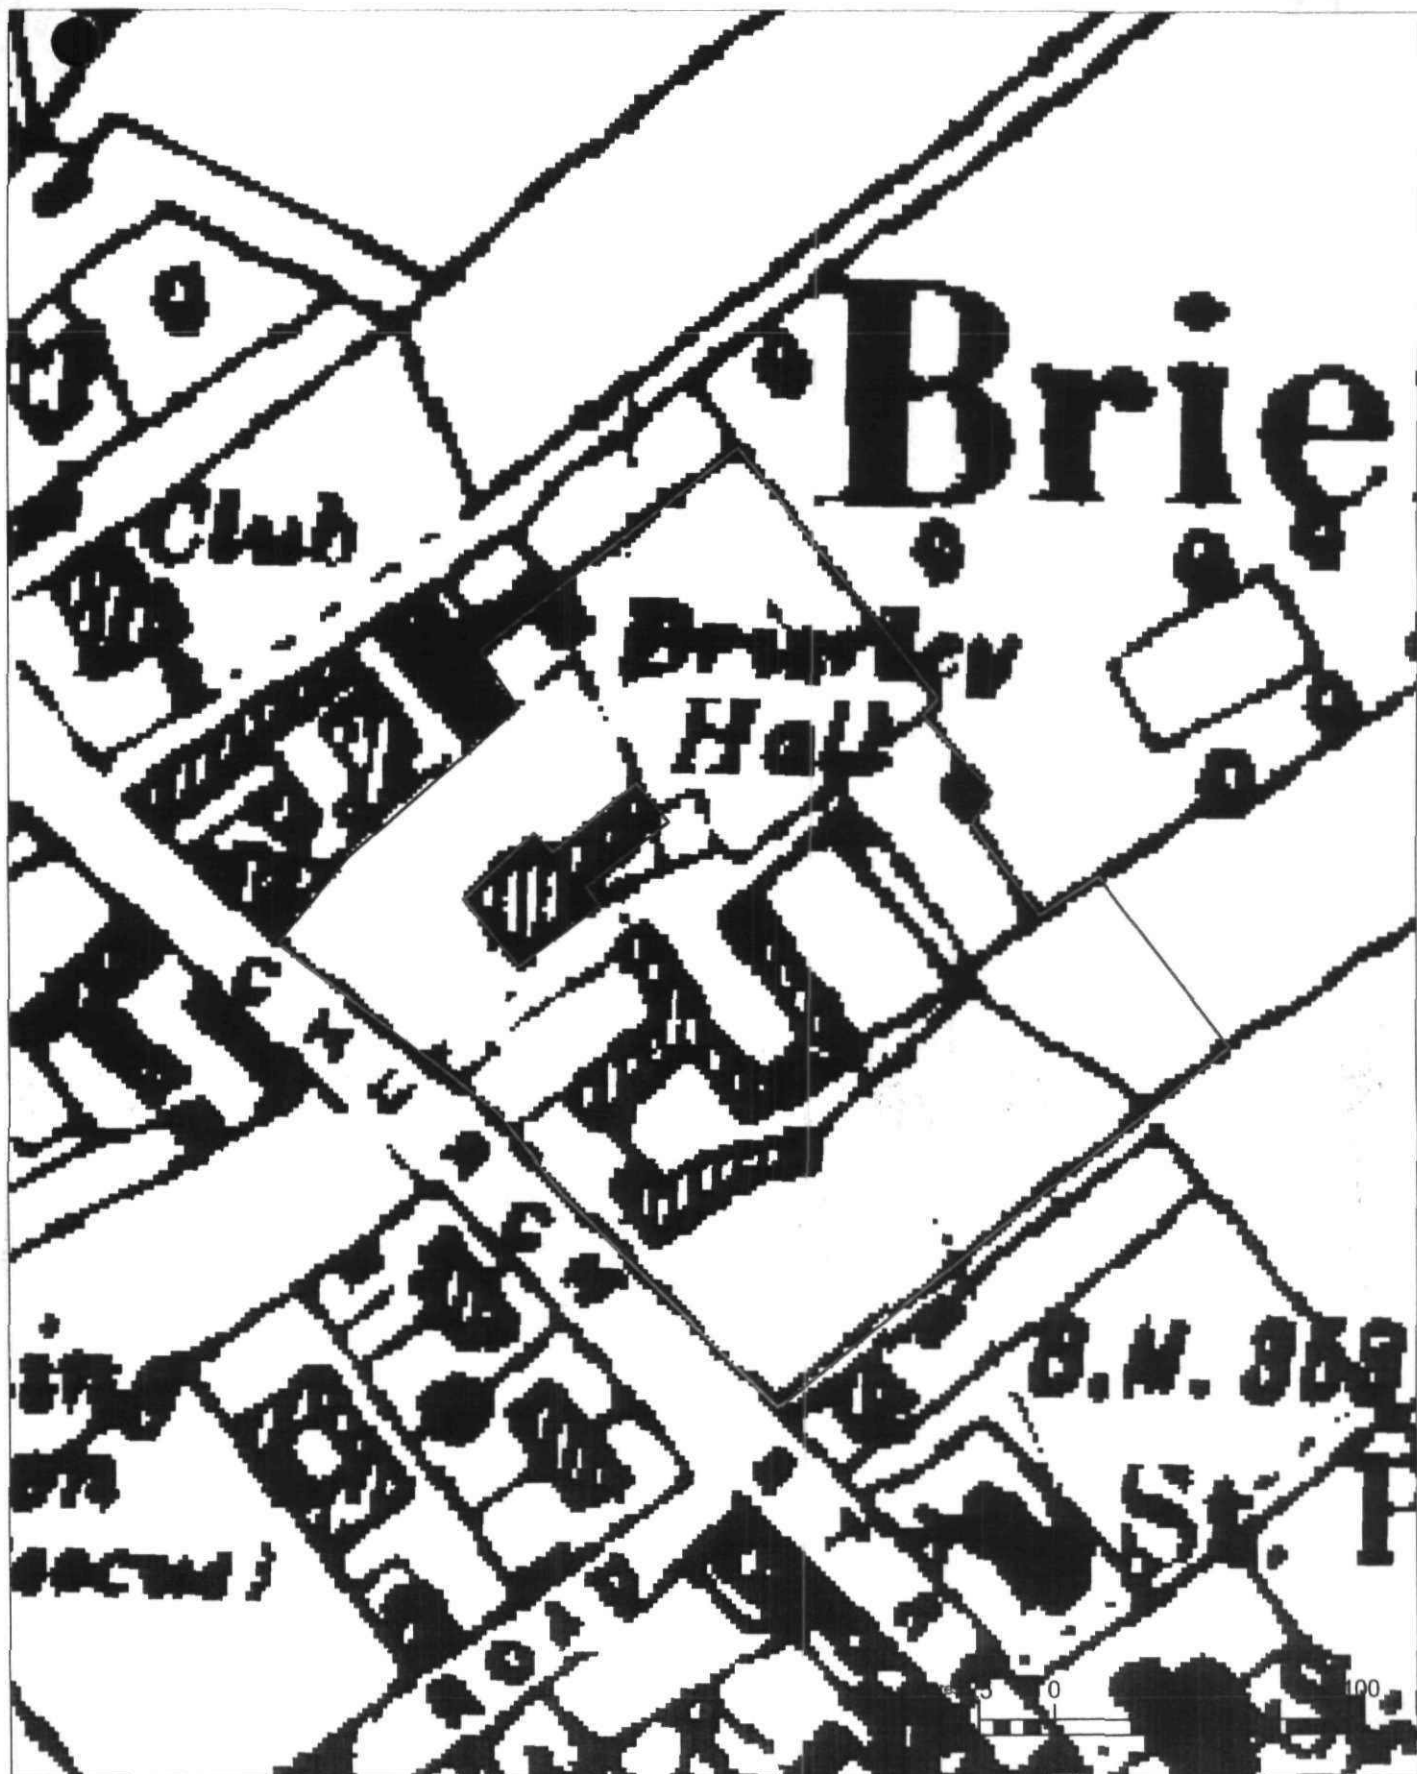
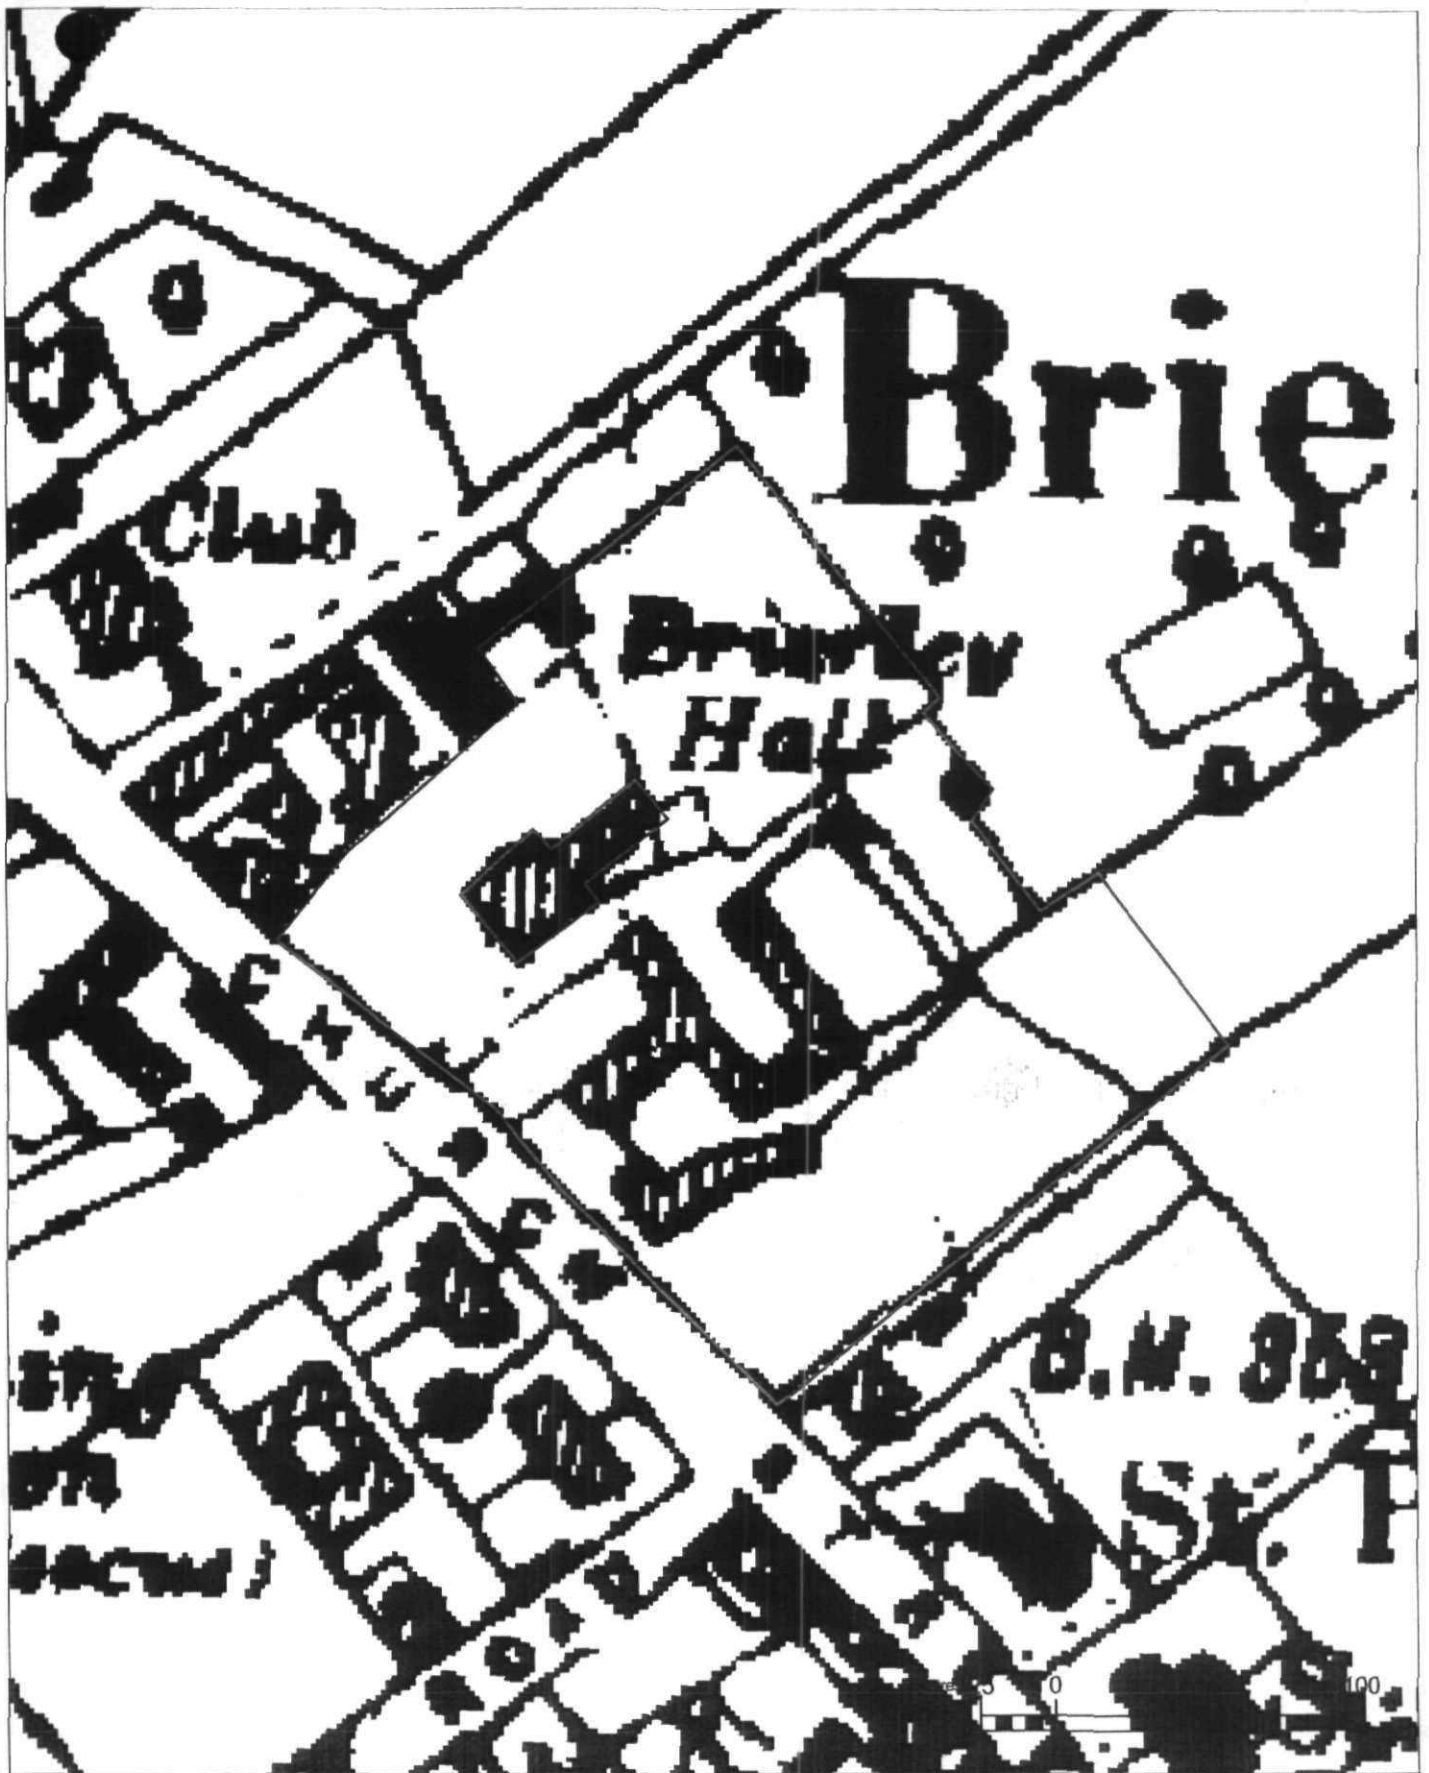
Figure 14
 OS map, 1939

The OS map dated 1939 is of a poorer quality but does not appear to show any changes to the buildings and still does not show the extension to the North (Fig. 14).

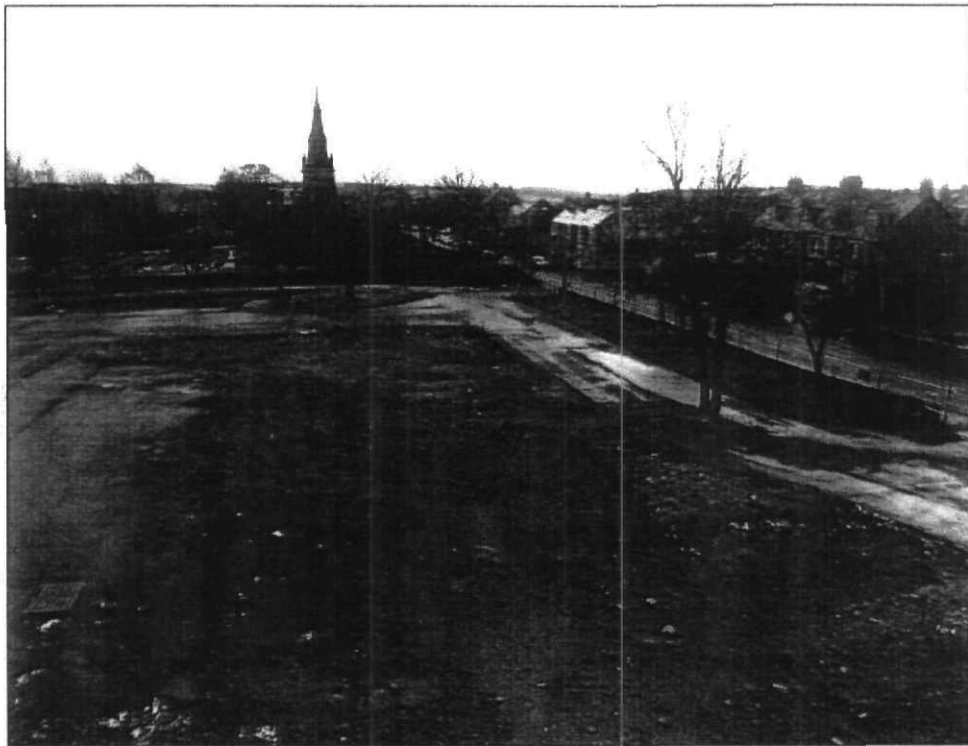
Fig. 18 View of the site looking towards St. Paul's Church showing the footprint of the earlier brick extension.

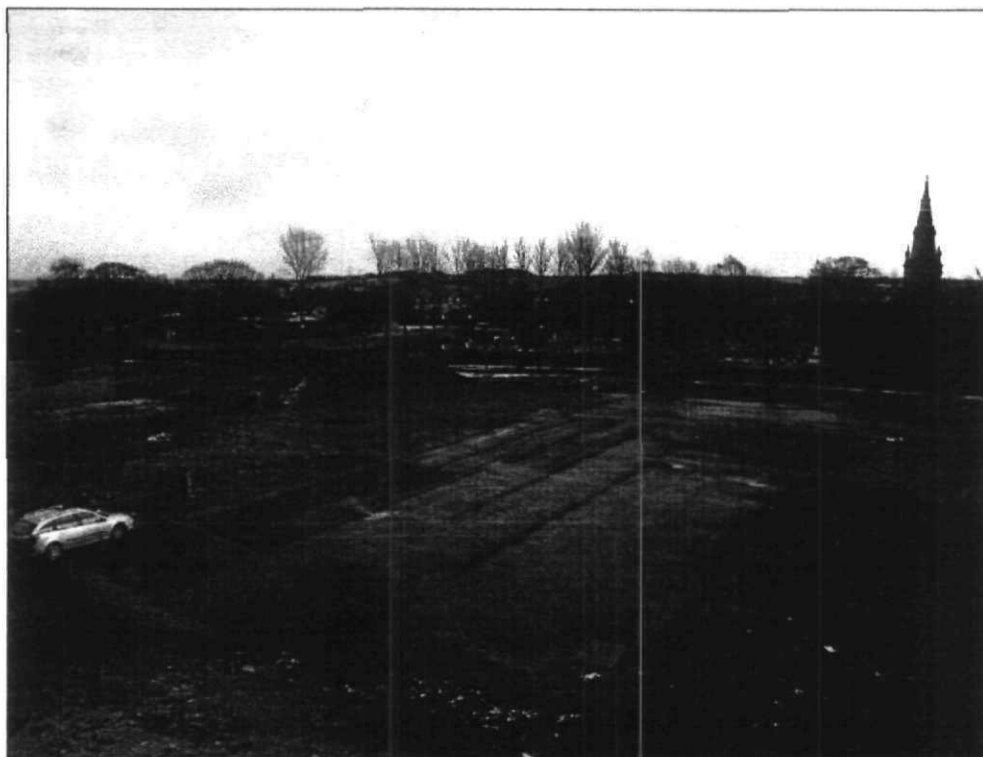
Fig. 19 View of the site looking left from Fig. 18 showing tarmac and mound of building rubble.

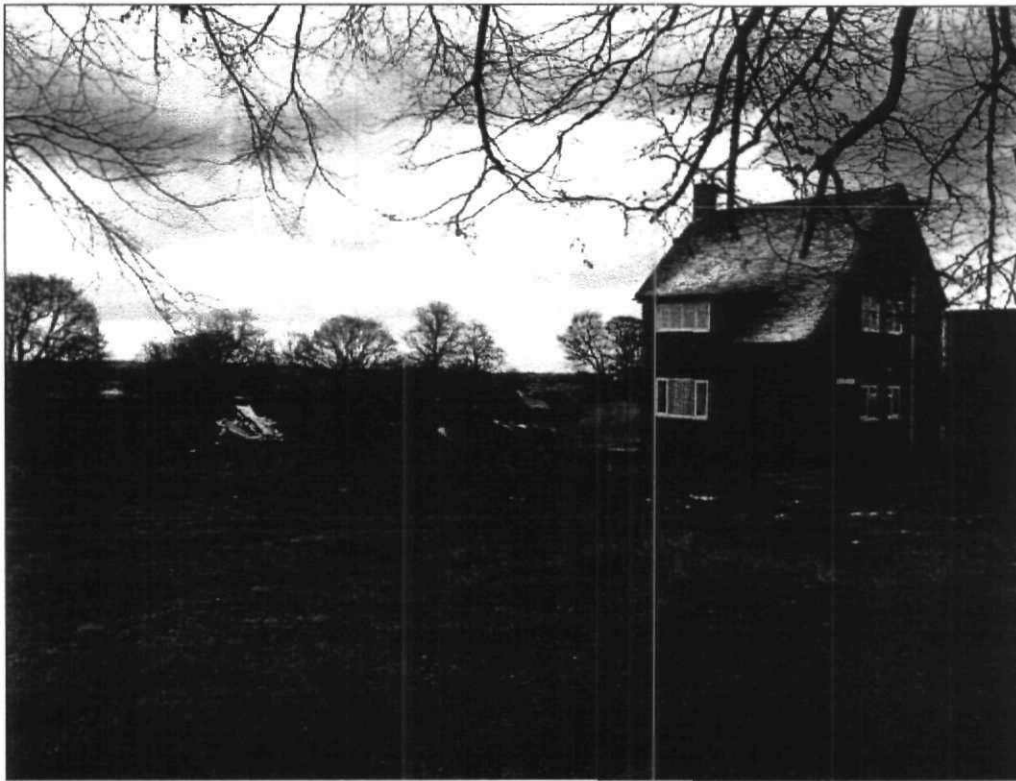
Fig. 21 View of the rear of the hall looking right of Fig. 20 showing the modern house.

- 5.2 A modern house that appears on OS maps from 1962 (Figs. 15 and 21) is currently inhabited but will be demolished during the development.
- 5.3 The remains of a building located along the Northern boundary of the site probably relates to the rectangular building identified on maps from 1893 (Fig. 12 and 22). Apart from this, the area to the rear of the hall appears to have remained undeveloped since the Hall was first built. There was no sign of the rectangular building indicated as being in this area on the 1985 OS map (Fig. 17).

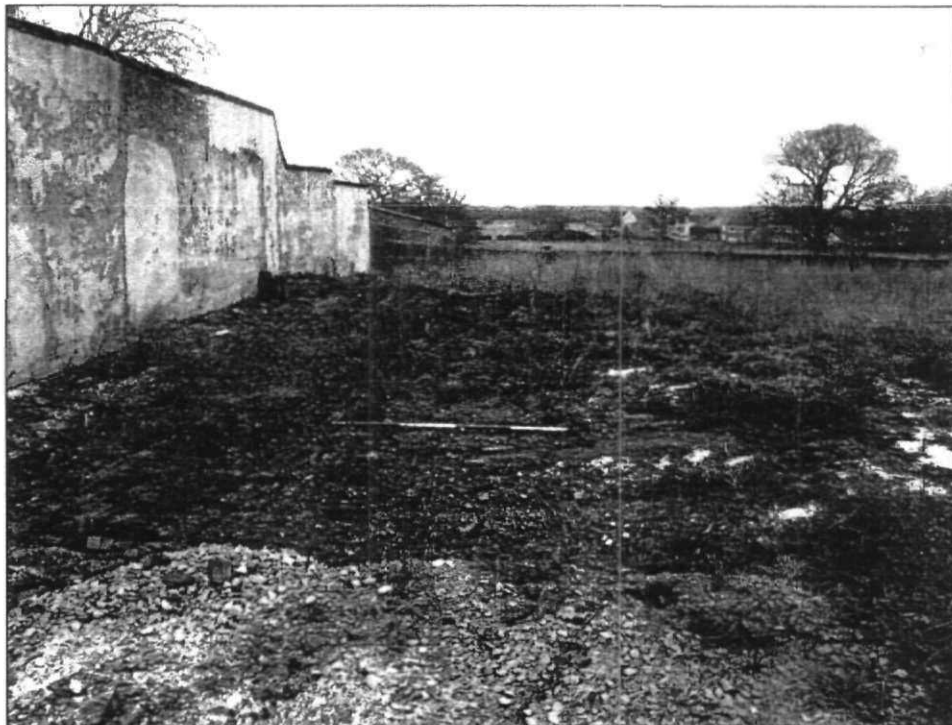
Fig. 22 Area of the demolished building along the North boundary of the site that is marked on OS maps from 1893. Also shows the brick wall that may be part of the original garden boundary.

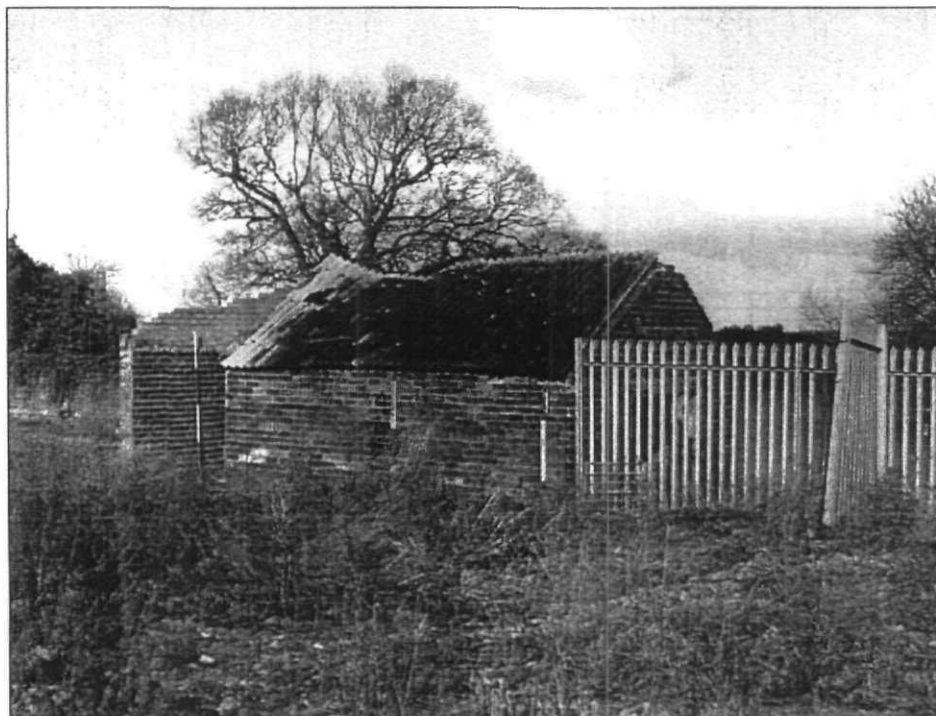
- 5.4 A small brick building was located along the Eastern boundary of the site which appears to have been marked on maps from as early as 1854 and some of the brick boundary wall for the garden is still intact (Figs. 11 and 23).

Fig. 23 The small brick outhouse that appears on maps from 1854.

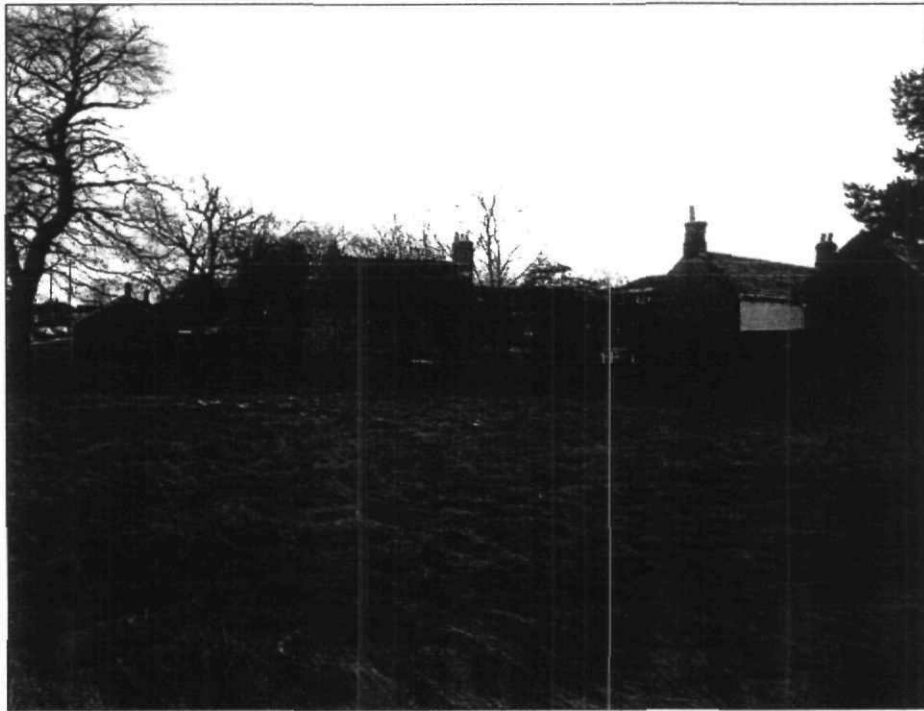
Fig. 24 View of out the front of the hall looking towards Church Street which would have been a former lawn.

- 5.5 The front of the hall is another area of the site appears to have remained undeveloped since 1853 (Fig.). The 1841 tithe map shows a building to the front of the Hall running along Church Street. Remains of this building or earlier Medieval settlement remains could still be preserved in this area.

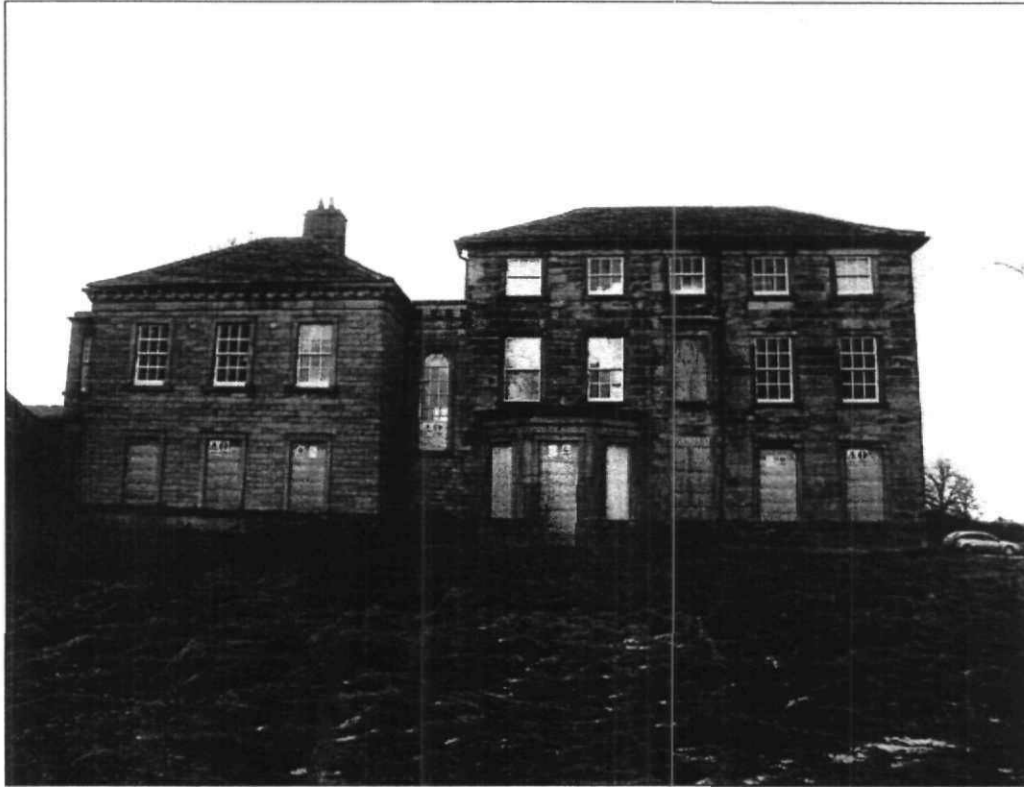
Fig. 25 Western elevation of Brierley Hall (on the left) and the north-western wing (on the right)

6.3.1 The current Brierley Hall complex consists of four amalgamated ranges, which are the original Brierley Hall, based on cartographic evidence most likely an early 19th century house built in a Georgian architectural style; a north-western wing built in the first quarter of the 20th century emulating the architectural style of the existing house; a long rear extension abutting the eastern elevation of the Brierley Hall which appears to have been built in around the first quarter of the 20th century although it might have incorporated an existing structure abutting the Hall; and a modern building abutting the eastern wall of the north-western wing (Figs 25 and 26). The complex also included a later

- 6.5.1 The North-western wing is a two-storey high and three-bay wide stone-built rectangular building (north-west/south-west) abutting the northern end of Brierley Hall (Fig. 25). It is built in the same style as Brierley Hall with a hipped roof and a chimney stack positioned at the rear end. There are two recessed narrow bays on the northern and southern ends. The bay adjoining Brierley Hall has an elongated window with semi-circular arched head.

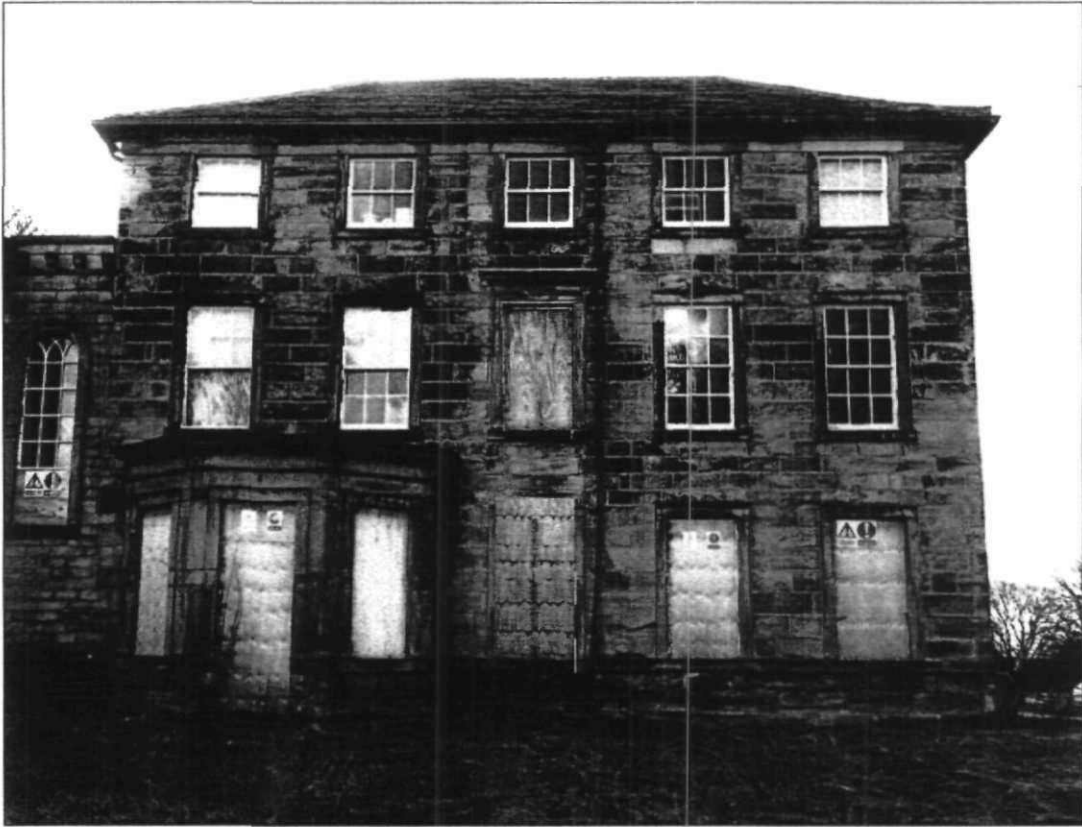
Fig. 27 Western elevation of Brierley Hall

- 6.4.2 The main western elevation (Fig. 27) has a continuous string course which functions as a sill for the window openings of the ground floor. It has a later canted bay porch with a central doorway flanked by two large window openings built in a similar architectural design as the main building. On the first floor the central window opening has a decorated stone canopy emphasised by architrave, frieze and cornice. The window openings on the second floor are shorter. All the window openings have square-faced surrounds and projecting sills.

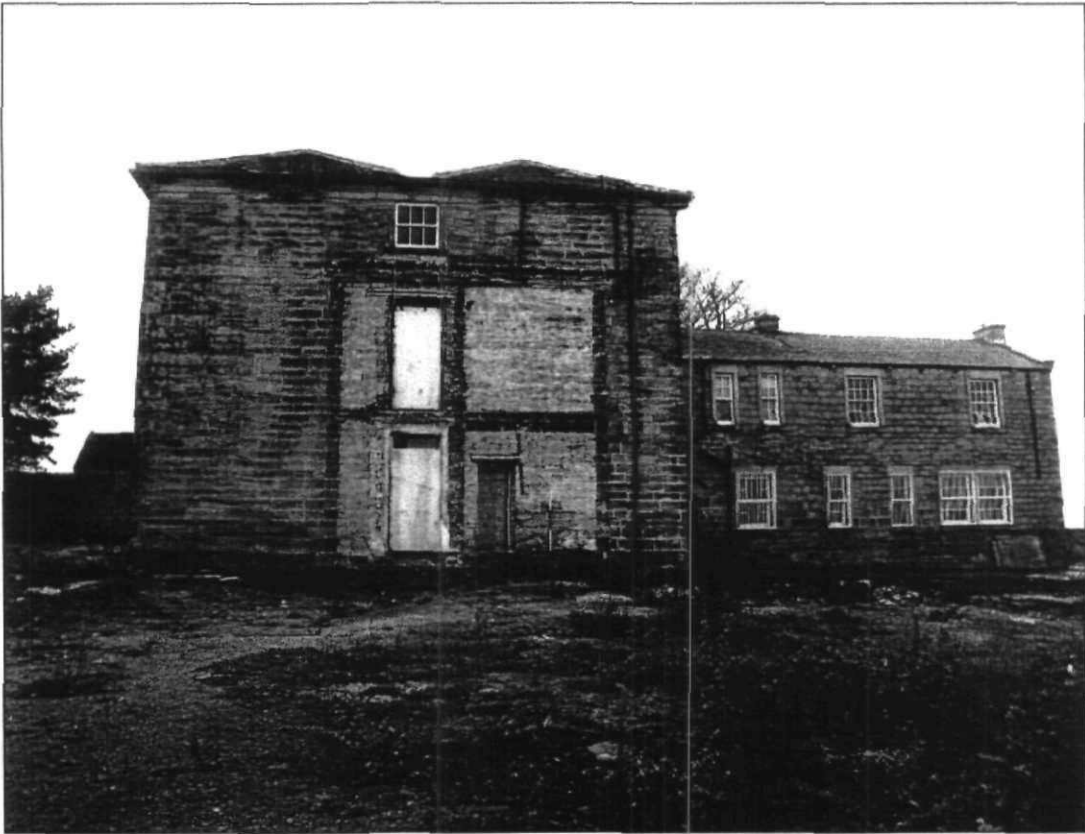
Fig. 28 Southern elevation of Brierley Hall (on the left) and the rear extension (on the right)

- 6.4.3 The Southern elevation (Fig. 28) has a central doorway which is now boarded up. This doorway would have had some steps but they would have been removed when a later extension was built against this elevation. The scars of the later extension can be seen in the form of sockets carved in the stone wall and paint. A window opening on the first floor has been modified into a later doorway which would have connected the existing building with the later extension when it was still standing.

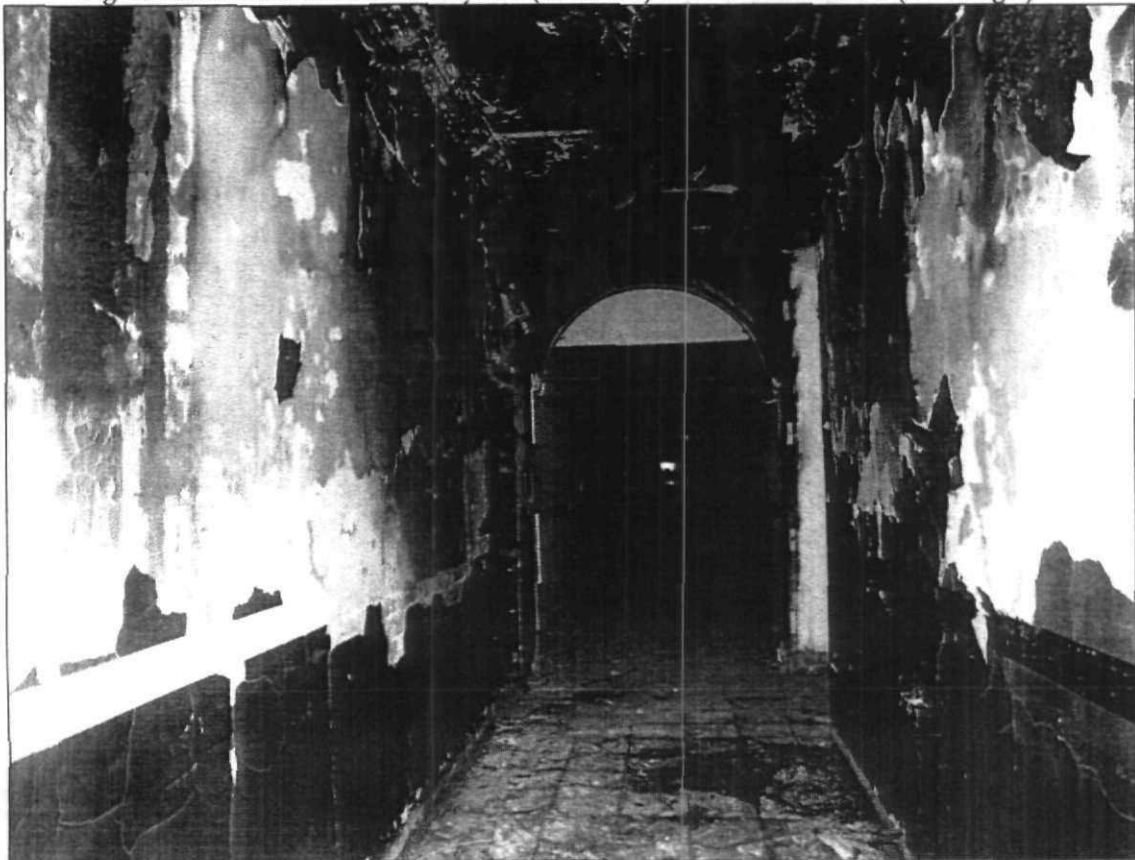
room and the staircase (Fig. 29). The floor appears to be a later replacement of wooden panels. The plasterwork is in poor condition due to the fire.

Fig. 29 Hallway on the ground floor

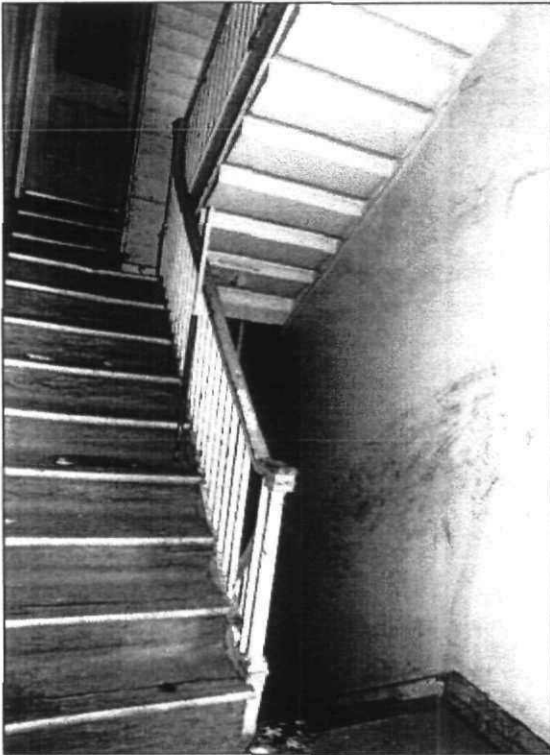
Fig. 34 Dog-leg staircase

- 6.4.11 The building has an elegant dog-leg cantilever staircase made of sandstone blocks and a timber carved balustrade (Fig. 34). The entire staircase is extant except for the newel post on the ground floor.

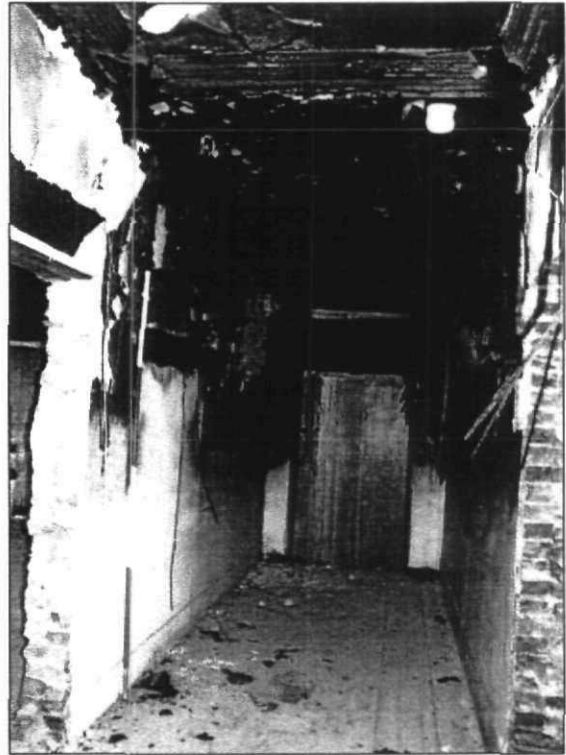
- 6.4.12 The central hallway on the first floor has also been partially damaged by the fire (Fig. 31). Partial fire damage is also perceivable in the western rooms (Fig. 35). The fire places on the first and second floors have been blocked up and radiators were installed beneath the windows which entailed partial dismantlement of the window shutters and sills (Figs 36 and 37).

Fig. 35 Hallway on the first floor

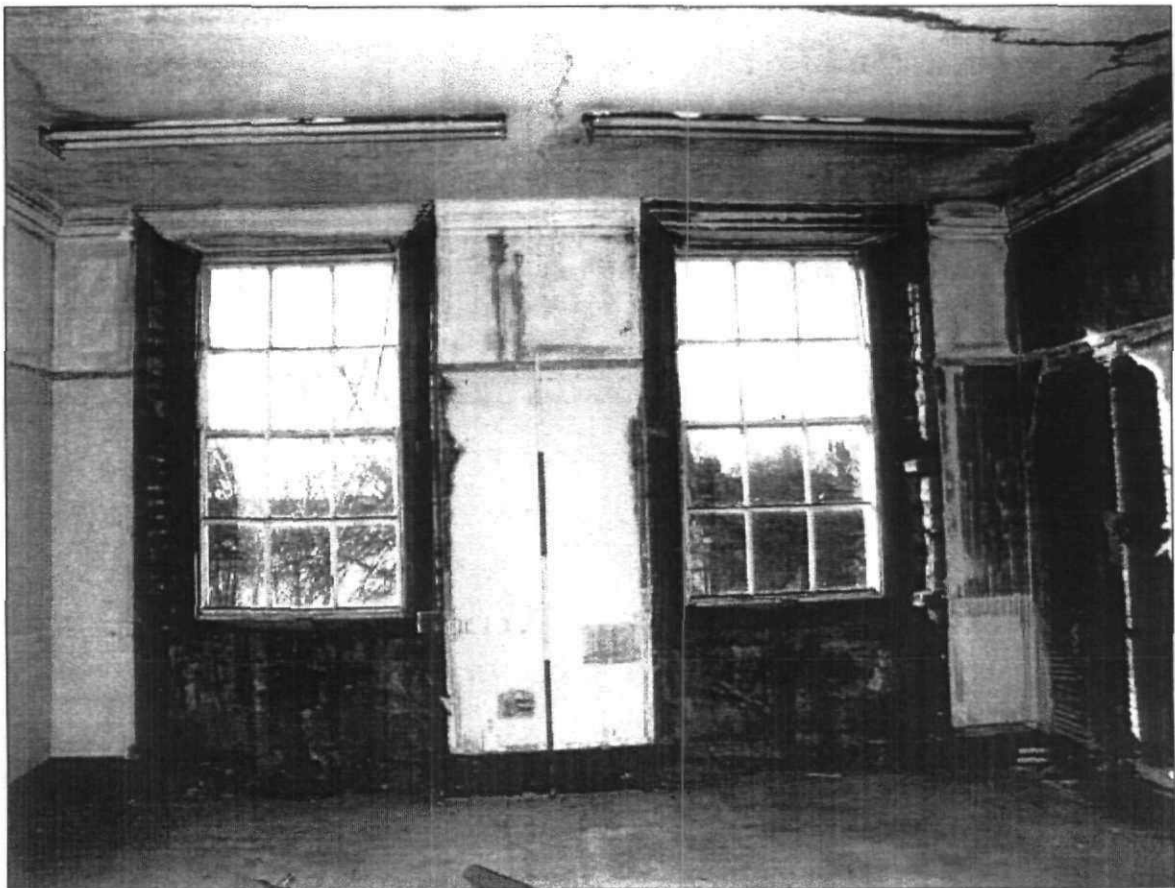
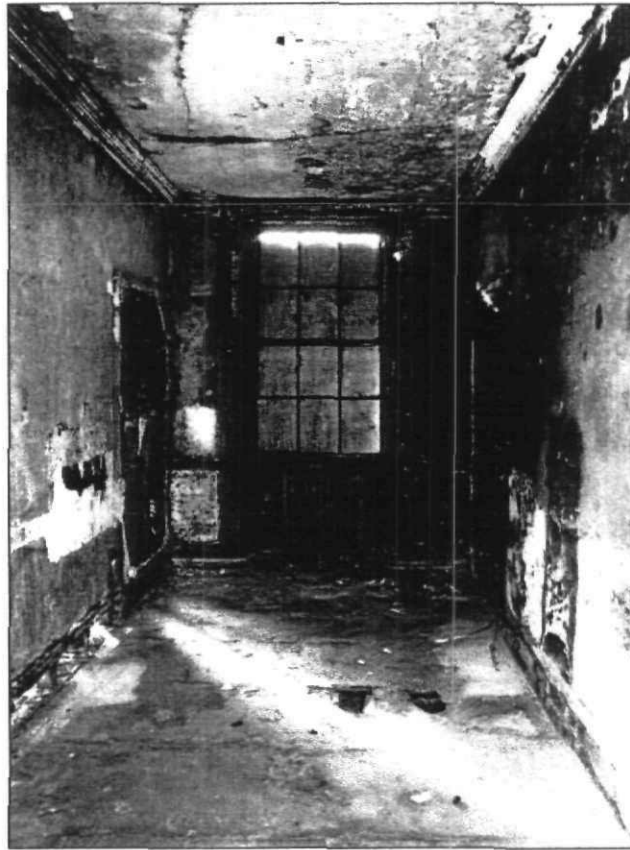
Fig.36 View of the south-western room on the first floor

Fig.37 Window on the central bay of the first floor with additional radiator

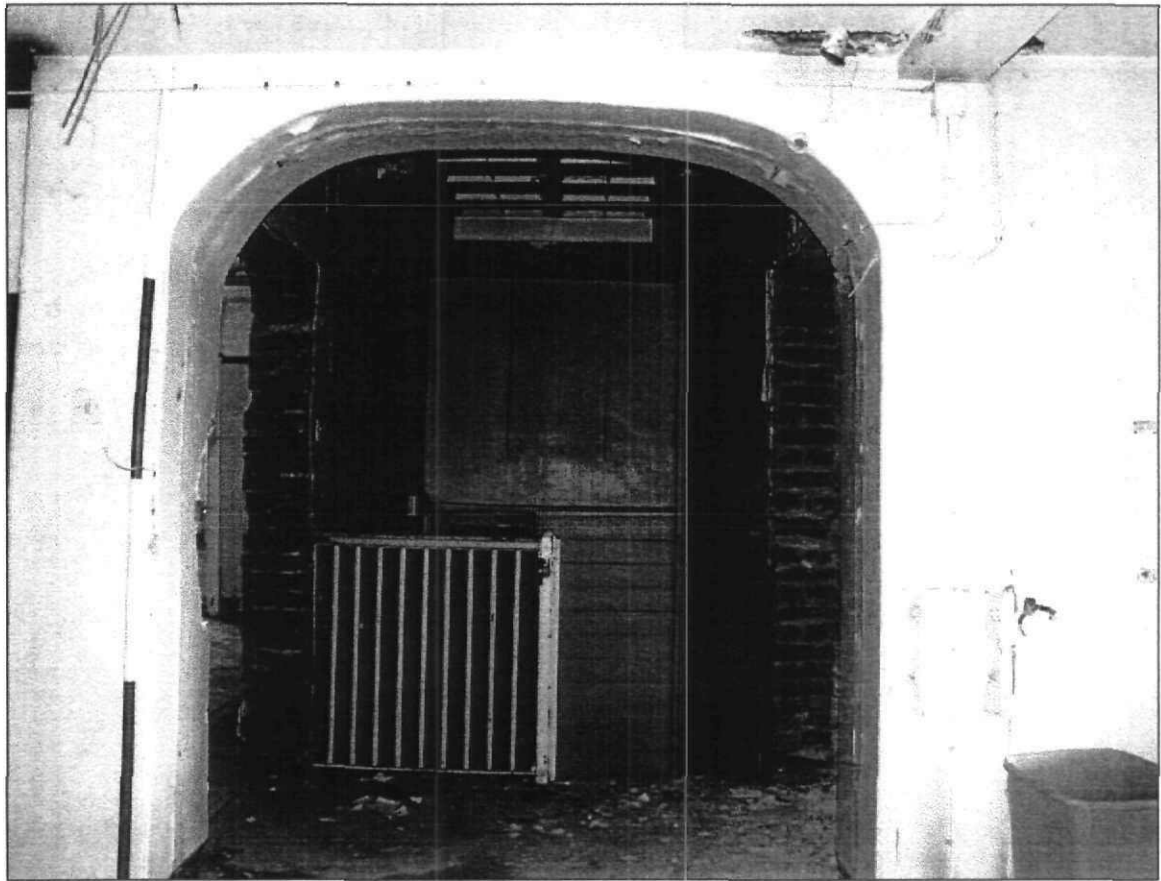
Fig. 39 Elliptical archway leading to the top of the staircase

- 6.4.14 The second floor has an elliptical archway leading to the top of the staircase (Fig. 39). There is a glazed ceiling light at the top of the staircase which may have had a lantern roof above it allowing light to the entire stairway. A few examples of plaster cornices, skirting boards, etc. survive on this floor (Fig. 40). However, some existing fabrics such as wall plaster have been recently stripped from several walls (Fig. 41).

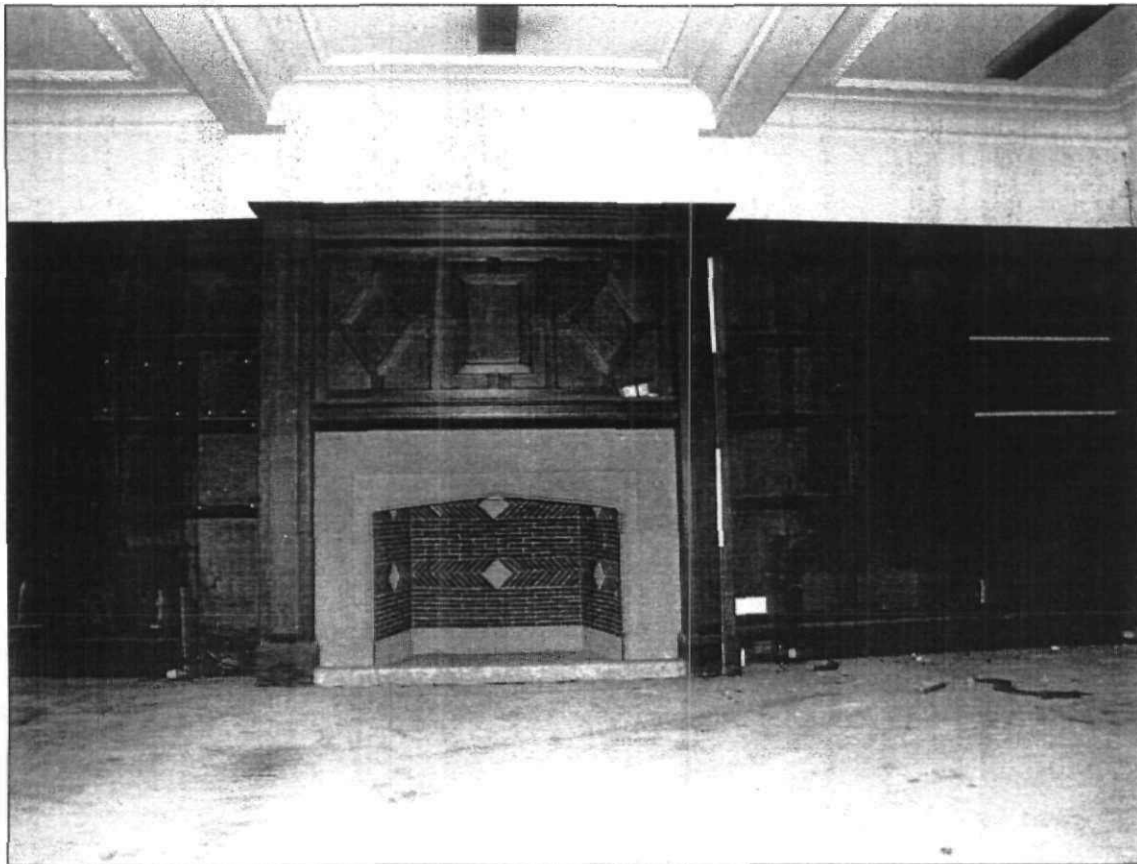
Fig. 43 General view of the billiard room, looking east

- 6.5.3 The interior consists predominantly of two large rooms on each level. The room on the ground floor used to be the billiards room (Fig. 43) which has a central sandstone fire place, decorated plaster ceiling and oak wall panelling which incorporates a cabinet with a rack for snooker cues (Fig. 44). The room has horned sash windows which are externally boarded up (Fig. 45).
