**An Archaeological Desk-Based Assessment
of Brierley Hall, Brierley, Barnsley**

Archaeological Research Services Ltd
Report No. 2010/12
February 2010

**An Archaeological Desk-Based Assessment
of Brierley Hall, Brierley, Barnsley.**

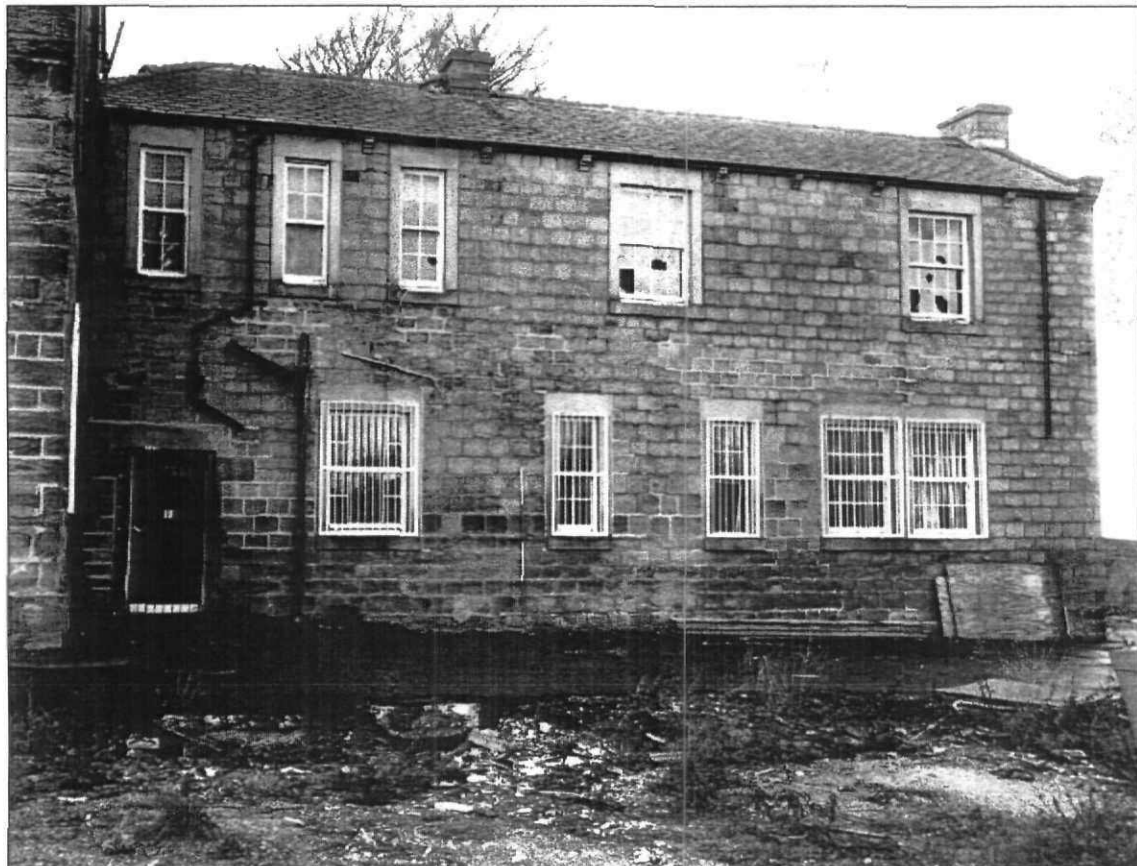
Fig. 47 Southern elevation of the rear extension

- 6.6.1 The rear wing is a long rectangular two-storey range made of sandstone with asymmetrical bay sub-divisions marked by a series of sash windows of different width on both floors. It has a slated roof with two chimney stacks with a hipped abutting the eastern elevation of Brierley Hall and a pitch gable end on the eastern end with stone coping supported by two kneeler stones at the end of the verge (Fig. 47).
- 6.4.2 This range appears to have been built in around the first quarter of the 20th century although it might have incorporated an existing structure abutting the Hall.
- 6.6.3 Internally, it has been mostly stripped revealing the brick walls and the timber joists for the first floor which has herringbone strutting (Fig. 48). Most of the rooms are empty although there is a metal money safe box inserted in the wall of one of the rooms (Fig. 49).

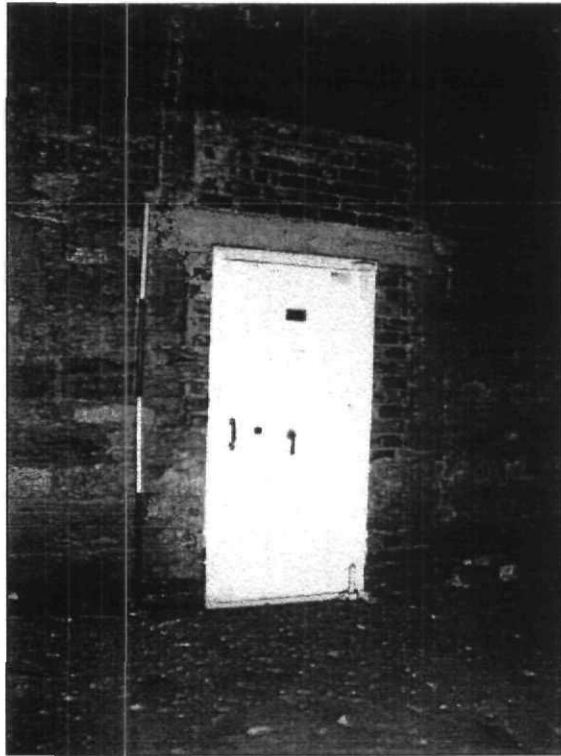
Fig. 49 Inserted metal money safe box
