**Bat Roost Suitability Assessment**

**Dearne Playhouse, Washington Road**

Barnsley Metropolitan Borough Council

Report Reference: ER-5873-01

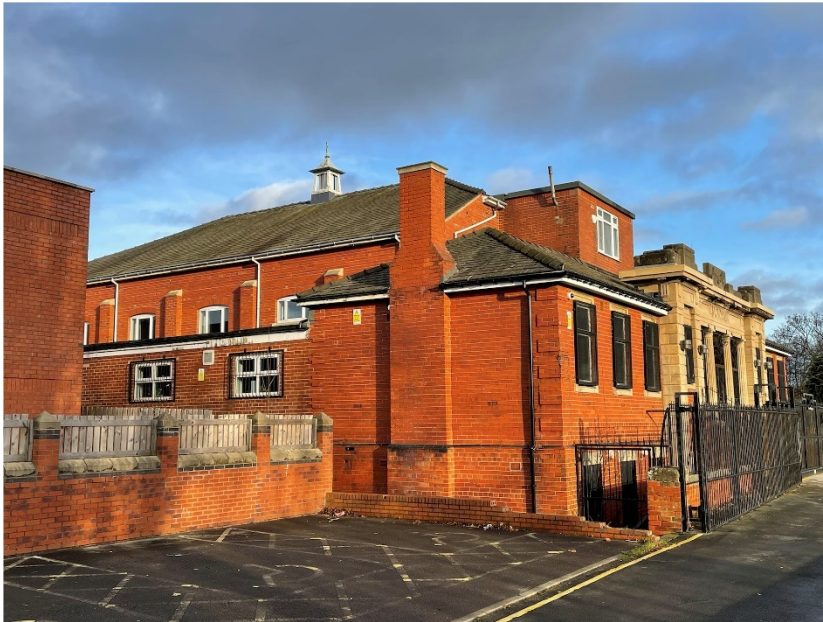
**Figure 3** General view of the building on site.

14. The Playhouse building has a complex series of multi-level roofs, with a main central hall and several extensions. A decorative entrance is also included at the southern elevation.
15. The building is constructed from red brick, with tiled roofs of hipped design, whilst the areas of flat roof are covered by felt.
16. Throughout the building external structure, masonry is a good condition, with no missing mortar noted and no damaged bricks.
17. In general, the roofs are also in good condition, though some areas were found to contain features that could be used by roosting bats. On the

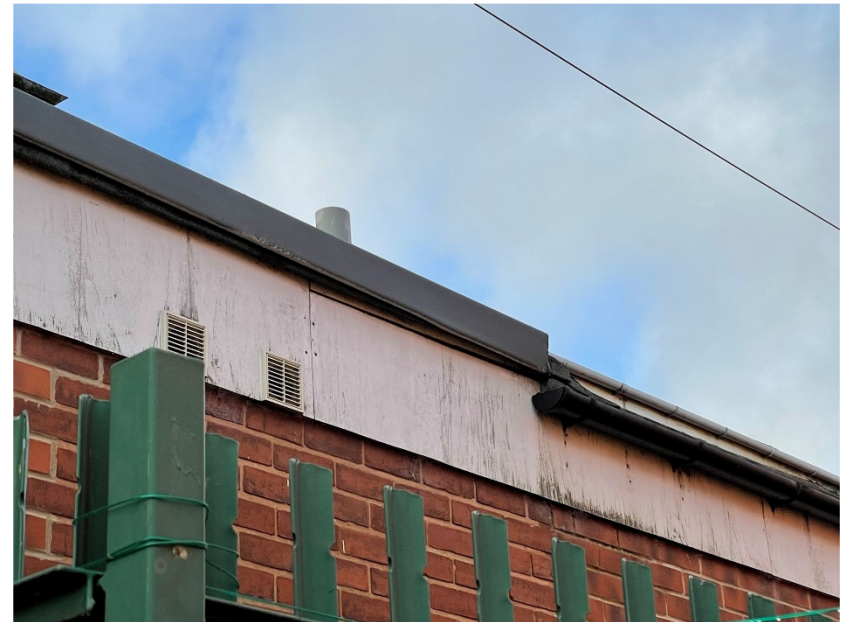
**Figure 4** Showing raised tiles on the south-west corner of the building

18. Some slipped and damaged tiles are present however, predominantly on the single storey south-west and south-east blocks.

27. Based on the features present, the Dearne Playhouse is assessed as having moderate suitability for roosting bats and, further detailed survey is recommended in order to ascertain the status of roosting bats.

28. In line with best practice guidelines (Bat Conservation Trust, 2016), further survey should take the form of two nocturnal surveys; either dusk emergence or dawn re-entry surveys. These surveys should be undertaken during the main active bat season, which runs from May to August inclusive, with September providing sub-optimal conditions.

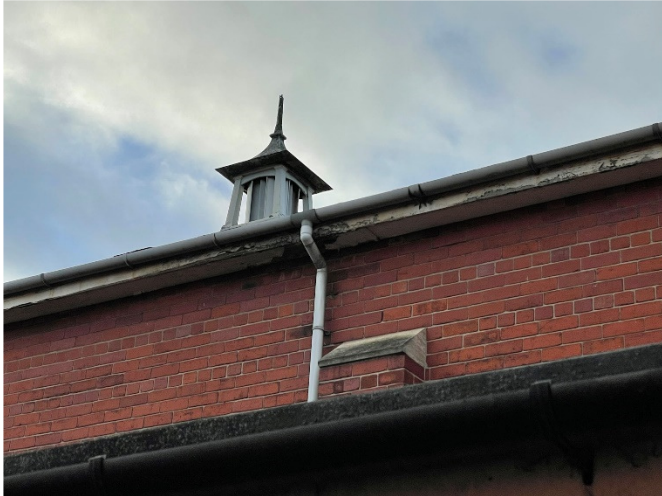
**Figure 5** Showing water damaged wooden fittings on the east side of the building

19. The guttering, fascias and soffits were found to be well maintained. Some of the fittings have been recently installed, with no signs of wear noted. Others, such as along the east and west side of the main hall have been damaged by water (Figure 5). A soffit end is in poor condition at the south-west corner as well, with small gaps present between the brick and wood (Figure 6). These gaps may allow access behind the wooden fittings, creating cavities that could be used by small numbers of roosting bats.
20. A small section of guttering, fascia and soffit at the south-east corner of the building is worn, with gaps visible behind the wood fittings. These crevices could also be used by roosting bats.
21. A section of fascia on the northern side of the main hall is also in poor condition, with gaps possibly present between it and the wall.

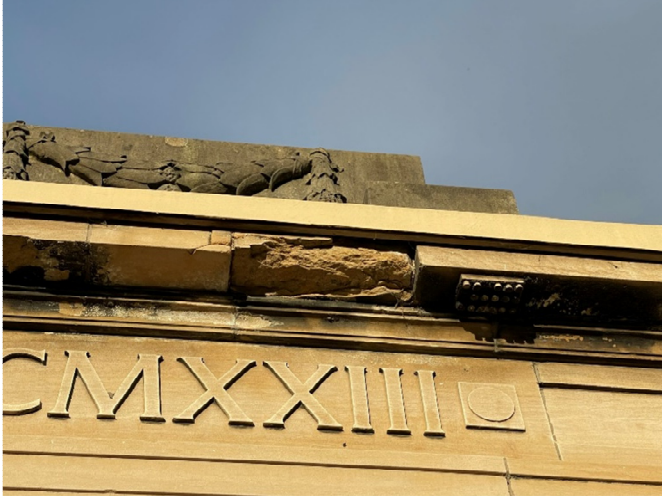
**Figure 8** Showing damaged stonework within the entrance feature

22. At the front of the building, the decorative entrance stonework has suffered from erosion, creating several gaps between the individual stones, which could be used by roosting bats (Figure 8).
23. Around the edges of the sandstone entrance feature, there are gaps present where flashing has lifted up (Figure 9). Bats could potentially roost between the flashing and the roof files underneath.
24. The chimney and bell tower were found to be in good condition, with no potential roost features recorded in association them.
